COMANDO DA AERONÁUTICA
CENTRO DE INVESTIGAÇÃO E PREVENÇÃO DE
ACIDENTES AERONÁUTICOS

FINAL REPORT
A - 036/CENIPA/2017

OCCURRENCE:	ACCIDENT
AIRCRAFT:	PR-MEY
MODEL:	S-76C
DATE:	01MAR2017

This is the Final Report of the 01MAR2017 accident with the S-76C aircraft model, registration PR-MEY. The accident was classified as “[ARC] ABNORMAL RUNWAY CONTACT – Abrupt Landing”.

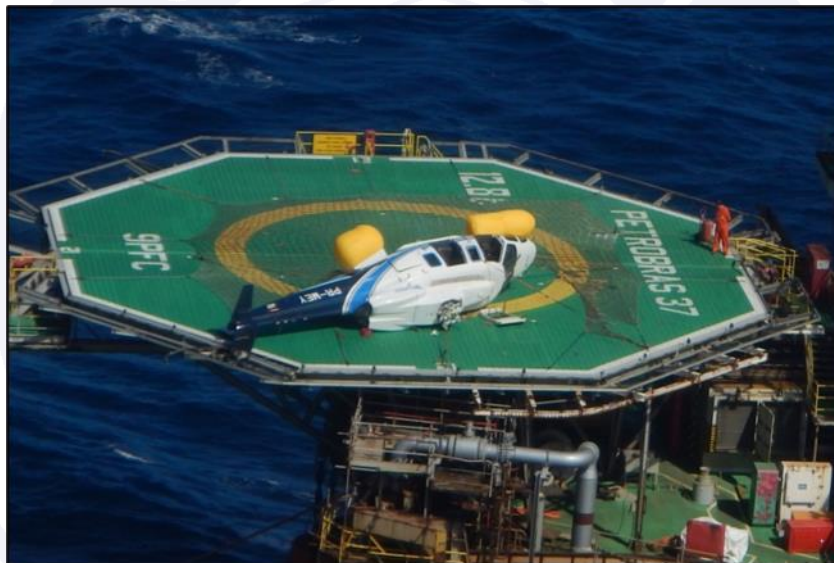
Figure 1 - Aerial view of the aircraft at the scene of the occurrence.

The landing took place in a left roll attitude (approximately 5°), causing the left landing gear to touch the helideck before the right one. Then there was the tip-over of the helicopter on the right and the breakage of the main rotor and tail rotor blades, as well as damage to the aircraft structure.

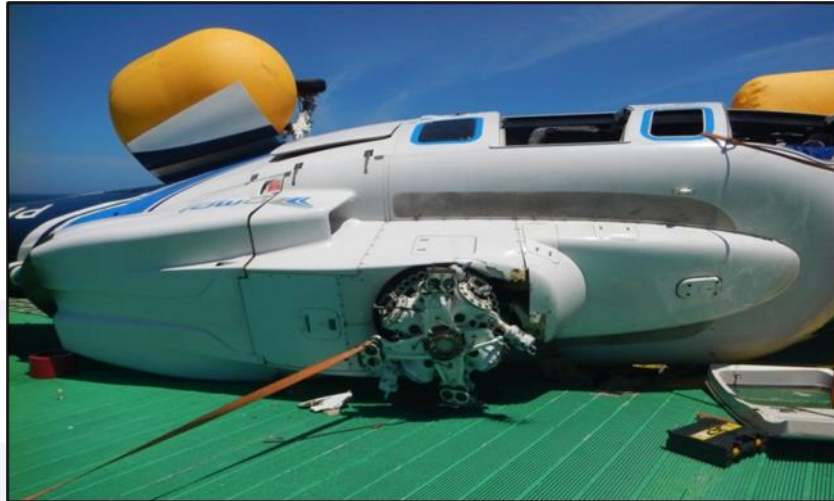
The aircraft had substantial damage to the main rotor, tail rotor, landing gear and internal engine damage due to the sudden stop of the rotors, in addition to deformations in the fuselage.

Figure 2 - View of the aircraft, highlighting the damage to the main rotor head.

After the aircraft overturned, the main rotor and tail rotor blades broke, as well as damage to its structure.

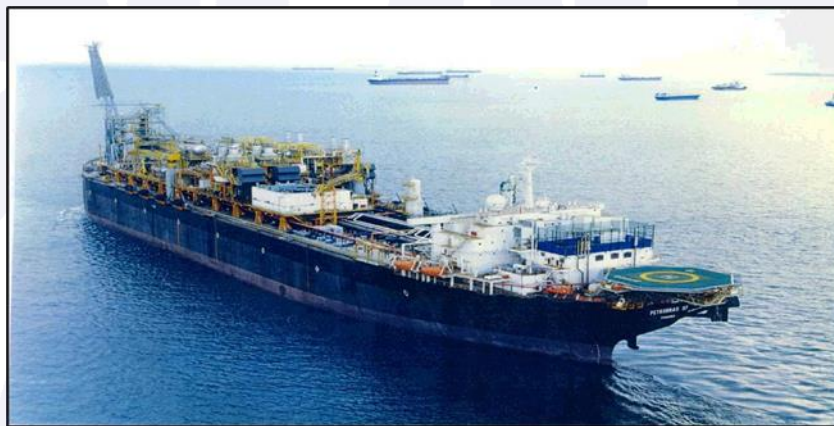
The P-37 platform helideck was privately owned and managed by the Petrobras and had technical conditions for helicopter take-offs and landings during the day and for emergency take-offs and landings at night. It was located at the stern of the ship and in a lower position in relation to the vertical structures of the platform (Figure 3).

Figure 3 - View of the helideck at the stern of the P-37 platform.

Such discrepancies were caused by the different positioning of the windsock and the helideck. While the windsock was positioned at a high point of the ship, receiving a "clean" wind (without interference from obstacles), the helideck was positioned close to several obstacles that caused the turbulence of the air present at the landing site.

Such discrepancies were due to the positioning of the windsock, which was at a high point of the ship, receiving a "clean" wind (without interference from obstacles), while the helideck was located close to several obstacles, which caused the air to swirl on its surface.

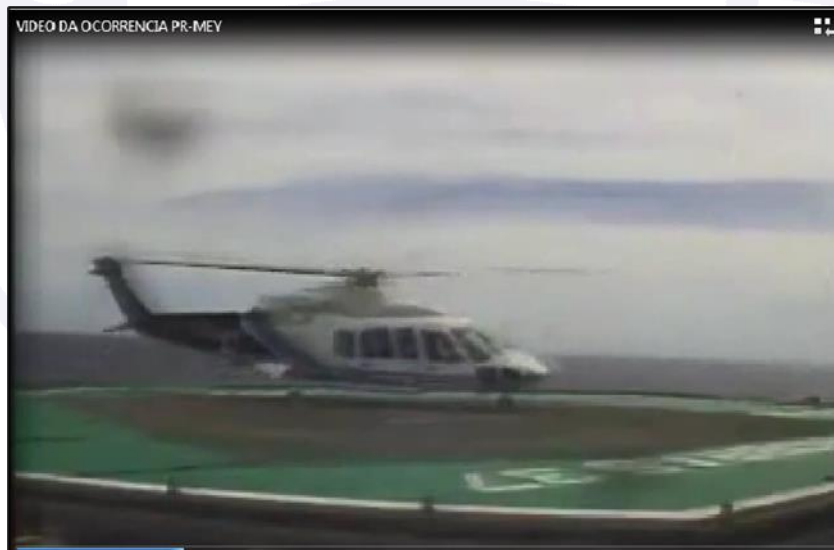
Figure 5 – Frame of the footage, highlighting the moment when the aircraft touched the helideck.

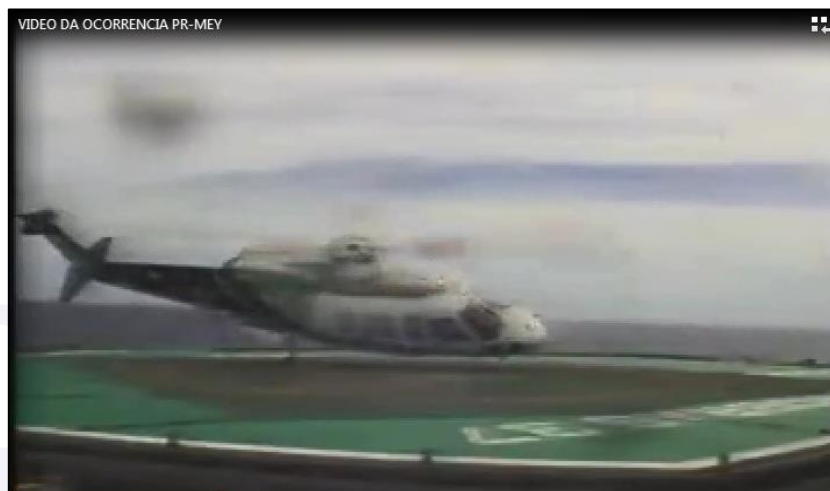
Figure 6 – Frame of the footage, highlighting the overturn of the aircraft after the hard landing.

- u) after tipping over, the aircraft slid to the right until it came to a complete stop, remaining on the helideck;
- v) the aircraft had substantial damage;

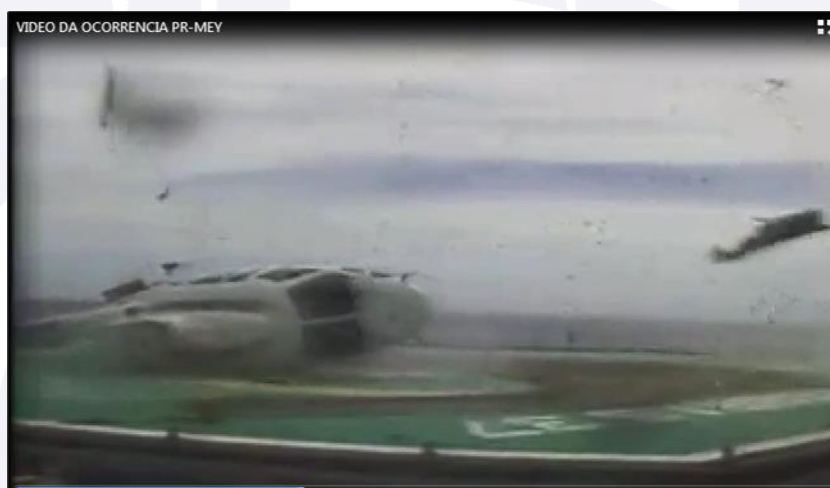
Figure 7 – Frame of the footage, highlighting the overturned aircraft and the collision of the main and tail rotor blades against the helideck surface after the hard landing.

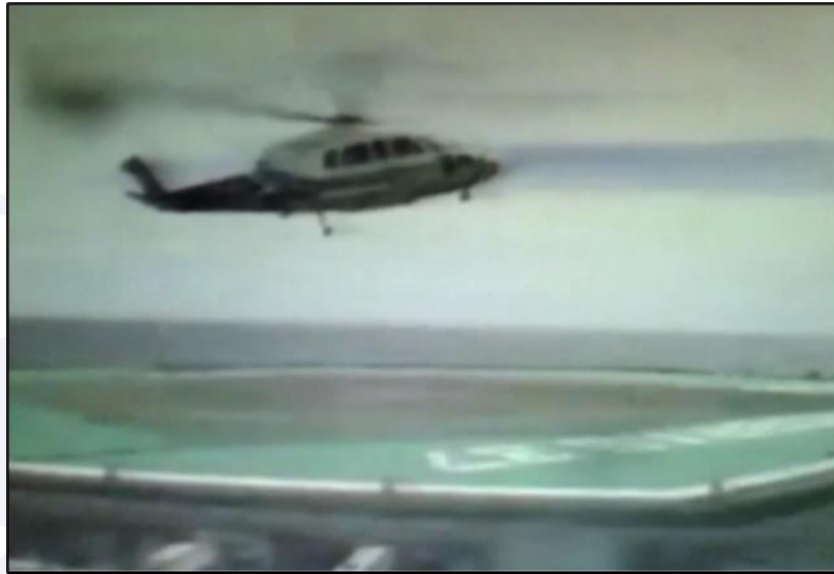
The video image also indicated that the aircraft's heading, when arriving over the helideck, was oriented slightly to the left, using the UM name painted on the helideck

"PETROBRAS 37" as a reference, which was perpendicular to the heading of the ship at 025°, as informed in the Helideck Report (Figure 12).

Figure 12 - P-37 camera footage frame, highlighting the aircraft's tilt to the left during the approach.

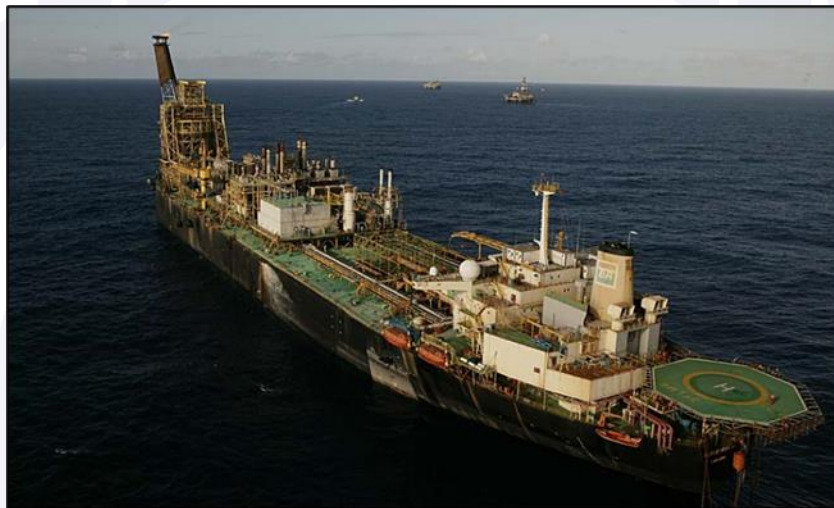
It is noteworthy that the P-35 had similar characteristics to the P-37 (Figure 14).

Figure 14 - View of the P-35 platform ship, highlighting the helideck at the stern of the ship.

Furthermore, in Petrobras' Detailed Investigation Report (RDI) No. 008/2011 of 30JUL2011, the company described as a causal factor the "turbulence and downdraft caused by the air flow that ascends when the wind strikes the structure ahead of the helideck, becoming descending and swirling after passing the structure, interfering with the approach ramp".
