**COMANDO DA AERONÁUTICA**  
**CENTRO DE INVESTIGAÇÃO E PREVENÇÃO DE**  
**ACIDENTES AERONÁUTICOS**

**FINAL REPORT**  
**A-089/CENIPA/2017**

<b>OCCURRENCE:</b>	<b>ACCIDENT</b>
<b>AIRCRAFT:</b>	<b>PR-MFR</b>
<b>MODEL:</b>	<b>210M</b>
<b>DATE:</b>	<b>03JUL2017</b>

This is the Final Report of the 03JUL2017 accident with the 210M aircraft model, registration PR-MFR. The accident was classified as “[SCF-PP] System/Component Failure or Malfunction Powerplant – Engine Failure in Flight”.

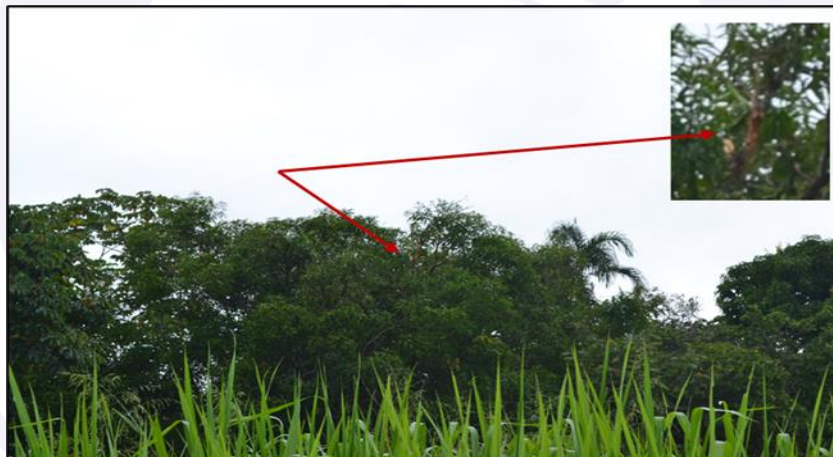
The first impact occurred in a pitch up attitude, causing the collision of the left horizontal stabilizer against a tree (Figure 1), which caused the detachment of the left elevator (Figures 2 and 3).

Figure 1 - View of the first impact point.

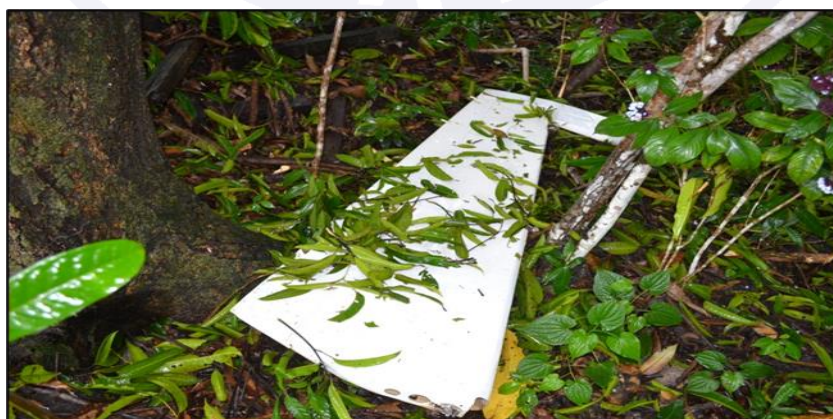
Figure 2 - Left elevator found near the site of the first impact.

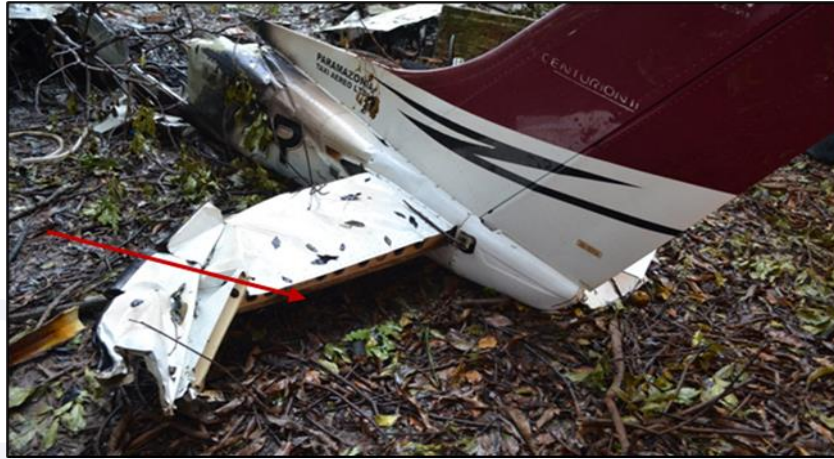
Figure 3 - Left horizontal stabilizer without elevator.

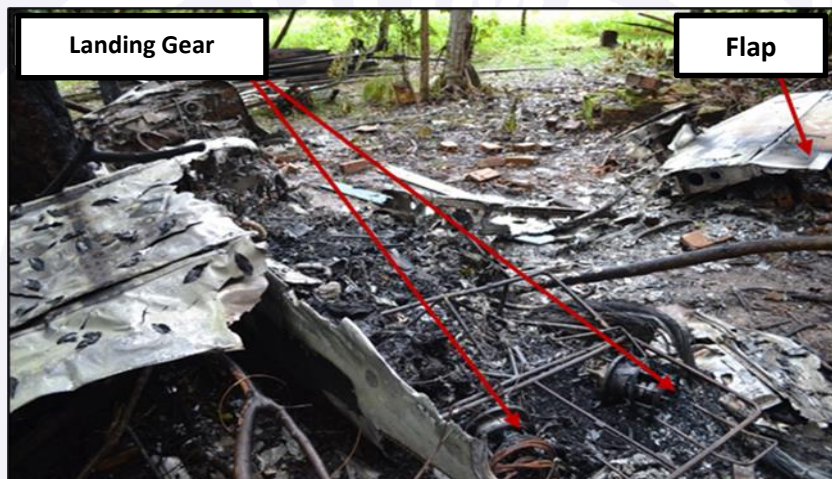
The landing gear and flaps were retracted (Figure 4). It was not possible to determine the position of the compensators.

Figure 4 - Aircraft destroyed by fire. Landing gear and flaps retracted.

As observed at the accident site, the flaps were retracted. Because of this finding, it was used the information available in the POH, which stated that takeoff distances should be increased by 10% for a takeoff with the flaps retracted. In this scenario, given the conditions of that flight, the total distance to clear the obstacle at 50ft would be approximately 760m.

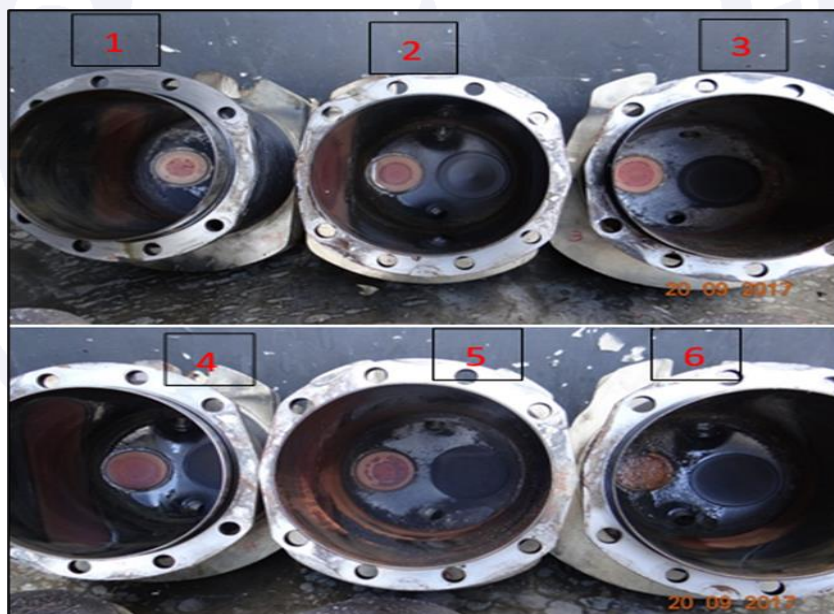
During the disassembly of the IO-520-L-12B engine, Serial Number (SN) 1002430, it was observed that all cylinder exhaust valves were reddish in color (Figure 5).

Figure 5 - Interior of the cylinders. Exhaust valves with reddish coloration.

This condition is a consequence of the engine operation with a lean fuel mixture, that is, the adjust of the mixture lever for a fuel and air ratio in the cylinder with less fuel. This procedure allowed the airplane to have a longer range.

Decreasing the fuel beyond that recommended in the manual (a too lean mixture), when used routinely, causes greater engine wear and the consequent gradual loss of power over time.

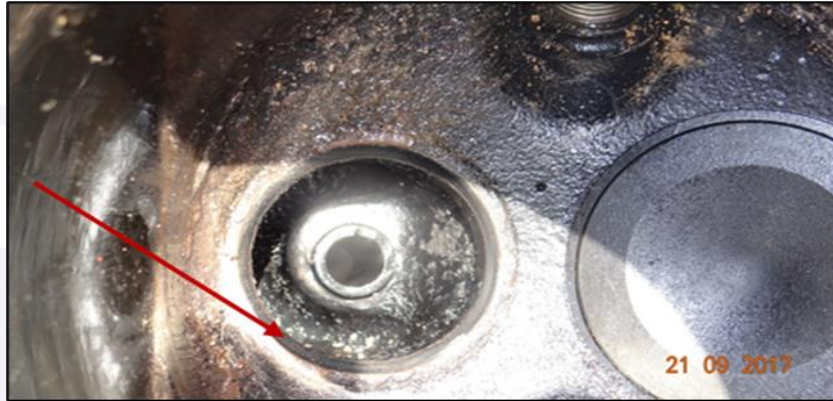
The valve seats of cylinders 1, 3, and 6 were darkly colored, resulting from poor seating (Figure 6).

Figure 6 - Valve seat with dark coloration.

The lack of engine power may be related to leakage in the valves of cylinders 1, 4, 5, and 6, allowing the air/fuel mixture to escape during compression time and causing low burning efficiency inside the combustion chamber. Cylinders 1 and 4 did not pass the GO/NO GO test.

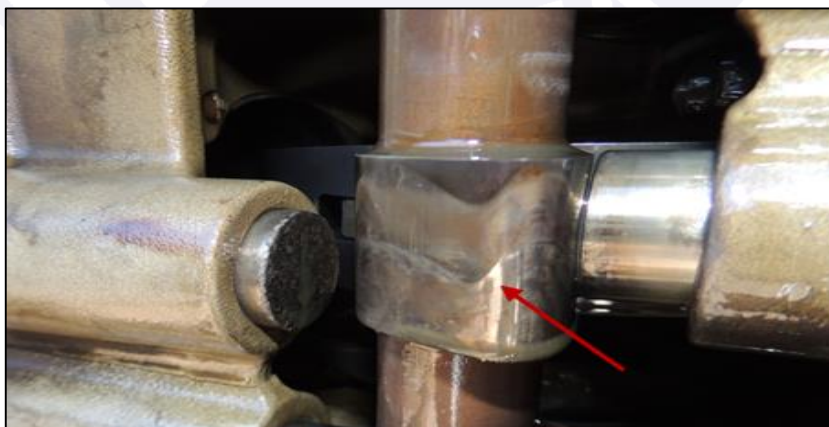
The camshaft drive assembly showed wear on one cam on the camshaft (Figure 8) and on three tappets (Figure 9).

Figure 8 - Wear on the cam of the camshaft drive assembly.

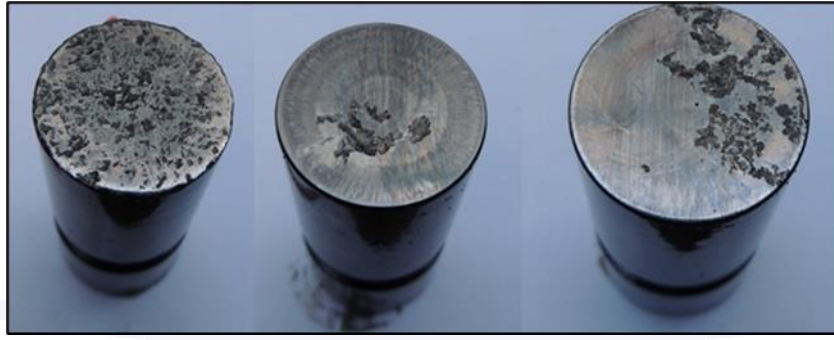
Figure 9 - Worn tappets.

The wear observed on the hydraulic tappets could generate microparticles and these were not retained by the primary and main oil filters.

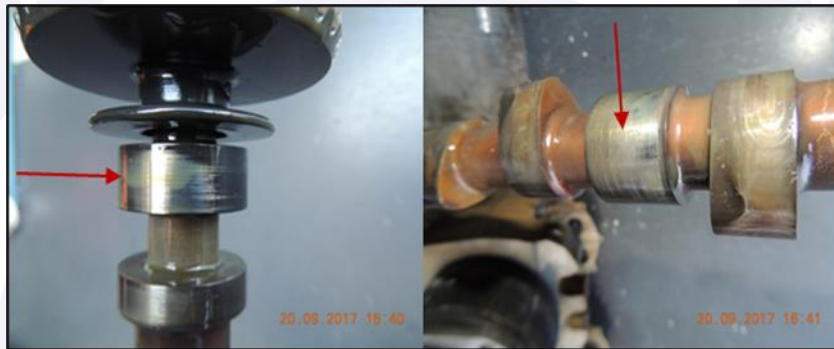
They followed the normal flow of engine lubrication, causing scratches on the camshaft support bearings (Figure 10), on the rear bearing of the crankshaft (Figure 11) and on the inside of the oil pump body. Fine filings were also observed in the residual oil in the crankcase.

Figure 10 - Camshaft support bearings.

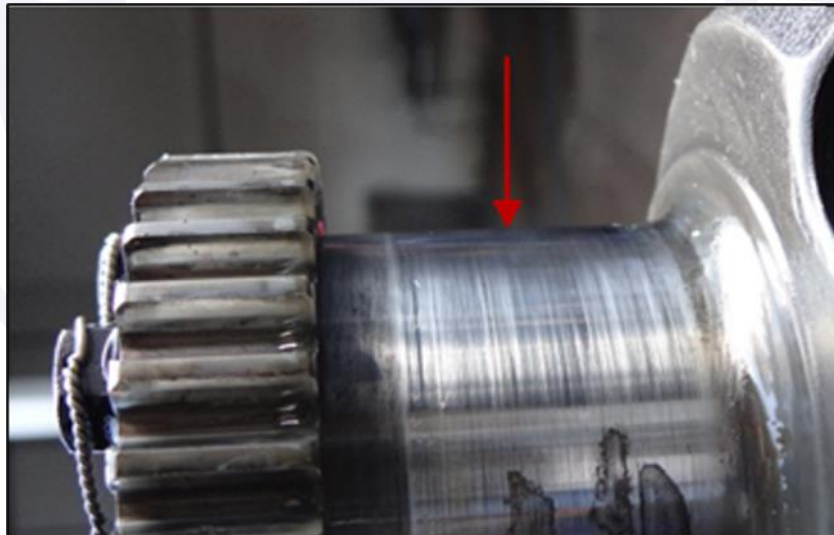
Figure 11 - Crankshaft rear bearing.

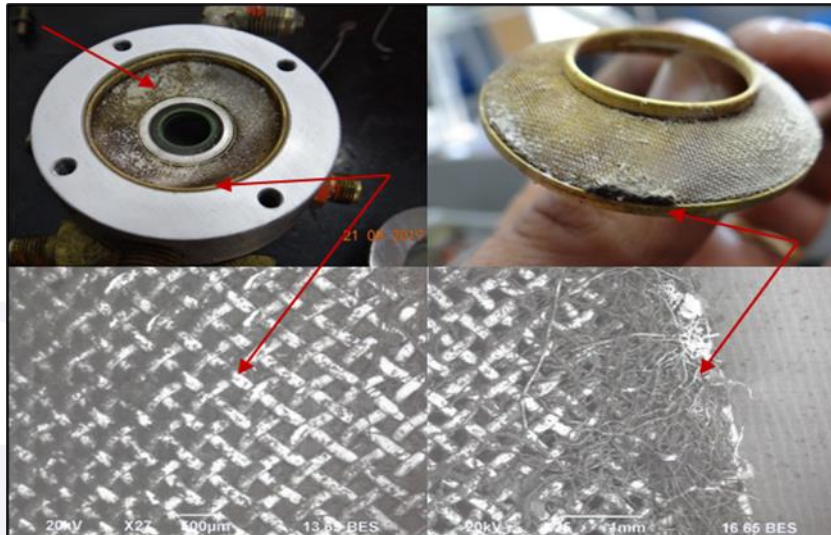
A white powder was found on the fuel distributor filter screen and on the bottom of the distributor diaphragm (Figure 12). After laboratory analysis, it was found that the presence of the residue was partially blocking the fuel filter screen.

Figure 12 - Fuel distributor filter with lead powder.

It was also possible to confirm the presence of lead (Pb), resulting from fuel degradation. This occurs when the fuel is stored or transported in a clear container, allowing contact with sunlight. This contact promotes the precipitation, in powder form, of the fuel's tetraethyl lead.

The lead found on the fuel distribution filter screen partially obstructed the fuel passage to the nozzles, reducing the gasoline supply to the cylinders.

The 200-hour inspection prevised in the aircraft manual foresaw a check of the fuel distributor (spider), only when a leak occurred, that is, if there was clogging, without leakage, there was no in loco inspection of the screen.

Disseminate the lessons learned from this investigation in order to alert operators and maintenance organizations to the importance of checking, during corrective maintenance procedures, the condition of the fuel system of IO-520-L-12B engines not only for leaks, but also for the possibility that this system may be contaminated by foreign material.

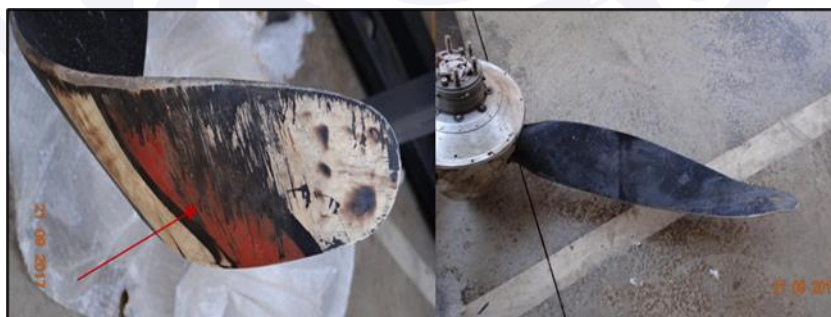
The propeller assembly had its blades dented backwards and had transverse scratches on its ends (Figure 13). This denoted that, at the moment of impact against the ground, the engine was developing little power, however, in the field investigation, it was observed that the metering valve was in the maximum power position.

Figure 13 - Scratches and dents on the propeller blades.
