FINAL REPORT
IG - 057/CENIPA/2015

OCCURRENCE:	SERIOUS INCIDENT
AIRCRAFT:	PR-MHV
MODEL:	A320-214
DATE:	08APR2015

This is the final report of the serious incident with the A320-214 aircraft, registration PR-MHV, occurred on 08APR2015. The event was classified as “[USOS] Undershoot/Overshoot”.

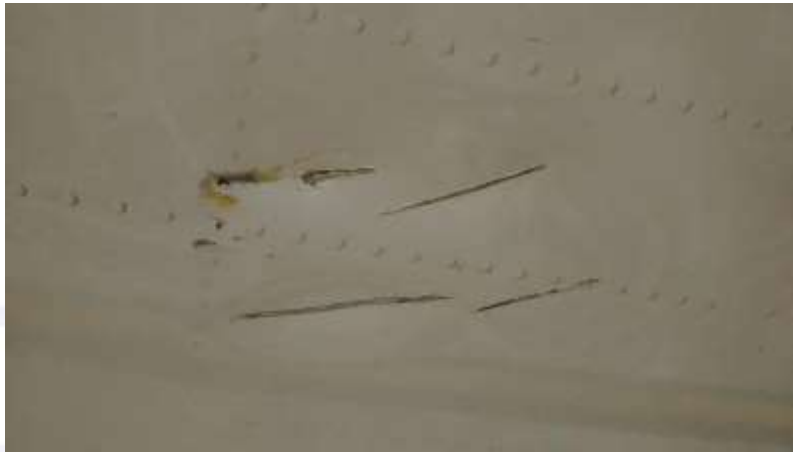
The aircraft suffered damage to the right main landing gear tires, and minor damage to the fuselage due to the shrapnel created by hitting the light.

Figure 1 – Damage to the PR-MHV fuselage.

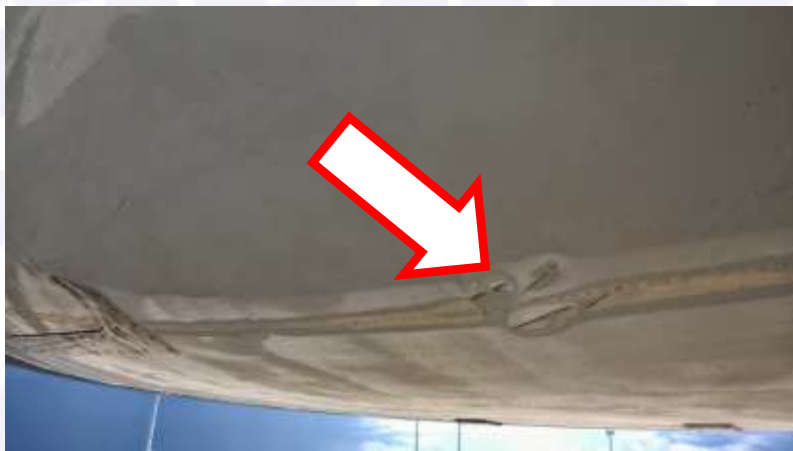
Figure 2 – Other sight of the damage to the PR-MHV fuselage.

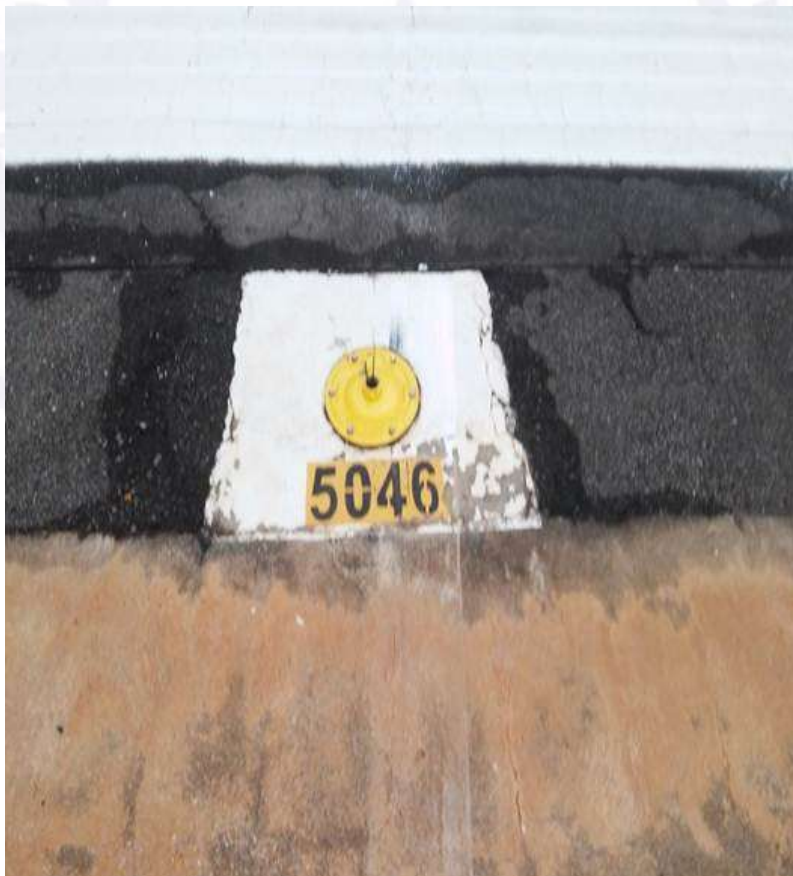
Figure 3 – Place where the struck threshold light was installed. (THR RWY29R)

A threshold light of the runway 29R was damaged, and it was necessary to be switched.

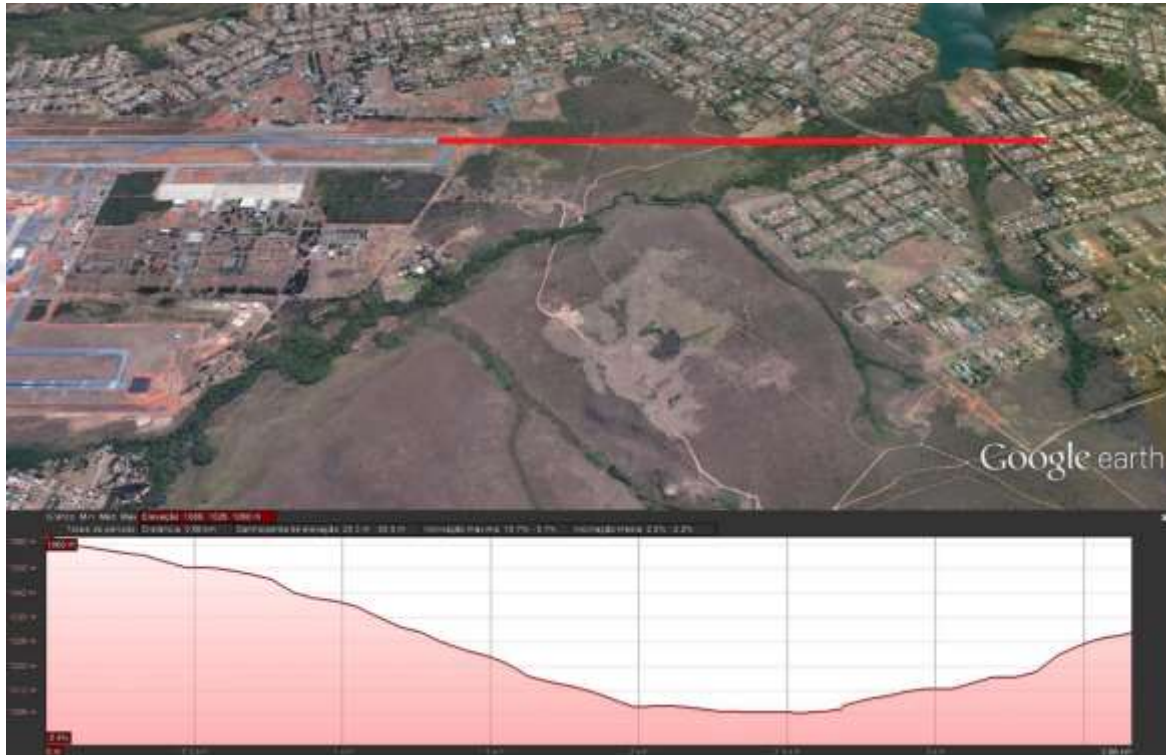
Although the runway was on a flat area, the terrain prior to the RWY 29R was an uphill slope (Figure 13).

Figure 13 – Vertical section along the red line, prior to the RWY 29R of SBRR.
Credit: Google Earth.

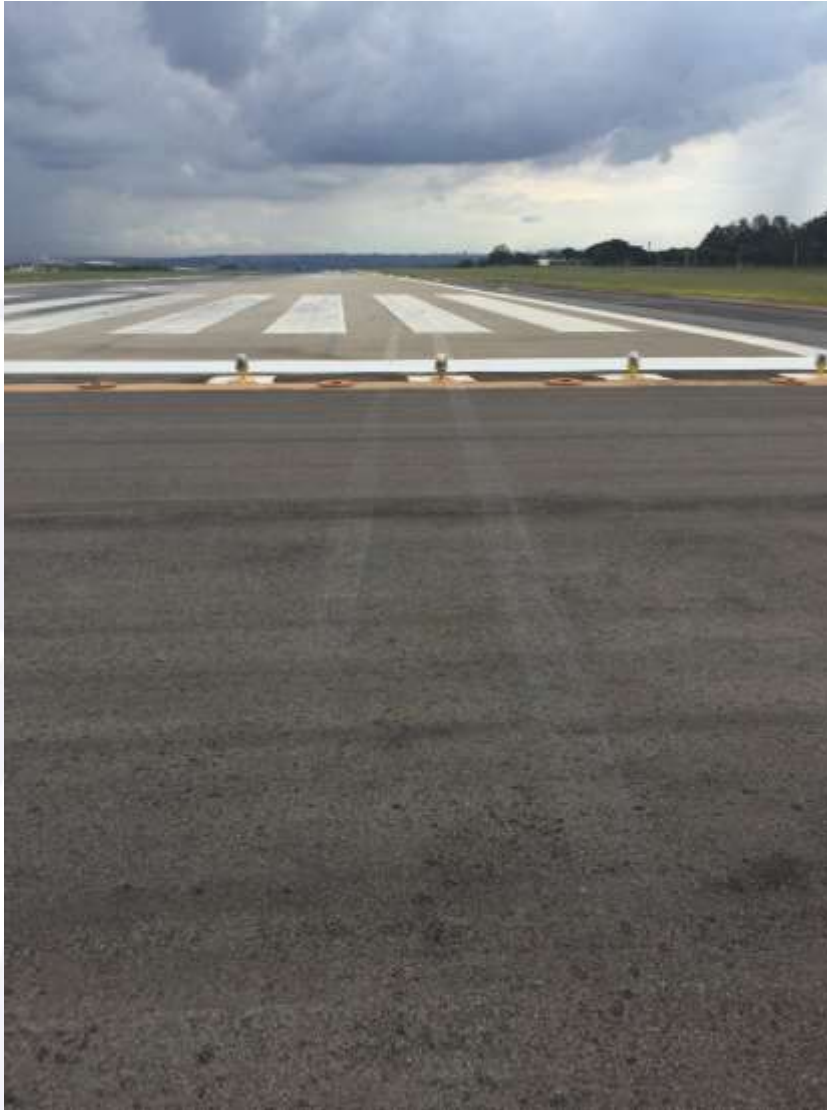
The airplane right landing gear initially touched down at RESA, 13,3m prior to the runway threshold. The left landing gear touched down within the runway limits.

The aircraft rolled a total of 31,5m with the landing gear on the ground.

Figure 14 – Right main landing gear marks on RESA.

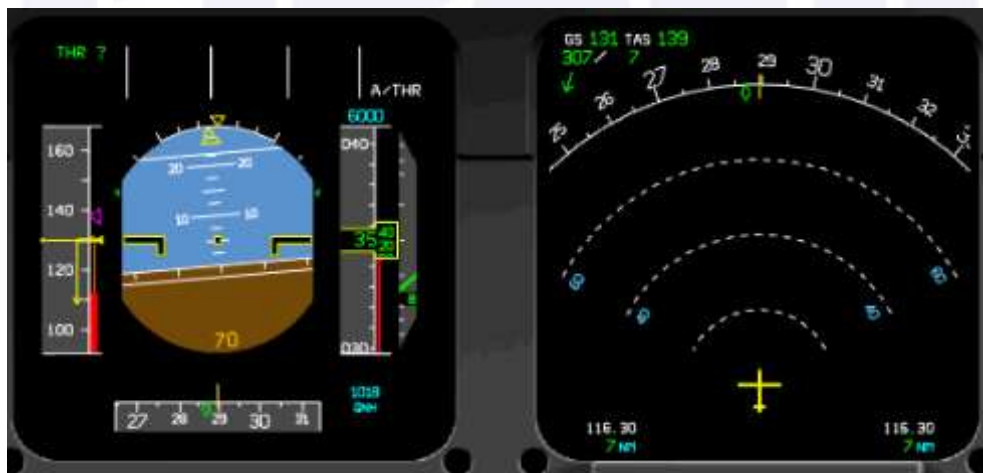
Figure 18 - FDM data on PFD and ND showing the beginning of the go-around procedure, the moment the levers were pushed forward, passing through the FLX-MCT thrust position, hitting TOGA thrust position, 1 second later.

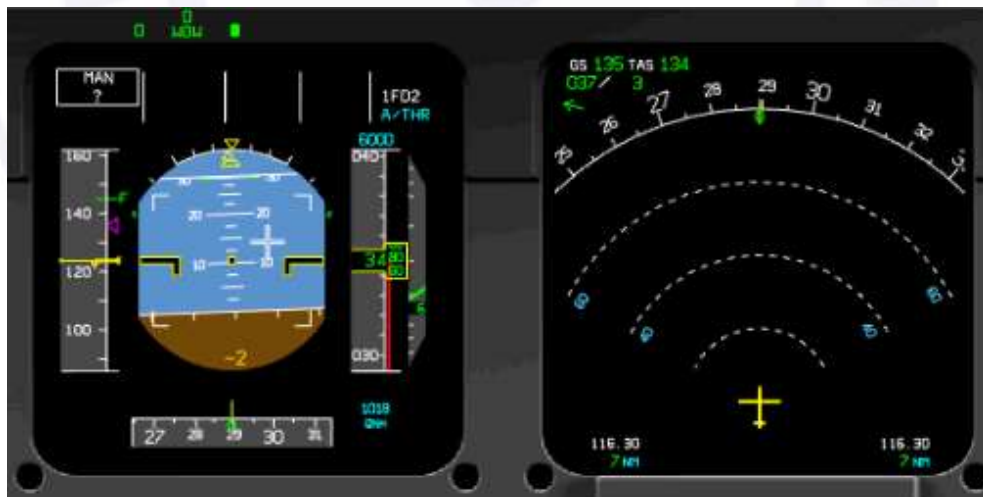
Figure 19 - FDM data on PFD and ND at the moment the right main landing gear touches the ground.
