COMANDO DA AERONÁUTICA
CENTRO DE INVESTIGAÇÃO E PREVENÇÃO DE
ACIDENTES AERONÁUTICOS

FINAL REPORT
A-093/CENIPA/2020

OCCURRENCE:	ACCIDENT
AIRCRAFT:	PR-MJX
MODEL:	AS-350 B2
DATE:	30JUL2020

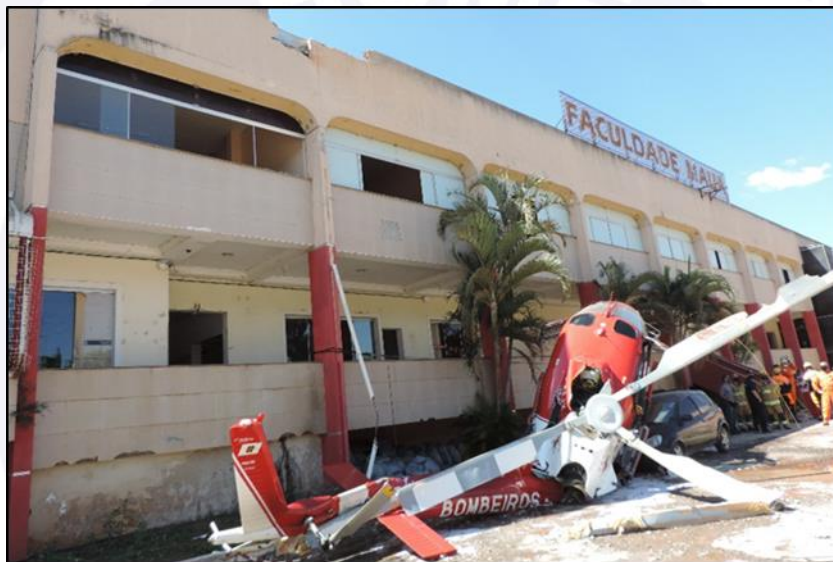
During the final approach for landing at the college parking lot, the helicopter's main rotor blades collided with the facade of a building.

Figure 1 - View of the PR-MJX at the accident site.

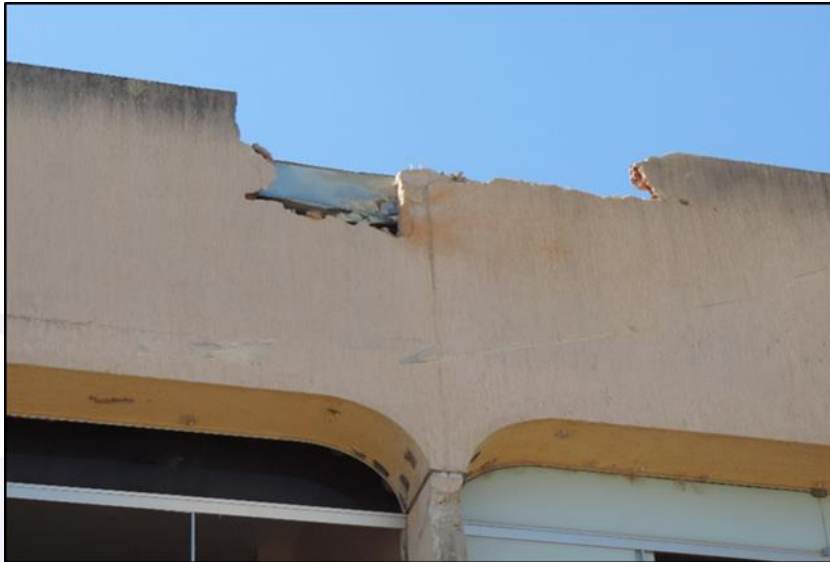
There was damage to a vehicle parked at the site, to the facade of the college building, and to a window of another building located near the accident site (Figures 2, 3 and 4).

Figure 2 - Damage to the facade of the building.

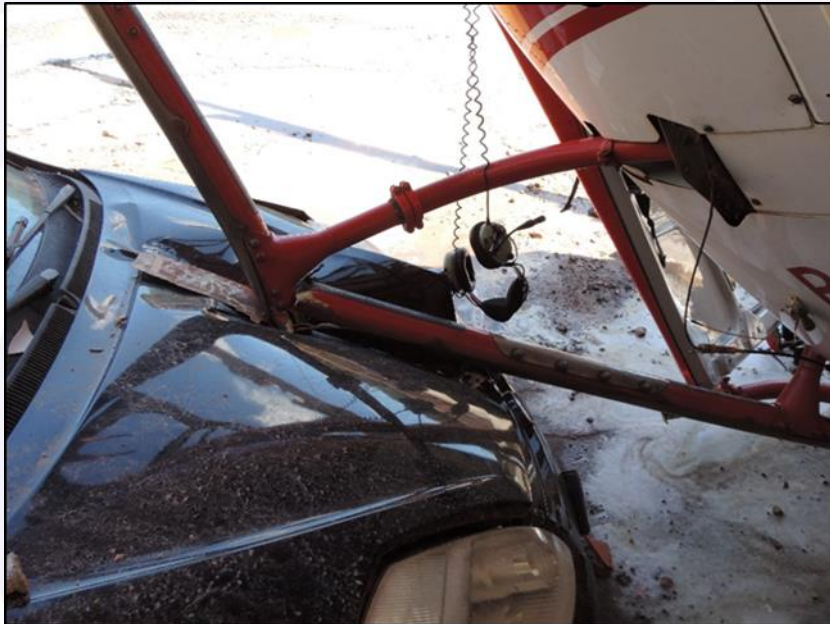
Figure 3 - Damage to a vehicle caused by the helicopter's skid.

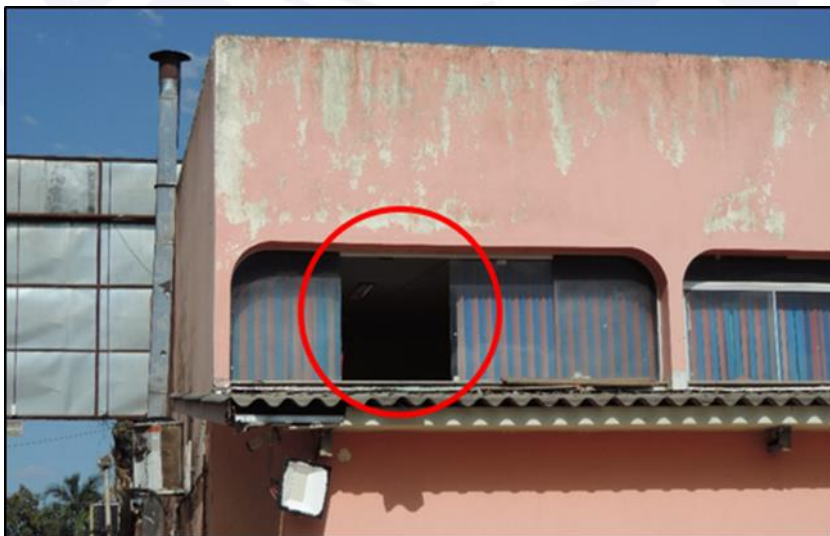
Figure 4 - Windowpane of a nearby building broken by debris.

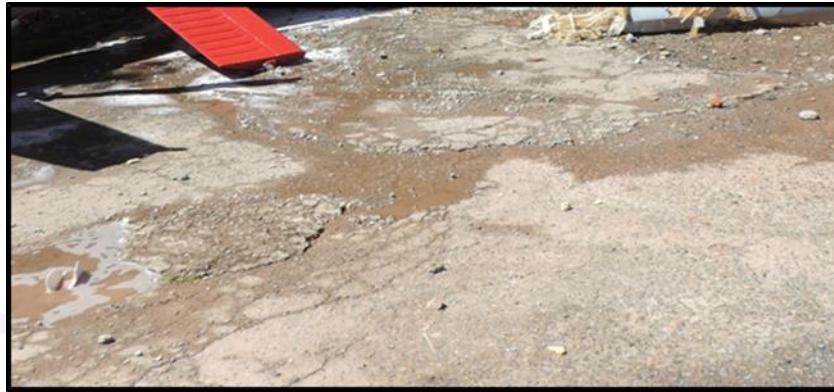
The surface of the landing area was made of concrete. However, there was a lot of accumulated dust and debris - consisting of small pieces of concrete, sand and gravel - due to the prolonged period of drought in the Federal District and due to the degradation of the parking lot pavement (Figure 6).

Figure 6 - Condition of the landing area surface.

Although the surface of the selected *ZPH* was made of concrete, it was covered by a considerable amount of dust and debris, due to the prolonged dry season in the Federal District and to the degradation of the surface.

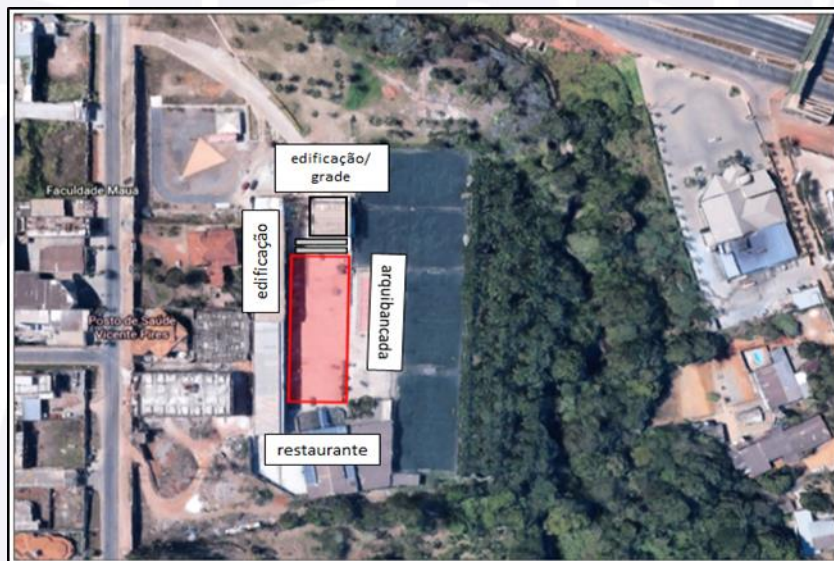
Figure 7 - Obstacles located in the landing area.
Source: adapted from Google Maps.

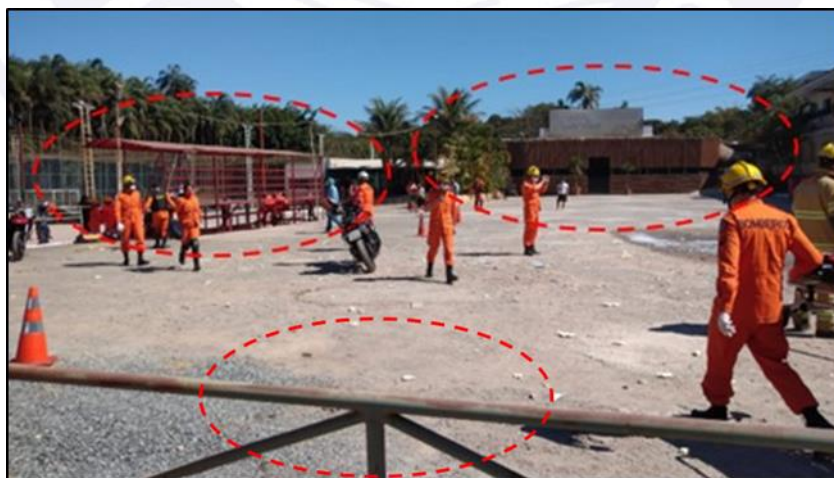
Figure 8 highlights the fence, the small set of bleachers, and the restaurant, which were all located on the sides of the landing area.

Figure 8 - Detail of the obstacles located in the landing area.

The buildings located around the occasional landing area made it difficult to disperse the dust raised by the downwash of the helicopter's main rotor.

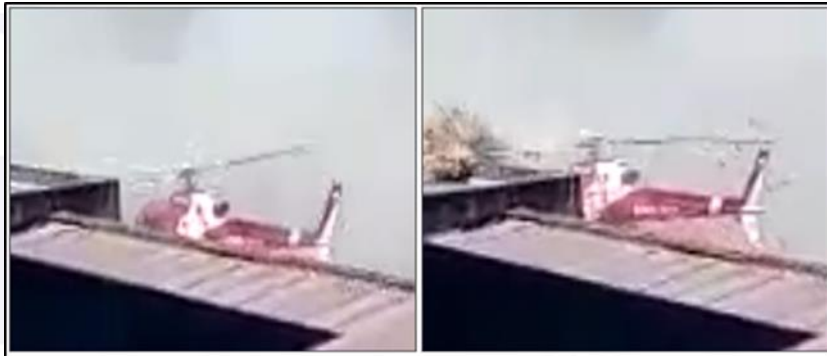
The impact occurred on the approach for landing in the college parking lot, when the aircraft's main rotor blades collided with the facade of a building located to the left of the landing area (Figures 9 and 10).

Figure 9 - Sequence of the collision of the PR-MJX with the college building.

During the Initial Action of the investigation, one verified that the building was approximately 9.35 m tall, and that the collision occurred near the top of the building.

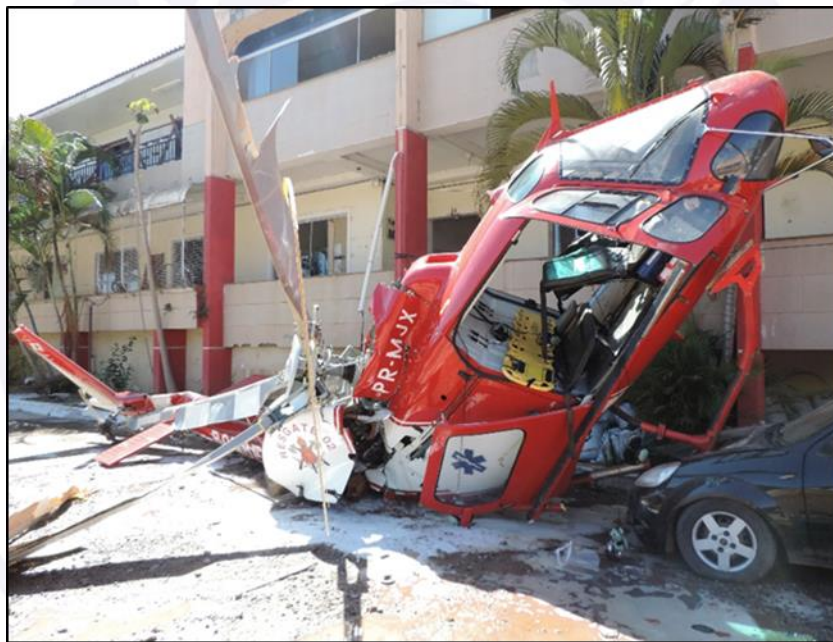
The wreckage ended up concentrating near the building struck by the aircraft (Figure 10).

Figure 10 - Location of the concentration of the aircraft wreckage.

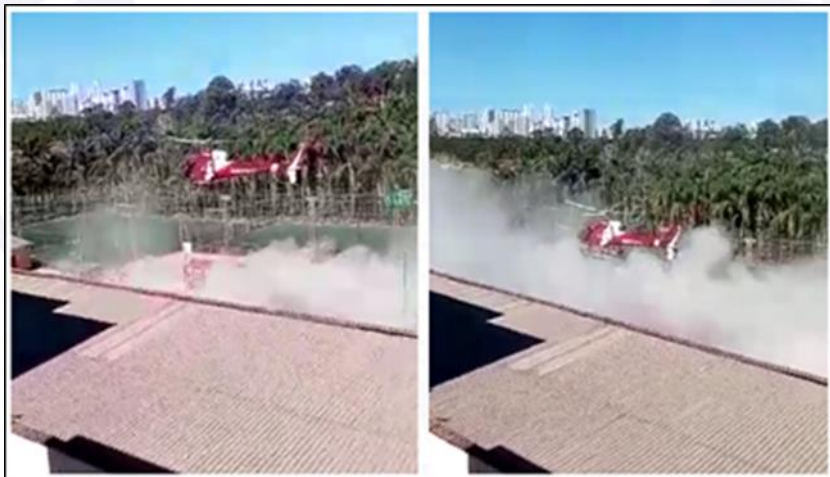
Figure 16 shows the helicopter crossing the line of the buildings' roofs, and the onset of the *brownout* effect. At this point, it is possible to see the downwash from the main rotor beginning to lift the dust particles from the landing site.

Figure 16 - Beginning of the *brownout* effect (left side view).

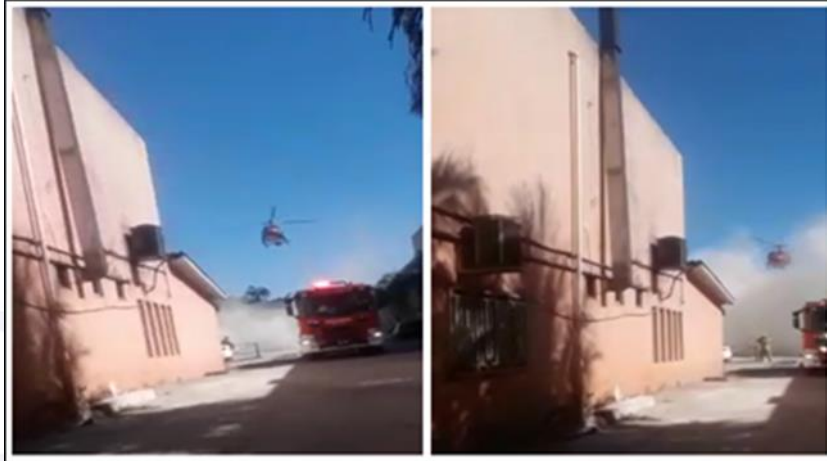
Figure 17 - Front view of the onset of the *brownout* effect.

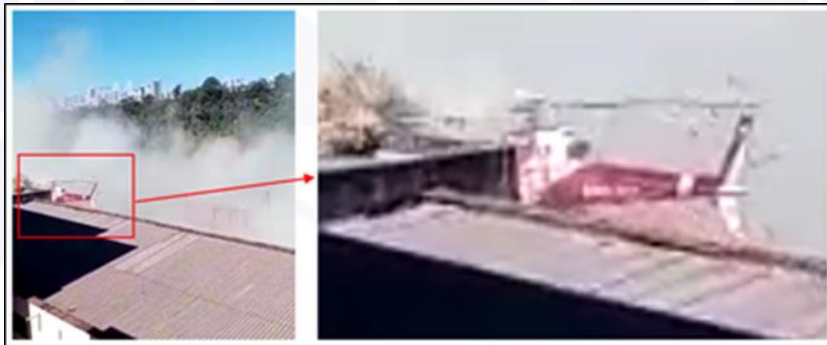
Figure 18 - Rear view of the onset of the *brownout* effect.

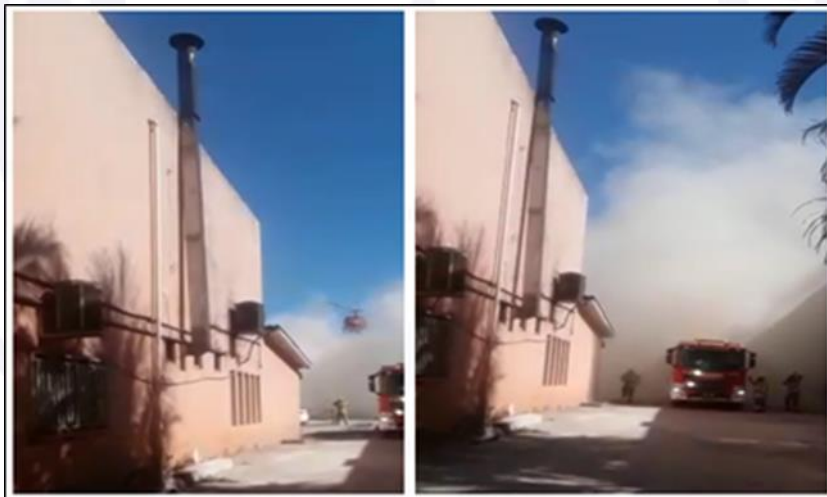
In the following two seconds, the *brownout* effect intensified, and the visibility deteriorated, causing the pilots to lose visual references with the ground (Figure 19).

Figure 19 - View of the *brownout* effect intensifying.

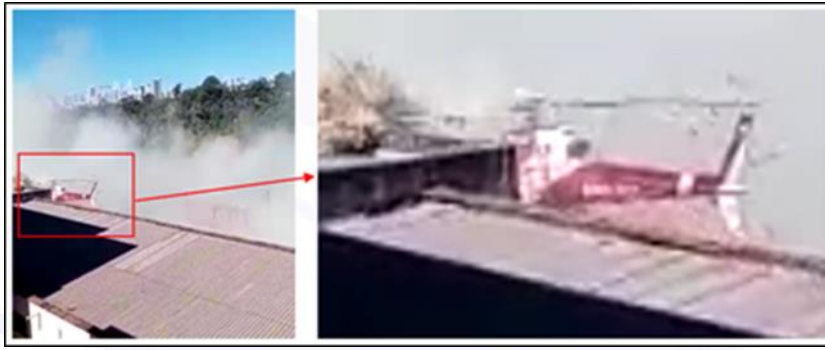
As soon as visual conditions were lost, the PIC initiated the go-around. However, the helicopter had a slight lateral displacement to the left, which caused the main rotor to collide with the upper part of the college building (Figure 20).

Figure 20 - Moment at which the main rotor blades collided with the facade of the building.

Corroborating this statement, despite the attempted go-around, the helicopter, moving sideways to the left, impacted the lateral facade of the college. Incidentally, the PIC reported that he did not visualize the collision and that he just felt it on the flight controls and heard the noise of the blades hitting the building.

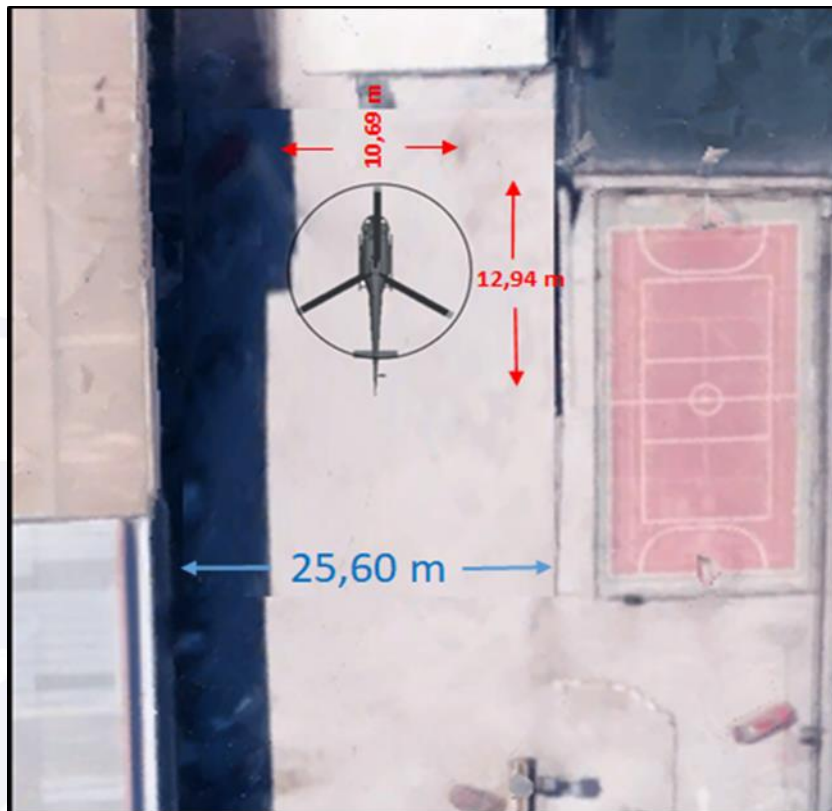
Considering that the landing site had a lateral dimension of 25.6 m after deducting the area of the bleachers, it is possible to state that, in an approach to the central point of the selected area, there were at least 14.9 m available to perform any necessary variations in the helicopter's axes (Figure 21).

Figure 21 - Croquis of the accident site with the dimensions of the landing area and of the helicopter. Source: adapted from *Google Maps*.

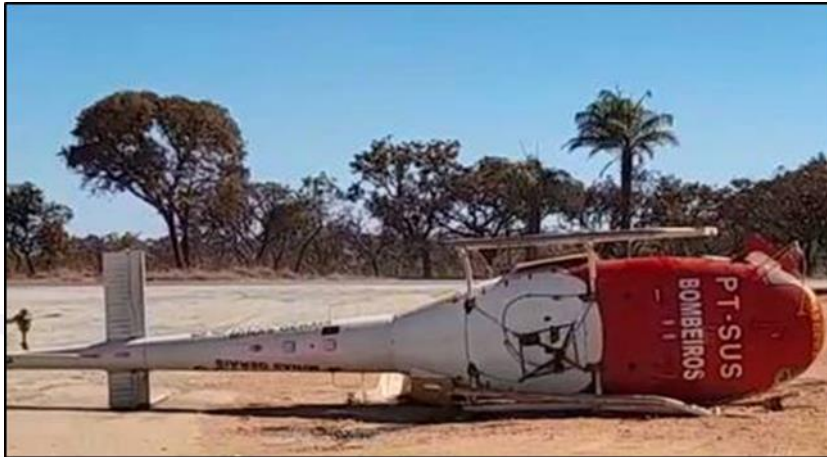
During the landing at the destination, a cloud of dust formed (*brownout*) and the aircraft rolled sideways to the left. The aircraft sustained substantial damage. The pilot, the tactical air-operator, and the nurse were not harmed. The physician suffered serious injuries.

Figure 42 - View of the PT-SUS after the accident.
