**COMANDO DA AERONÁUTICA**  
**CENTRO DE INVESTIGAÇÃO E PREVENÇÃO DE**  
**ACIDENTES AERONÁUTICOS**

**FINAL REPORT**  
**A-125/CENIPA/2020**

<b>OCCURRENCE:</b>	<b>ACCIDENT</b>
<b>AIRCRAFT:</b>	<b>PR-MJZ</b>
<b>MODEL:</b>	<b>AS350 B2</b>
<b>DATE:</b>	<b>08OUT2020</b>

This Final Report pertains to the October 8, 2020, accident involving the model AS350 B2 aircraft of registration marks PR-MJZ. The occurrence was typified as “[SCF-PP] Powerplant failure or malfunction.”

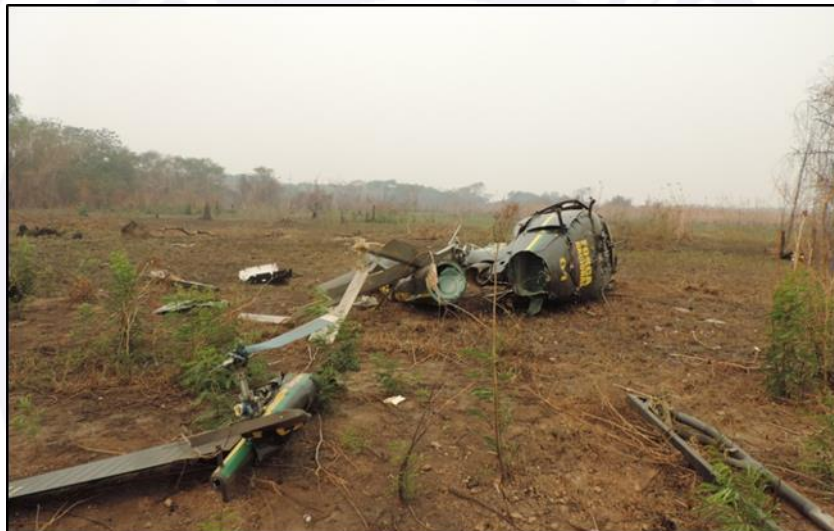
Figure 1 – Final position of the aircraft.

The aircraft sustained substantial damage to its whole structure. The skids, stabilizers, main transmission rotor, tail rotor, and tail boom were severed. The engine also sustained damage but remained attached to the aircraft. There was minor internal damage to the pilot's cockpit and to the passenger cabin.

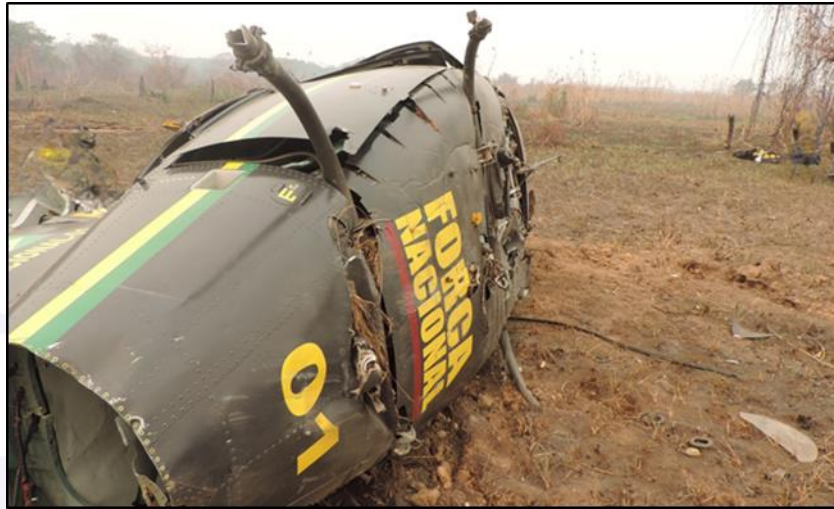
The weather data gathered in the region indicated extremely low humidity, temperatures near 40°C, presence of wind, fire outbreaks, and smoke in the area – factors that contributed to reduced visibility. It was possible to confirm that, throughout the analyzed area – especially at the accident site – visibility was significantly reduced, as shown in photographic records taken shortly after the occurrence (Figure 4).

Figure 4 – Photograph taken moments after the occurrence, showing the reduced visibility prevailing at the accident site.

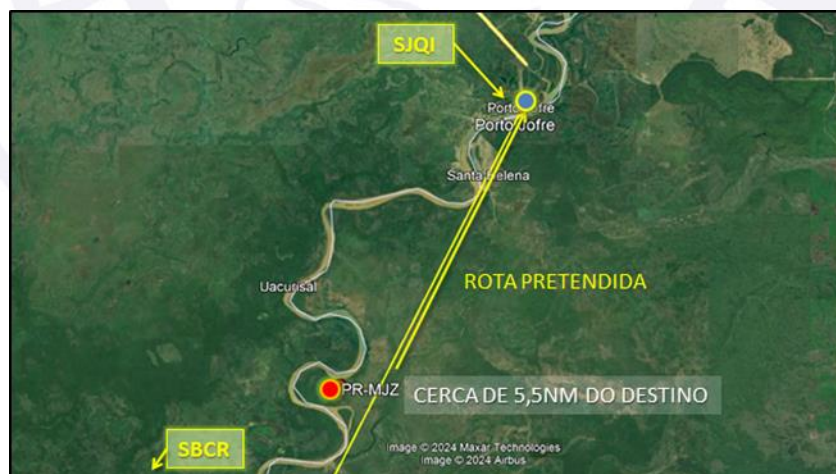
The wreckage was located 5.5 NM southwest of the intended landing site, SJQI, approximately 200 meters from the right bank of the *São Lourenço* River, in a rural area of the municipality of *Corumbá*, MS, in an open field, still within the State of *Mato Grosso do Sul* (Figure 5).

Figure 5 – Overview of the area.

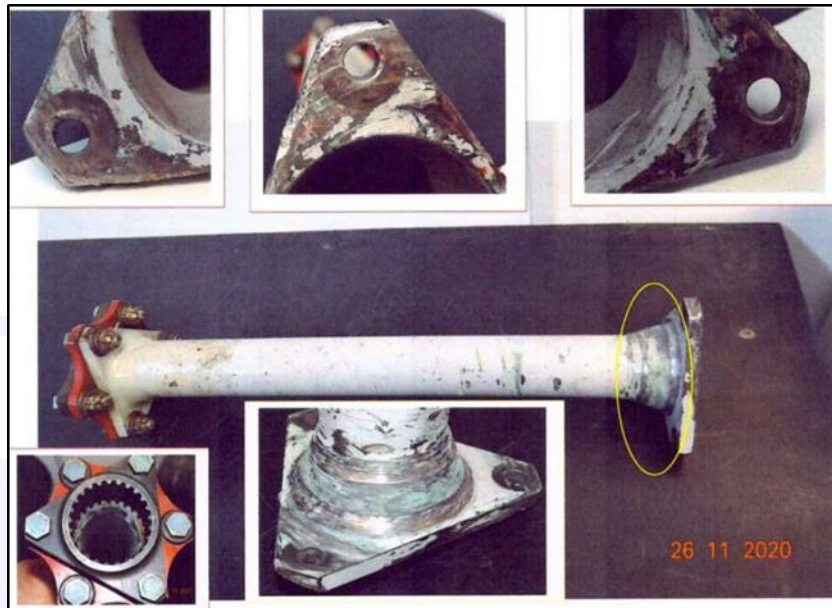
Figure 6 shows the power transmission shaft from the freewheel unit to the Main Gearbox (MGB). The damage observed exhibited characteristics consistent with disconnection while the engine was still running, resulting from the impact against the ground.

Figure 6 – View of the power output shaft from the freewheel to the Main Gearbox (MGB), showing scuff marks.

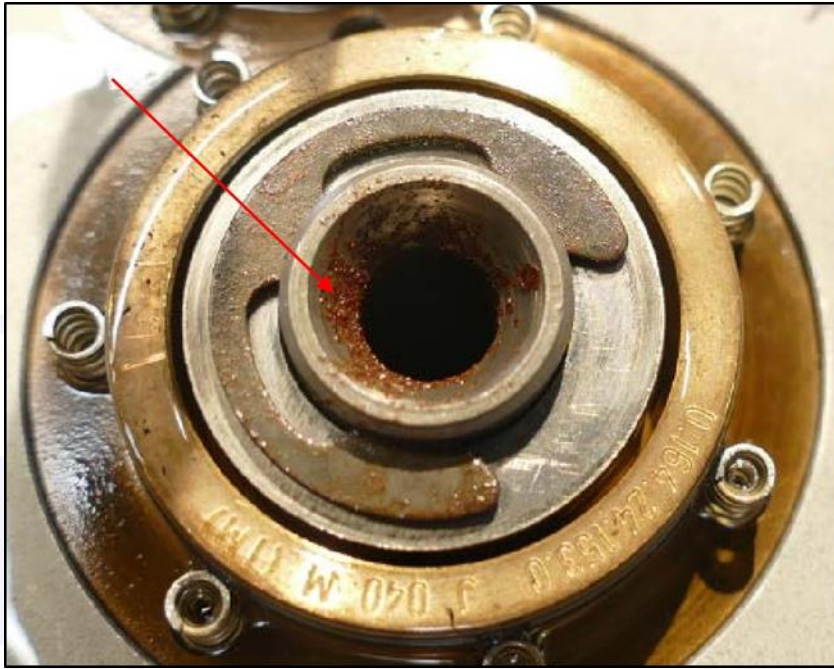
In the next phase of the examinations, upon checking the bench test filter, residues were identified and analyzed. When disassembling the FCU, corrosion and material contamination were observed in the internal NG chamber. The contamination contained iron oxide particles, likely resulting from the degradation of internal FCU components, possibly due to exposure to contaminated fuel during previous flights (Figures 10, 11, 12 and 13).

Figure 10 – Presence of corrosion and contamination on the edge of the FCU's NG chamber.

Contamination found inside the FCU, consisting primarily of iron oxide elements, could be explained by corrosion of internal components, likely resulting from exposure to contaminated fuel at some point during its operational life – not necessarily during recent refueling.

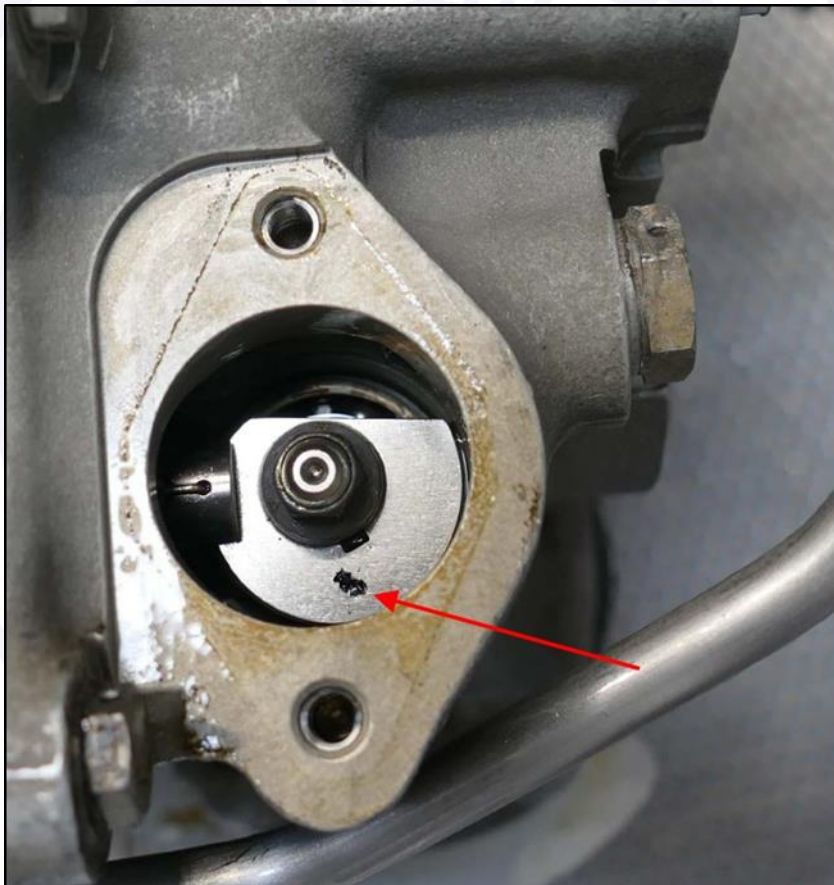
Figure 11 – Visible contamination in the anticipator chamber.

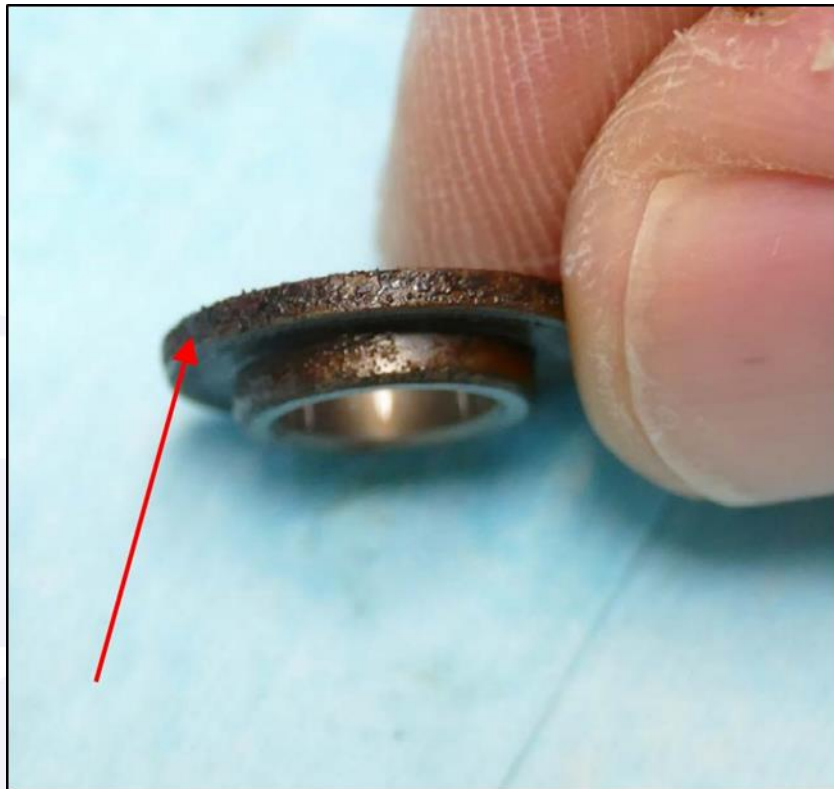
Figure 12 – Significant corrosion on the anticipator control spring seat.

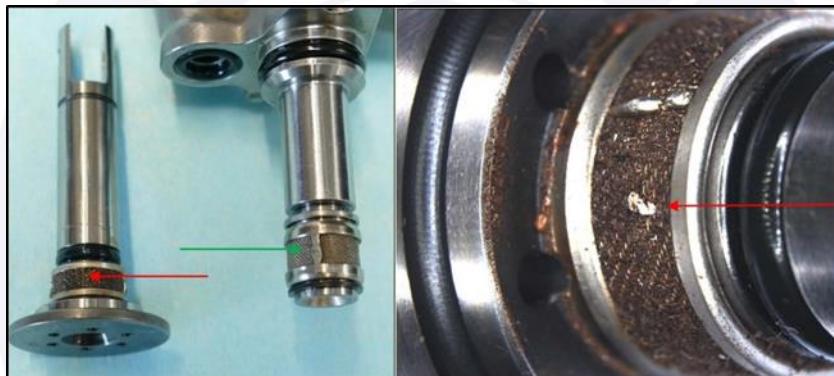
Figure 13 – Detail of the partially clogged amplifier piston filter (internal FCU component). Highlighted in red as found, and in green as it should appear when unobstructed.

- p) internal corrosion was found in the FCU;
- q) partial clogging of the FCU filter was identified;
- r) the aircraft sustained substantial damage; and
