COMANDO DA AERONÁUTICA
CENTRO DE INVESTIGAÇÃO E PREVENÇÃO DE
ACIDENTES AERONÁUTICOS

FINAL REPORT
A-057/CENIPA/2021

OCCURRENCE:	ACCIDENT
AIRCRAFT:	PR-MLA
MODEL:	35A
DATE:	20ABR2021

This Final Report pertains to the accident involving aircraft PR-MLA, model 35A, which occurred on April 20, 2021, classified as “[ARC] Abnormal Runway Contact and [RE] Runway Excursion.”

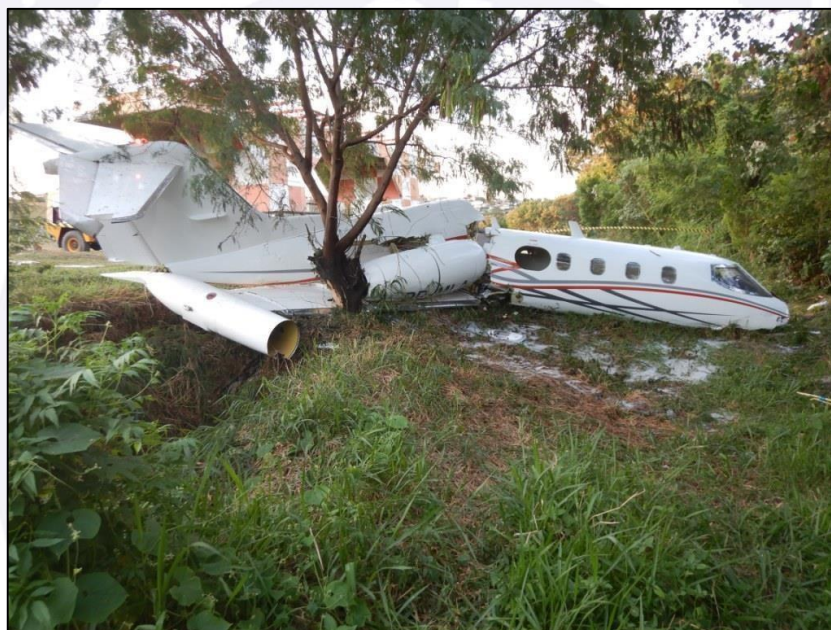
Figure 1 – Photograph of the aircraft after coming to a complete stop.

While descending the slope beyond the opposite runway threshold, the aircraft struck a tree and sustained substantial structural damage.

The cabin area and both wings sustained substantial damage from multiple ground impacts.

The underside of the aircraft sustained minor damage due to contact friction with the runway.

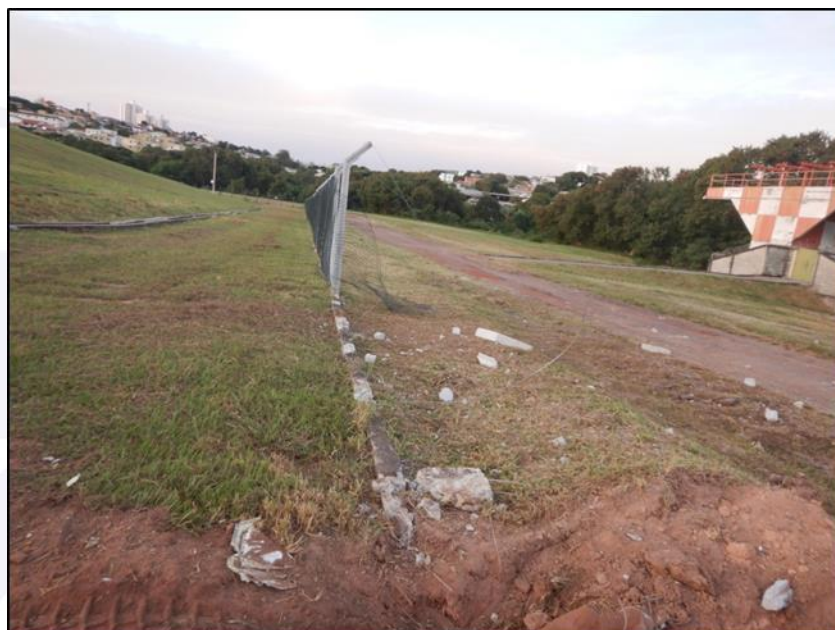
During the runway excursion, the aircraft collided with the aerodrome's security fence.

Figure 2 – Image of the fence damaged by the aircraft impact.

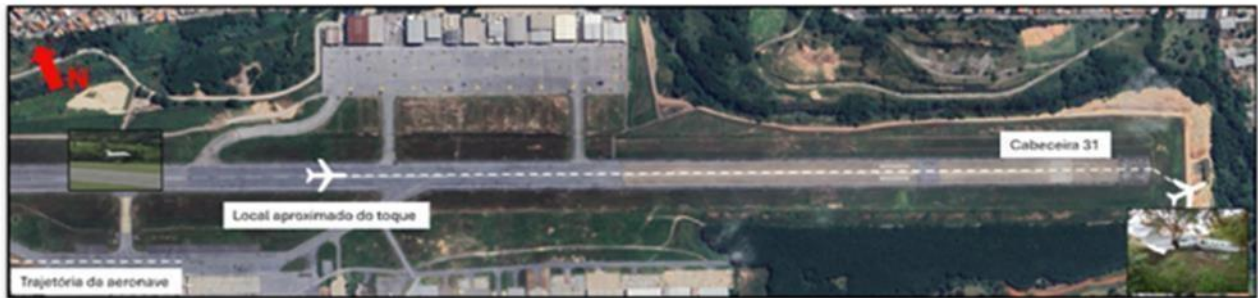
After touching down with the landing gear retracted, the aircraft overran the departure end of runway 13, and traveled 270 meters before striking a tree (Figure 5).

Figure 5 – Sketch of the occurrence.
Source: adapted from Google Earth.

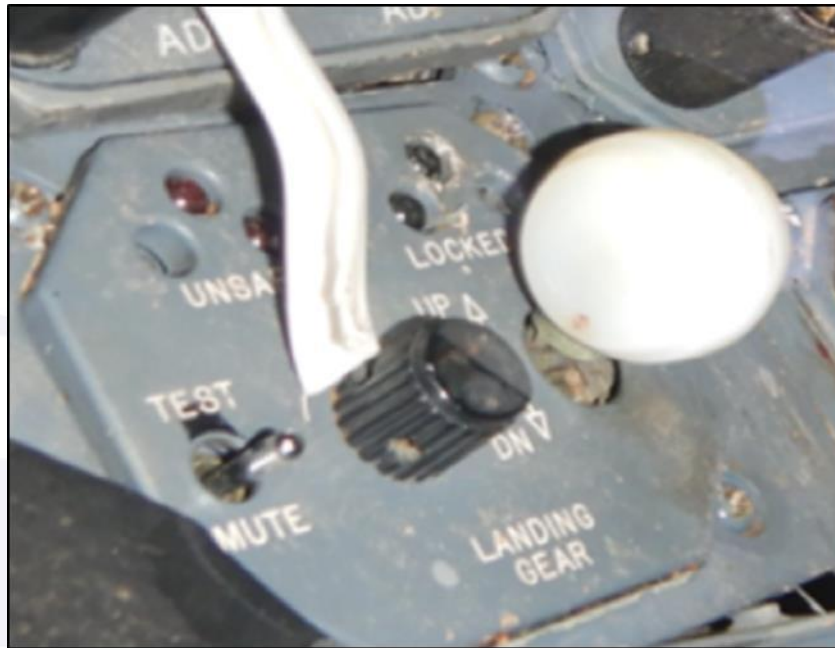
The aircraft's landing gear was in full retracted position, and the landing gear control lever was found in the UP position (Figure 6).

Scraping was observed on the underside of the fuselage, and fuselage fragments were recovered from the runway.

Figure 6 – Landing gear lever in the UP position (top).

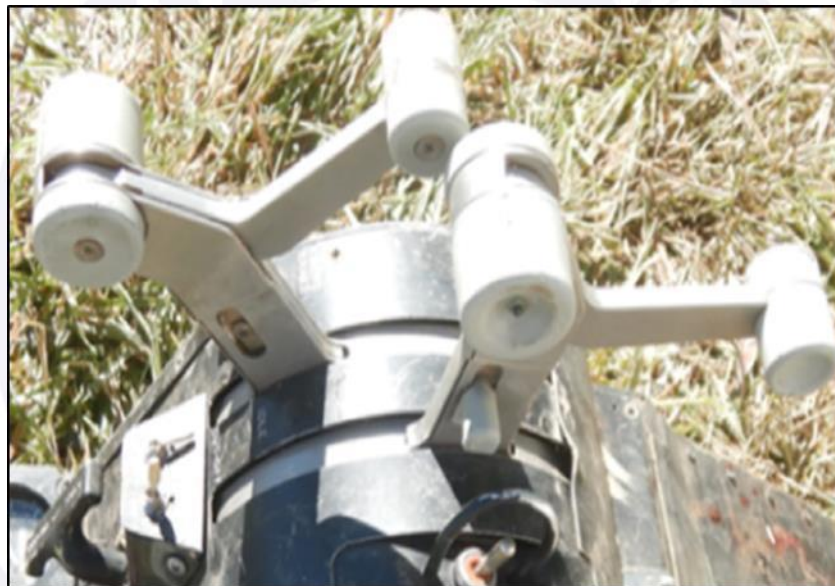
On the throttle pedestal, the left engine lever was near the idle position, and the right engine lever was near maximum power.

Figure 7 – Throttle pedestal.

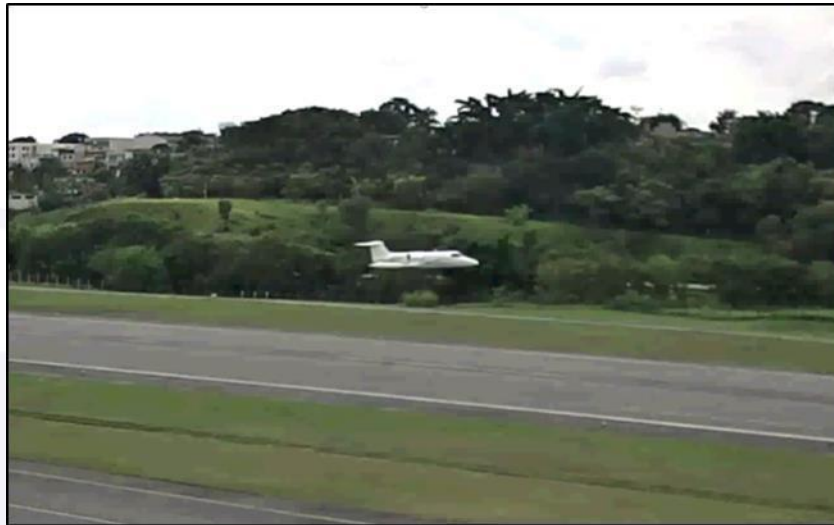
The aircraft was captured by airport security cameras flying over the runway at a height above the usual for landing and with the landing gear retracted.

Figure 10 – Aircraft captured by security camera
Source: Aerodrome Administration.

During landing, the aircraft was recorded by surveillance cameras while flying over the runway with the landing gear retracted. At that time, the pilot in the right seat was alerting the PIC that the aircraft was too fast – a condition consistent with the landing gear being retracted, since drag would have been lower than expected.
