COMANDO DA AERONÁUTICA
CENTRO DE INVESTIGAÇÃO E PREVENÇÃO DE
ACIDENTES AERONÁUTICOS

FINAL REPORT
IG-133/CENIPA/2019

OCCURRENCE:	SERIOUS INCIDENT
AIRCRAFT:	PR-MPY
MODEL:	ATR-72 202
DATE:	16SET2019

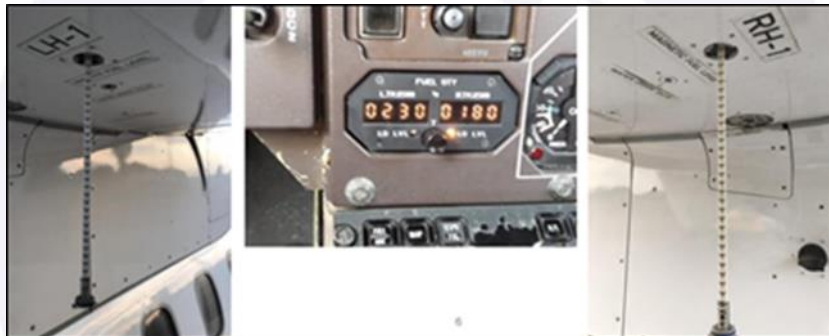
The information obtained shortly after the occurrence revealed that the quantity of fuel indicated in the FQI corresponding to the left-hand wing tank was 230 kg, and 180 kg in the right-hand wing tank. In such condition, the Fuel-Level Magnetic Indicators indication was *zero fuel* (Figure 9).

Figure 9 - Indication of the PR-MPY FQI and Fuel-Level Magnetic Indicators measured after the landing in SBIH.

condition, the Fuel-Level Magnetic Indicators (located under the wings) indicated *zero fuel* after being measured.

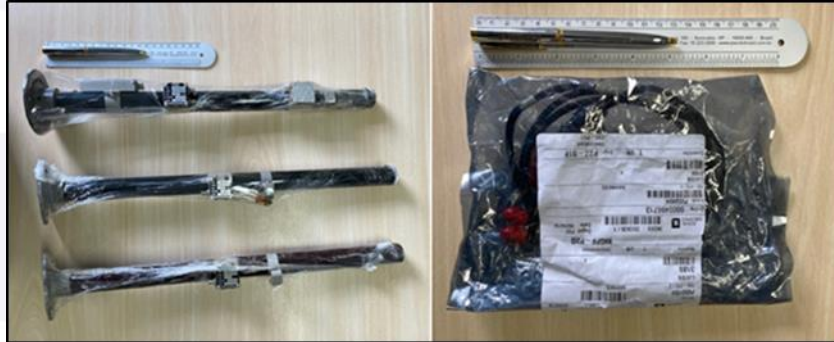
The number-3 fuel probes (P/N 768-100) of both wings were out of the parameters and were replaced. The same occurred with the Harness (Cabling), P/N 798-078-2, of the number-3 fuel probe of the right-hand wing, which was also out of the parameters and was replaced.

However, the indication of low fuel-level in the FQI of the left-hand wing tank was still not appearing, leading to the replacement of the number-1 fuel probe (P/N 766-983-1).

Figure 10 - Fuel probes and number-3 probe wiring sent for testing.

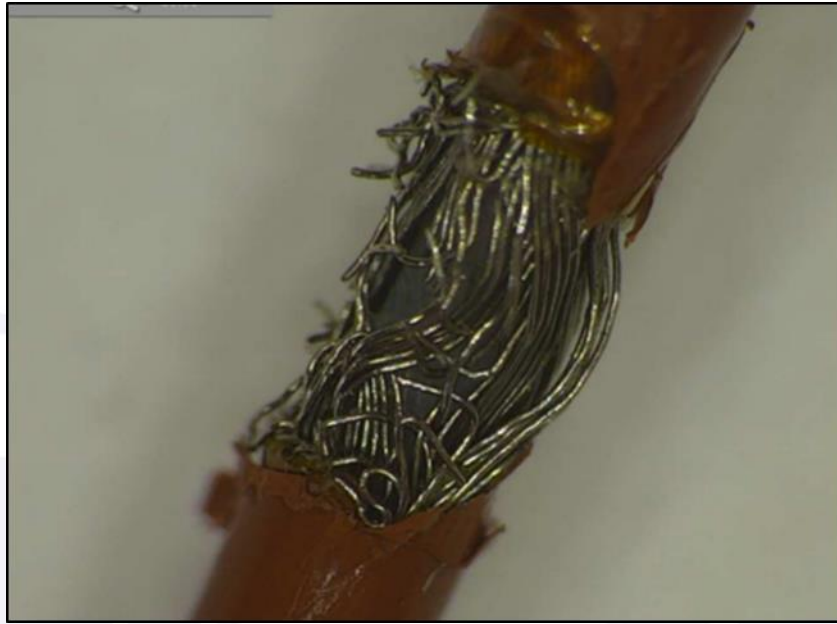
As for the Harness P/N 798-078-2, S/N 563, the connectors were in good condition, and there was no visible damage to the respective pins.

However, there was a splice past the label of identification of the component. One clearly verified that several wires for protection of the cabling were broken (Figure 11).

Figure 11 - Wiring protection found damaged.
Source: SAFRAN Investigation Report.

Thus, no discrepancies existed that might result in non-conformities, despite the damage found in the cable shielding.

In spite of the results, several pieces of equipment showed signs of aging, such as scratches and corrosion. The analysis conducted by *SAFRAN* also highlighted that the worst damage observed related to the Harness P/N 798-078-2, S/N 563.

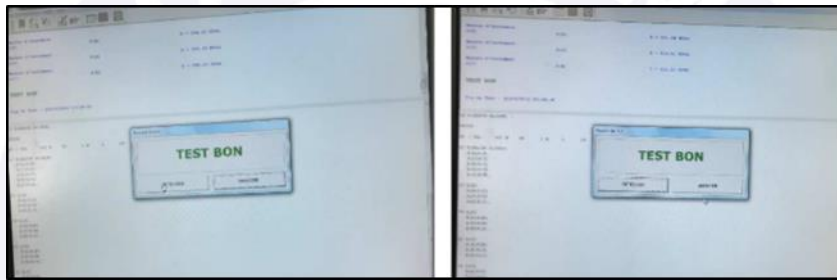
The cabling underwent two electrical tests for resistance, insulation and continuity. The item passed both tests (Figure 12).

Figure 12 - Result of electrical tests.

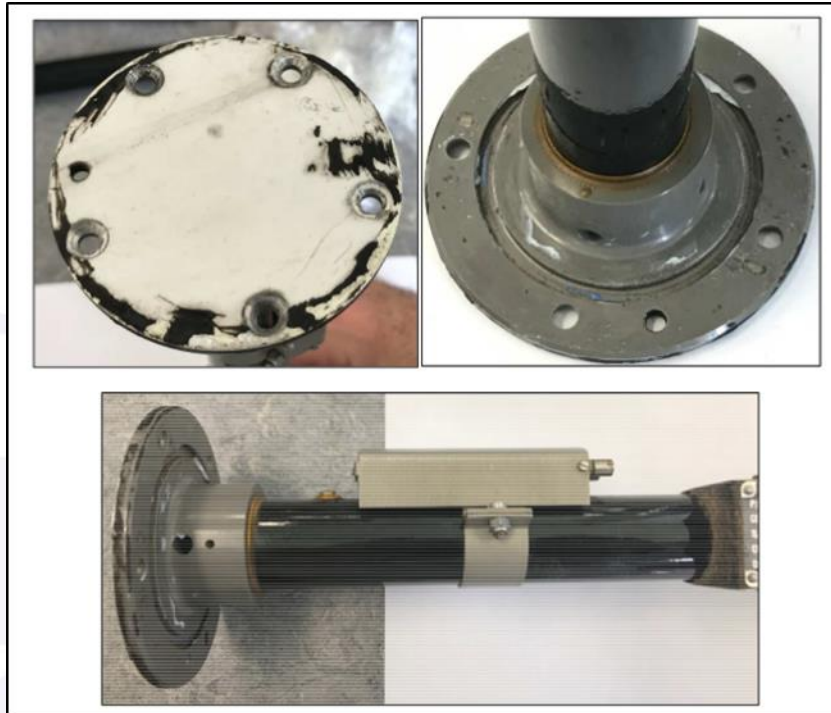
In the P/N 766-983-1 S/N 1647 fuel probe, it was possible to see pollution inside the tube, oxidation in the electrical box, and scratches and shocks on the probe head (Fig. 13).

Figure 13 - Damage to the P/N 766-983-1 S/N 1647 fuel probe.
Source: SAFRAN Investigation Report.

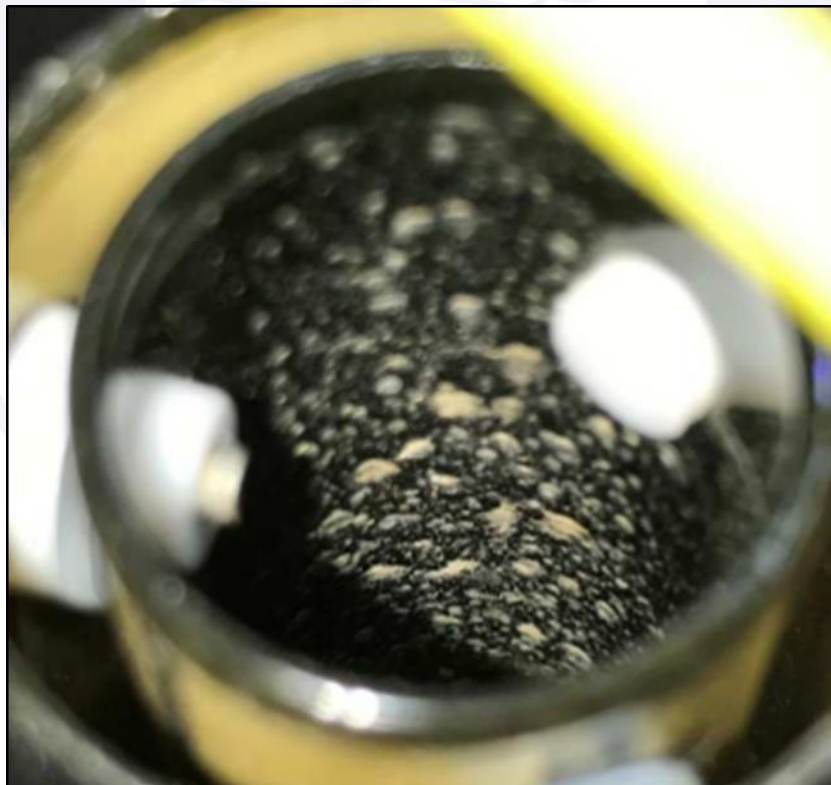
On the P/N 768-100 S/N 1358 fuel probe, it was possible to observe scratches, traces of shock, and oxidation of the probe head, along with scratches on the outside of the tube. No oxidation was visible in the electrical box. There were also signs of pollution inside the tube (Figure 14).

Figure 14 - Pollution inside the P/N 768-100 S/N 1358 fuel probe.
Source: SAFRAN Investigation Report.

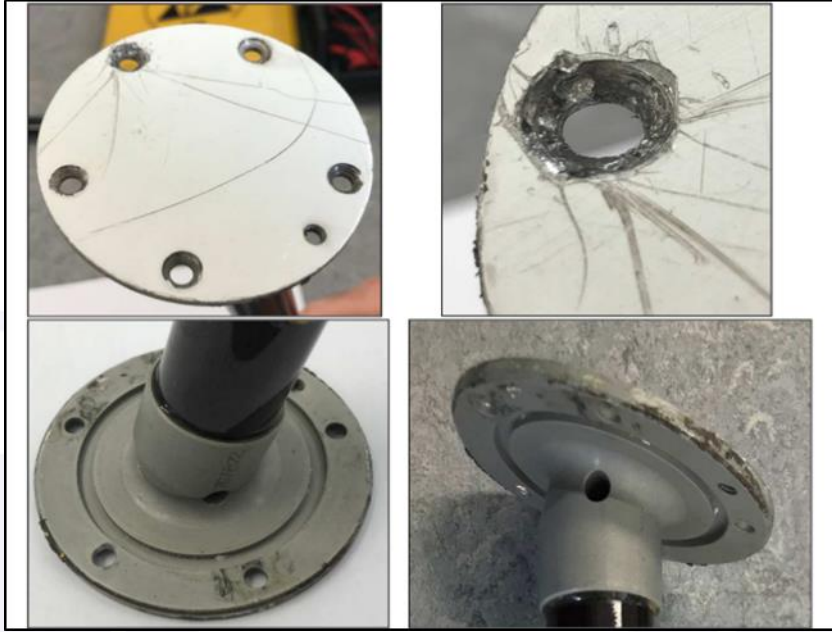
On the P/N 768-100 S/N 516 fuel probe, one observed scratches, traces of shock, and oxidation on the probe head (Figure 15).

Figure 15 - Damage to the P/N 768-100 S/N 516 7 fuel-probe head.
Source: SAFRAN Investigation Report.

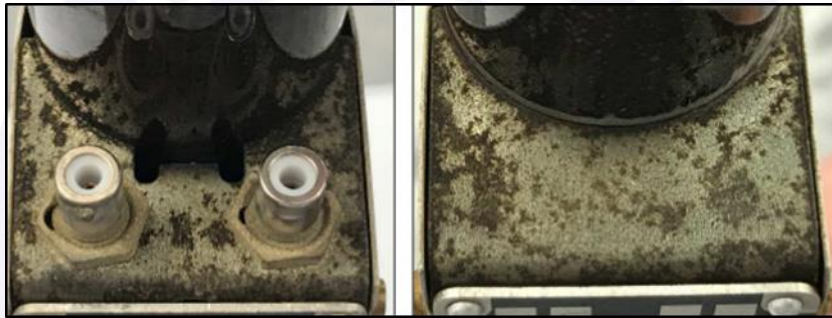
Pollution was visible inside the tube, as well as oxidation in the electrical box (Figure 16).

Figure 16 - Oxidation in the electrical box of the P/N 768-100 S/N 516 7 fuel probe.
Source: SAFRAN Investigation Report.

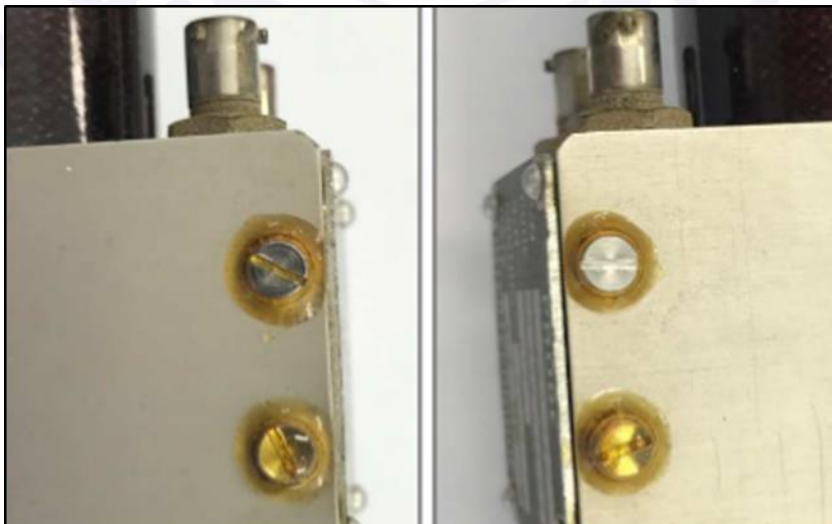
In all the probes, one verified the presence of varnish on the screws of the respective boxes (Figure 17).

Fig. 17 - Varnish on the screws of the electrical box of P/N 768-100 S/N 516 fuel probe.
Source: SAFRAN Investigation Report.

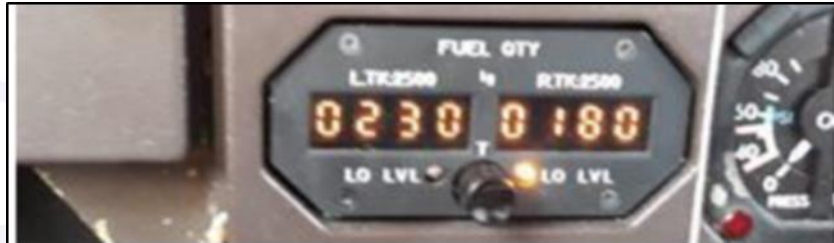
In order to proceed to the apron and disembark the passengers, the crew restarted the right-hand engine. According to the pilots, it was only at that very moment that the LO LVL low fuel-level light on the right-hand side came on in the FQI (Figure 23).

Figure 23 - PR-MPY LO LVL Fuel of Engine no. 2 illuminated in SBIH.
