COMANDO DA AERONÁUTICA
CENTRO DE INVESTIGAÇÃO E PREVENÇÃO DE
ACIDENTES AERONÁUTICOS

FINAL REPORT
A-009/CENIPA/2022

OCCURRENCE:	ACCIDENT
AIRCRAFT:	PR-NEW
MODEL:	R44 II
DATE:	19JAN2022

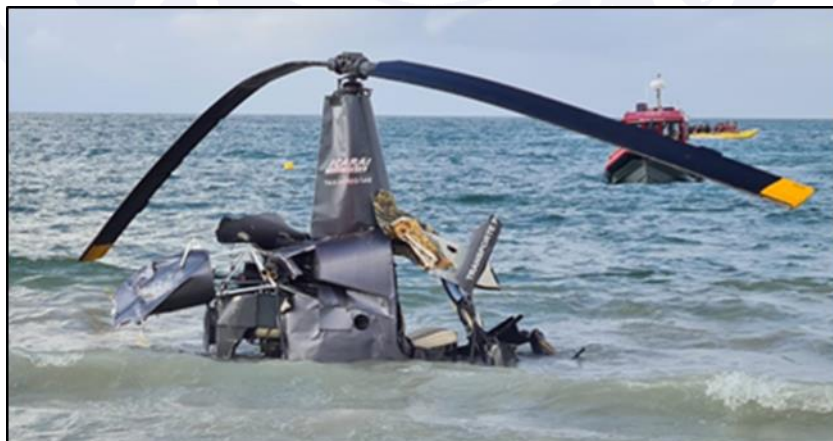
The aircraft sustained substantial damage. The front section of the cabin was destroyed. The tail boom separated from the fuselage, and the rotor blades ended up sharply bent downwards.

Figure 1 - Picture of the PR-NEW taken approximately 20 minutes after the accident.

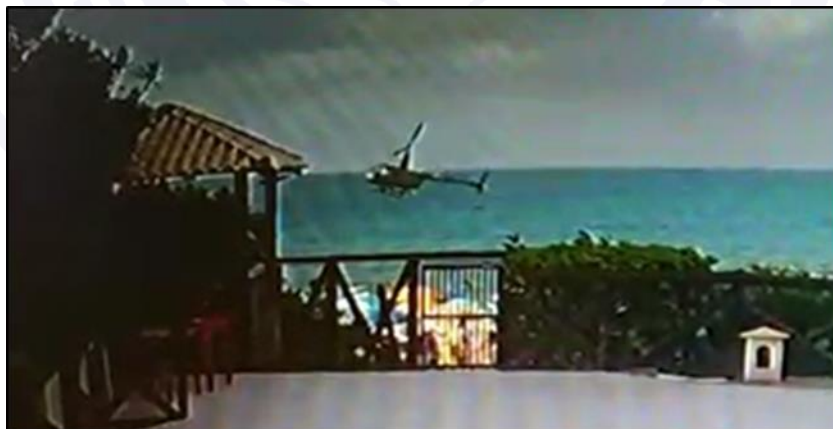
Figure 2 - View of the PR-NEW moments before colliding with the sea.

The impact against the water occurred with the aircraft in a pitch-up attitude and with a right-hand side banking. At the collision, the tail boom separated from the fuselage. After that, the aircraft came to a complete stop. There was no fire.

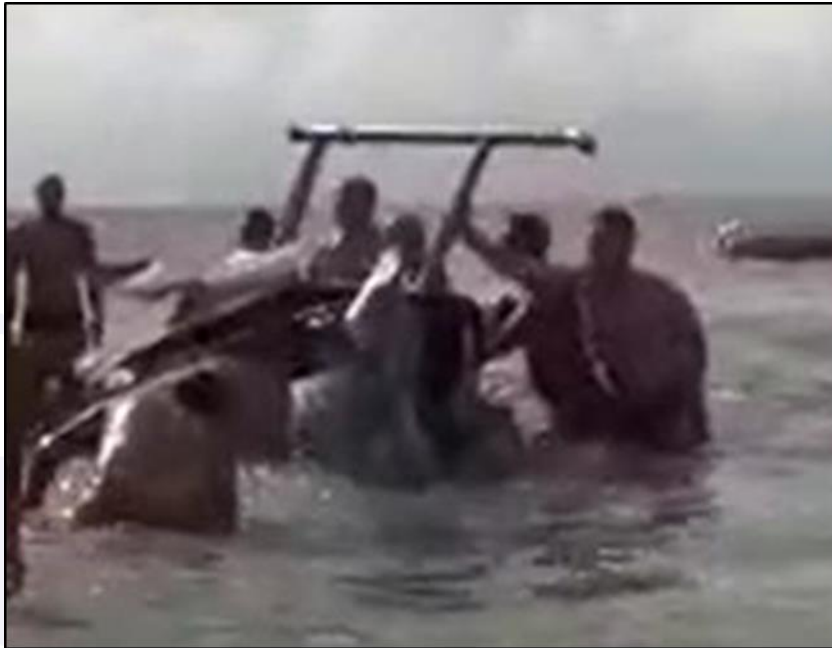
Figure 3 - Picture of the PR-NEW taken by third parties approximately five minutes after the accident.

There was no evidence of a previous impact and, although the tail boom had detached from the fuselage, the debris remained concentrated.

The front section of the cabin was completely destroyed. The front seats, including the pilot's one, got separated from the aircraft structure. The rear seats remained attached to their positions.

The main rotor blades were sharply bent downwards and remained connected to the rotor head. This type of deformation was compatible with an impact in which the rotor was low on energy, indicating that it might not be being driven by the engine.

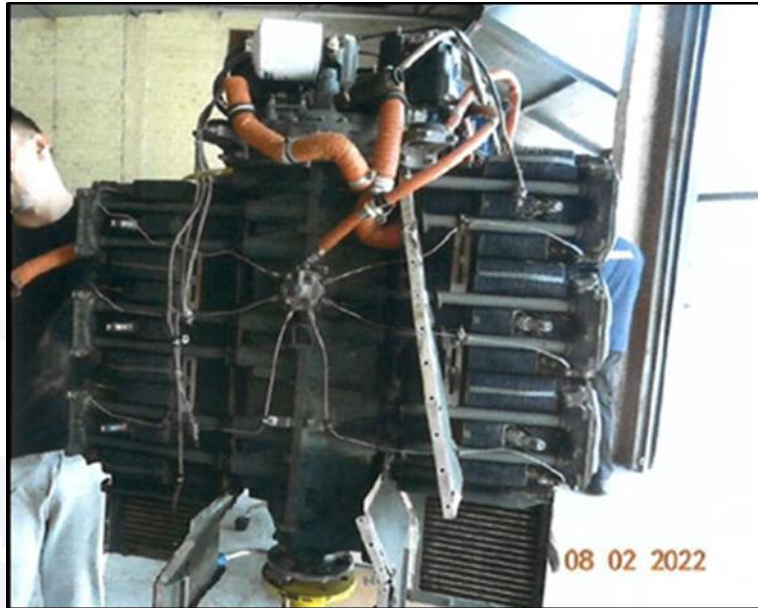
Figure 4 - Top view of the engine.

Externally, it showed no apparent damage resulting from the forced landing. However, one observed oxidation and/or corrosion in all of its components, on account of the submersion in sea water. In addition, the engine was jammed.

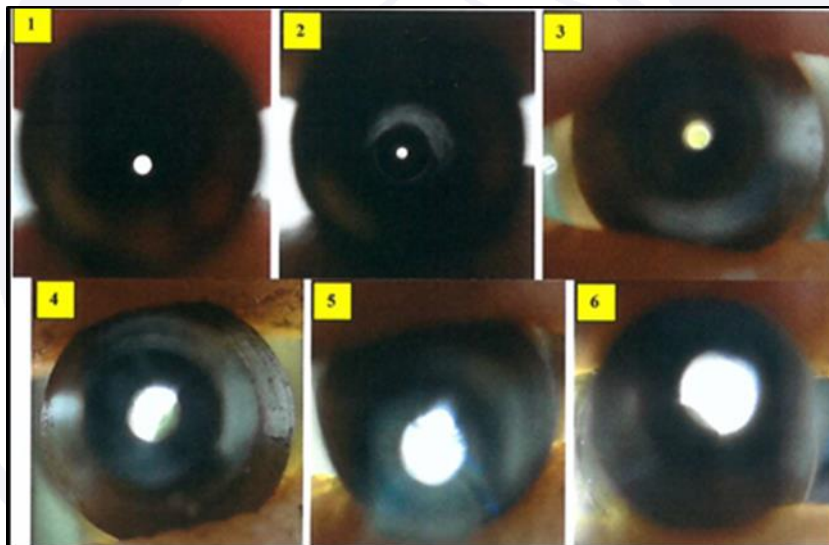
Examination of the fuel injection nozzles showed that they did not have obstructions.

Figure 5 - View of the injection nozzles.

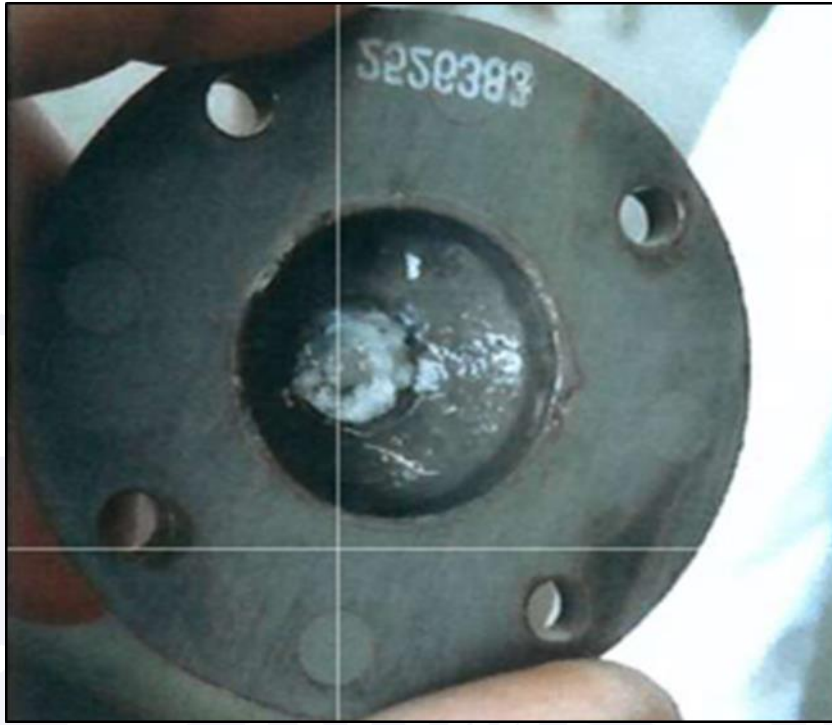
At the disassembly of the fuel distribution valve, corrosion was observed on the inside of its cover and on the diaphragm spring. There was presence of salt water residues in the upper part of the diaphragm.

Figure 6 - View of the upper cover of the fuel distributor.

The distributor valve had an orifice of communication with the atmosphere on its upper part. Examination of the component revealed the presence of severe corrosion in the referred orifice.

Such orifice should have no obstructions in order to allow free movement and correct functioning of the diaphragm. Any obstructions would result in the blocking of the diaphragm movement, a condition that would, either partially or completely, prevent the supply of fuel to the injection nozzles.

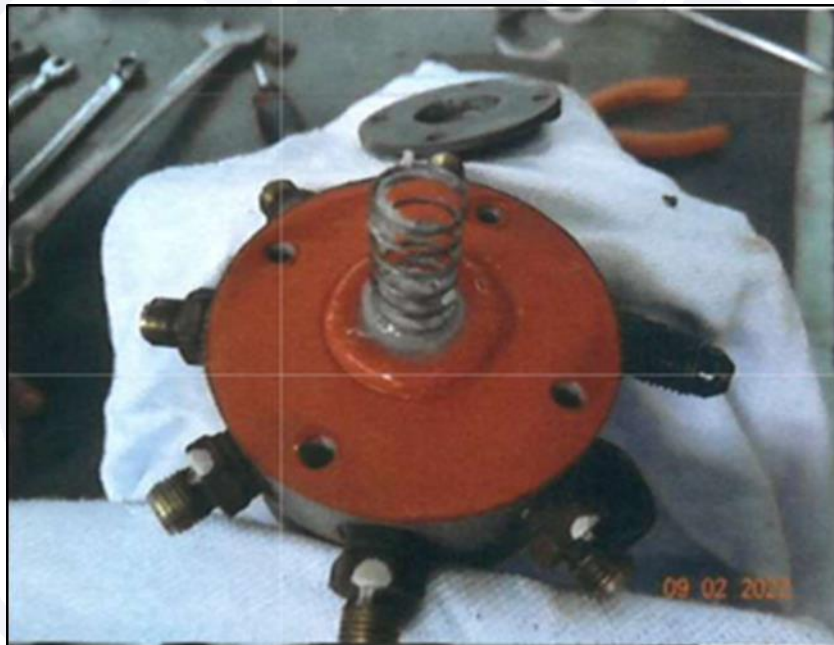
Figure 7 - View of the fuel distributor diaphragm with salt water and corrosion on its spring.

The presence of salt water on the upper part of the diaphragm indicated that the fuel distributor orifice was not obstructed at the moment of the helicopter's immersion in the sea.

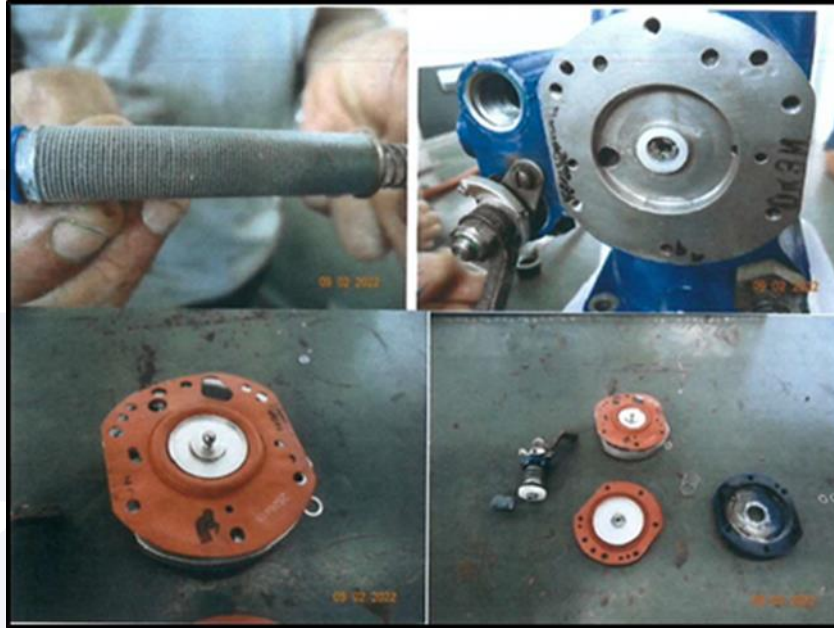
The servo injection valve could not be bench-tested. However, upon visual examination, one found that all its internal components were in normal working order and, also, that there was fuel inside the valve (Figure 8).

Figure 8 - View of the servo injection valve components.

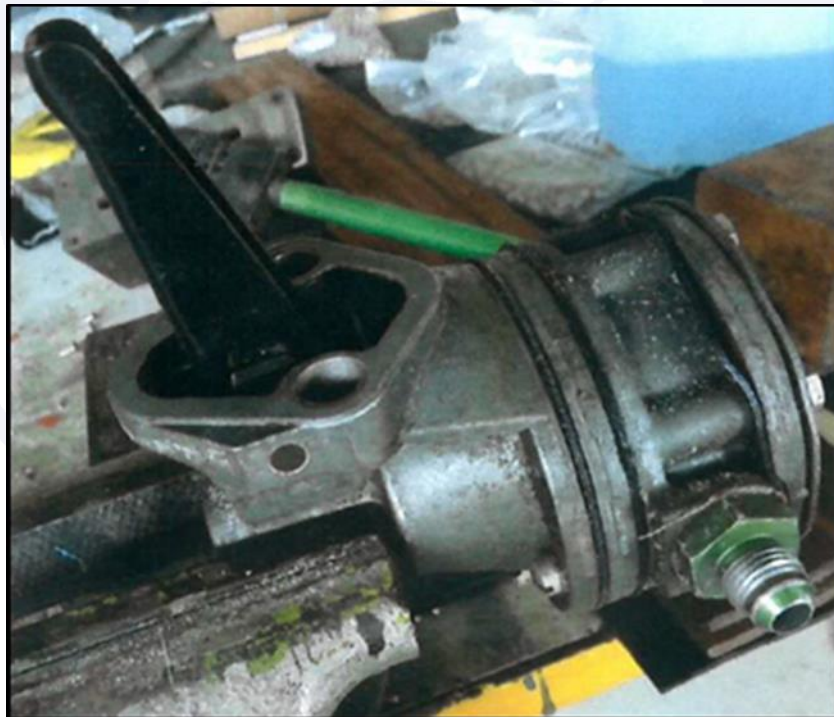
The fuel pump could not be bench-tested either. The component was moved manually, and showed normal operation, characterized by the presence of fuel pressure in its exit. This situation was consistent with normal operation of its unidirectional valves.

Figure 9 - View of the fuel pump.

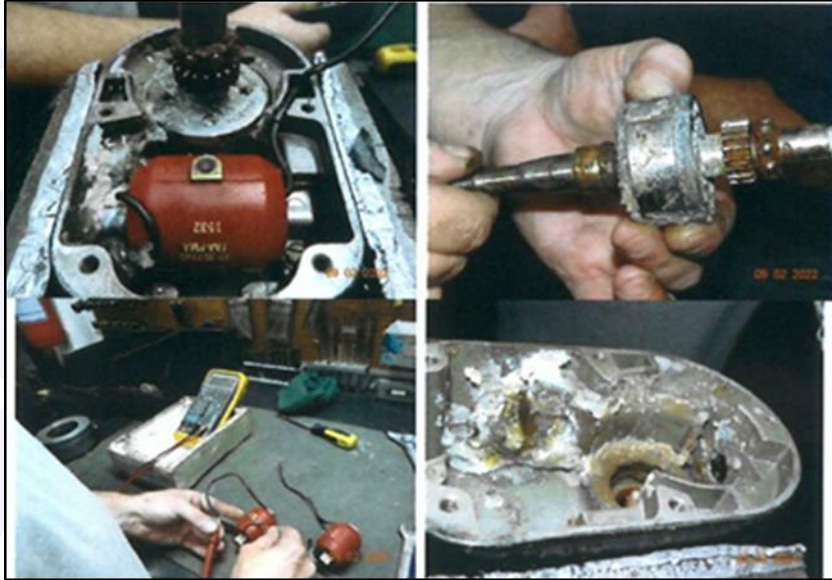
The magnetos showed severe corrosion. For this reason, they were not submitted to a bench test. However, the measurement of the coils' resistance in both magnetos presented values within the limits specified by the manufacturer.

The bearings of the magnetos were in good condition. The gears of the distributors were intact and showed no damage. There was neither oxidation on the cable terminals nor excessive play on the armature bushings.

The contact points also showed severe corrosion, a fact that precluded the analysis of their operating conditions.

Figure 10 - Images of exams and tests of the right-hand magneto.

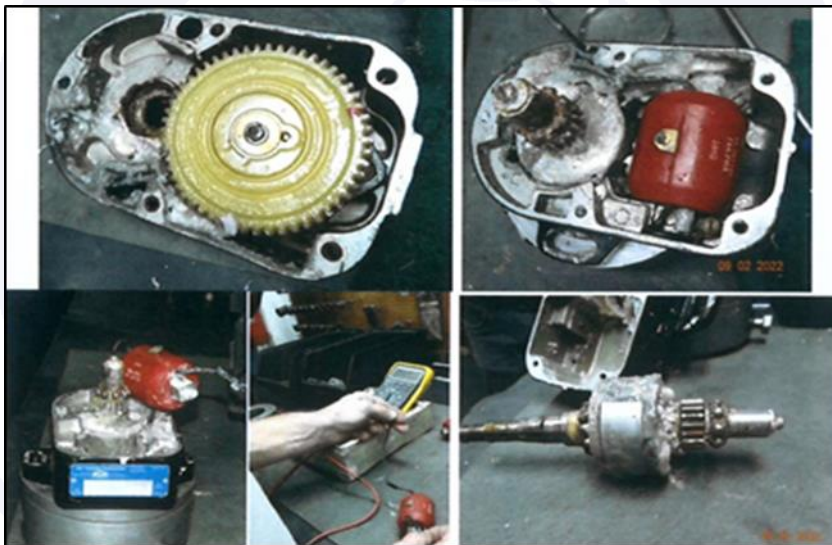
Figure 11 - Images of exams and tests of the left-hand magneto.

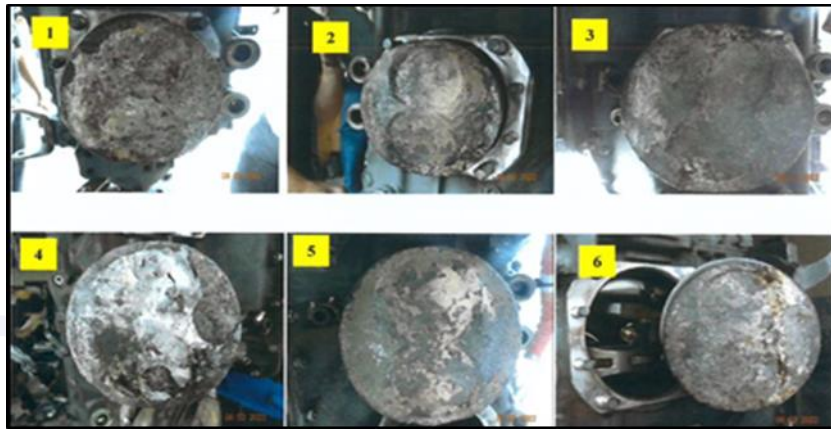
All engine cylinders were oxidized due to contact with sea water. The cylinders were jammed. Their removal from their respective housings was made difficult by the oxidation caused by contact with salt water. However, the tests did not identify abnormalities that could compromise the functioning of these components.

Figure 12 - General view of the pistons.

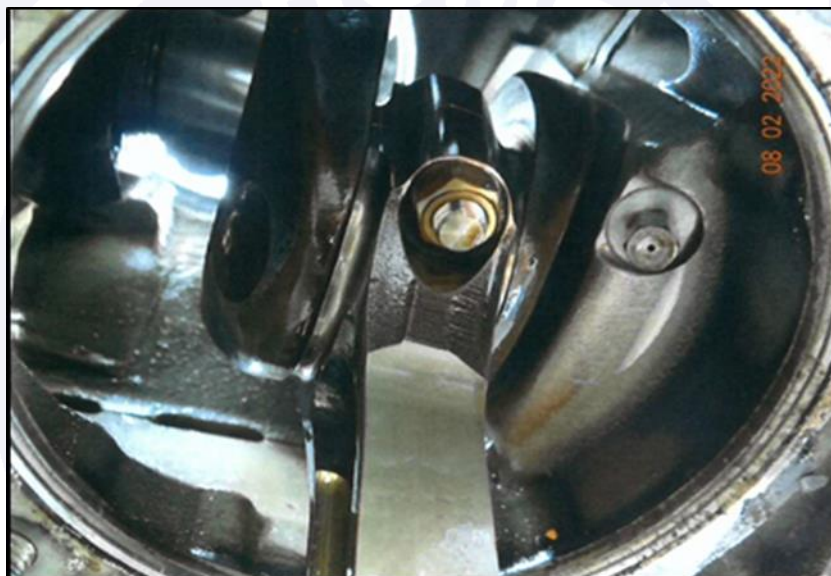
After the removal of the cylinders, one found that the crankshaft and valve timing shaft were functioning normally, rotating freely and in synchrony. Despite the existence of severe corrosion on the semi-carcasses, these components were rotated in different directions, without presenting resistance to motion.

The bearing supports and the bearings of the crankshaft and connecting rods were also in good working condition.

Figure 13 - General view of one of the connecting rods.
