COMANDO DA AERONÁUTICA
CENTRO DE INVESTIGAÇÃO E PREVENÇÃO DE
ACIDENTES AERONÁUTICOS

FINAL REPORT
A-028/CENIPA/2021

OCCURRENCE:	ACCIDENT
AIRCRAFT:	PR-NEX
MODEL:	PA-28-161
DATE:	20FEV2021

This Final Report pertains to the February 20, 2021, accident involving the model PA-28-161 aircraft of registration marks PR-NEX. The occurrence was classified as “[SCF-PP] System/Component Failure or Malfunction (Powerplant).”

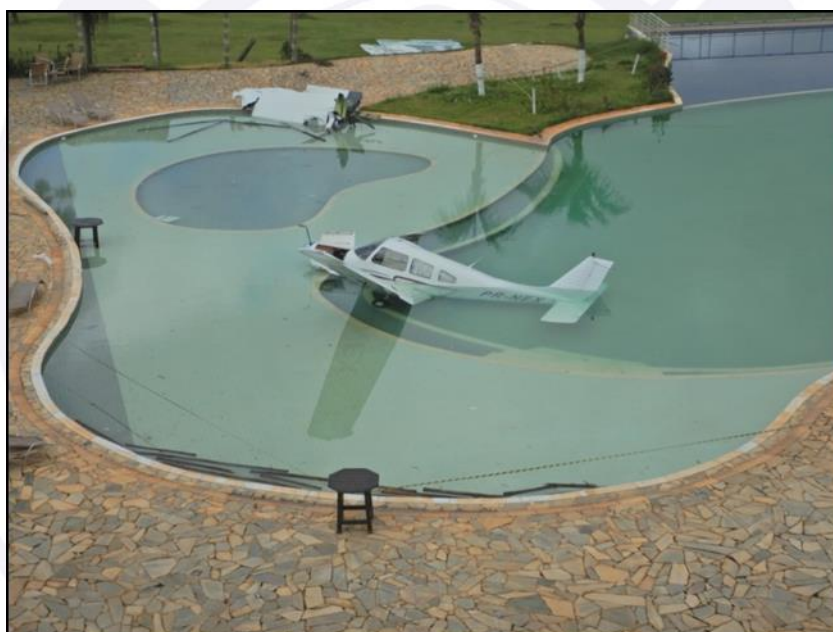
At low altitude, the aircraft overflew a hotel area near the runway and struck the tip of its right wing on a pergola (wooden structure), crashing into the hotel's swimming pool.

Figure 1 – View of the aircraft at the crash site.

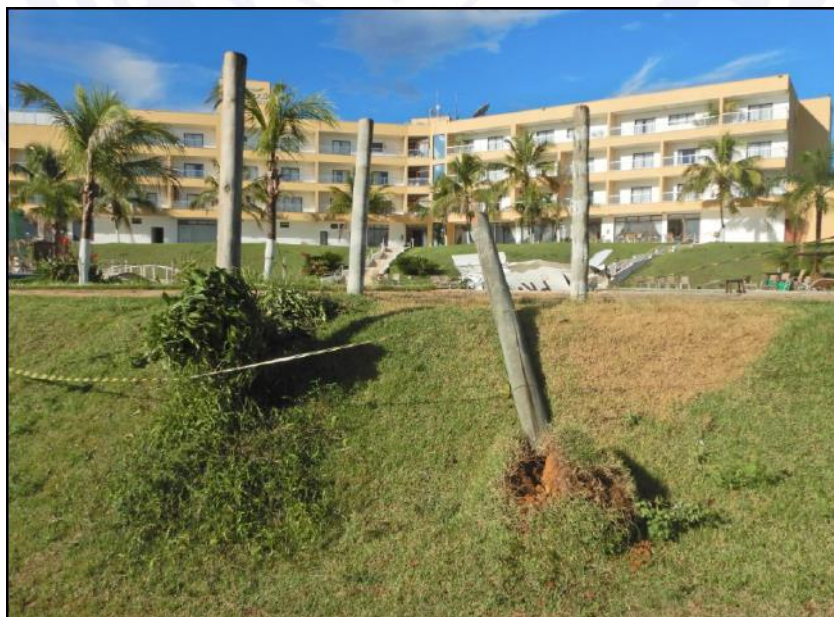
According to physical evidence at the impact site and footage from security cameras, the aircraft was in a turn when it collided with a structure near the leisure area of the Furnaspark Resort and came to rest inside the hotel's swimming pool (Figure 2).

Figure 2 – Site of the aircraft's first impact.

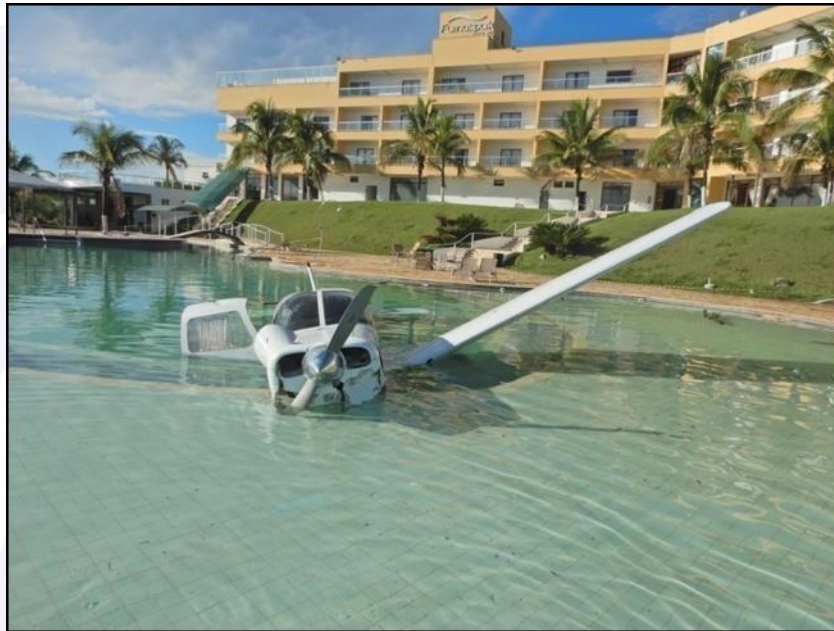
The right wing separated from the aircraft moments before it came to a complete stop and was found 18 meters away from the fuselage. Damage was observed along the entire lower section of the aircraft. Due to the extent of the damage, there was a fuel leak into the swimming pool where the aircraft came to rest (Figure 3).

Figure 3 – Frontal view of the aircraft at the accident site.

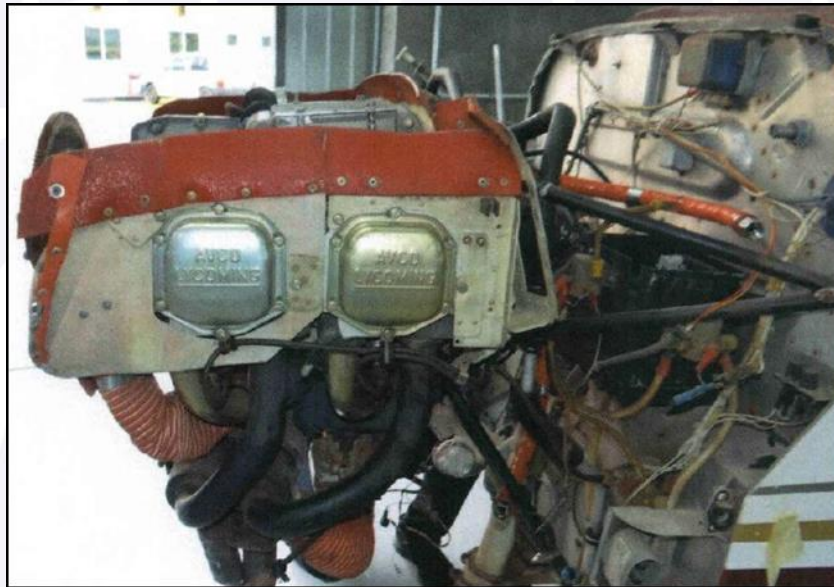
The SN L-9774-39A Lycoming O-320-D3G engine, which powered aircraft PR-NEX, was examined, removed, and installed in another aircraft that served as a platform for functional testing. Technicians from the Investigation Committee conducted the procedure (Figure 4).

Figure 4 – Left side view of the engine installed in another aircraft for testing.

During the work performed, one observed that the engine had no severe damage resulting from the accident in which the aircraft was involved. For the functional test, the technicians carried out only checks that would not alter the engine's characteristics compared to the day of the event.

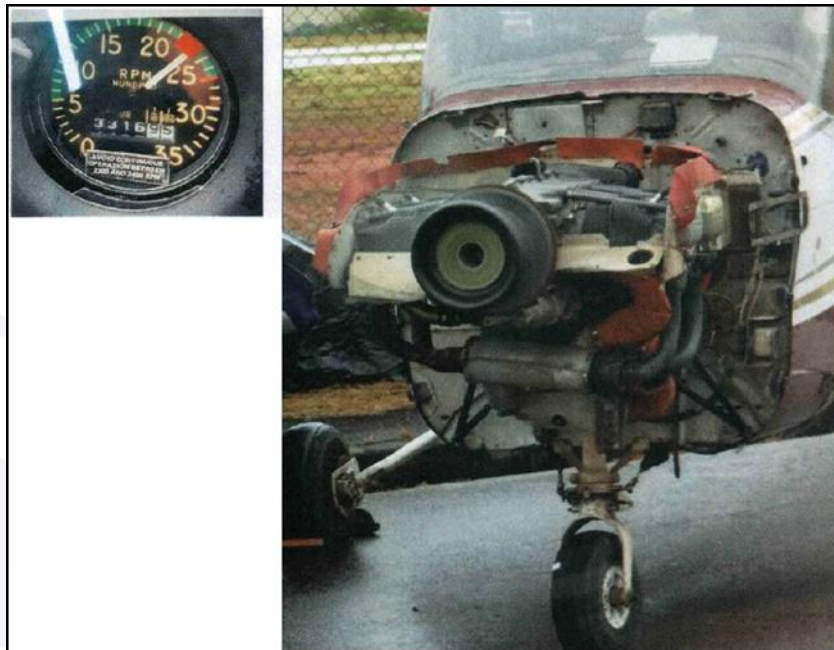
Then, the engine was set to maximum RPM and remained in that condition for 9 minutes without abnormalities (Figure 5).

Figure 5 – Engine operating at maximum RPM.

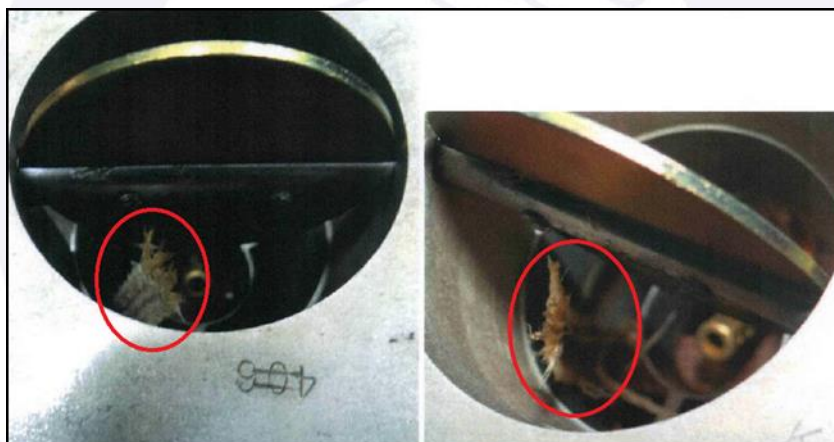
After this test, the carburetor was removed for inspection. Upon removal, a foreign object was found inside the carburetor venturi (Figure 6).

Figure 6 – Images of the foreign material lodged in the carburetor venturi.

The foreign material lodged in the carburetor venturi was a piece of fabric located in the air passage to the carburetor. It had been stuck in the hot air muff and was carried into the carburetor by the airflow.

The end of the fabric caused a disturbance in the airflow and fuel mixture feeding the engine. This led to the malfunction observed, resulting in a loss of engine power.

At the inspection of the carburetor, one found a piece of fabric lodged in the venturi. The fabric was removed, the carburetor cleaned, and reinstalled on the engine. Then, one tested the engine and it operated normally without failures or abnormalities.

After the removal of the foreign material and subsequent cleaning of the carburetor, it was reinstalled on the engine. One then started the engine again and operated it for an additional 10 minutes without any signs of abnormalities. It remained at maximum RPM and was subsequently throttled down and up several times. No further abnormalities or discrepancies were observed that could lead to malfunction.

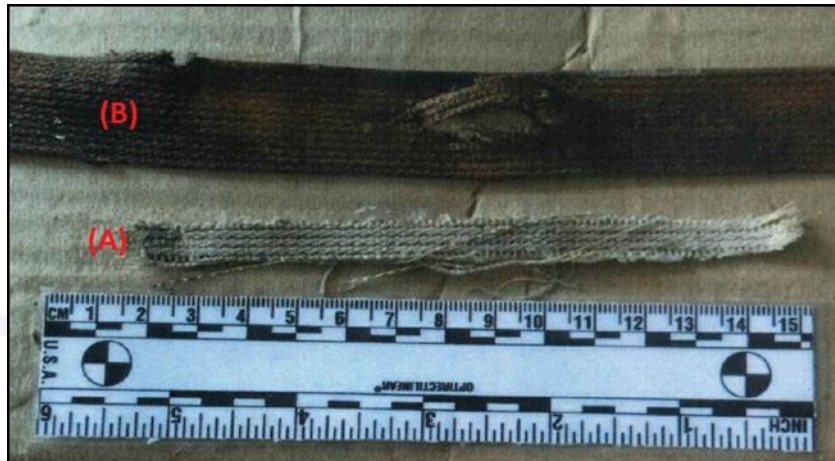
Figure 7 – (A) Fabric found inside the carburetor – (B) Fabric from the aircraft fuselage.

The fragment found obstructing the carburetor may have originated from a piece of anti-friction fabric visibly worn and poorly positioned on the left side of the fuselage, where the engine cowling rested.

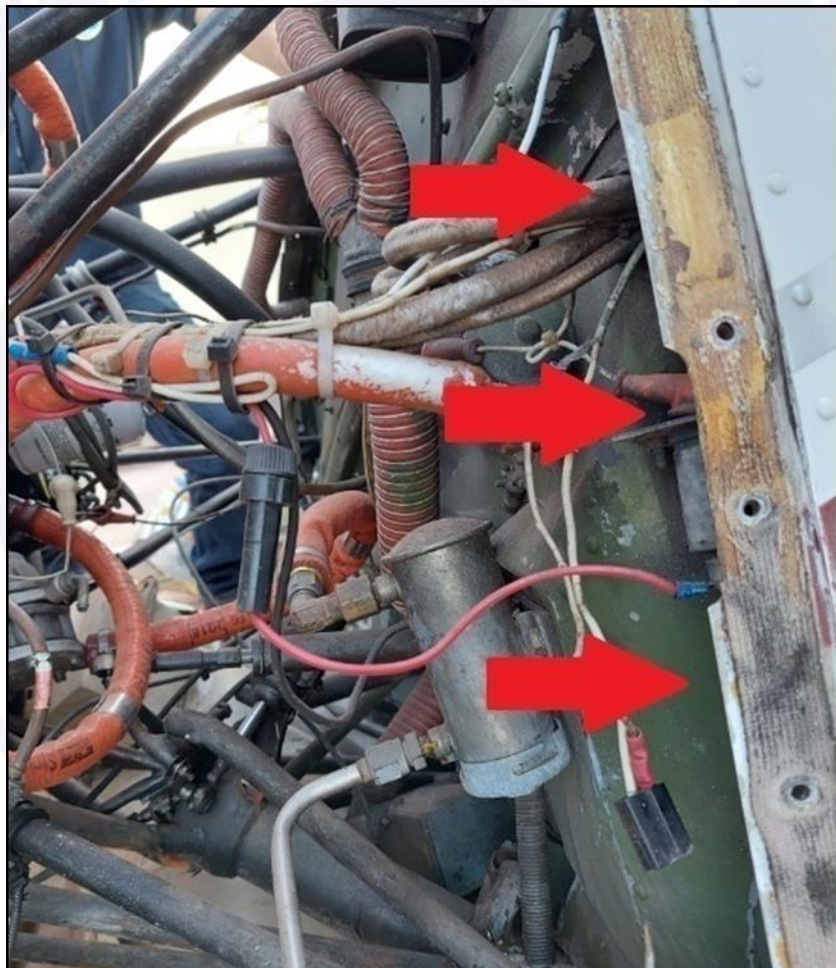
The investigation team observed that the anti-friction fabric located on the left side of the aircraft fuselage – where the engine cowling rested – showed clear signs of wear (Figure 8).

Figure 8 – Area with worn anti-friction fabric.

This improper positioning and the undetected or uncorrected wear by maintenance personnel may have allowed the fabric to be sucked into the airflow and carried into the carburetor, disrupting the normal airflow and fuel mixture. This disruption directly caused the engine failure and subsequent power loss during flight.

The presence of that fabric fragment in the carburetor venturi indicated a failure in preventive and corrective maintenance procedures, including deficiencies in ensuring the integrity of components that could affect engine performance.

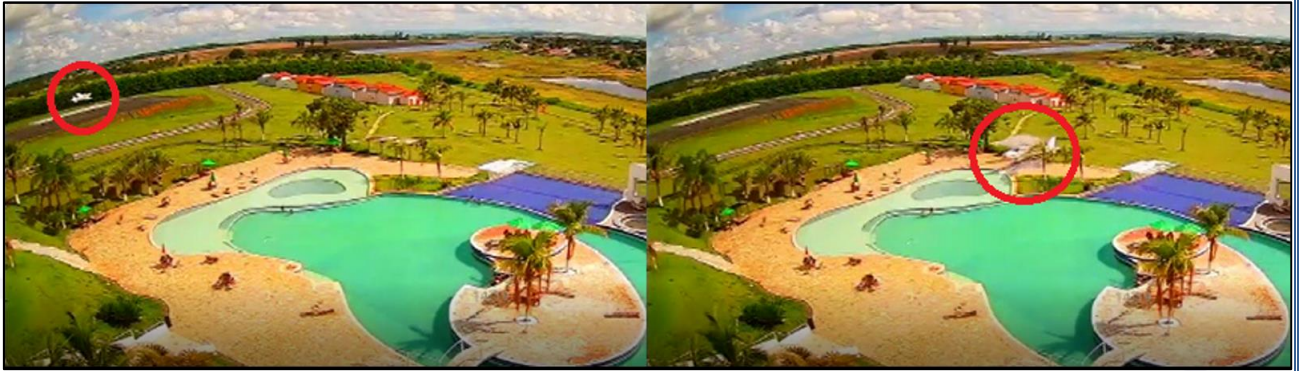
Based on the video footage, it was not possible to determine the aircraft’s exact flight path. However, one observed that 64 seconds elapsed between the crossing of the Runway 06 threshold during takeoff and the initial impact with the hotel structures (Figure 10).

Figure 10 – Images of the takeoff and first impact of the aircraft.

This time interval suggested that there were more actions or maneuvers performed than a simple immediate attempt to return to the runway following a power loss. If the engine indeed failed shortly after takeoff, at around 250 ft as reported by the PIC, the aircraft would typically have had little time to maneuver before ground impact.

The trajectory observed prior to the impact, which was perpendicular to the runway, indicated that the PIC conducted a significant overflight of the area surrounding the aerodrome – an atypical pattern for a direct and immediate response to a loss of engine power right after takeoff.
