**FINAL REPORT**  
**IG - 083/CENIPA/2019**

<b>OCCURRENCE:</b>	<b>SERIOUS INCIDENT</b>
<b>AIRCRAFT:</b>	<b>PR-NIA and PP-PTQ</b>
<b>MODEL:</b>	<b>AS 350 B2 and ATR-72-212A</b>
<b>DATE:</b>	<b>27MAY2019</b>

This is the Final Report of the 27MAY2019 serious incident with the AS 350 B2 and ATR-72-212A aircraft models, registrations PR-NIA and PP-PTQ. The serious incident was classified as “[MAC] Separation loss/collision in flight | Air Traffic”.

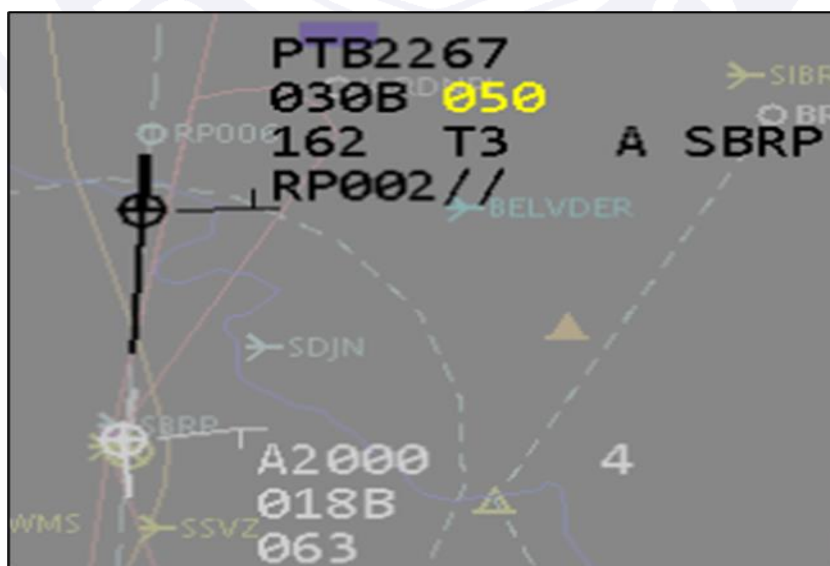
Due to the images, it was also noticed that the turn after takeoff was carried out a few meters from the ground and that, due to the small radius, it practically did not provide separation from the main SBRP runway.

Figure 6 - RADAR image of the PR-NIA during the left turn.

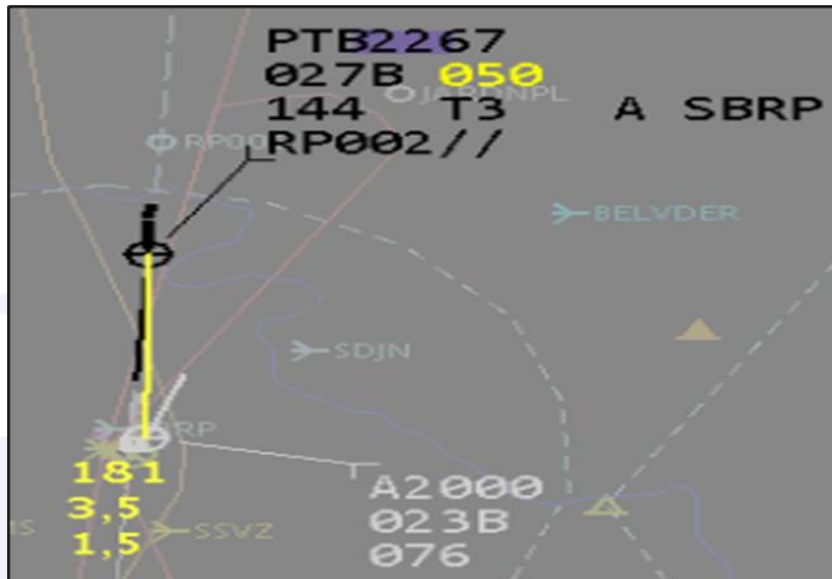
Figure 7 - RADAR image of the PR-NIA a few seconds before the end of the left turn.

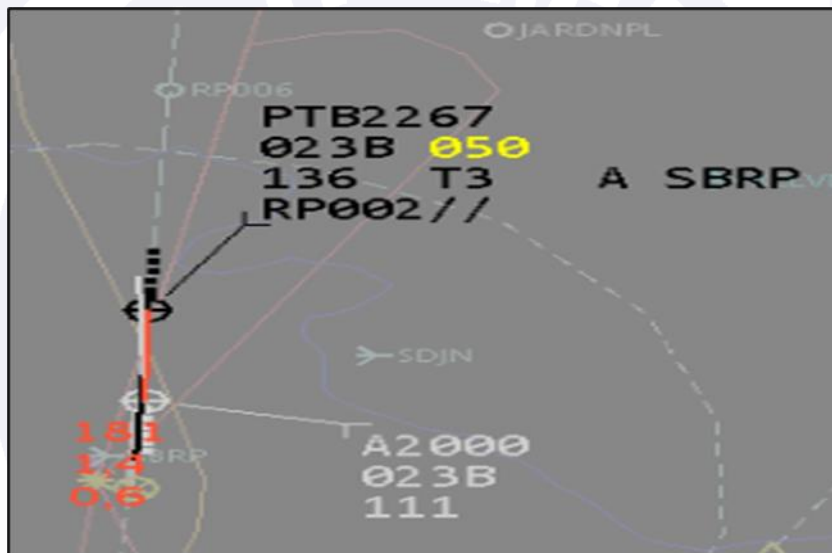
Figure 8 - RADAR image showing the aircraft on the same axis and at the same level.

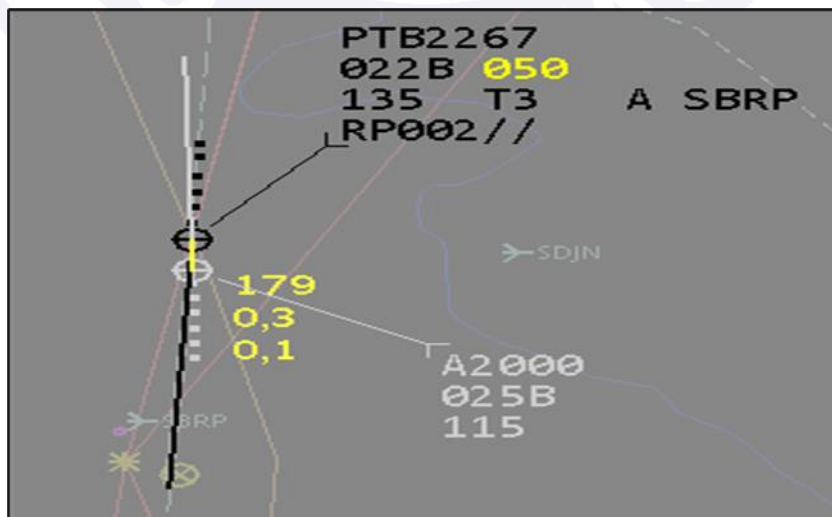
Figure 9 - Image of the aircraft on the same axis (PR-NIA 300 ft above the PP-PTQ).

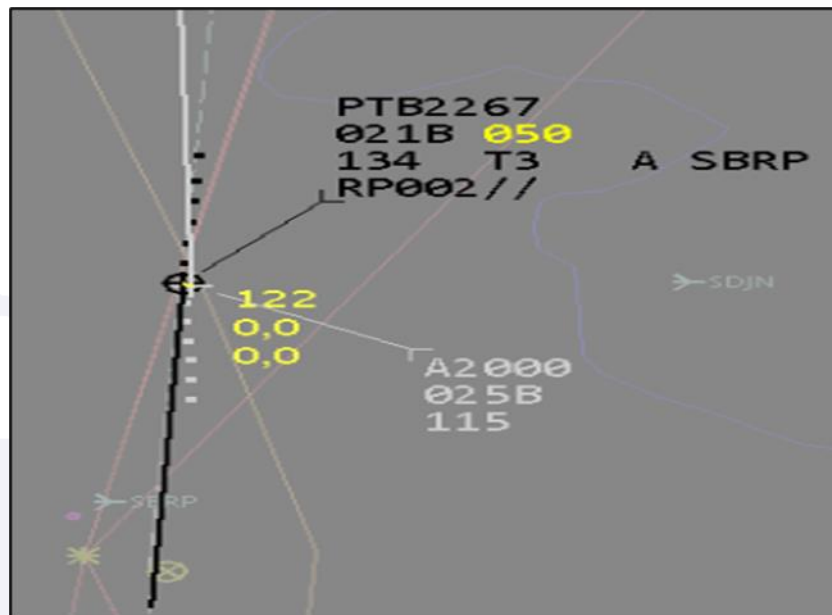
Figure 10 - Moment of the intersection. PR-NIA 400 ft above PP-PTQ.

As noted on the RADAR images, at the time of the intersection, the PP-PTQ was at 300 ft altitude, and the PR-NIA was at 700 ft altitude. Therefore, a vertical separation of 400 ft.

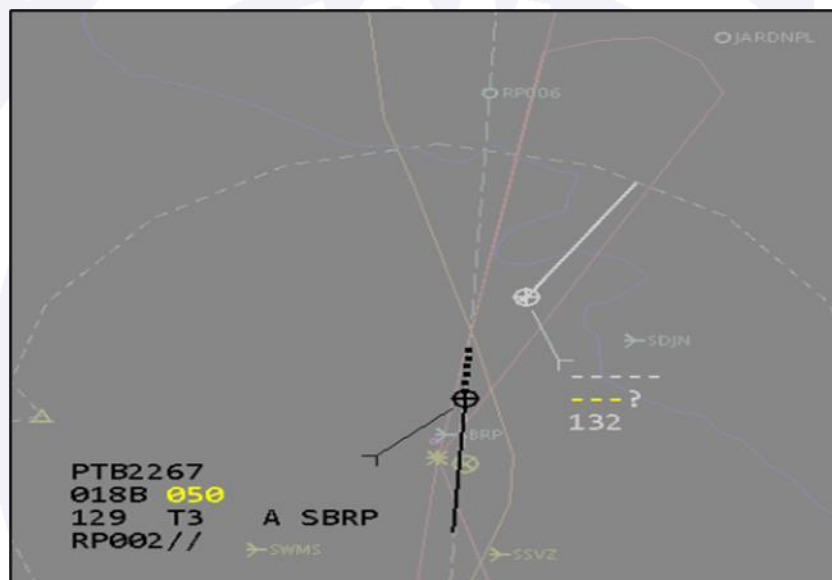
Figure 11 - PR-NIA moving away from the approach of runway 18, heading toward Jardinópolis.
