COMANDO DA AERONÁUTICA
CENTRO DE INVESTIGAÇÃO E PREVENÇÃO DE
ACIDENTES AERONÁUTICOS

FINAL REPORT
A-082/CENIPA/2020

OCCURRENCE:	ACCIDENT
AIRCRAFT:	PR-OFI
MODEL:	BE 58
DATE:	08JUL2020

This is the Final Report of the 08 July 2020 accident with the BE-58 aircraft of registration marks PR-OFI. The accident was typified as “[SCF-PP] Engine failure or malfunction | In-flight engine failure”.

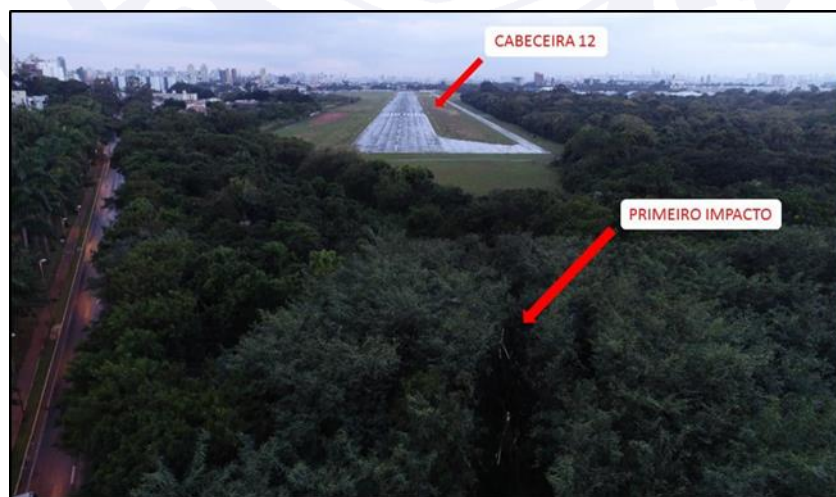
The aircraft came to a complete stop on Braz Leme Avenue, at a distance of 550 m away from the departure end of the runway 30. The first impact of the aircraft was against high vegetation in the overshoot area.

Figure 2 – Aerial image of Runway 12 threshold (i.e. departure end of rwy 30) and vegetation where the first impact occurred.

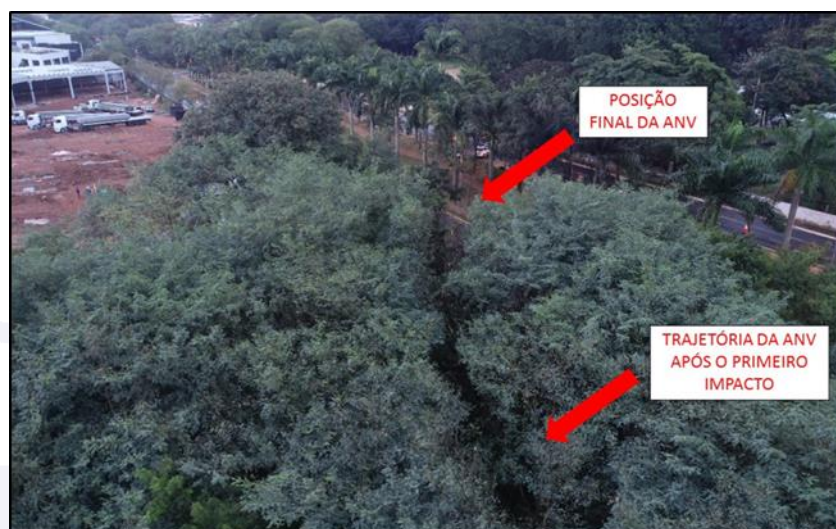
Figure 3 – Aerial image of the aircraft trajectory.

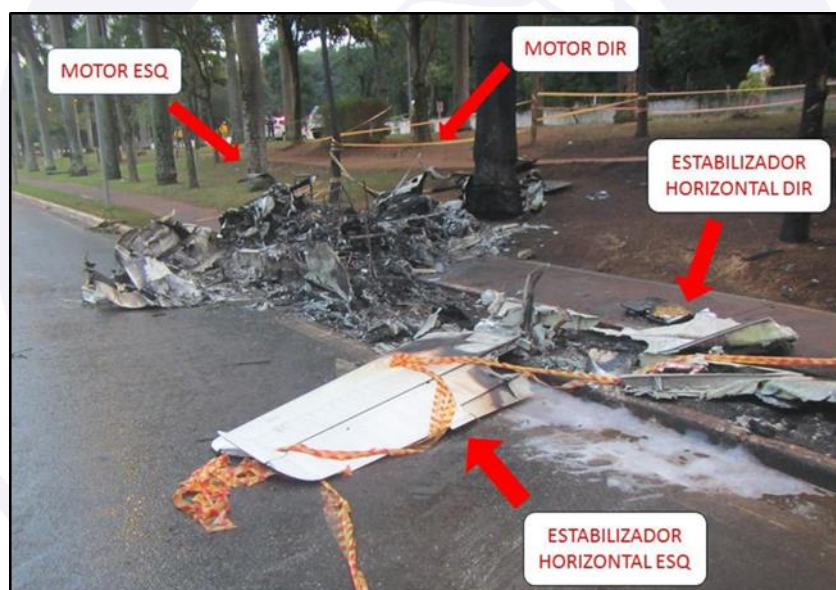
The distribution of the wreckage was concentrated and, due to its characteristics, the impact occurred with low forward speed.

Figure 4 – Aircraft wreckage in the crash site.

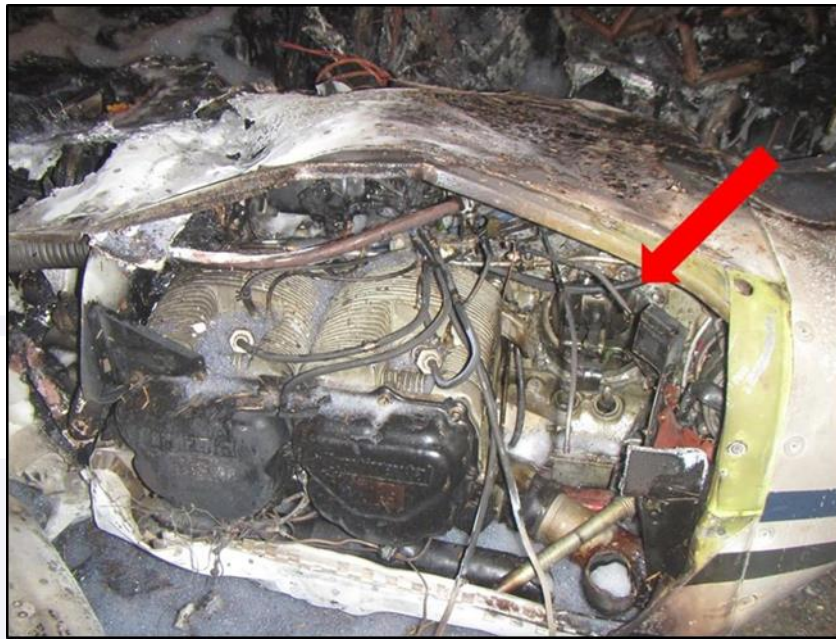
At the analysis of the wreckage, it was possible to observe that the cylinder number 5 of the right-hand engine was lying approximately 10 m away from the aircraft wreckage.

From the position of the right-hand engine propeller (feathered), and from the evidence found by the Investigation Committee, there were indications that the right-hand engine was not operating (motionless) at the moment of impact, as informed by the pilot.

Figure 5 – Detail of the right-hand engine without the cylinder number 5.

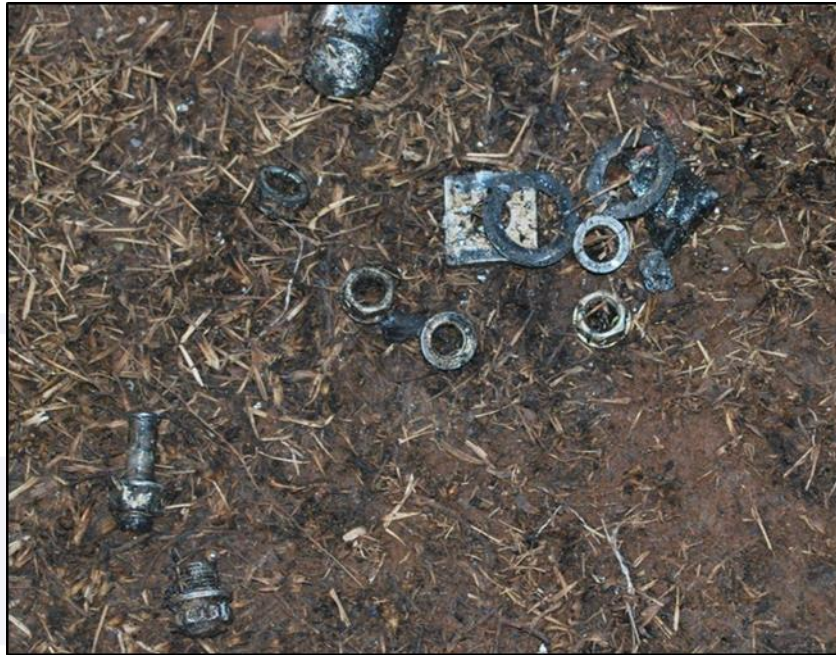
In relation to the right-hand engine (SN 685165), during the preliminary verification of the wreckage, one found that the cylinder no. 5 had separated from the engine assembly and was found approximately 10 meters away from the airplane. Pieces of the crankcase studs of the cylinder number 5 were found in the lower cowling of the engine, as shown in Figure 6, and were segregated for analysis.

Figure 6 – Image of fragments of studs and nuts of the right engine.

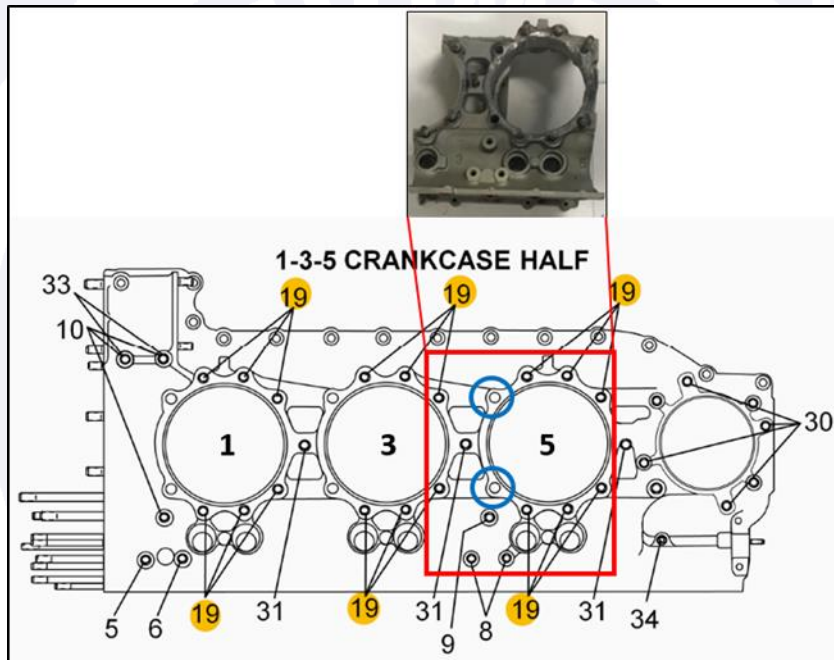
Figure 7 – Image of the right section of the PR-OFI's right engine's semi-crankcase, with the corresponding drawing extracted from the manual. Yellow highlights indicate the fixed studs .44-14 X .44-20, PN 646140-1. The blue circles show the position of the through-bolts .50-20 X 10.75, PN 641931-10.75, at the level of cylinder n° 5.

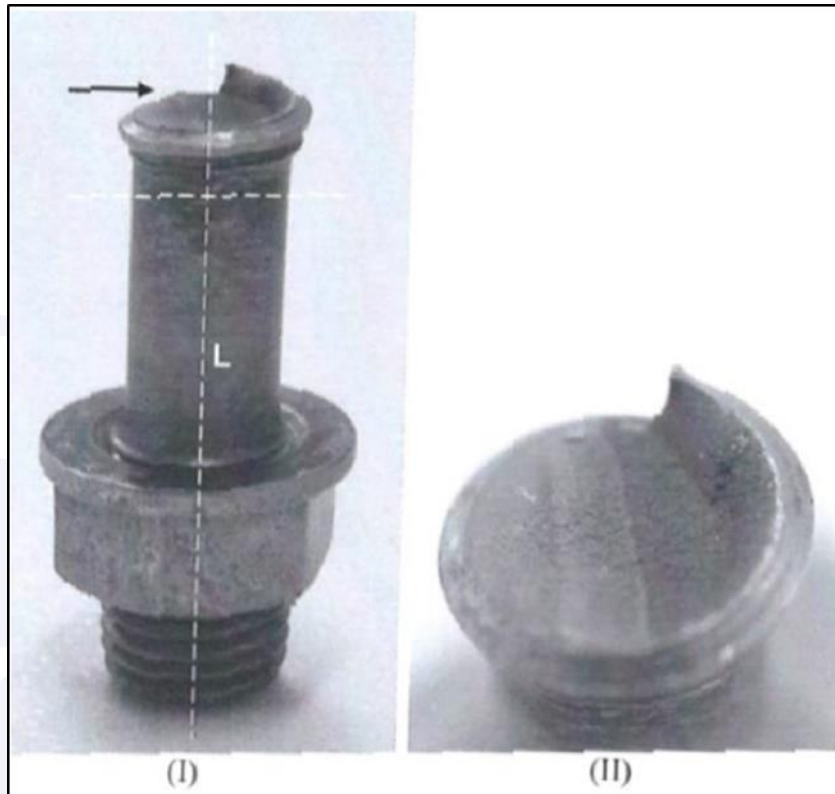
The analysis of this material revealed that one of the fractured studs, PN 646140-1, showed a fractured surface perpendicular to the longitudinal axis (Item I in Figure 8), with typical characteristics of fatigue failure (Item II in Figure 8).

Figure 8 - Image extracted from the analysis of the right engine's stud.

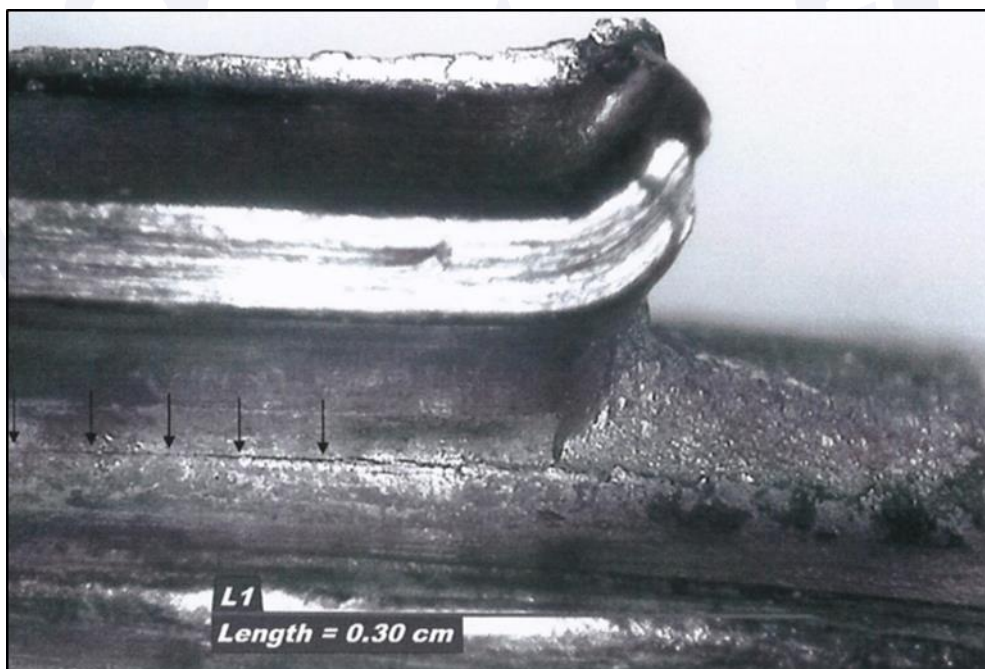
Additionally in the region where the bolt fracture began, grooves were found on the thread similar to those resulting from a material removal process in the form of chips. However, it was not possible to determine how these characteristics may have formed in that region (Figure 9)

Figure 9 – Detail of the groove with characteristics of material removal in the form of chips at the root of the thread on the same plane as the crack (black arrows).

It was found that one of the studs (PN 646140-1) and two trough-bolts (PN 641931-10.75) near cylinder 5 had fractured due to fatigue. Additionally, for the stud PN 646140-1, the presence of grooves in the thread fillet was observed, resembling those resulting from a material removal process in the form of chips.

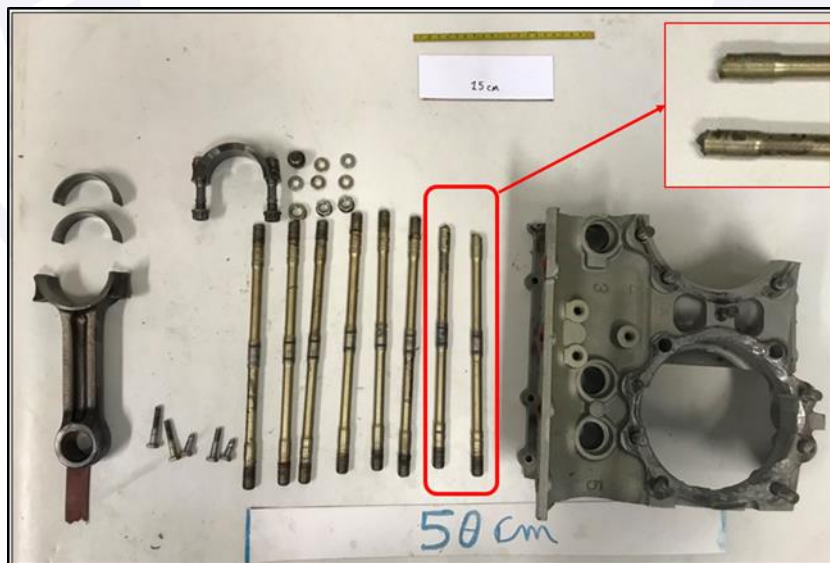
Additionally, as a result of the analysis of this engine, it was found that the through-bolts securing cylinder number 5 (Crankcase Through Bolts .50-20 X 10.75, PN 641931-10.75) also experienced fatigue failure (Figure 11). Consequently, the nuts on the other studs on this cylinder became overloaded and fractured. This allowed the cylinder to detach, resulting in engine stoppage.

Figure 11 – Parts of the right engine during analysis, highlighting two fractured crankcase through-bolts.

Regarding the right engine, it was found that two of the crankcase through-bolts for cylinder number 5 had fractured due to fatigue during the flight. This occurred when the engine had approximately 86 hours of operation since the overhaul, with an elapsed time interval of around 33 months.

Following the fatigue failure of the two crankcase through-bolts, the nuts on the other bolts of this cylinder became overloaded, leading to their failure and detachment in flight, which resulted in the shutdown of the right engine.

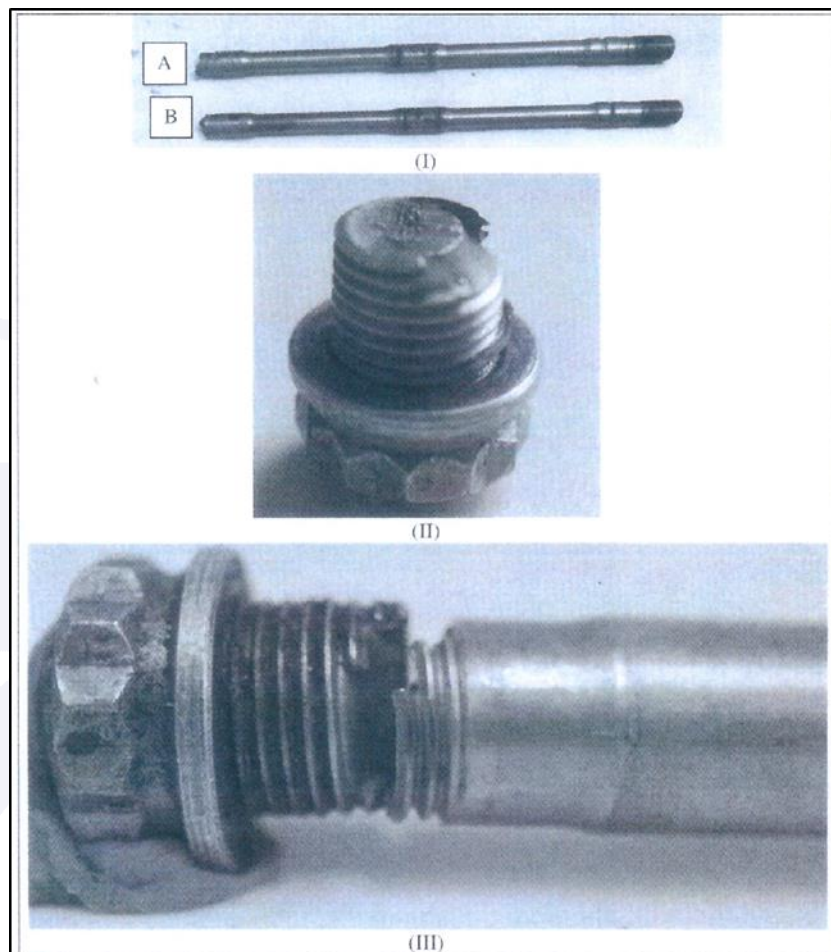
Figure 12 – Image detailing the fractured crankcase through-bolts. The details (II) and (III) pertain to bolt A.

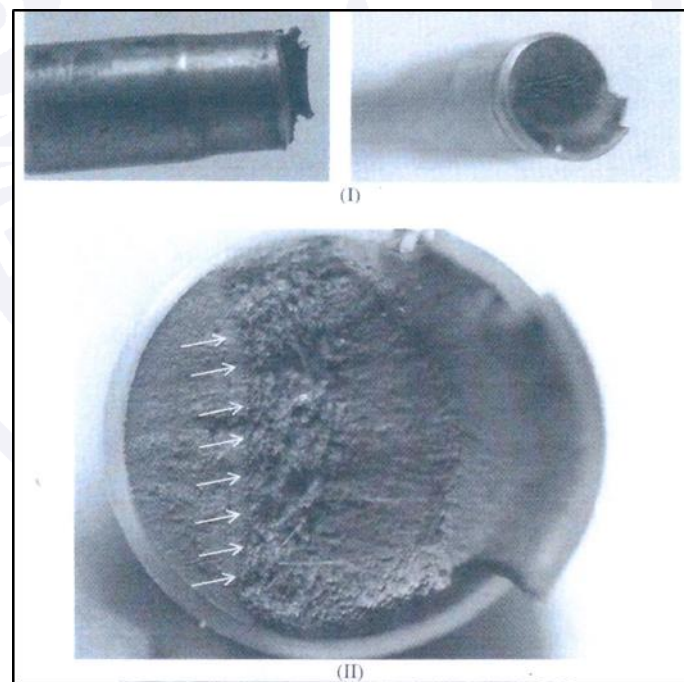
Figure 13 - Image detailing the fracture of the long end of the through-bolt A. in detail (II), under stereoscopy, the white arrows indicate beach marks characteristic of material fatigue fracture.

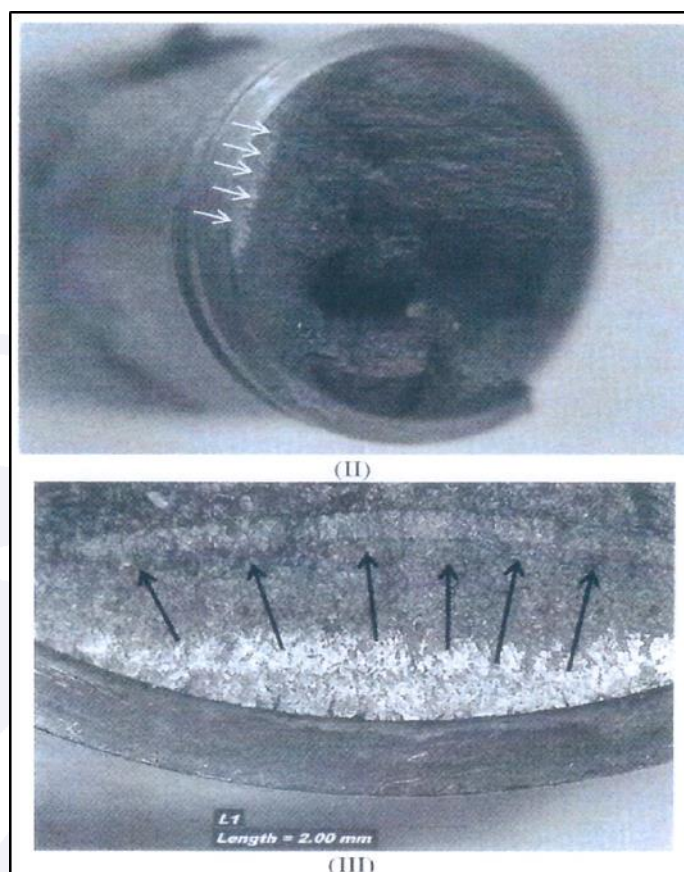
Figure 14 - Image detailing the fracture of the end of through-bolt B. In detail (II), under stereoscopy, the arrows indicate beach marks characteristic of material fatigue fracture. In detail (III), the fracture surface is magnified.
