COMANDO DA AERONÁUTICA
CENTRO DE INVESTIGAÇÃO E PREVENÇÃO DE
ACIDENTES AERONÁUTICOS

FINAL REPORT
A-082/CENIPA/2020

| AIRCRAFT: | PR-OFI |
| MODEL: | BE 58 |

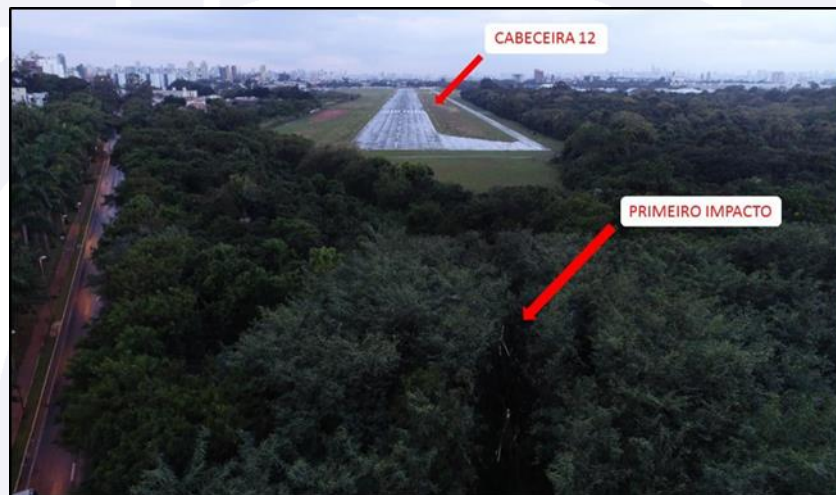
The aircraft came to a complete stop on *Braz Leme Avenue*, at a distance of 550 m away from the departure end of the runway 30. The first impact of the aircraft was against high vegetation in the overshoot area.

Figure 2 – Aerial image of Runway 12 threshold (i.e. departure end of rwy 30) and vegetation where the first impact occurred..

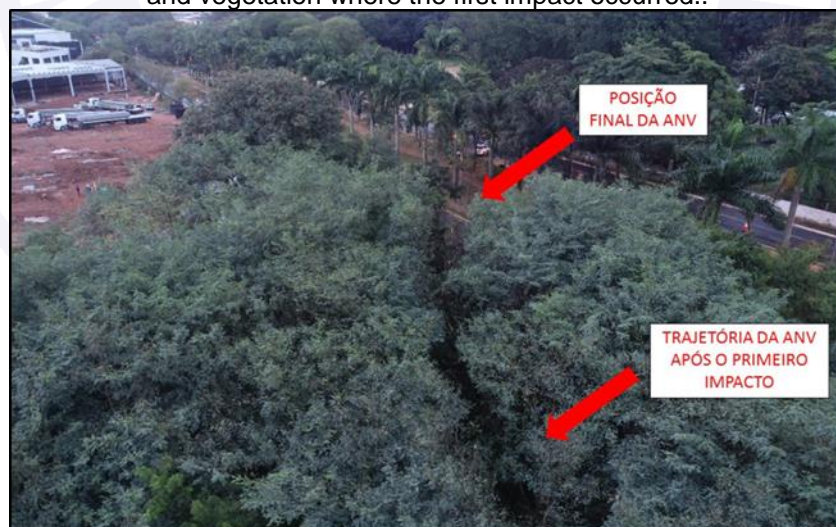
Figure 3 – Aerial image of the aircraft trajectory.

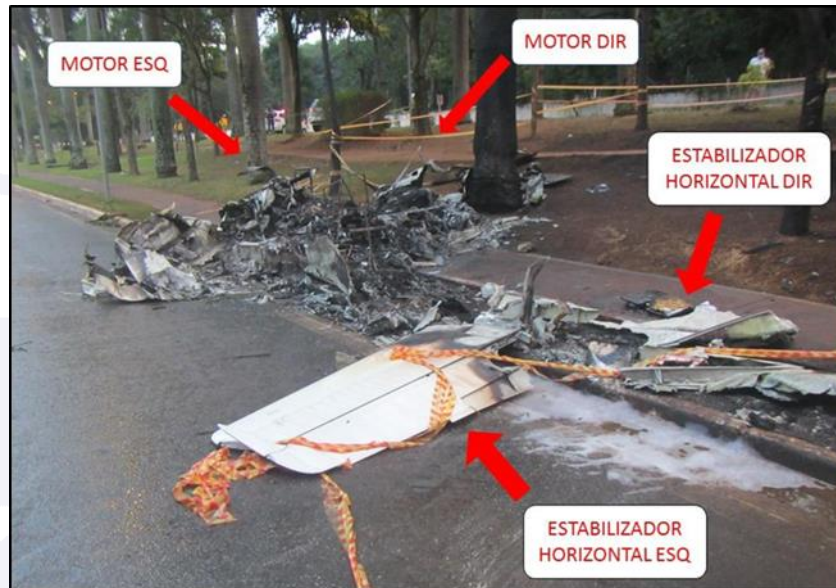
The distribution of the wreckage was of the concentrated type and, due to its characteristics, the impact occurred with low forward speed.

Figure 4 – Aircraft wreckage in the crash site.

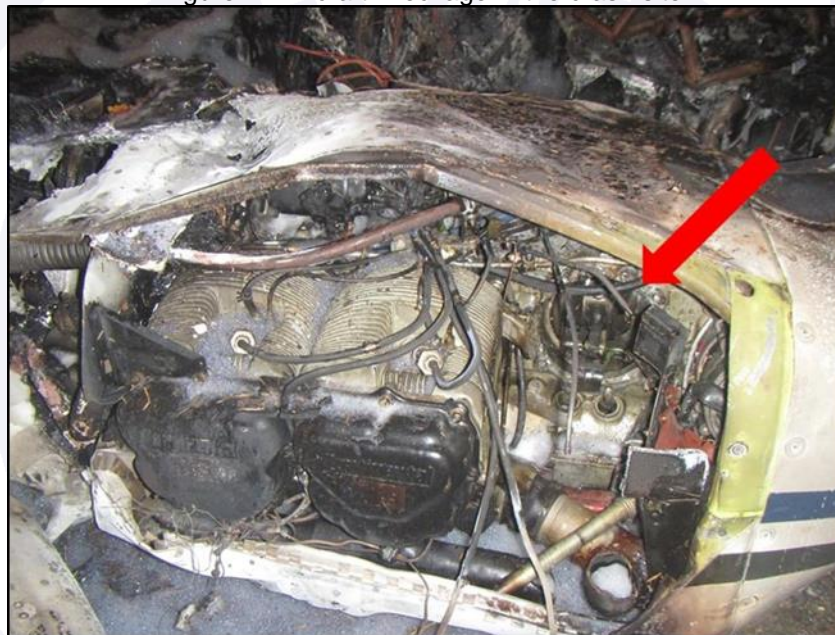
At the analysis of the wreckage, it was possible to observe that the cylinder no. 5 of the right-hand engine was lying approximately 10 m away from the aircraft wreckage.

Figure 5 – Detail of the right-hand engine without the cylinder no. 5.

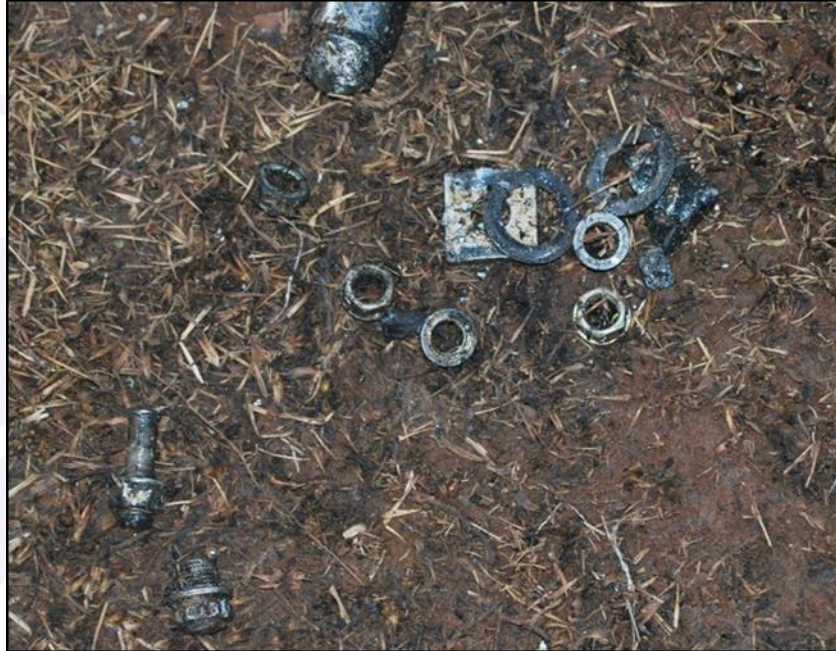
At the analysis of the wreckage, it was verified that the cylinder no. 5 of the right-hand engine had separated from its assembly, and was found approximately 10 m away from the aircraft. Parts of the *crankcase through bolts* of the cylinder were found in the lower cowling of the engine, as shown in Figure 6, and were sent for analysis at the Department of Science and Aerospace Technology (DCTA).

Figure 6 – Image of the *crankcase through-bolts* of the right-hand engine.

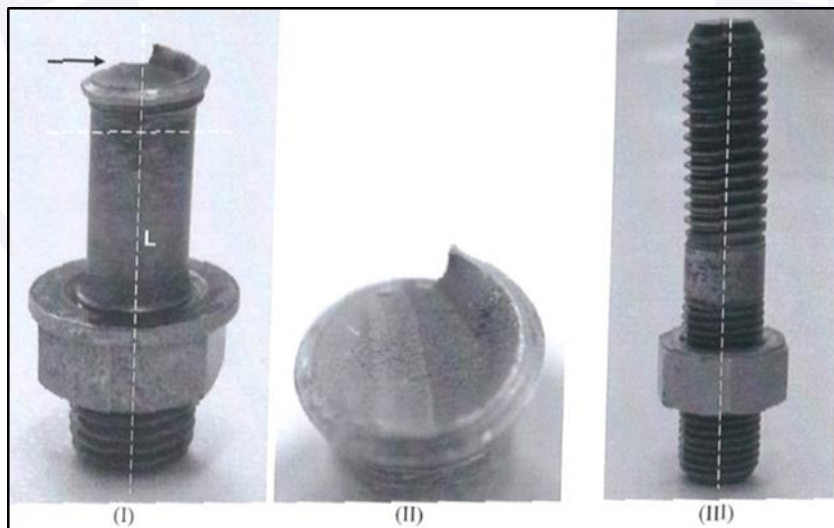
The results of the analysis showed that the ruptured bolt (PN EQ7050) presented a fracture surface perpendicular to the longitudinal axis (item I of Figure 7), with characteristics typical of failure due to fatigue (item II of Figure 7).

Still in Figure 7 (item III), there is an image of a *crankcase through bolt* with plastic deformation in its longitudinal axis.

Figure 7 - Image of the right-hand engine *crankcase thru bolts* extracted from the analysis report.

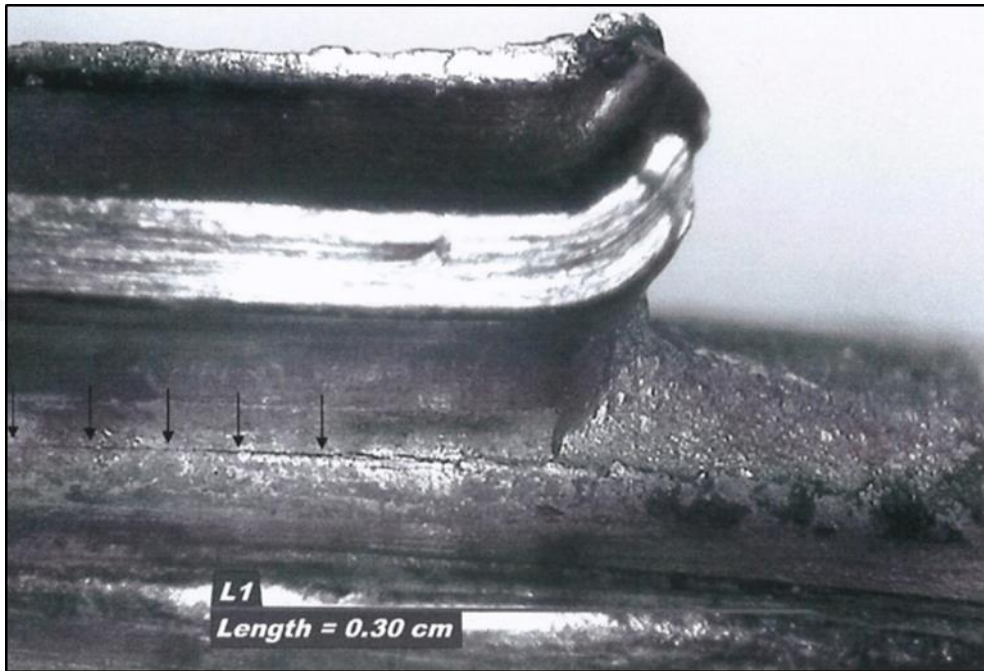
Additionally, it was possible to verify the presence of machining grooves in the thread fillet in the initial region of the fracture (Figure 8).

Figure 8 – Detail of a deep machining groove at the root of the fillet of the same plane of the crack (*black arrows*).

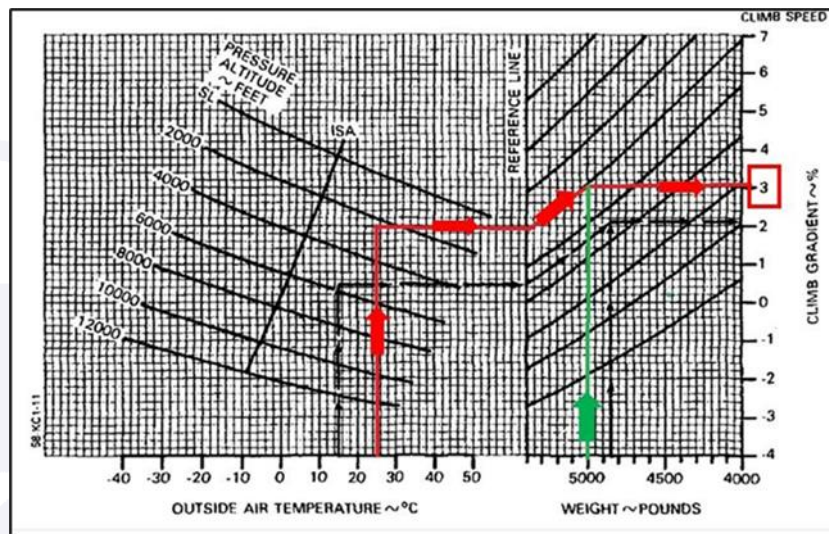
Thus, analyzing the *Takeoff Climb Gradient - One Engine Inoperative* diagram (Section V of the aircraft POH), and estimating an aircraft weight of approximately 5,000 pounds (2,267 kg.), one would obtain a gradient of 3%, according to the graphic projection in Figure 16.

Figure 16 - Extract from the *Take-off Climb Gradient - One Engine Inoperative* of the aircraft POH.

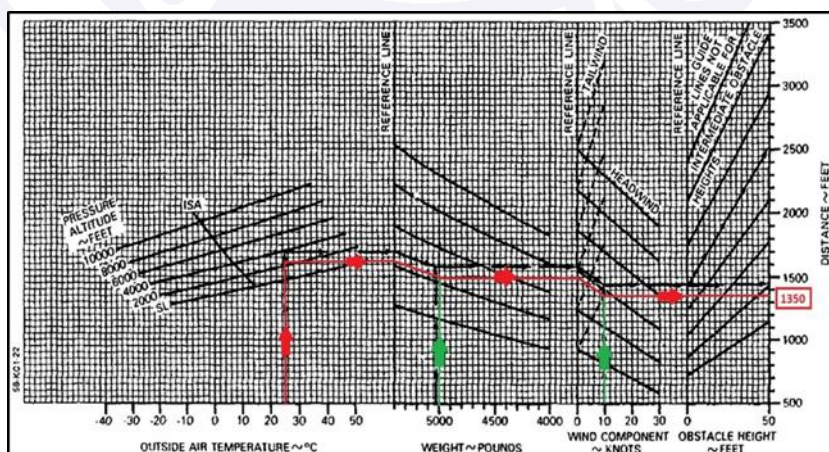
Should the pilot have chosen to apply the brakes from the middle of the runway onwards, and if one analyzes the Landing Distance diagrams in Section V, assuming that the aircraft was subjected to a headwind of 10 kt (as informed via radiotelephony by the control tower) with landing gear extended and the flaps down, at an approach speed of 91 kt., and fully applying the brakes, the aircraft would be able to stop in 1,350 ft (412 m), as per the performance diagram illustrated in Figure 17. The SBMT runway was 1,600 m long.

Figure 17 - Extract from the aircraft POH *Landing Distance* diagram.
