COMANDO DA AERONÁUTICA
CENTRO DE INVESTIGAÇÃO E PREVENÇÃO DE
ACIDENTES AERONÁUTICOS

FINAL REPORT
IG - 152/CENIPA/2015

OCCURRENCE:	SERIOUS INCIDENT
AIRCRAFT:	PR-OHD
MODEL:	AW139
DATE:	16NOV2015

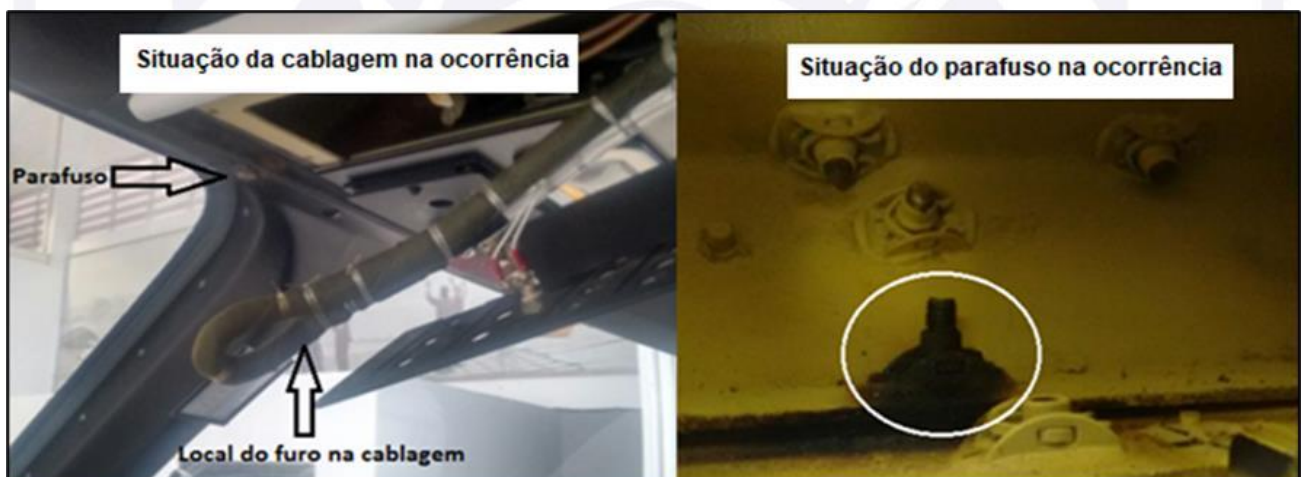
Figure 1 - Situation of the wiring and the screw in the event.

During an inspection to identify the source of the problem, it was observed that two electrical wirings (one from the EGPWS and the other from the TCAS) were rubbing against the aforementioned screw, causing a short circuit and an overheating in the screw, and also in the fiber where it was attached, generating smoke inside the cabin.

The images in Figure 1 indicate the location of the screw; the arrangement of the wiring (as it was inside the panel) and its hole; the point where there was friction, and the screw inside the top electrical panel. The screw without insulating and protective coating stands out.

When analyzing the condition of the wiring and other components in this area, it was found that two wirings were in contact with a screw, which did not have any protection to avoid friction, causing a small hole and the consequent electrical contact between different wirings.

Therefore, it was concluded that the aircraft manufacturing quality escape (misalignment of the production drawings of AWPC plant which were not aligned to the latest revisions available) contributed to the occurrence due to the inadequacy of the wiring positioning, which induced undue contact between the wirings and the screw causing a short circuit and overheating of the wiring.

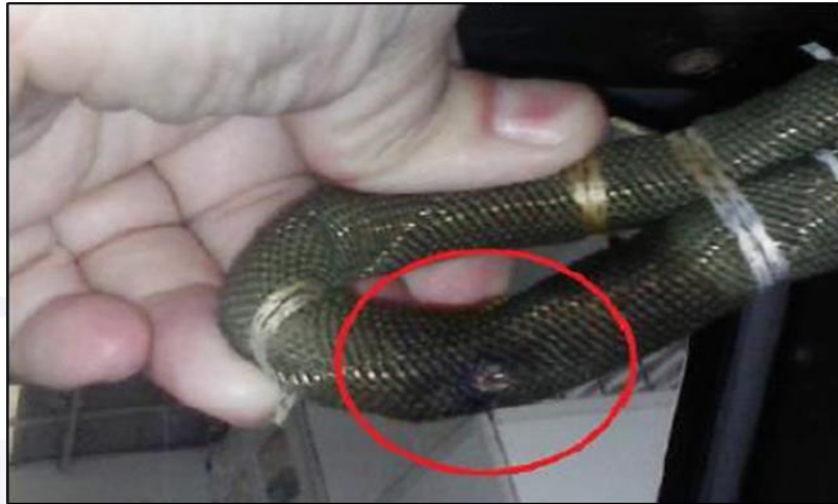
Figure 2 - Overheating marks and hole in the wiring.

In Figure 2, you can see highlighted, the overheating marks, and the hole in the wiring caused by friction between the aforementioned parts.

As a result, there was a short circuit and overheating of the place, causing the production of smoke and the characteristic smell of burnt material.
