FINAL REPORT
I - 055/CENIPA/2021

OCCURRENCE:	INCIDENT
AIRCRAFT:	PR-OMW
MODEL:	EC 225 LP
DATE:	15APR2021

This is the Final Report of the 15APR2021 incident with the EC 225 LP aircraft model, registration PR-OMW. The incident was classified as “[EXTL] With External Loads”.

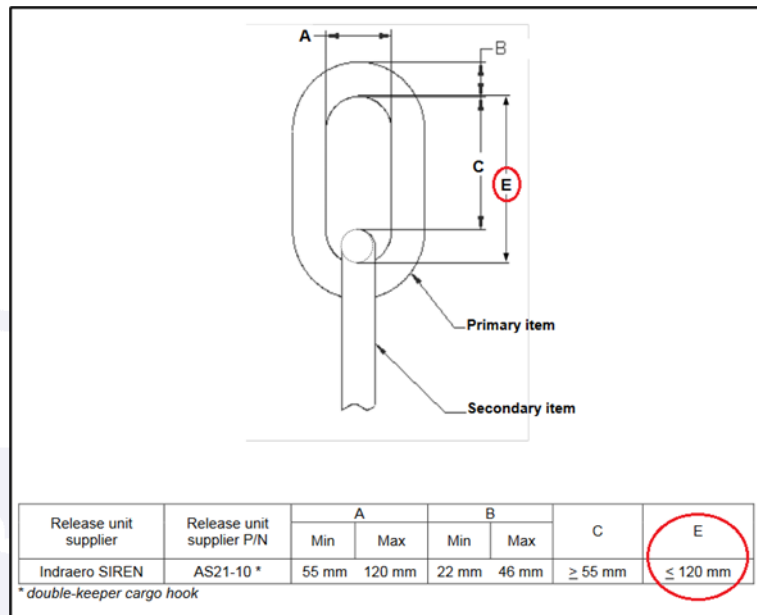
Specifically, regarding the dimensions of the rings that should be used to hook the external load, the aforementioned ASB established the following parameters in case the helicopter was equipped with the SIREN cargo hook (Figure 1):

Figure 1 - Dimensions of the rings to be used in the cargo hooks of the manufacturer SIREN. Source: ASB No. 04A004, of 12MAY2009.

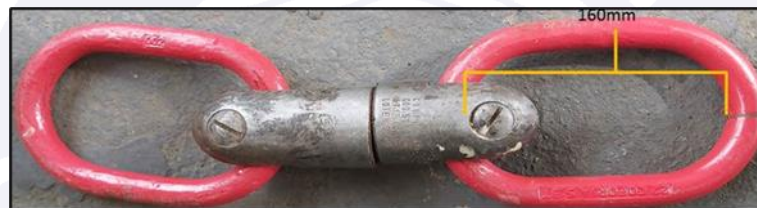
In this sense, as highlighted in Figure 2, it was found that the primary ring used to hook the load in the event measured 160 mm, that is, it was out of the 120 mm specifications, established in ASB No. 04A004, of 12MAY2009.

Figure 2 - Rings identical to those used to hook the external load at the time of the occurrence. The yellow lines indicate the inside measurement of the ring.

On the other hand, it was found that the primary ring used to connect the load to the respective hook was out of the dimensions specified by the manufacturer. The mandatory ASB 04A004, dated 12MAY2009, indicated that the internal diameter of the ring should be 120 mm. However, the one being used in the incident flight had 160 mm.

The ring used to attach the load to the aircraft hook was not within the measures recommended by the ASB EC225, No. 04A004, Limitations - SIREN Load Release Units: load jammed on the cargo hook in the open position, Revision 0, 12MAY2009, from Eurocopter An EADS Company.

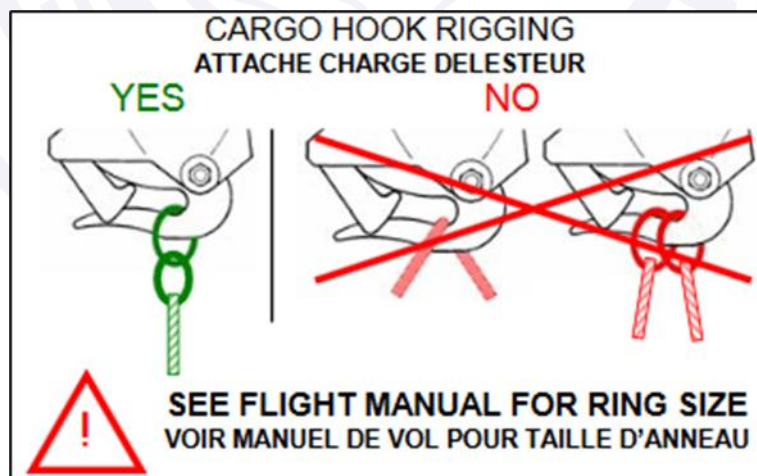
Likewise, the lack of the plate that should have been installed on the aircraft next to the cargo hook was observed (Figure 3).

Figure 3 - Plate containing loading guidelines for the cargo hook. Source: ASB nº 04A004, from 12MAY2009.

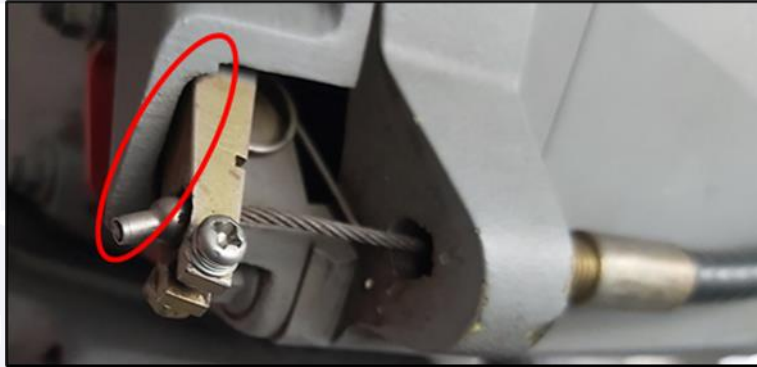
It was also verified that, on the day of the occurrence, the mechanical actuation lever did not present a clearance adjustment as required for its installation, as prevised in the MMA 25-31-03-061, sub- task 25-31-03-431-001, 3.3 Installation of the release unit PRE MOD 0726843 (Figure 4):

Figure 4 - The red circle shows that there was no clearance adjustment as required on the mechanical drive lever.

In spite of the fact that the documentation referring to the inspections is updated some nonconformities were found, such as: the mechanical actuation lever did not have a clearance adjustment as required for its installation, as provided for in MMA 25-31-03-061, sub-task 25-31-03-431-001, 3.3 Installation of the release unit PRE MOD 0726843 and the framing of the mechanical hook drive cable conduit.

On 02MAY2021, after the occurrence, the adjustment was carried out in the aforementioned activation lever, as stated in OS 210628-002 of 17APR2021. On that occasion, it was verified that the clearance was adjusted to approximately 4 mm, according to the orientation contained in the MMA 25-31-03-822.

Make sure that the clearance "F" between the housing unit (32) of the release unit (13) and the lever is lower than or equal to 4mm (.157in).

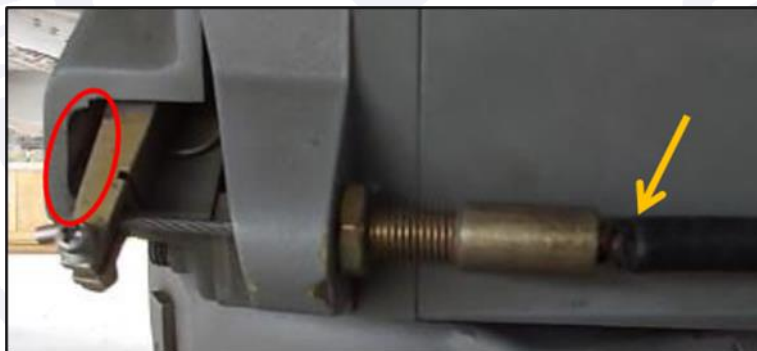
On the same occasion, it was noticed that the cable conduit for the mechanical activation of the hook was frayed (Figure 5).

Figure 5 - The red circle shows the clearance of approximately 4 mm between the lever and the housing unit. The yellow arrow shows frayed mechanical drive cable conduit (PN 704A31-813009).

As a corrective measure, the replacement of PN 704A31-813009, in question, was provided.

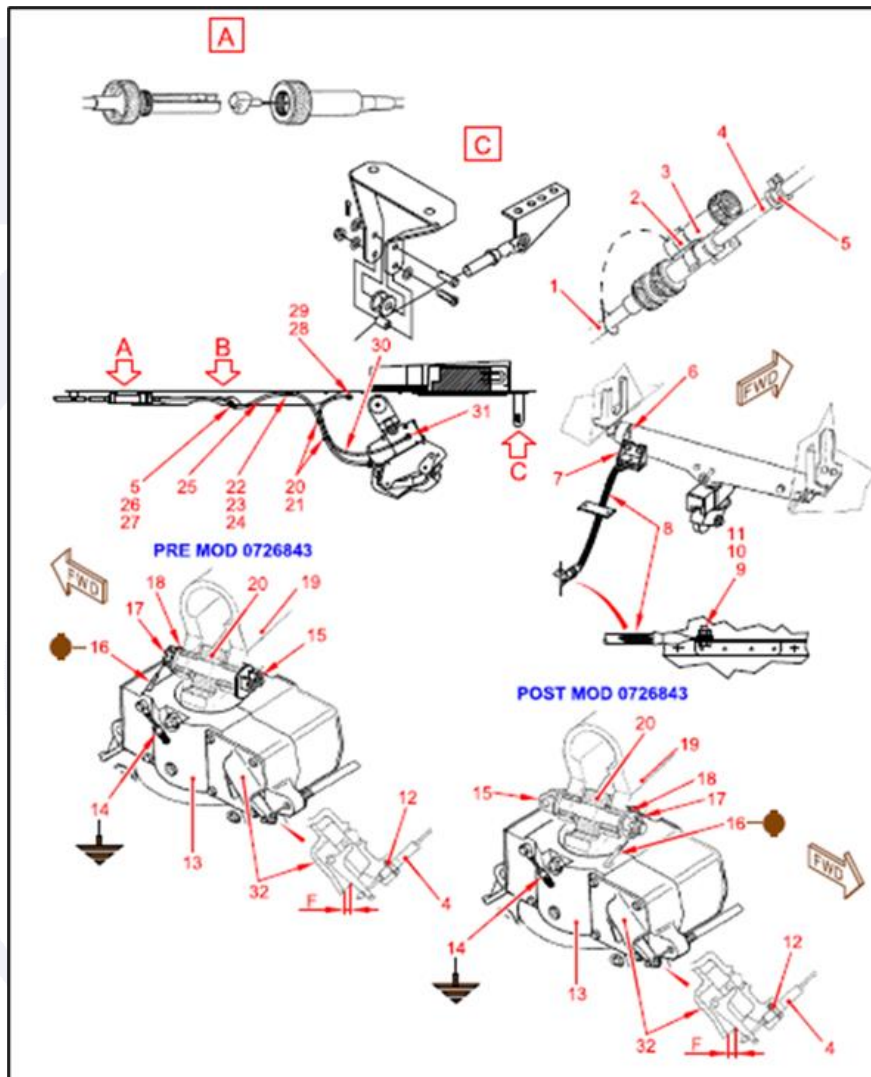
Figure 6 - Difference between the types of installation of the cargo hook opening mechanical actuation set. Source: SB No. EC225-25-122-Reversing T-3.8 Sling Hook.

This aircraft was manufactured in 2012 and was configured in the PRE MOD version.

It was found that both the electrical supply wiring and the mechanical control cable used for the cargo hook installation had specifications for the PRE-MOD configuration. However, the installation took place for the POST MOD (0726843) configuration, in disagreement with the provisions of the SB EC225-25-122.

It was found that both the electrical supply wiring and the mechanical control cable used for the cargo hook installation had specifications for the PRE-MOD configuration. However, the installation took place in the POST MOD configuration (0726843), in disagreement with the provisions of SB EC225-25-122.
