**COMANDO DA AERONÁUTICA**  
**CENTRO DE INVESTIGAÇÃO E PREVENÇÃO DE**  
**ACIDENTES AERONÁUTICOS**

**FINAL REPORT**  
**A-070/CENIPA/2021**

<b>OCCURRENCE:</b>	<b>ACCIDENT</b>
<b>AIRCRAFT:</b>	<b>PR-ORS</b>
<b>MODEL:</b>	<b>AT-502B</b>
<b>DATE:</b>	<b>11MAI2021</b>

This is the Final Report of the 11 May 2021 accident with the AT-502B aircraft, registration marks PR-ORS. The accident was typified as “[SCF-PP] Engine failure or malfunction”.

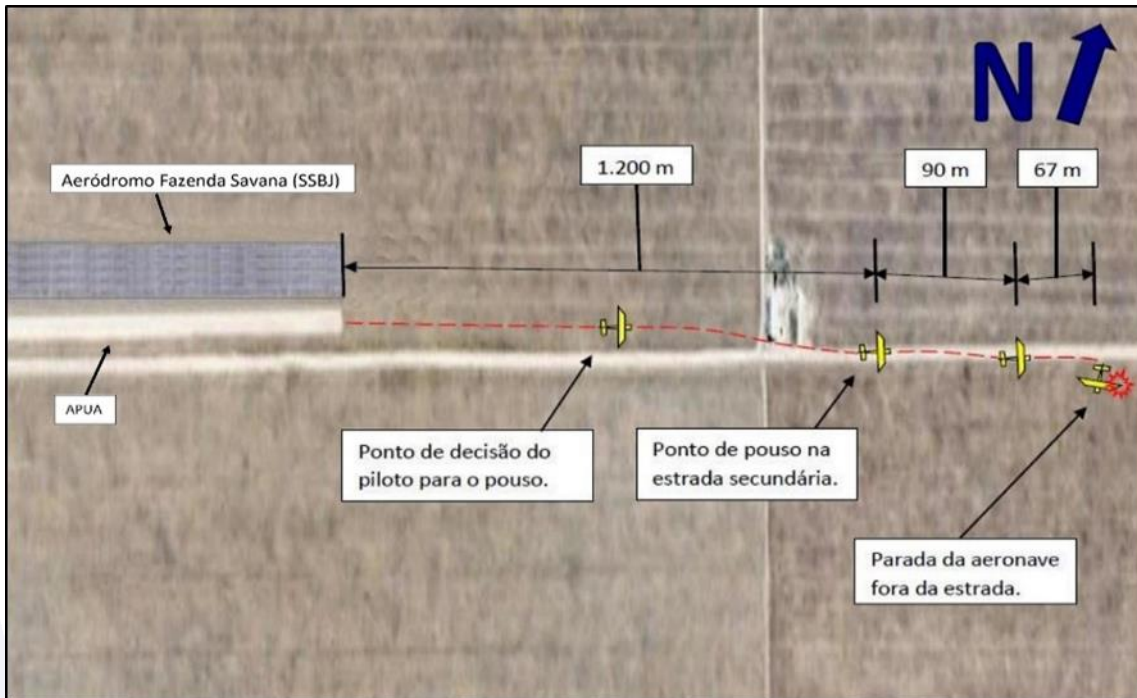
The first touchdown took place approximately 1,200 m beyond the departure end of the airstrip for aeroagricultural use, on a secondary dirt road of *Fazenda Savana*. After traveling on the ground for approximately 157 meters, the aircraft came to a stop off the road, in a direction that was 90 degrees offset to the right (Figures 1 and 2).

Figure 1 - Croquis of the accident.

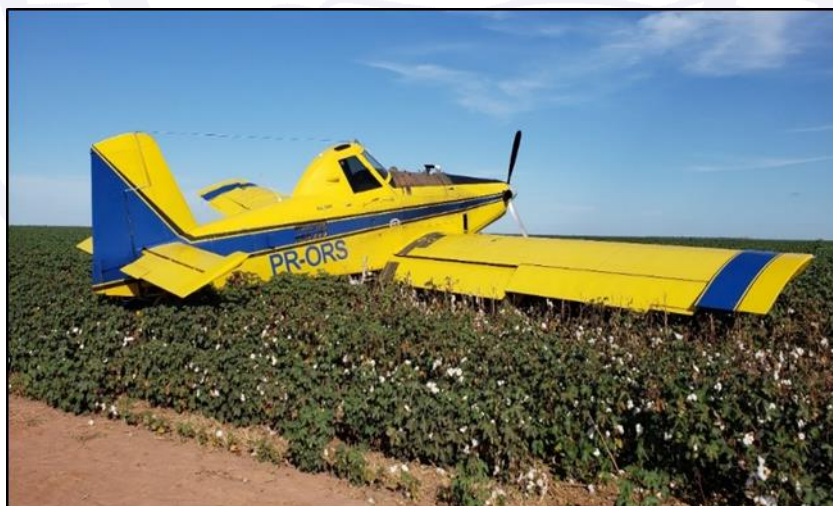
The aircraft sustained substantial damage. There was damage to the left main landing gear strut, to the left wing extrados, and to internal components of the engine.

Figure 2 - Aircraft at the stopping point, pointing in a direction 90 degrees offset to the right.

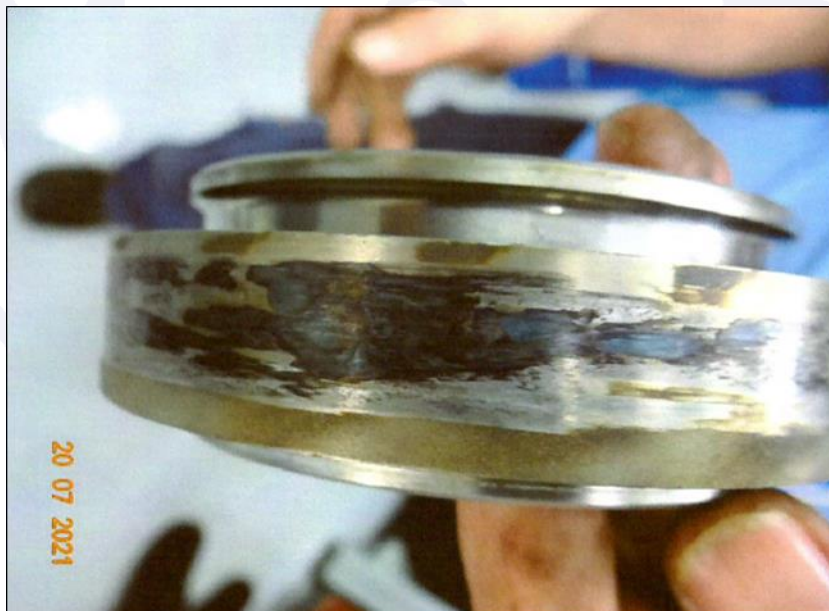
The SN PCE-PH1040 engine was analyzed by the investigation commission. The technical work was done in the Pratt & Whitney's workshop in Brazil. Engine disassembly and analysis revealed the existence of damage resulting from intense rubbing between the compressor rotor and its housing (Figure 3).

Figure 3 - Rubbing marks observed on the spacer between the 1st and 2nd compression stages.

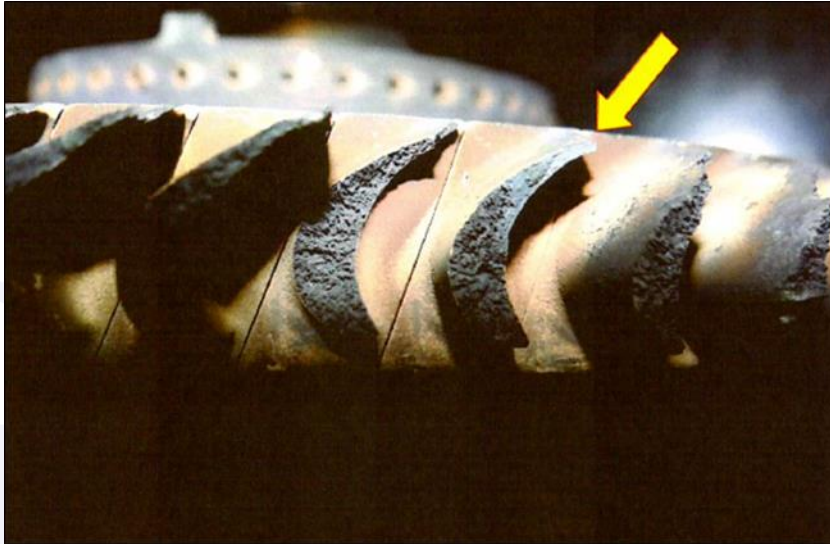
Among all the blade ruptures, the one indicated in Figure 4 had different characteristics on the rupture surface.

Figure 4 - Top view showing the type of flat fracture in one of the blades.

The objective was to identify the fracture mechanism of the blade n° 4 (PN 3120751-01) indicated in Figure 4.

Laboratory analyses of the CT disc assembly showed that the failure in blade n° 4 likely occurred due to high cycle fatigue. Furthermore, the aforementioned analyses indicated that the loss of material from the trailing edge of the said blade made it impossible to determine the origin of the failure accurately. The other blades suffered rupture due to overload. The results of the analyses were confirmed by the investigation commission.

Such rupture, according to the analyses of the engine carried out at the engine manufacturer's laboratory, occurred probably due to high cycle fatigue. Still according to the aforementioned analyses, the loss of part of the material from the trailing edge of the blade made it impossible to determine the origin of the failure accurately. Furthermore, one found that the other blades of the disk rotor suffered rupture due to overload, resulting from the fracture of the blade n<sup>o</sup> 4.

It is possible that a contingent extrapolation of the ITT limits, as well as the use of agricultural pesticides with sulfur in their composition, contributed to the initiation of the high cycle fatigue.

One way to mitigate the sulphidation phenomenon would be to adopt procedures to remove those chemicals, in the case in question, by washing the engine compressor, in accordance with the guidelines established in the Aircraft's Engine Maintenance Manual, chapter 71-00-00 - Power Plant - Cleaning, nº 8, Compressor Turbine Wash. It is worth clarifying that, in the context of operation of this aircraft, the compressor washing procedures were in accordance with the maintenance instructions in force.
