**FINAL REPORT**  
**A-078/CENIPA/2021**

<b>OCCURRENCE:</b>	<b>ACCIDENT</b>
<b>AIRCRAFT:</b>	<b>PR-OTF</b>
<b>MODEL:</b>	<b>AW 139</b>
<b>DATE:</b>	<b>02JUN2021</b>

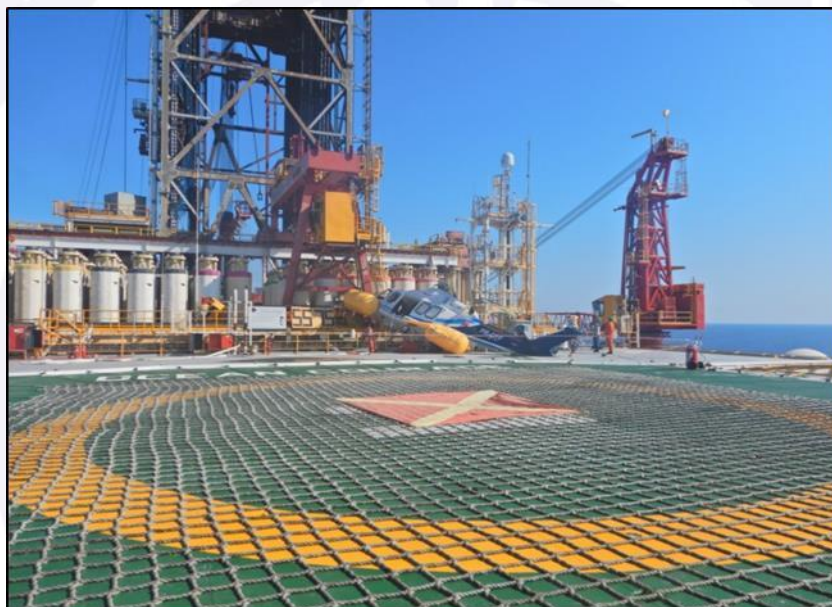
During the approach for the first landing, the aircraft's main rotor collided with structures near the platform's helideck.

Figure 1 - View of the PR-OTF aircraft at the accident site.

The aircraft sustained substantial widespread damage.

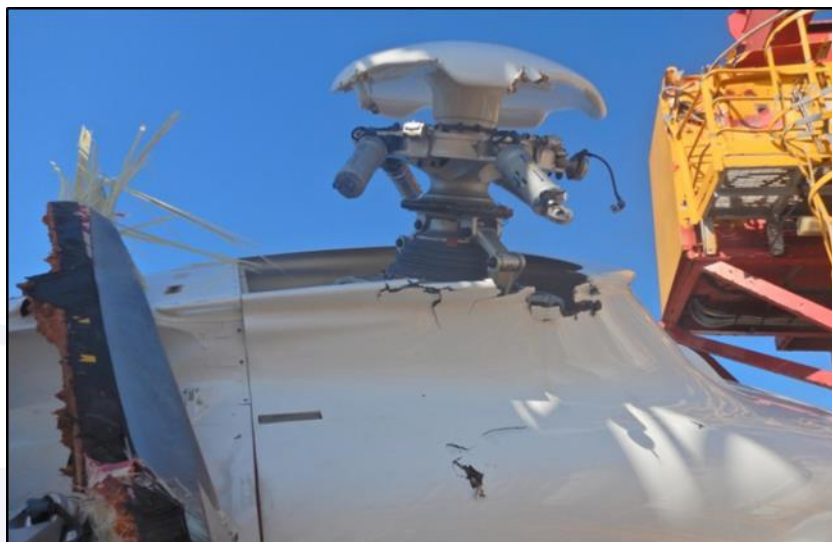
The aircraft sustained substantial damage to its entire structure. In addition, the engine was internally fragmented, with fragments being expelled onto the surface of the platform. The main rotor blades were destroyed after impact with the structure of the maritime unit (Figure 2).

Figure 2 - View of the main rotor head without the blades.

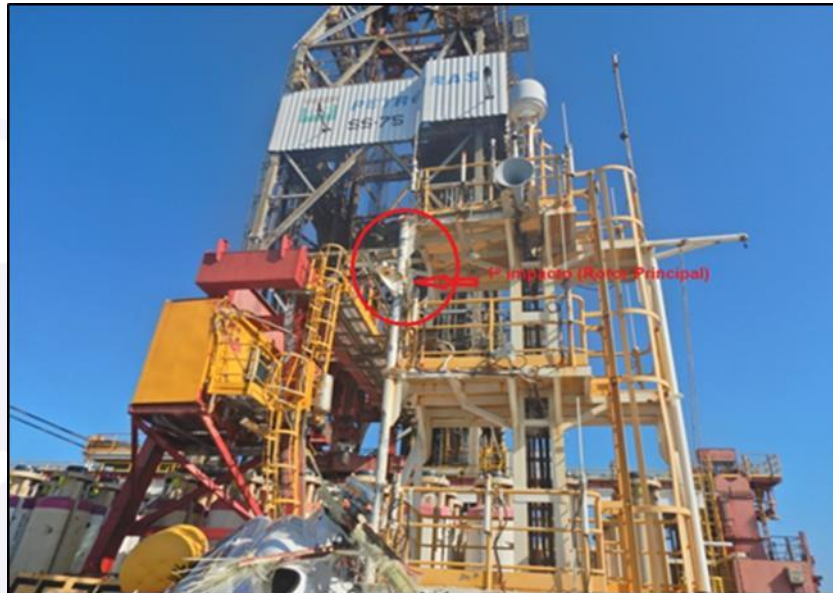
The investigators found two marks of the impacts of the main rotor against the platform surfaces. The first impact occurred between the main rotor and the crane operator cabin (Figure 5).

Figure 5 - Location of the first impact of the helicopter against the platform.

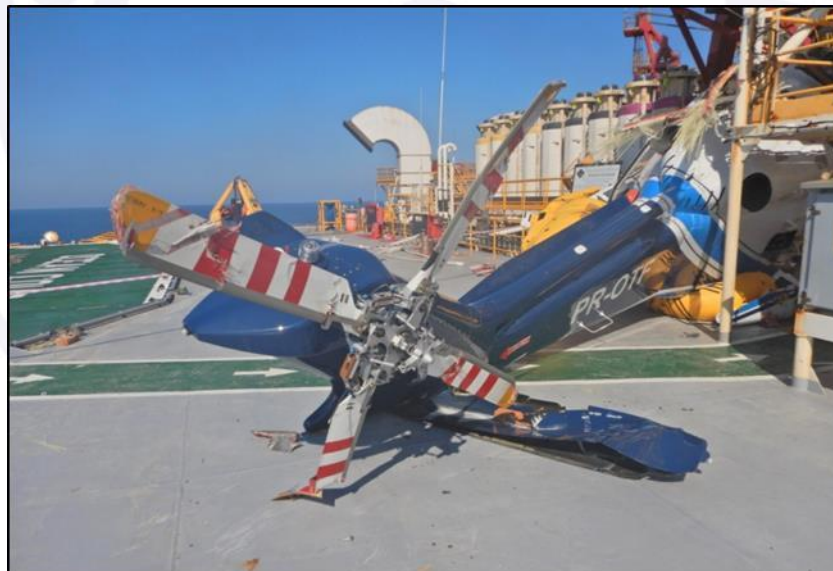
With the impact, the aircraft entered an uncontrolled clockwise spin around its own axis, which caused the second impact of the main rotor against a service structure, culminating in an abrupt fall and total stop on the platform. There was substantial damage to the tail rotor blades and to both engines. The main rotor blades were destroyed (Figure 6).

Figure 6 - View of the damage to the PR-OTF tail rotor blades.

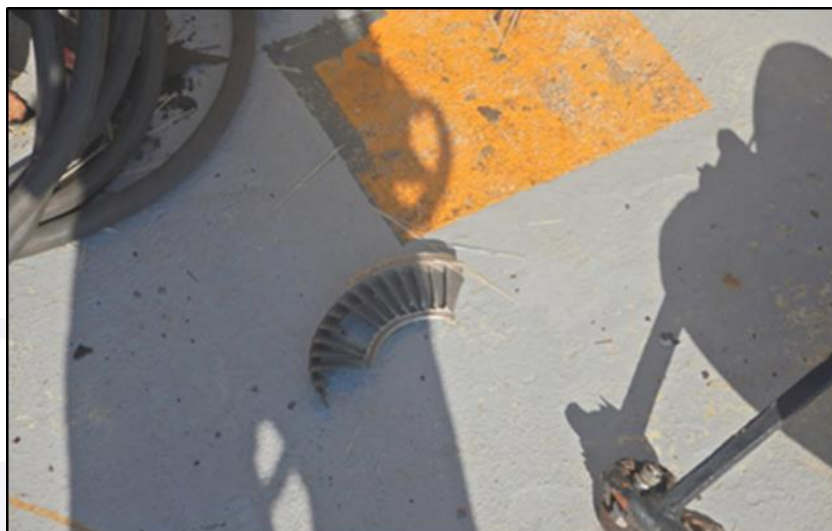
On the helideck floor, there were several fragments of the blades that were expelled from the aircraft's turbines (Figure 7).

Figure 7 - Stator of the aircraft's left-hand engine turbine.

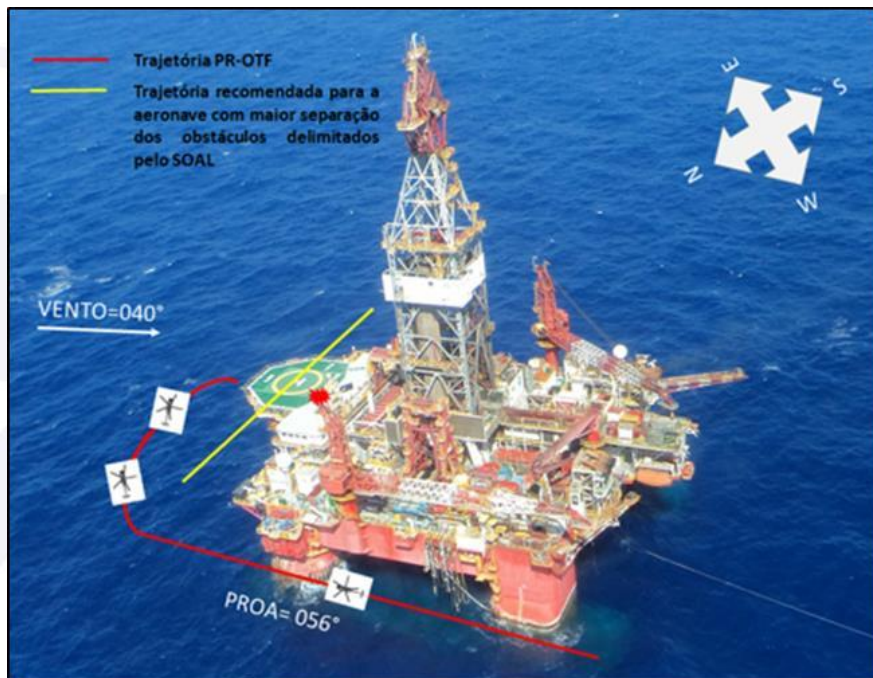
During the approach, as seen in Figure 10, the maritime unit remained to the PIC's right-hand side, until the aircraft passed by a crane located on the left-hand side of the platform. After clearing this obstacle, the helicopter turned to the right to avoid flying over the Obstacle Sector with Limited Heights (SOAL) and to maintain visual references.

Figure 10 - Approach profile of the PR-OTF aircraft toward the SS-75.

At that moment, the wind component began to align with the tail of the helicopter, something which was not recommendable.

Then, in an already unstable condition and at a height above the one expected, the aircraft entered the helideck area and, in the transition to hovering flight, there was loss of control of the helicopter after ample variations in height, heading, and power.

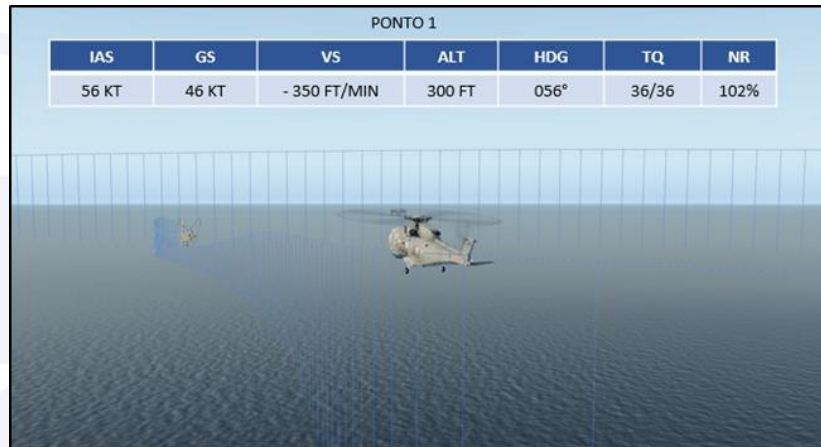
Figure 11 - Point 1 of the final approach flown by the PR-OTF.

It was possible to verify that the approach profile progressed normally at Points 1 and 2, with the aircraft at the heights of 300 ft. and 200 ft., respectively.

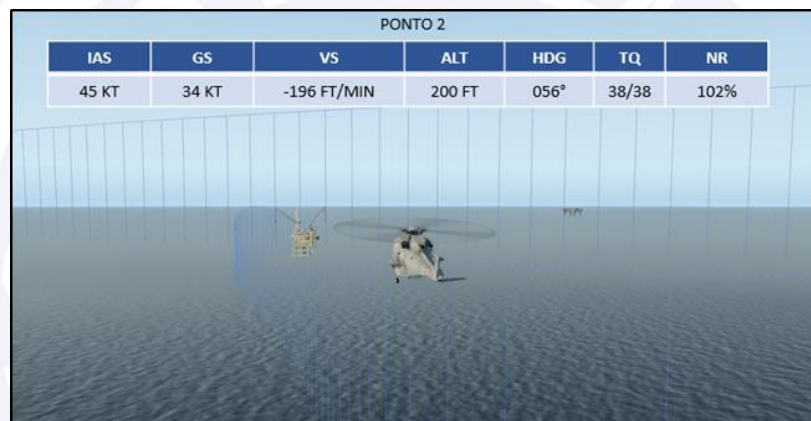
Figure 12 - Point 2 of the final approach flown by the PR-OTF.

Thus, upon analysis of the final moments of the flight, it was found that the approach proceeded normally up to an altitude of 200 ft., as can be seen at Point 2 in Figure 12.

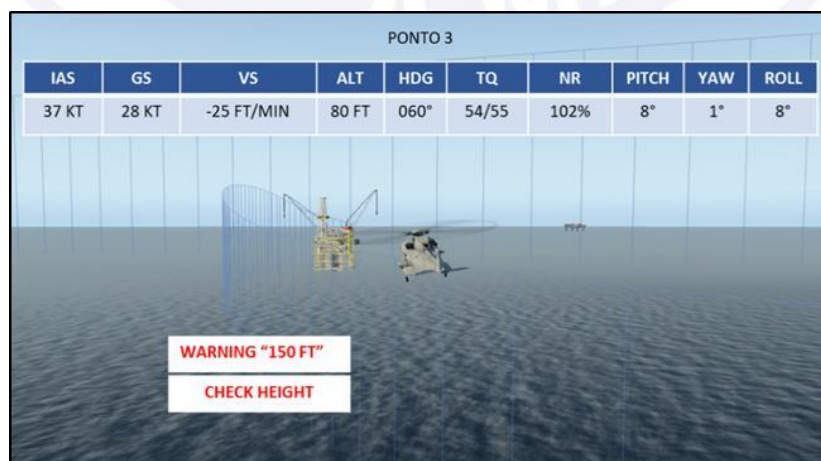
Figure 13 - Point 3 of the final approach flown by the PR-OTF.

At Point 3, the helicopter descended to 80 ft., that is, below the height of the SS-75 platform. In this condition, the aircraft maintained a magnetic heading of 060°, an indicated airspeed of 37 kt., and a rate of descent of 25 ft. /min. The aural alert “150 ft.” was also emitted, followed by “Check Height”.

However, when the PR-OTF was at Point 3 (Figure 13), it descended to an altitude of 80 ft., that is, below the height of the SS-75, indicating that the approach ramp was not stabilized. In that condition, the helicopter maintained a magnetic heading of 060°, at an indicated speed of 37 kt. and a rate of descent of 25 ft. /min. On the occasion, the aural alert of “150 ft.” was also emitted, followed by “Check Height”. Despite these alerts, no assertive action was taken to start a missed approach procedure.

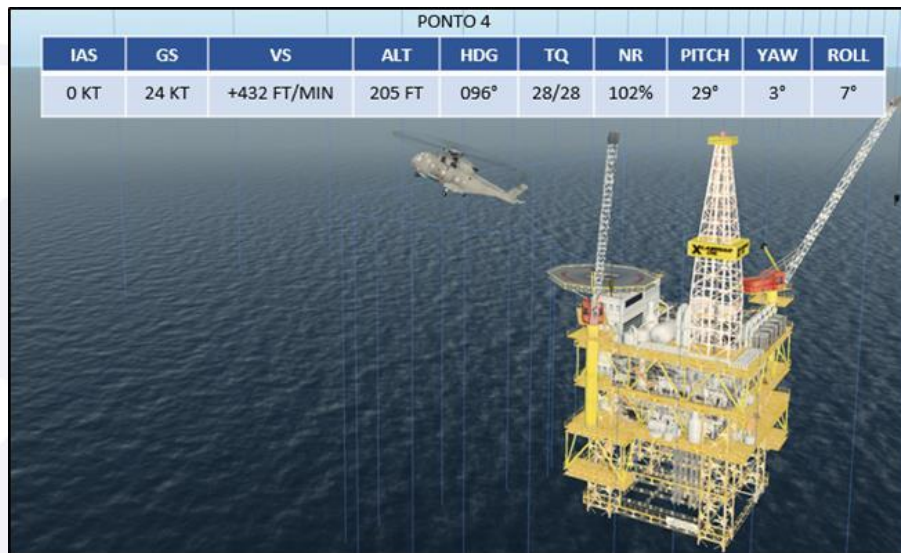
Figure 14 - Point 4 of the final approach flown by the PR-OTF.

At point 4, it was possible to observe that the heading had changed to 096°, with a pitch angle of 29°. It was found that, at this point, the PR-OTF had a rate of climb of 432 ft./min.

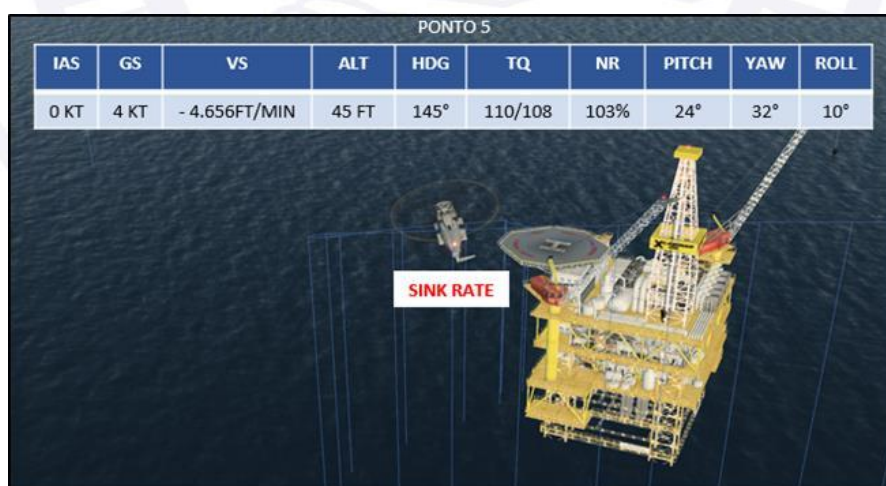
Figure 15 - Point 5 of the PR-OTF's final approach.

In such a scenario, the SOP 08 advised that the pitch angle could not exceed 10°, and that heading variations should be limited to between 30° and 45° of the heading initially planned for landing. During the landing attempt, the Vertical Speed (VS) reached -4,656 ft./min, the magnetic heading varied up to 145°, with a Pitch of 24°, yaw angle of 32°, and a roll of 10°.
