**COMANDO DA AERONÁUTICA**  
**CENTRO DE INVESTIGAÇÃO E PREVENÇÃO DE**  
**ACIDENTES AERONÁUTICOS**

**FINAL REPORT**  
**A - 005/CENIPA/2016**

<b>OCCURRENCE:</b>	<b>ACCIDENT</b>
<b>AIRCRAFT:</b>	<b>PR-PDD</b>
<b>MODEL:</b>	<b>ATR-72-212A</b>
<b>DATE:</b>	<b>09JAN2016</b>

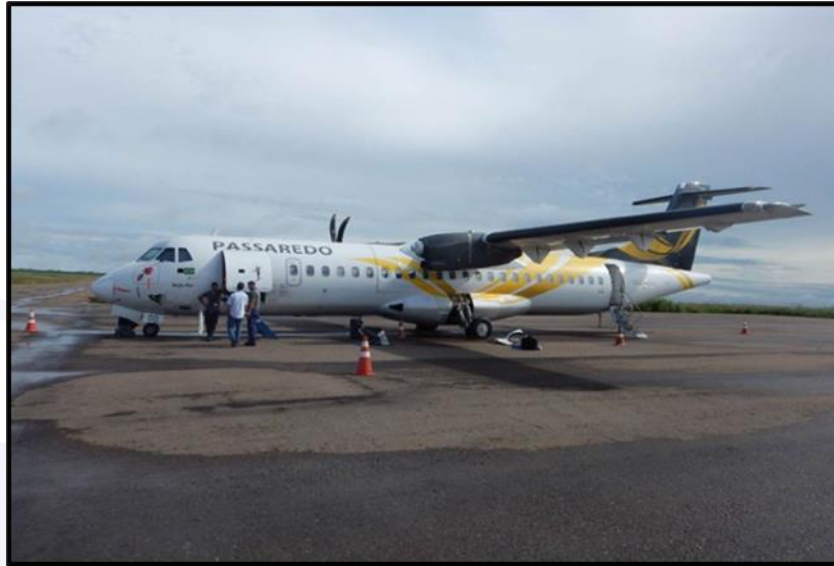
The damage found affected structural parts of the aircraft (Figures 1, 2 and 3) and, therefore, they were considered substantial.

Figure 1 - Left side view of the aircraft (Source: ATR).

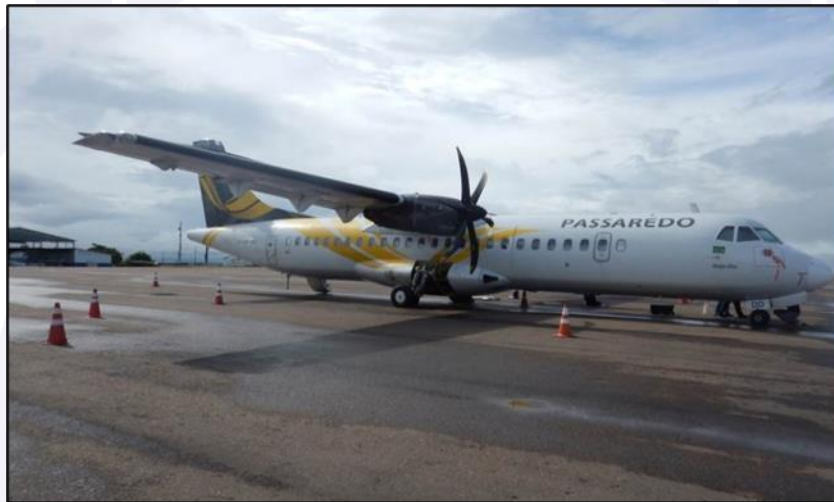
Figure 2 - Right side view of the aircraft (Source: ATR).

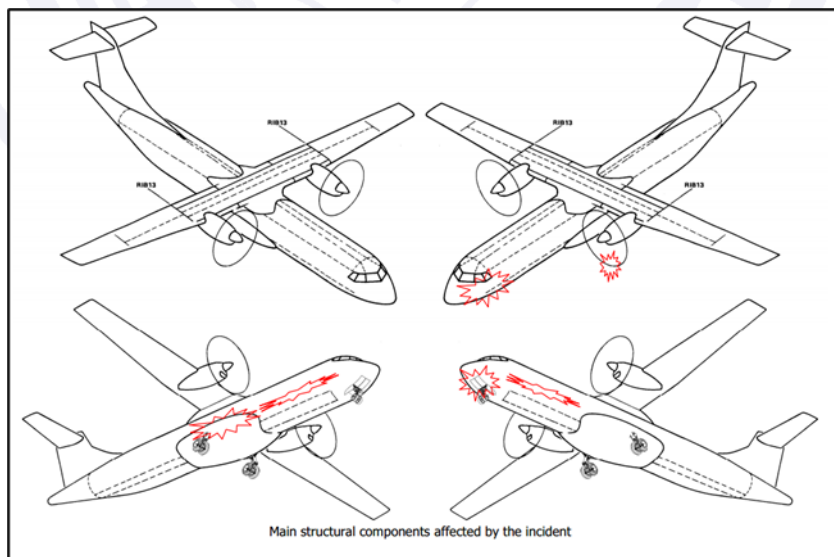
Figure 3 - Schematic view of the damage (Source: ATR).

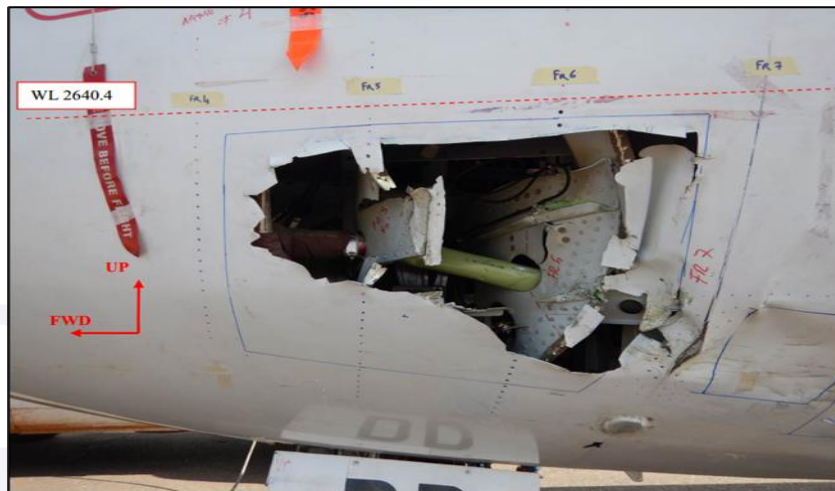
Figure 4 - Perforations in the left front Skin Panel (Source: ATR).

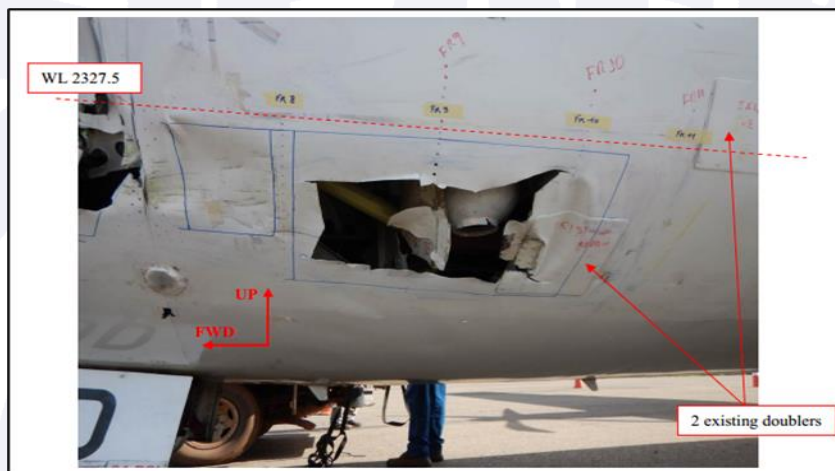
Figure 5 - Perforations in the left front Skin Panel (Source: ATR).

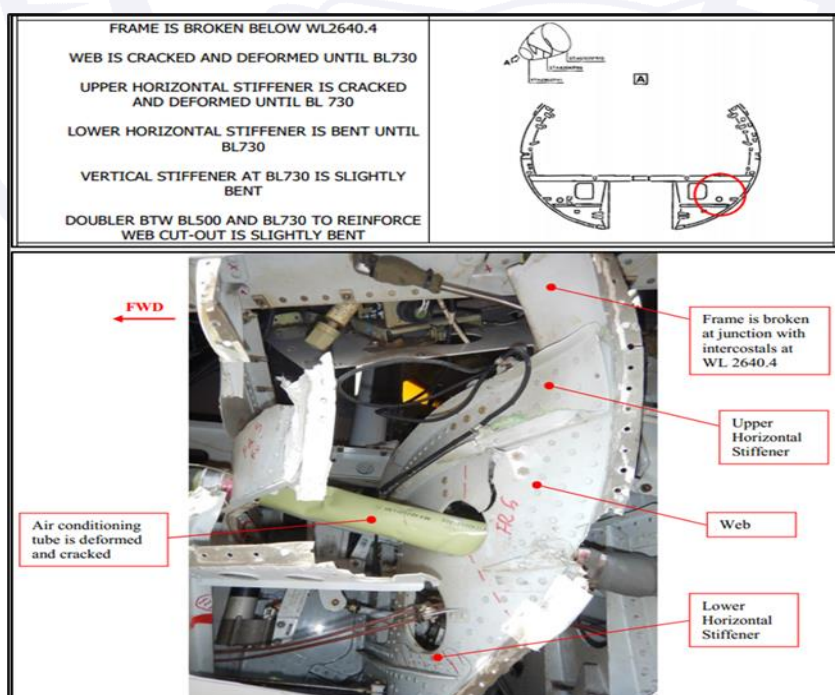
The aircraft had damage in the lower section of frames 5 to 10 (Figures 6, 7, 8, 9, 10 and 11).

Figure 6 - Damage to frame 5 (Source: ATR).

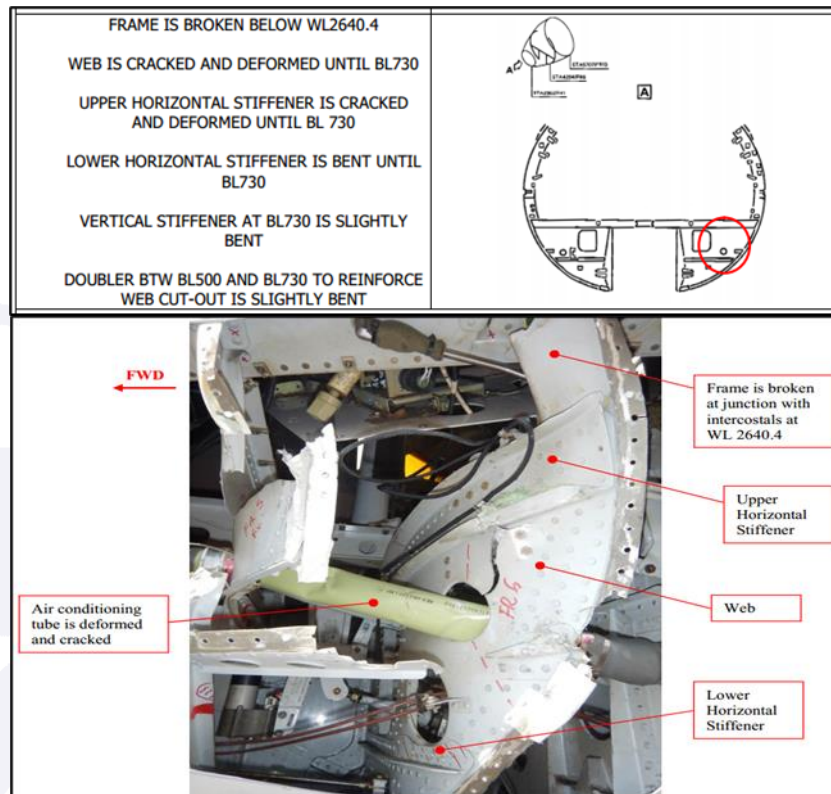
Figure 7 - Damage to frame 6 (Source: ATR).

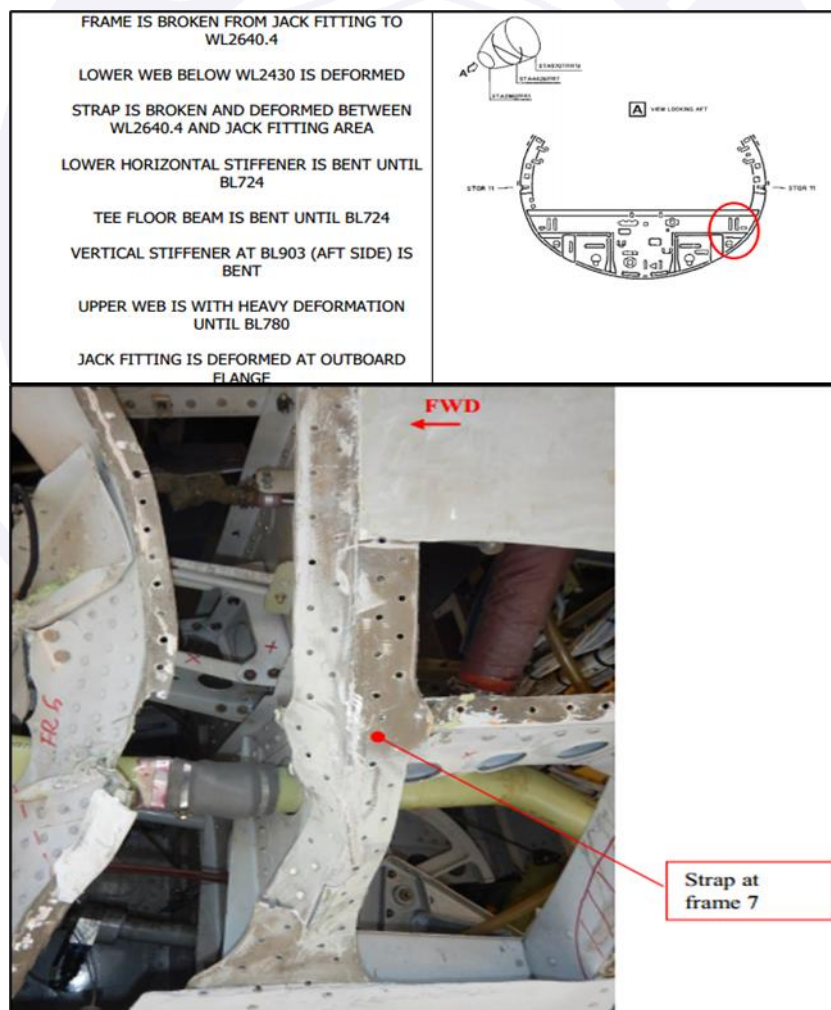
Figure 8 - Damage to frame 7 (Source: ATR).

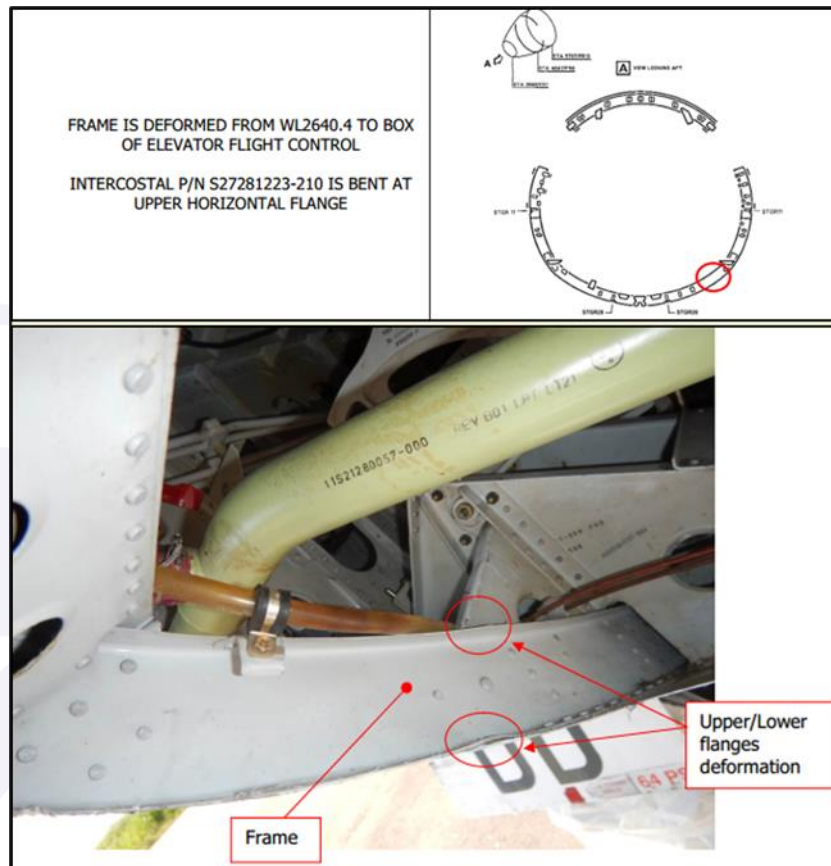
Figure 9 - Damage to frame 8 (Source: ATR).

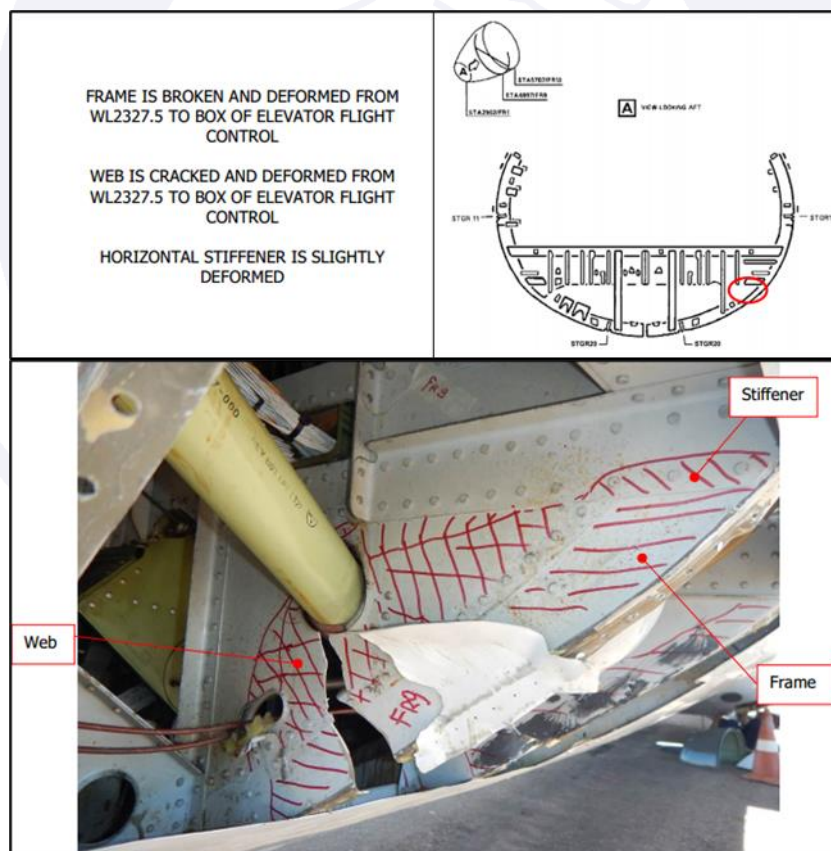
Figure 10 - Damage to frame 9 (Source: ATR).

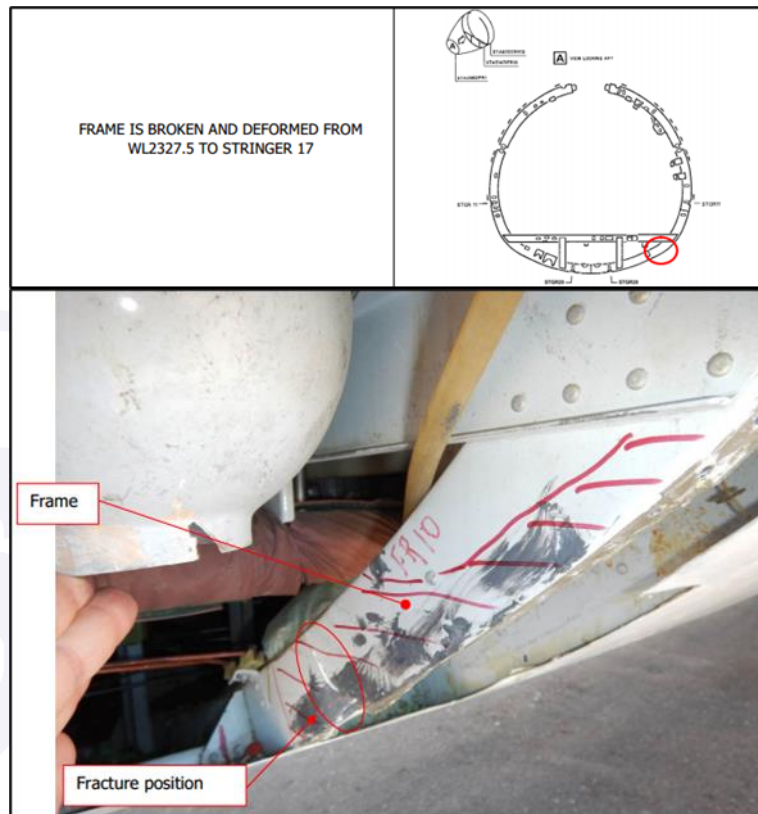
Figure 11 - Damage to frame 10 (Source: ATR).

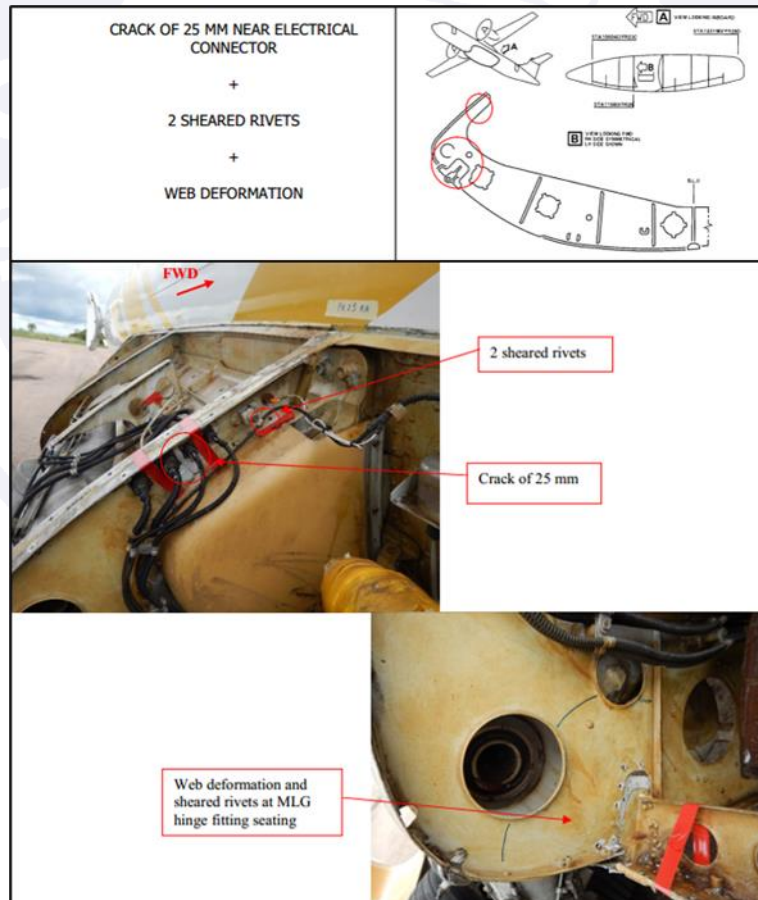
The aircraft had damage in frames 25 and 27 (Figures 12 and 13).

Figure 12 - Damage to frame 25 (Source: ATR).

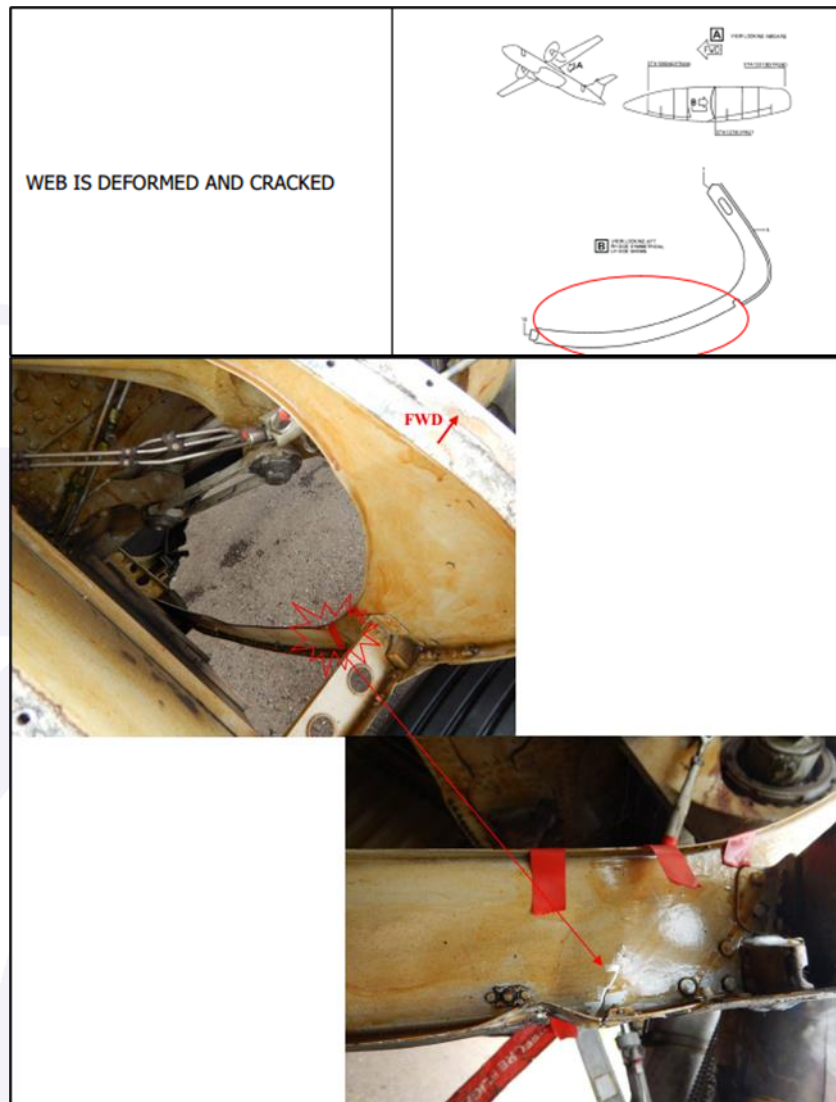
Figure 13 - Damage to frame 27 (Source: ATR).

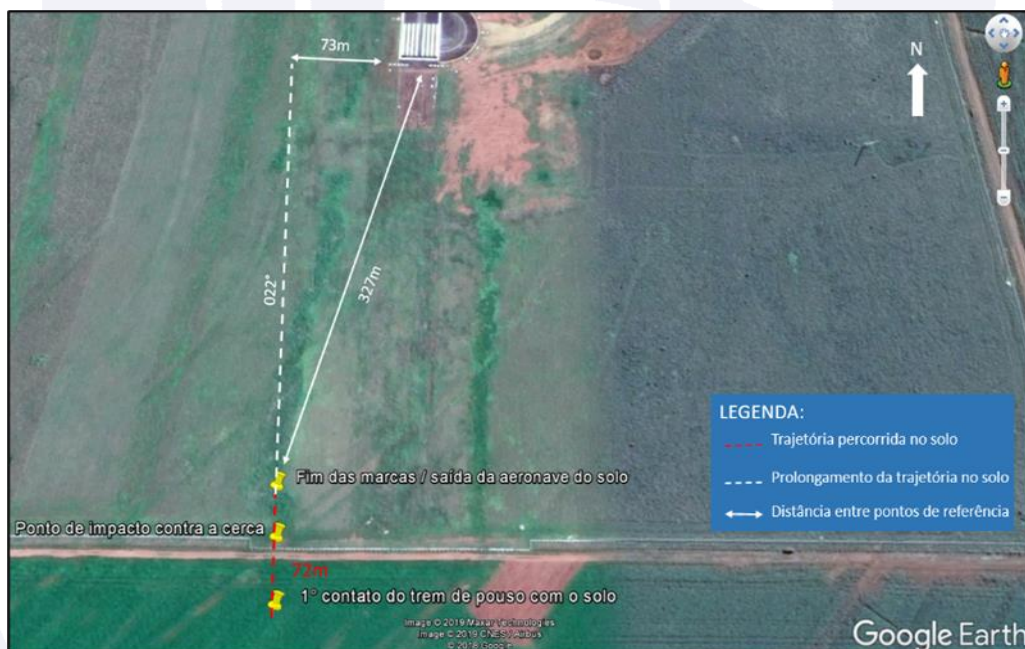
The contact with the terrain took place in one of the soybean plantations that surrounded the Aerodrome. The plane traveled 42m in contact with the ground, until it collided with two concrete posts of the patrimony fence. After the collision, it covered another 30m over the vegetation, within the patrimony area of the Aerodrome, until it took off again.

The marks left on the ground had a displacement course approximately equal to 022° in relation to the magnetic North (N), 73m away from the axis of the SBRD runway 02 (Figure 19).

Figure 19 - Sketch of the aircraft's displacement on the ground.  
Source: Adapted from Google Earth.

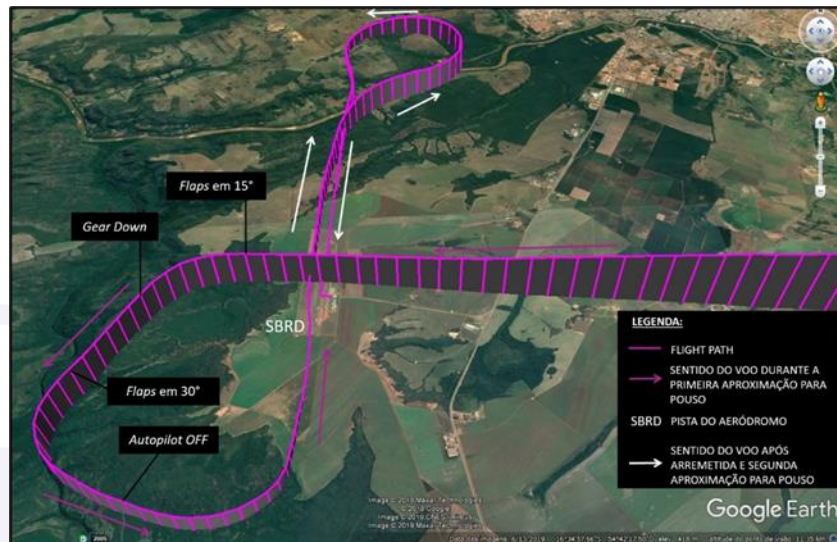
Figure 24 illustrates the aircraft's path during the visual traffic landing procedure, as well as the path taken after touching the ground, go-around procedure and repositioned for final landing on the SBRD runway.

Figure 24 - Aircraft path.  
Source: Adapted from Google Earth.

Comparing Figures 22 and 24, there are some differences between the profile defined by the SOP and the one performed by the crew, mainly with regard to the moment of the aircraft configuration for landing and the moment of disconnection of the autopilot.

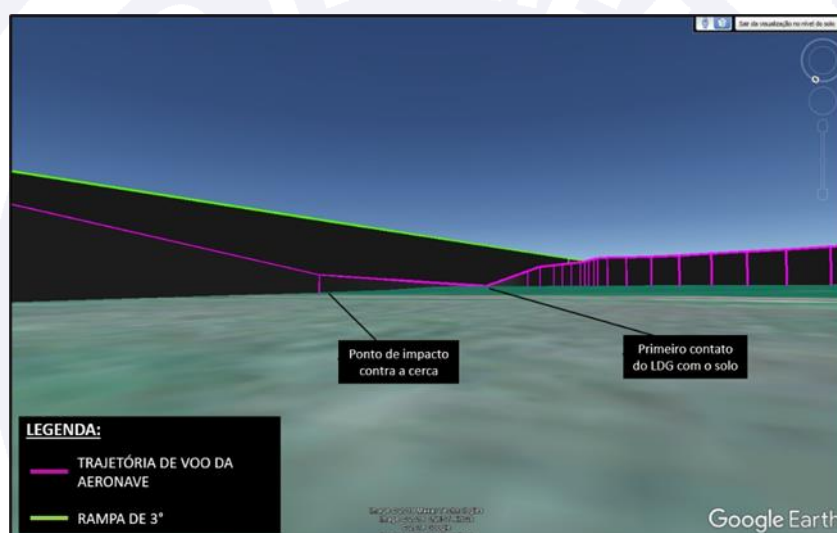
Figure 27 - Side perspective view of the path traveled by the aircraft, compared to the 3° ramp.

It is noted that, at the beginning of the final approach, the aircraft was above the nominal flight path. Later in the approach the aircraft went below the 3° flight path until 20ft where a go around was initiated.

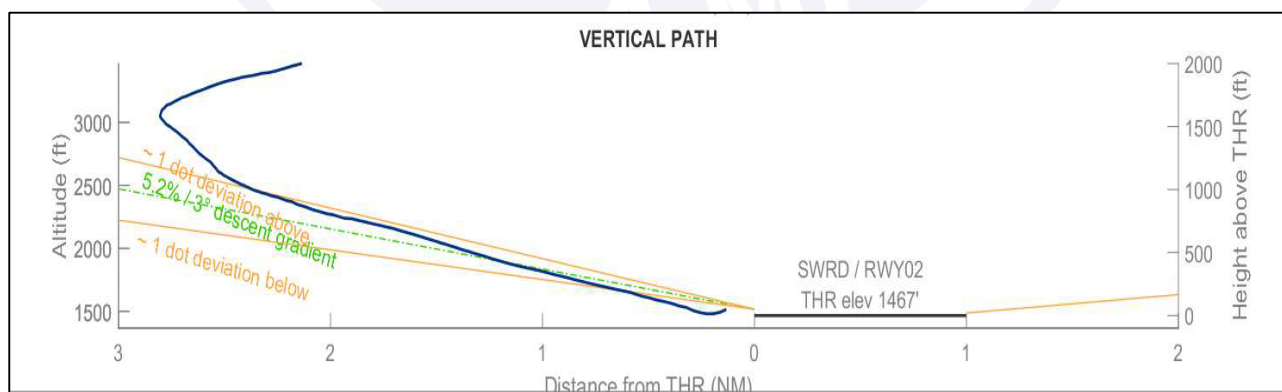
Figure 28 - Vertical path profile. Source: ATR.
