FINAL REPORT
A-157/CENIPA/2018

OCCURRENCE:	ACCIDENT
AIRCRAFT:	PR-PMT
MODEL:	A109E
DATE:	11OUT2018

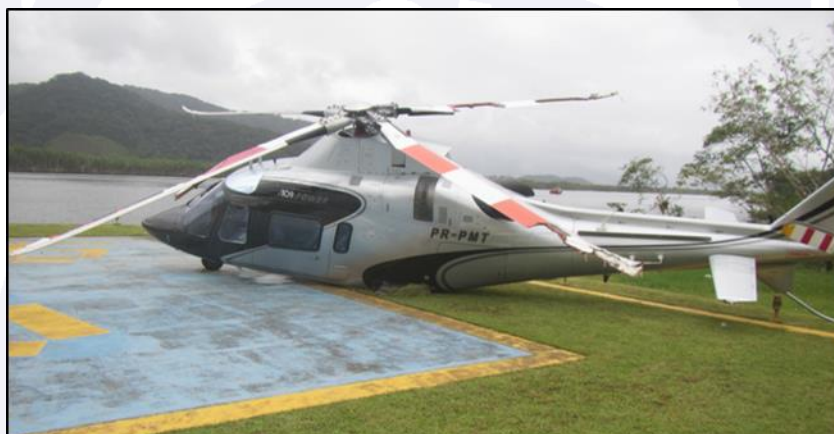
Figure 1 - View of the PR-PMT at the accident site.

The aircraft sustained substantial damage. Neither the crew nor the passengers were injured.

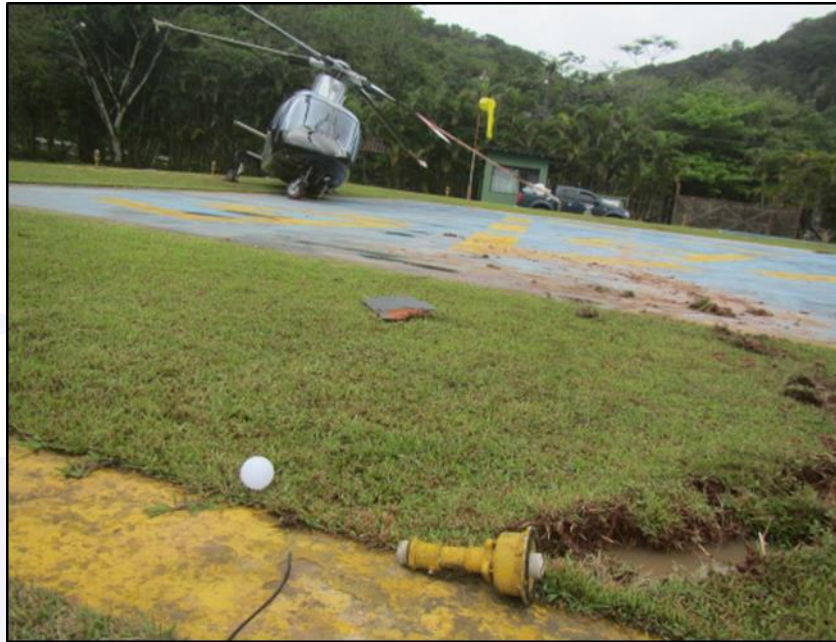
There was damage to the helipad's beaconing system (Figure 2).

Figure 2 - Damage to the helipad beaconing.

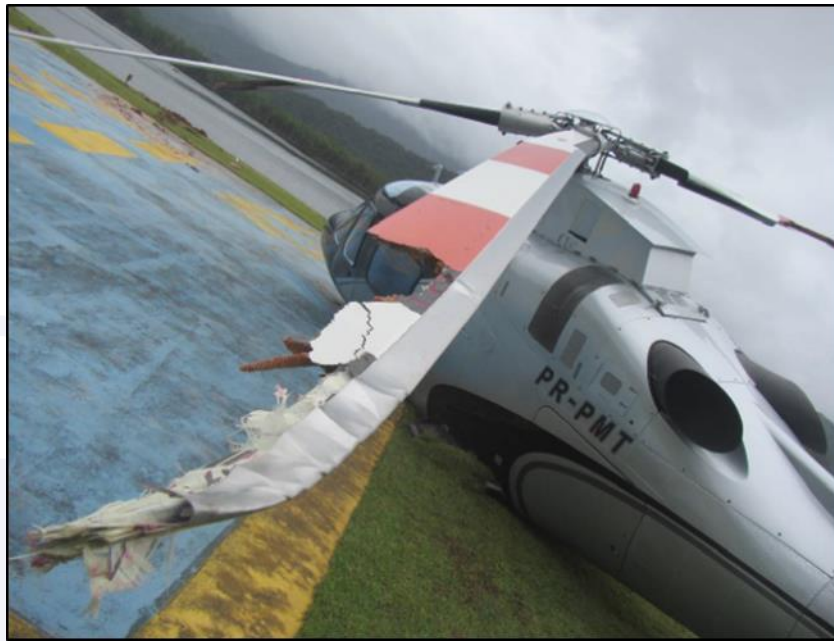
The left landing gear broke, and there was contact of the main rotor with the ground. The aircraft rotated around its vertical axis in a counterclockwise direction while maintaining a short forward displacement, until coming to a stop on the left side of the helipad. In this process, there was a heading variation of approximately 135° in relation to the direction of approach.

All main rotor blades were severely damaged, and there was significant twisting of the airframe, evidenced by misalignment of the doors. The tail boom suffered a perforation caused by material detached from the main rotor (Figure 7).

Figure 7 - View of the damage to the main rotor blades.

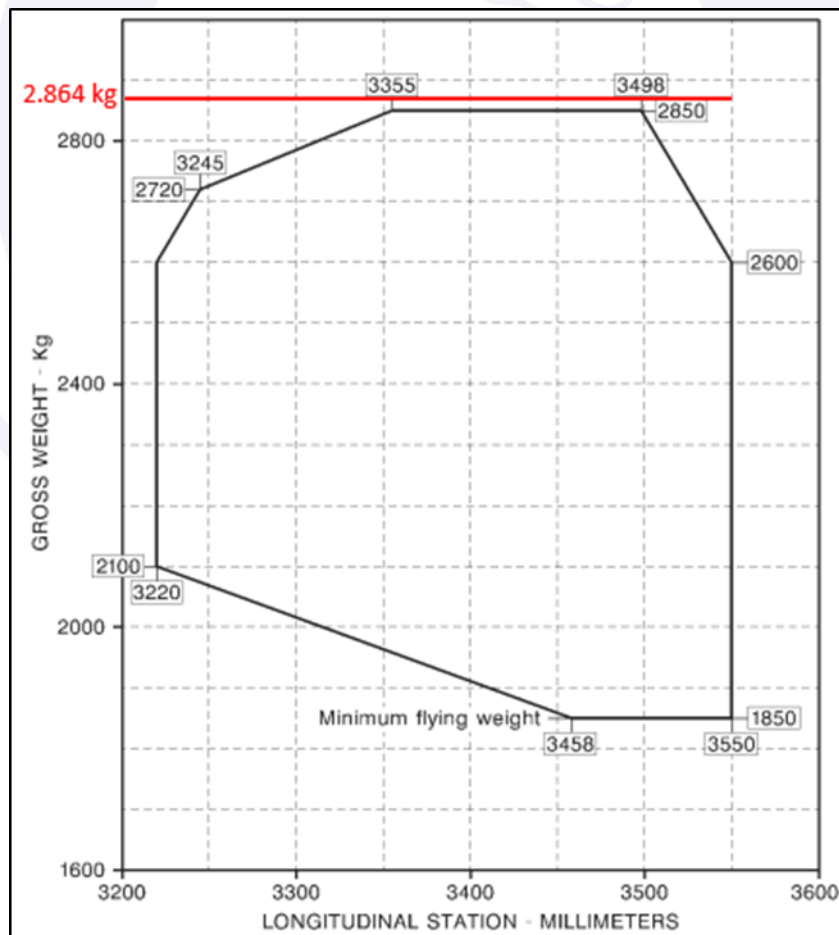
Based on the fuel remaining in the tanks (248 kg), it was calculated that, at the time of the accident, the helicopter had a weight of 2,864 kg, that is, 14 kg above the weight limit, and still outside the longitudinal limits of the CG (Figure 8).

Figure 8 - A109E CG longitudinal limits.
Source: A109E Rotorcraft Flight Manual (RFM).

Therefore, the aircraft was above the weight limits, and outside the center of gravity limits both at the takeoff from SDPT and at the landing in SJNN.

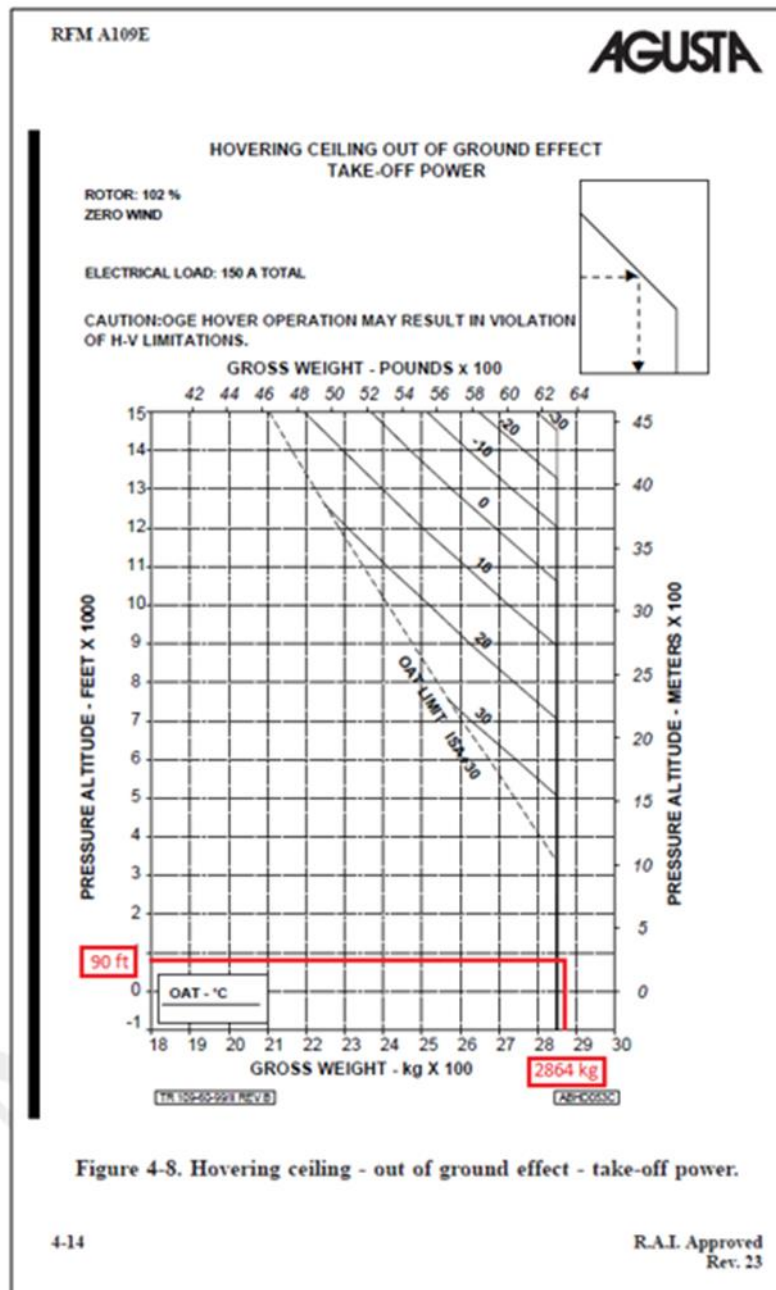
By using the *Hovering ceiling - out of ground effect - take-off power* diagram, available on the page 4-14, Section 4 - Performance Data, of the Agusta-A109E-RFM, one concluded that the calculated weight of 2,864 kg at the time of landing, would be an indication that the PR-PMT performed the approach with 14 kg above the maximum landing weight limit.

For that purpose, the following parameters were considered: aircraft hovering outside of ground effect (OGE), pressure altitude of 90 ft., at an elevation of 30 ft. for SJNN, temperature 20° C, aircraft weight 2,864 kg, takeoff power, 102% rotor RPM, and zero wind (Figure 9).

Figure 9 - PR-PMT OGE-Hovering Calculation for the time of occurrence.
Source: RFM A109E.

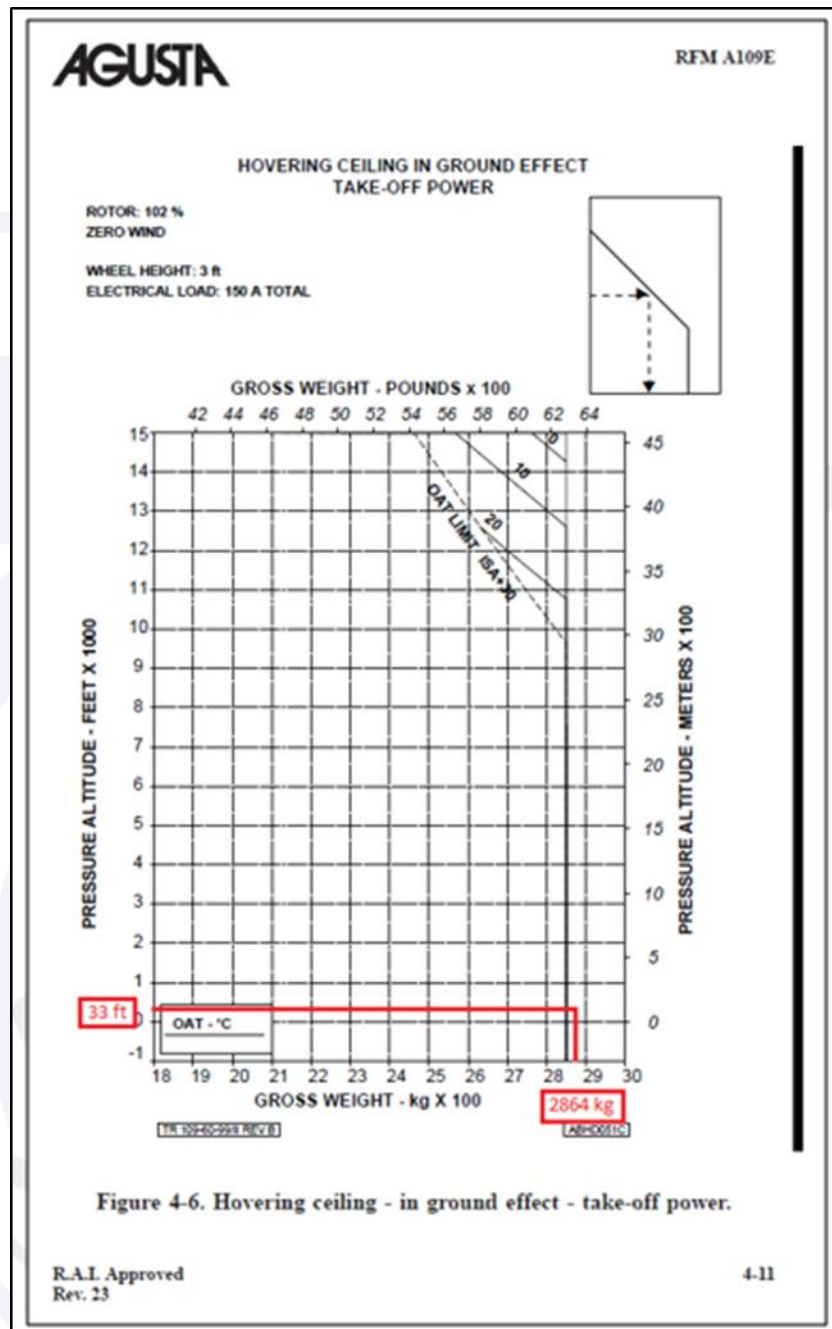
The analysis of the *Hovering ceiling - in ground effect - take-off power* diagram as per page 4-11 of Section 4 - Performance Data, for the Agusta-A109E-RFM, for a Hover Height Into Ground Effect (IGE) of 3 ft., considering a field elevation of 30 ft., also revealed that the

landing attempt with aircraft weighing 2,864 kg, was performed in excess of the prescribed maximum landing weight (Figure 10).

Figure 10 - PR-PMT IGE-hovering calculation for the time of occurrence.
Source: RFM A109E.
