COMANDO DA AERONÁUTICA
CENTRO DE INVESTIGAÇÃO E PREVENÇÃO DE
ACIDENTES AERONÁUTICOS

FINAL REPORT
A-022/CENIPA/2021

OCCURRENCE:	ACCIDENT
AIRCRAFT:	PR-PPJ
MODEL:	PA-36-375
DATE:	12FEV2021

This Final Report refers to the accident involving the PR-PPJ aircraft, model PA-36-375, which occurred on February 12, 2021, classified as "[SCF-PP] System/Component Failure or Malfunction (Powerplant)".

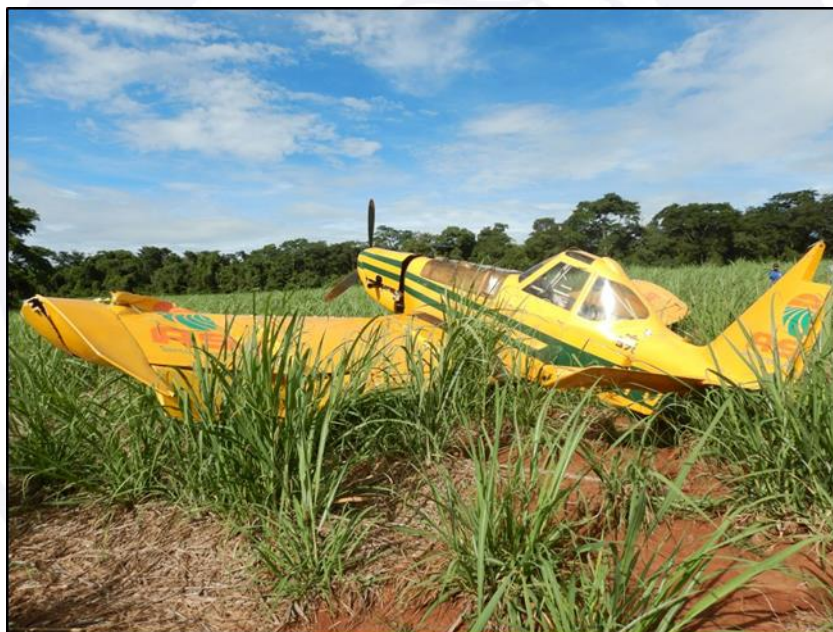
During the landing, the left wingtip struck a tree. Upon ground contact, the aircraft rotated around its vertical axis and came to a stop facing the direction opposite to its initial trajectory.

Figure 1 - Aircraft after coming to a complete stop.

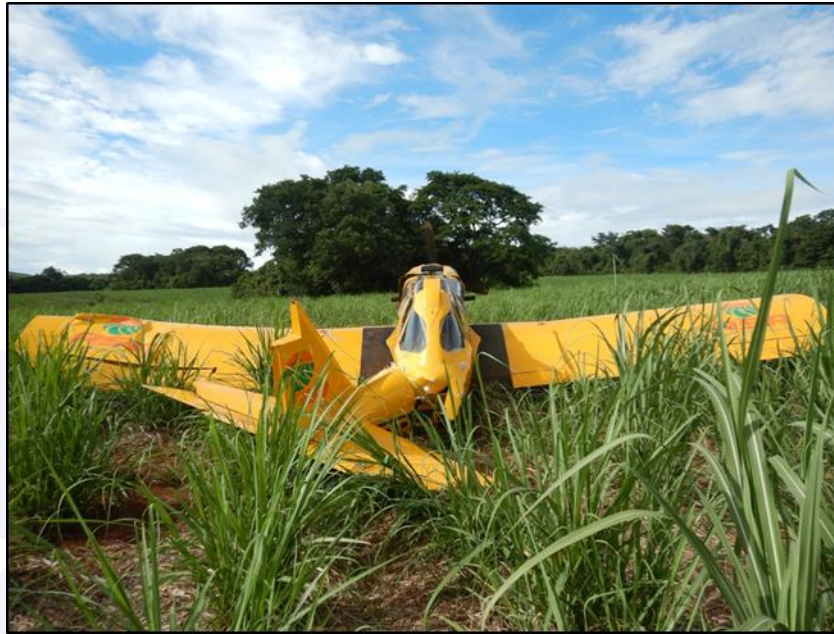
The aircraft sustained substantial damage to its entire structure.

Dents and wrinkles were observed on the wings, tail cone, empennage, and underside of the fuselage.

Figure 2 - Image captured from the rear of the aircraft.

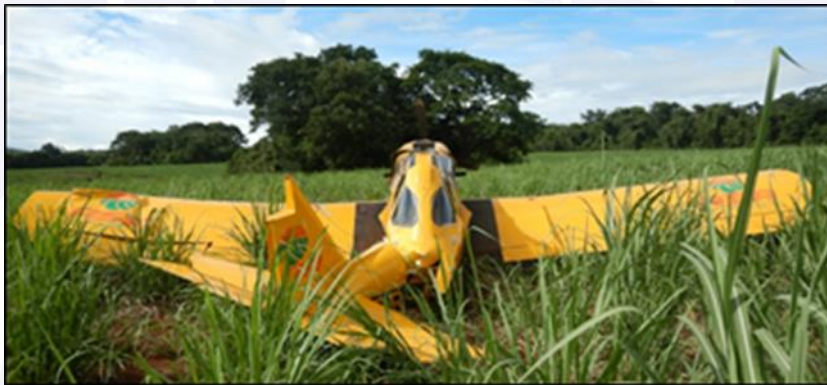
The aircraft's landing site was located 9 NM from SWAU and consisted of a sugarcane field. The plantation had an average height of 1 meter, and the terrain was predominantly uneven (Figure 3).

Figure 3 - Rear view of the aircraft at the final stop location.

The deflection of left landing gear strut upon ground impact caused the fairing to break in the root area, suggesting that the aircraft was in a yawing attitude to the left when it struck the terrain. After this collision, it rotated approximately 180° to the left, which resulted in the fuselage breaking apart and the empennage shifting about 30°.

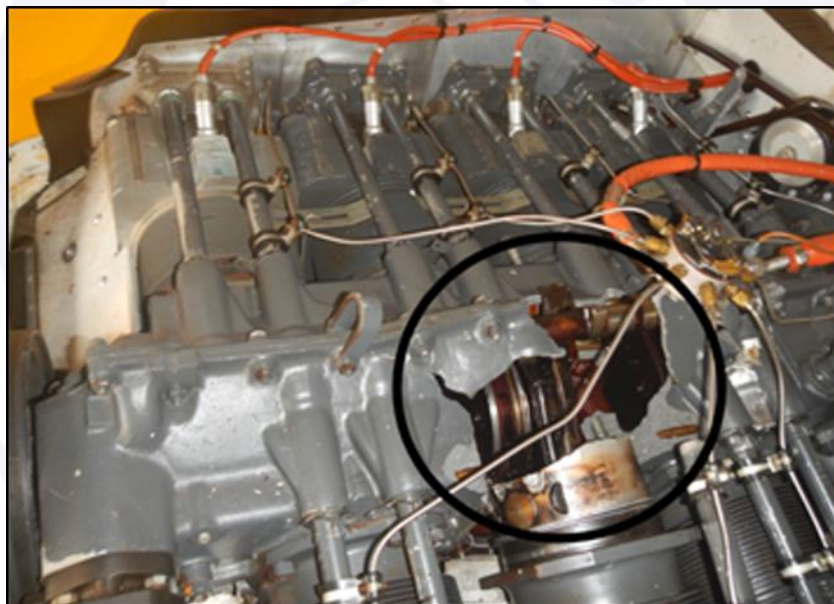
During the initial inspection, upon removal of the aircraft's engine cowling, it was observed that cylinder nº 4 was detached from its base on the engine block, and the corresponding piston rod had separated from its crankshaft journal (Figure 4).

Figure 4 - Upper view of the engine showing the rupture of cylinder No. 4.

During the engine teardown, one observed that two through-studs and one fixed stud at the base of the cylinder nº 4 were fractured, and that the piston rod was no longer attached to the crankshaft journal.

The investigation of the engine concluded that the failure of the studs caused cylinder nº 4 to detach from its base, leading to misalignment of its piston. The misaligned piston's movement toward bottom dead center resulted in a collision with the cylinder base.

The investigation identified the source of the failure in the cylinder nº 4, after verifying that it had detached from its base on the engine block. This detachment resulted from the failure of the studs (bolts) securing the cylinder to the block.

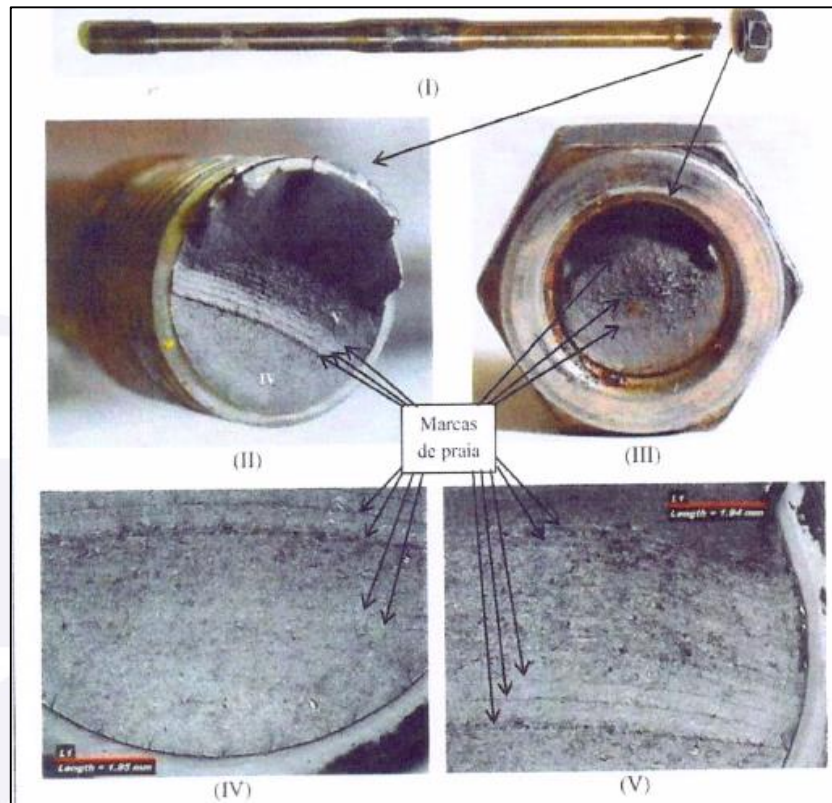
The results of the analysis indicated that the cause of the failure of the studs (through-studs and fixed studs) was material fatigue.

Figure 5 – View of the fracture surfaces of the P5 stud.

The analysis of the fractured components revealed that two through-studs and one fixed stud exhibited signs of material failure due to fatigue. This process compromised the structural integrity of these components, ultimately leading to their failure.

- m) during the engine teardown, one observed that two through-studs and one fixed stud at the base of the cylinder nº 4 were fractured;
- n) the failure of the studs, both through-studs and the fixed stud, was caused by material fatigue;

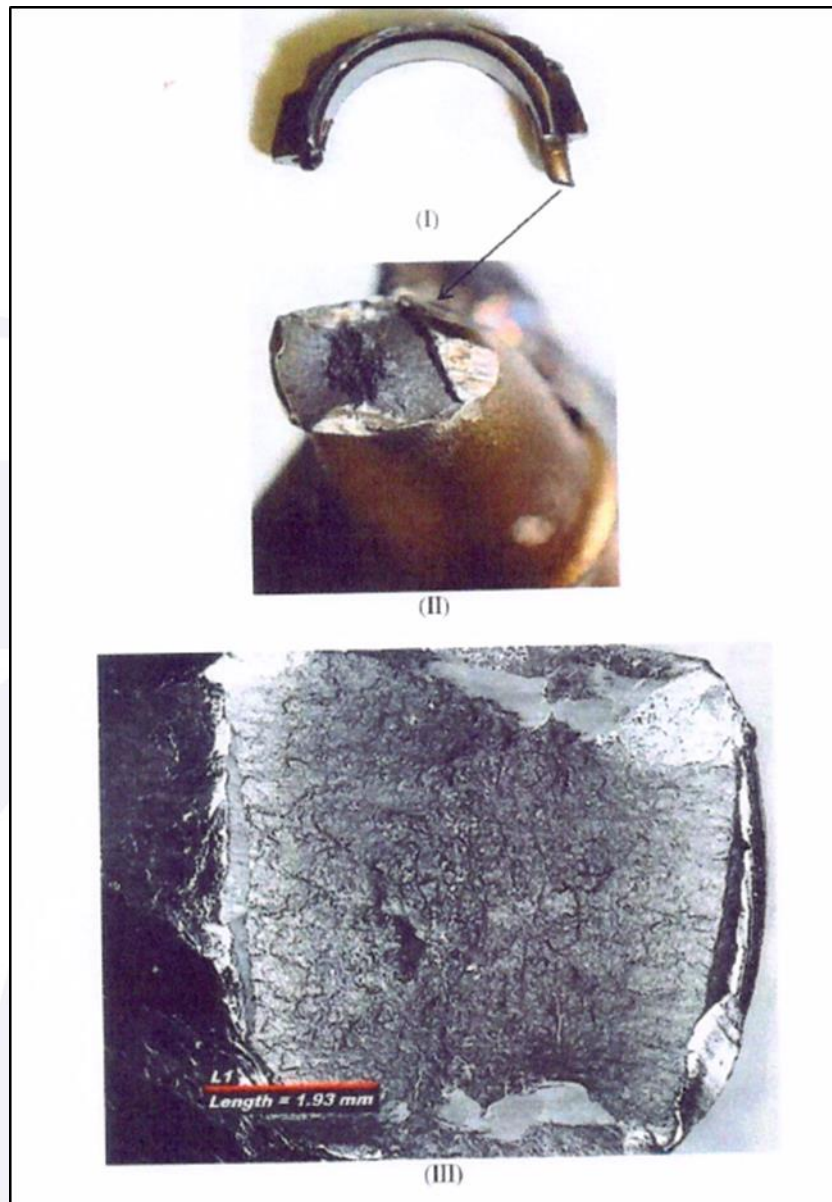
The analysis of the fastening bolt that was found along with the connecting rod cap revealed that the fracture surfaces had characteristics typical of tensile overload failure (Figure 6).

Figure 6 – View of the fracture surface of the connecting rod cap-fastening bolt, with characteristics of tensile overload failure.

The resulting overload transferred stress to the connecting rod cap bolts, which failed, as the crankshaft continued rotating toward bottom dead center. The loose connecting rod was then compressed against the camshaft and engine block.

The failure of the bolt of the connecting rod cap occurred due to overload and was a consequence of increased stress in the engine, associated with the misalignment of the piston and the crankshaft's movement toward bottom dead center.

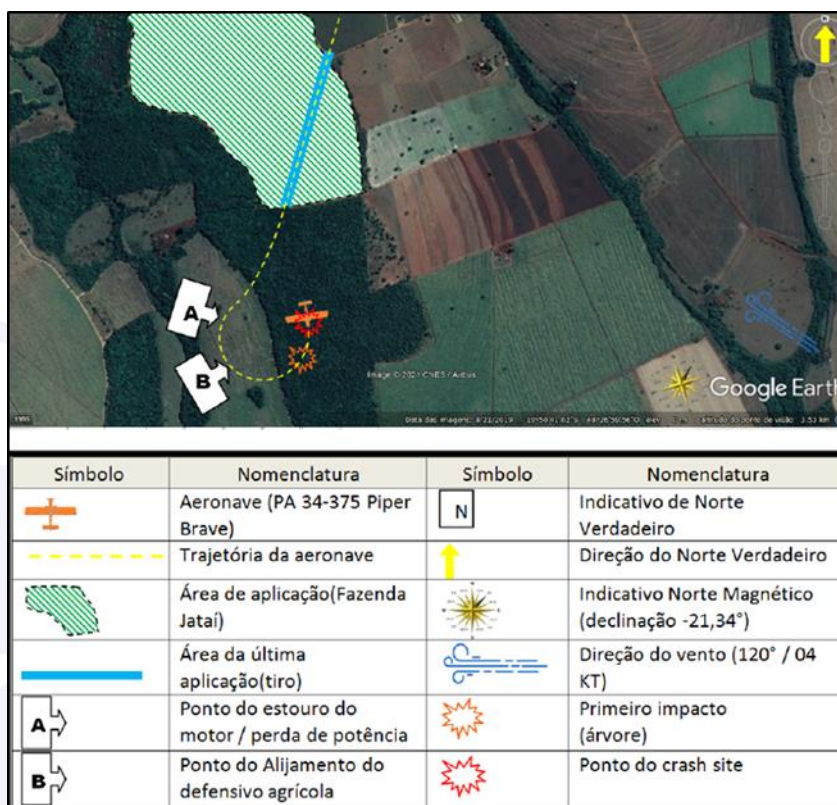
The aircraft came to a stop approximately 180° misaligned in relation to its initial direction of travel. (Figure 7).

Figure 7 - Sketch of the occurrence.
