**COMANDO DA AERONÁUTICA**  
**CENTRO DE INVESTIGAÇÃO E PREVENÇÃO DE**  
**ACIDENTES AERONÁUTICOS**

**FINAL REPORT**  
**A-116/CENIPA/2021**

| <b>AIRCRAFT:</b> | <b>PR-PRB</b> |
| <b>MODEL:</b> | <b>T188C</b> |

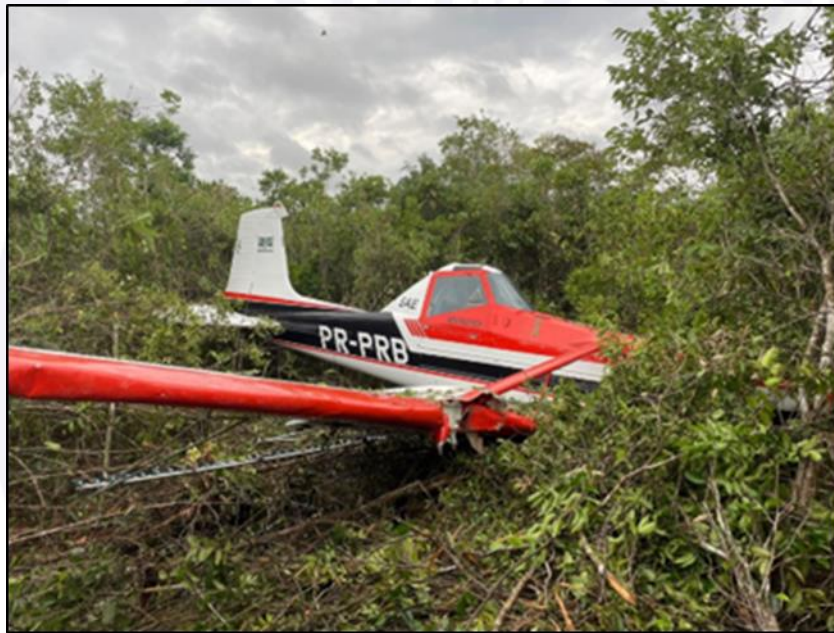
When the aircraft joined the traffic circuit for landing on runway 20 of SD9A, its engine failed. An emergency landing was made in an area of forest approximately 230 meters short of the runway. There was no fire.

Figure 1 - Final position of the aircraft after the forced landing.

The aircraft sustained substantial damage to the fuselage, landing gear, wings, flaps and right-hand aileron.

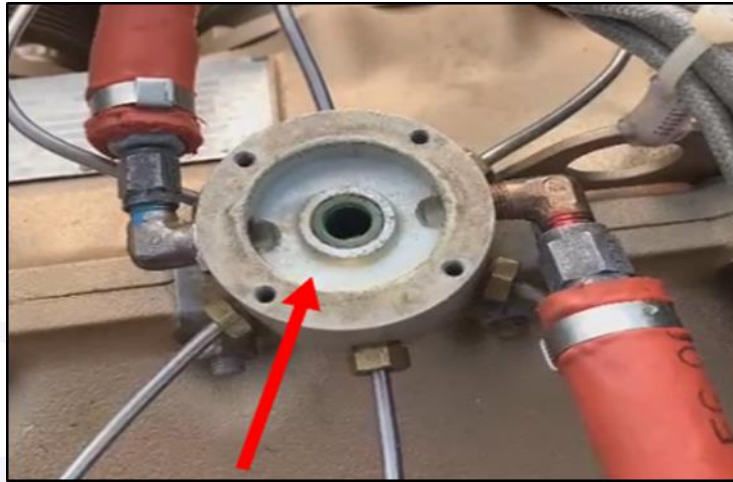
The fuel distribution valve was opened at the time of the initial action of investigation, and one verified that there was no fuel inside (Figure 2).

Figure 2 - Close-up photo of the fuel distribution valve. It is possible to verify the absence of fuel inside, as indicated by the red arrow.

The fuel tanks were also found empty.

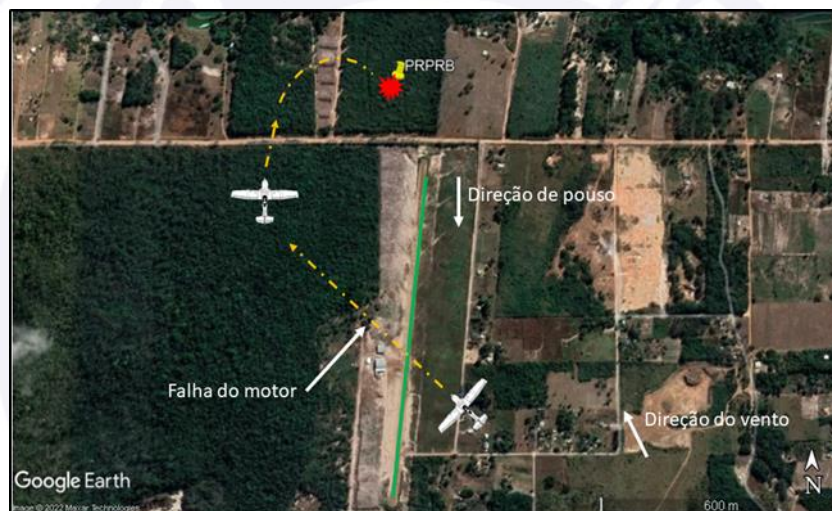
As mentioned before, the aircraft was at a height of approximately 300 feet. The PIC joined the base leg, but was unable to reach the runway. Thus, he made a forced landing in an area of forest.

Figure 4 - Enlarged view of the croquis of the occurrence. The green color symbolizes the landing strip. In yellow, the aircraft trajectory. In red, the crash site.

It should be noted that the traffic being flown by the PIC was in disagreement with the provisions of the ICA 100-37/2020. The height being used was lower, and the turn was made to the opposite side.
