COMANDO DA AERONÁUTICA
CENTRO DE INVESTIGAÇÃO E PREVENÇÃO DE
ACIDENTES AERONÁUTICOS

FINAL REPORT
A - 148/CENIPA/2018

| AIRCRAFT: | PR-RFB |
| MODEL: | C90A |

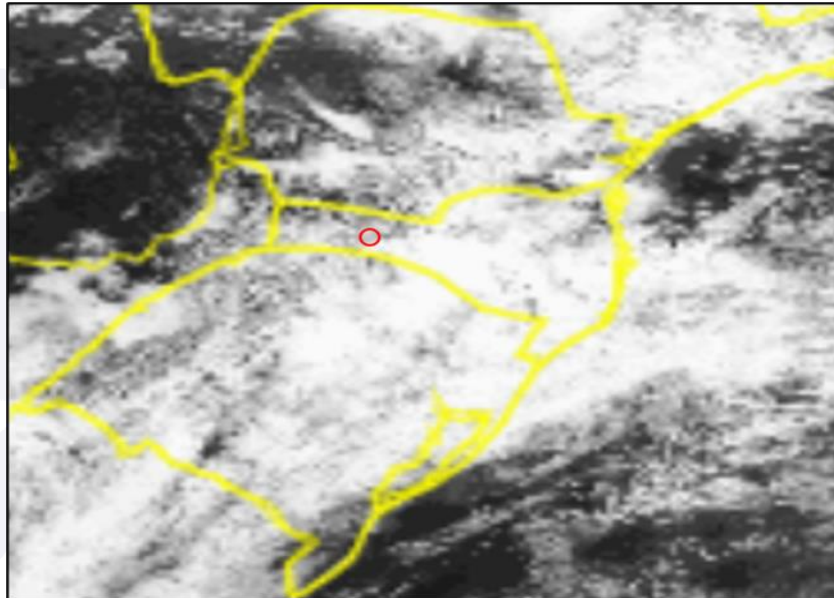
Figure 1 - Satellite image visible at 1300 (UTC) highlighting the accident region.

Figure 1 shows the visible satellite image at 1300 (UTC), in which one can observe the cloudiness over the state of Santa Catarina - SC.

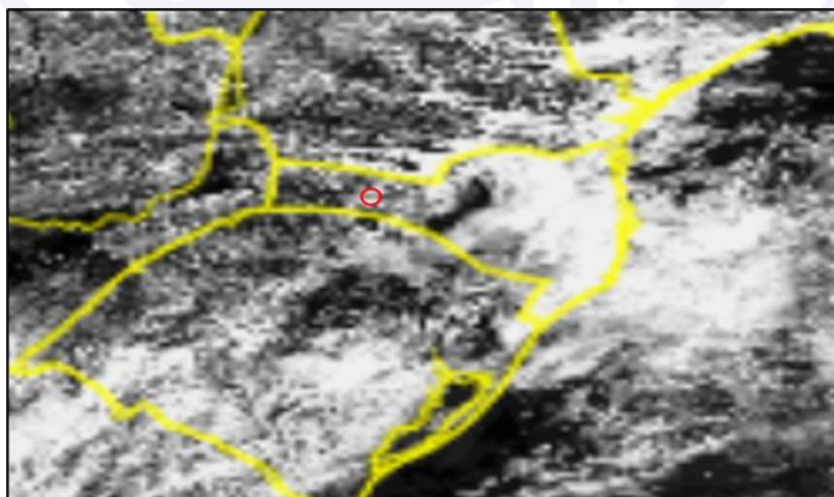
Figure 2 - Satellite image at 1500 (UTC). The accident area is highlighted.

Local observers and the rescue team reported that, at the time of the accident, there was a dense fog that covered the entire region close to the occurrence.

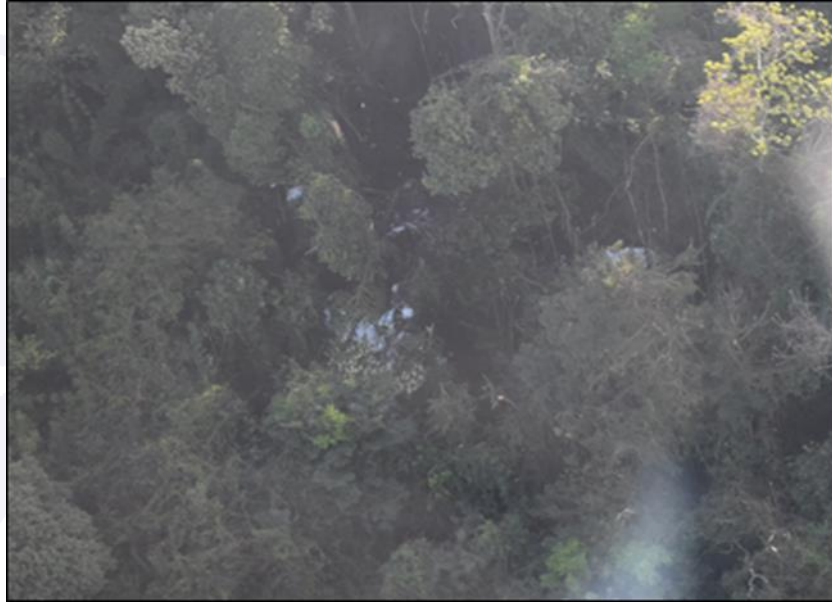
Figure 5 - Aerial view of the wreckage.

The impact occurred out of the Aerodrome, in a mountainous and wooded region. The distribution of the wreckage was linear (Figure 5).

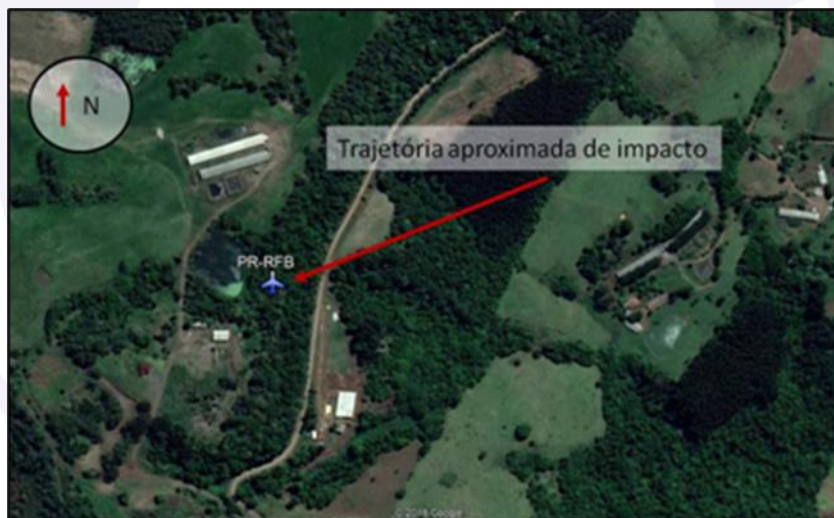
Figure 6 - Approximate impact trajectory.

Figure 6 illustrates the approximate trajectory of the aircraft before impact.

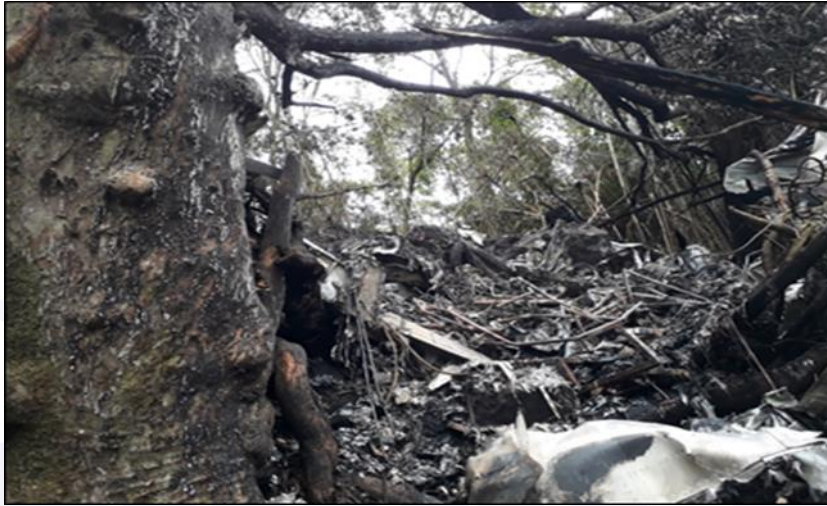
Figure 7 - Bottom view of the wreckage.

The first impact occurred against the trees, in a pitch-down attitude (approximately 10°) and with leveled wings. The second impact occurred against the ground (Figure 7).

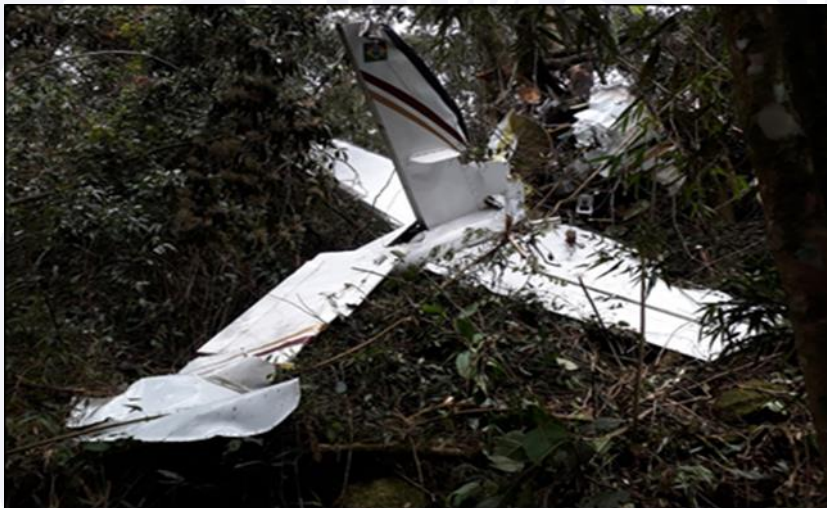
Figure 8 - View of the aircraft tail assembly.

After the second impact, there was a fire that consumed practically the entire aircraft, except the tail cone and the vertical and horizontal stabilizers, which were partially preserved (Figure 8).

The degree of destruction and carbonization of the aircraft prevented the verification of much of the equipment and instruments.

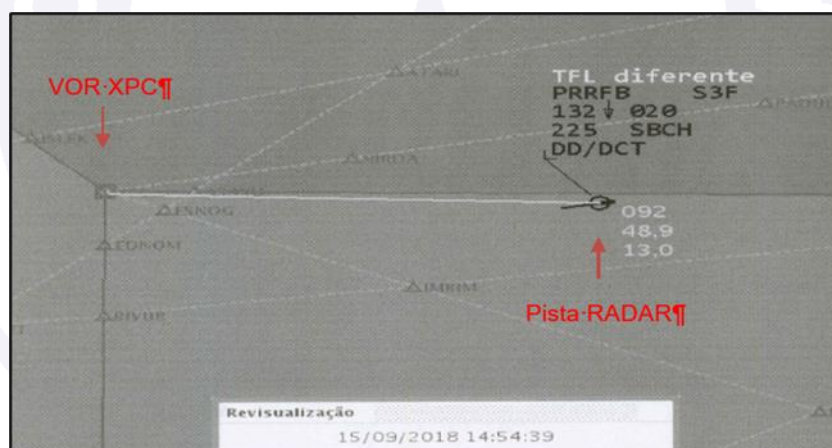
Figure 10 - RADAR image at 14:54:39 (UTC).

At 47 NM from SBCH, the pilot reported to AFIS-CH that he had already started the descent and cleared FL200. The RADAR image at 14:54:39 (UTC) shows the PR-RFB descending, crossing FL132, on the 092° radial, 48.9 NM away from the XPC VOR (Chapecó), as shown in Figure 10.

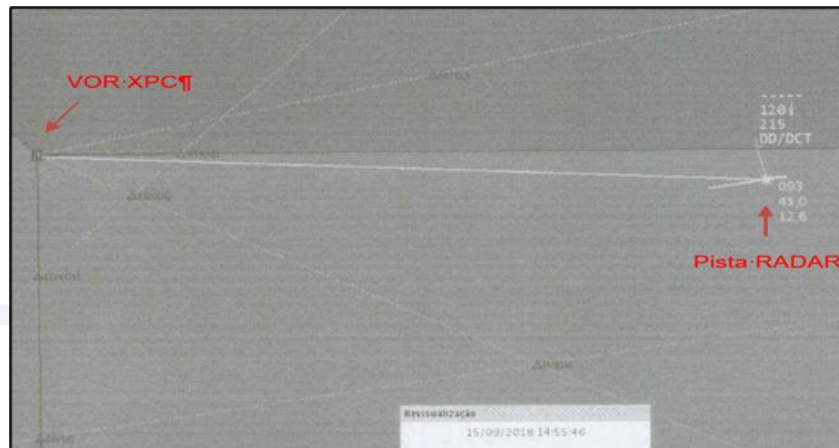
Figure 11 - RADAR image at 14:55:46 (UTC).

The last RADAR synthesis, with data from the PR-RFB, took place at 14:55:46 (UTC), when the aircraft was descending, crossing FL120, on the 093° radial, 45 NM away from the XPC VOR, as shown in Figure 11.

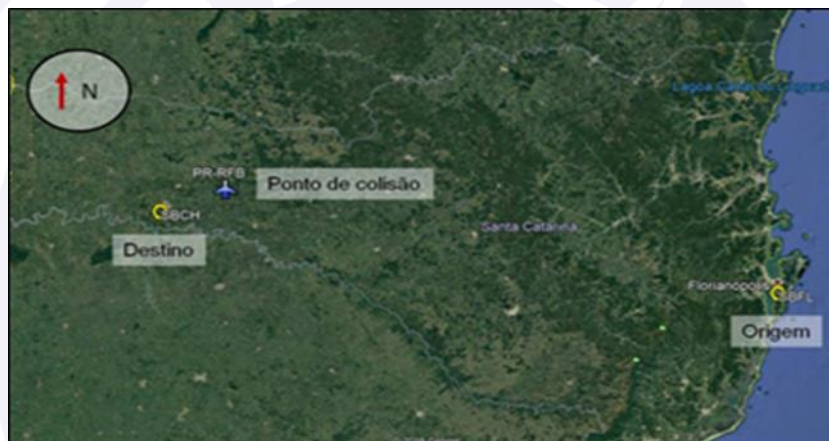
Figure 12 - Positions of the departure aerodrome (SBFL), the destination aerodrome (SBCH) and the PR-RFB impact point.

The impact occurred 23.92 NM from VOR XPC, at an altitude of 3,195 ft. In this position, the VOR/DME RWY 11 instrument approach procedure prevised the FL060 as the minimum flight level and the SBCH RNAV (GNSS) RWY 11 procedure prevised an MSA of 5,000 ft.

Figure 12 illustrates the positions of the origin Aerodrome (SBFL), the destination Aerodrome (SBCH), and the point of impact.
