**COMANDO DA AERONÁUTICA**  
**CENTRO DE INVESTIGAÇÃO E PREVENÇÃO DE**  
**ACIDENTES AERONÁUTICOS**

**FINAL REPORT**  
**A-002/CENIPA/2019**

<b>OCCURRENCE:</b>	<b>ACCIDENT</b>
<b>AIRCRAFT:</b>	<b>PR-RMZ</b>
<b>MODEL:</b>	<b>R44 II</b>
<b>DATE:</b>	<b>01JAN2019</b>

This is the Final Report of the 01 January 2019 accident with the R44 II helicopter, registration marks PR-RMZ. The occurrence was typified as “[SCF-PP] Engine failure or malfunction”.

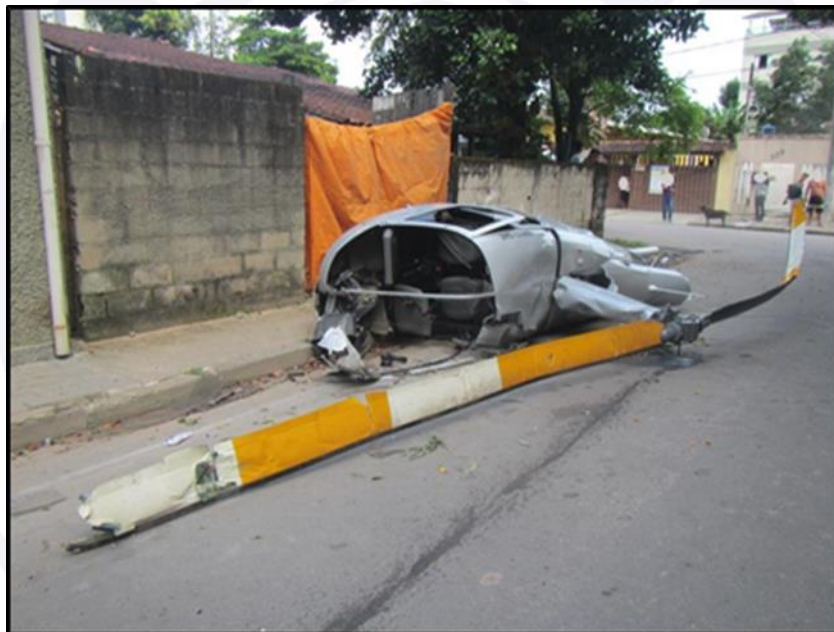
During the final approach, the helicopter collided with the wires of a utility pole and trees located along the street. After colliding with the ground, the wreckage of the aircraft also hit vehicles parked nearby.

Figure 1 - View of PR-RMZ at the accident site.

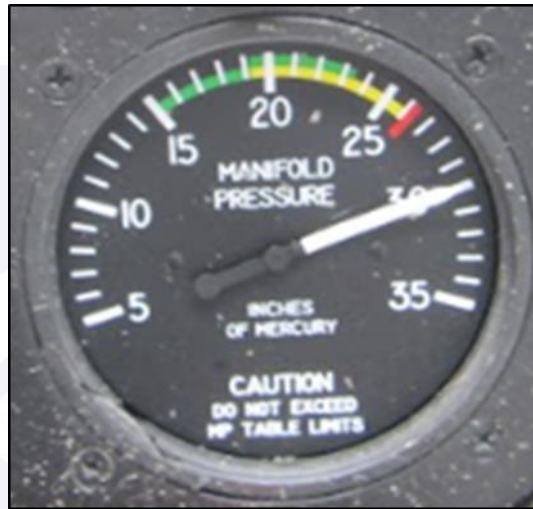
Figure 2 - PR-RMZ engine intake pressure indicator, after the accident.

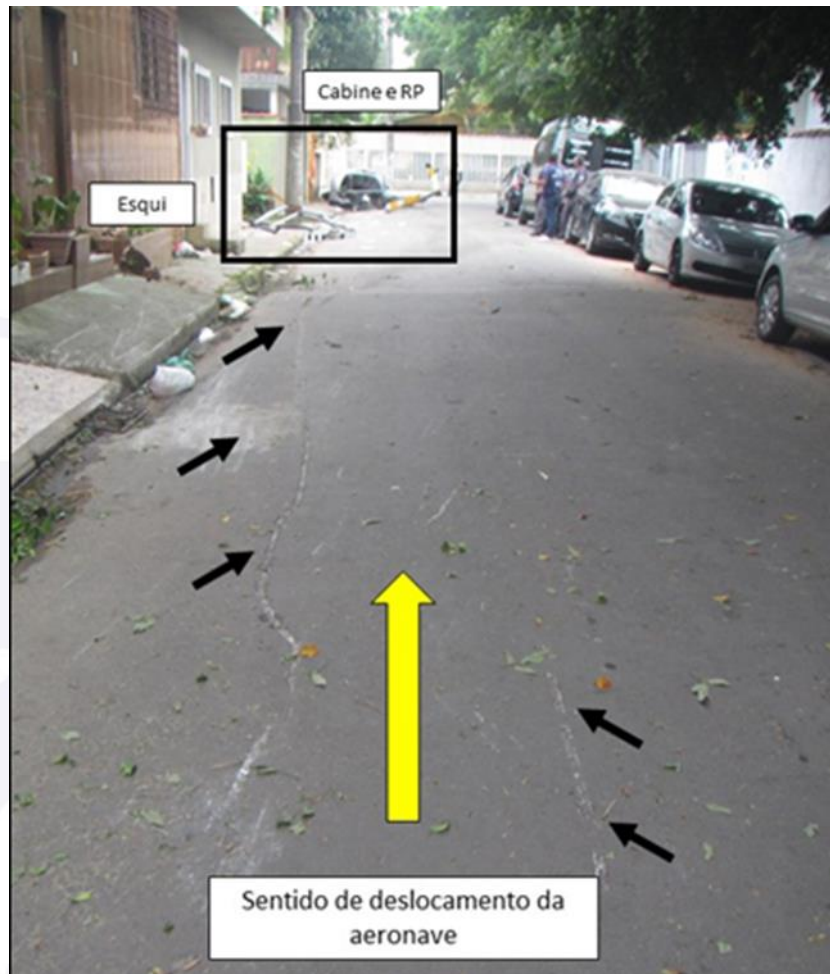
As the helicopter slid down the street, it collided with a second utility pole, objects, and parked vehicles, breaking up into three parts: skids and tail rotor; cabin and main rotor; and tail boom (Figure 4).

Figure 4 - View of the PR-RMZ trajectory on the ground.

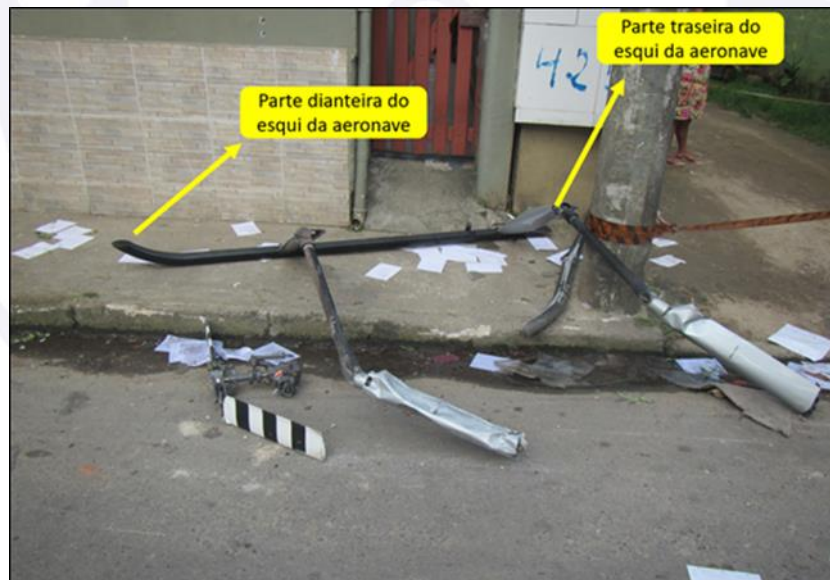
One observed that the aircraft's skids hit the utility pole with their rear part (Figure 5).

Figure 5 - Helicopter skid after collision against a public utility-pole.

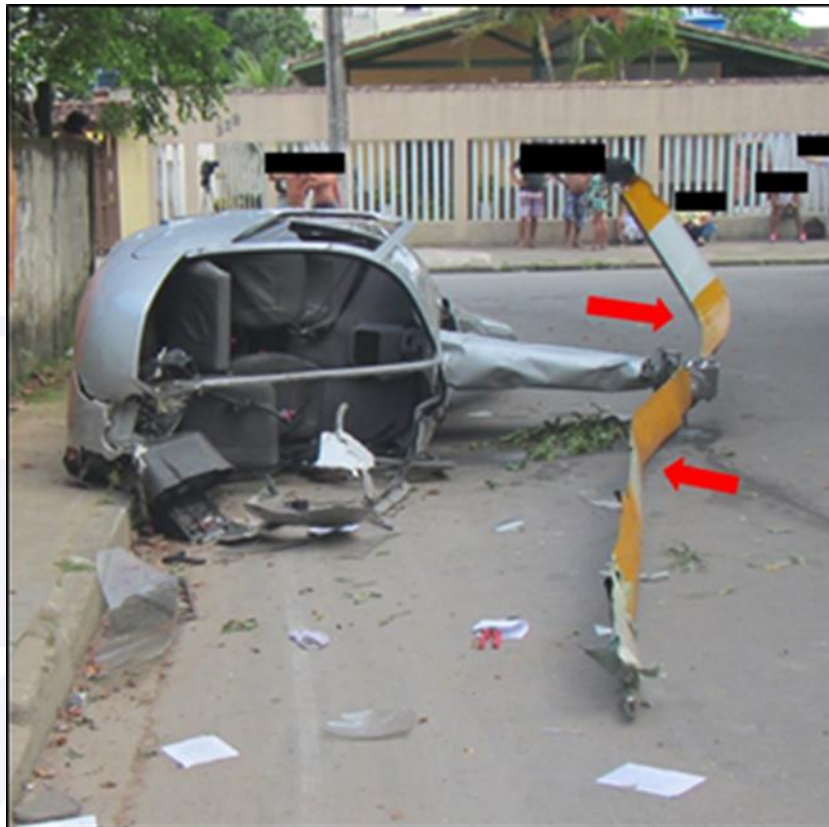
Based on the images recorded by one of the passengers, and the fact that the main rotor blades were not fractured, but bent upwards, one inferred that the main rotor was turning at low RPM at the moment of impact (Figure 6).

Figure 6 - The red arrows show the main rotor blades bent upwards. One of the blades rotated 180° in the longitudinal axis and became inverted (upside down) in relation to the other one.

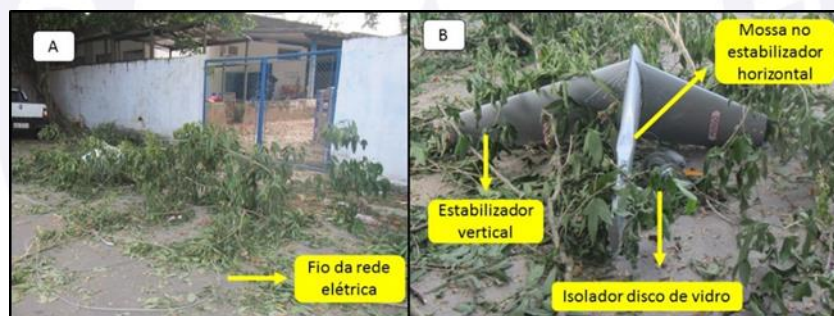
Also, a public utility-pole wire and a glass insulating-disc were found, along with the helicopter's vertical and horizontal stabilizers, at a distance of approximately 40 meters from the aircraft cabin (Figure 7 A and B).

Figure 7 - Electrical network wire (A) / Aircraft vertical and horizontal stabilizers and insulator (B).

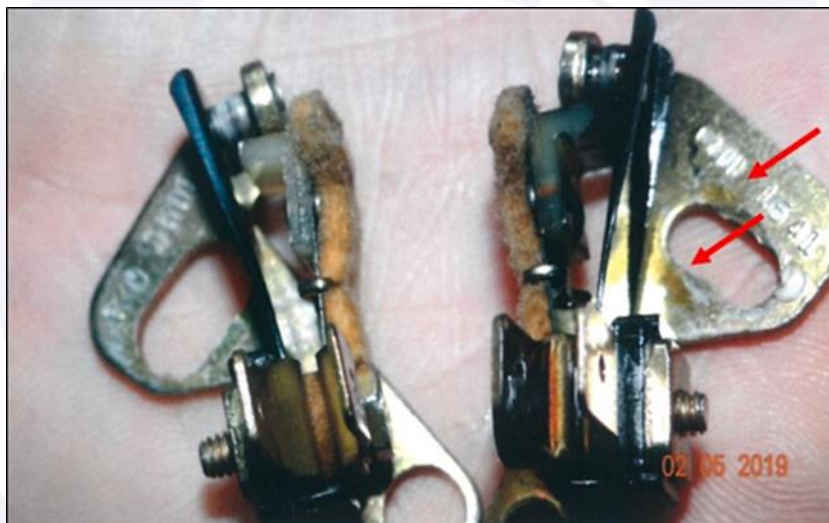
After the test, the magnetos were removed and tested on the bench. Both of them functioned normally. However, the presence of lubricating oil residue unforeseen by the manufacturer was observed in the right-hand magneto, as evidenced in Fig. 8, 9 and 10.

Figure 8 - Lubricating oil residue on the contact breaker of the right-hand magneto.

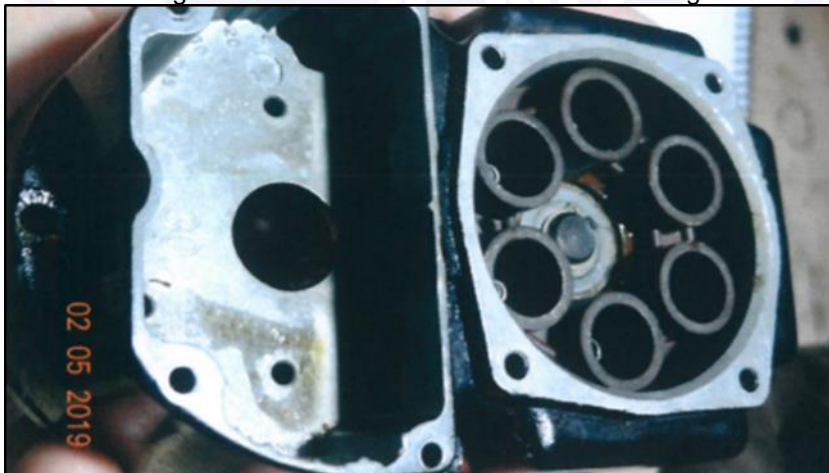
Figure 9 - Lubricating oil residue on the base of the contact breaker.

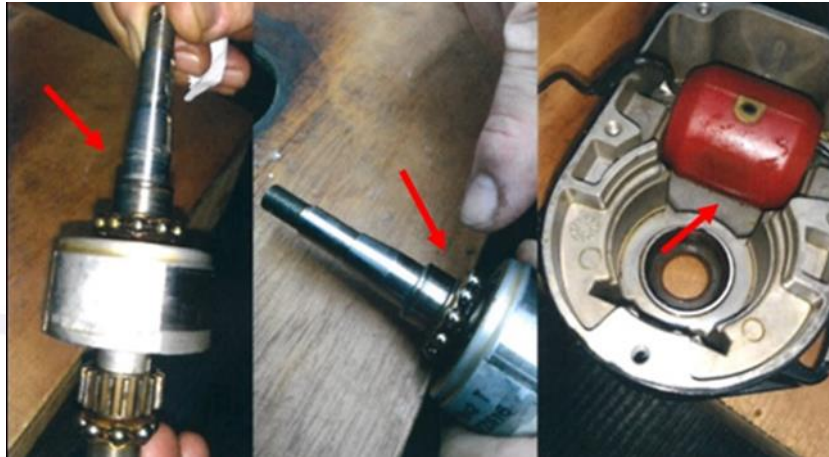
Figure 10 - Presence of lubricating oil in the rotor and right-hand magneto housing.

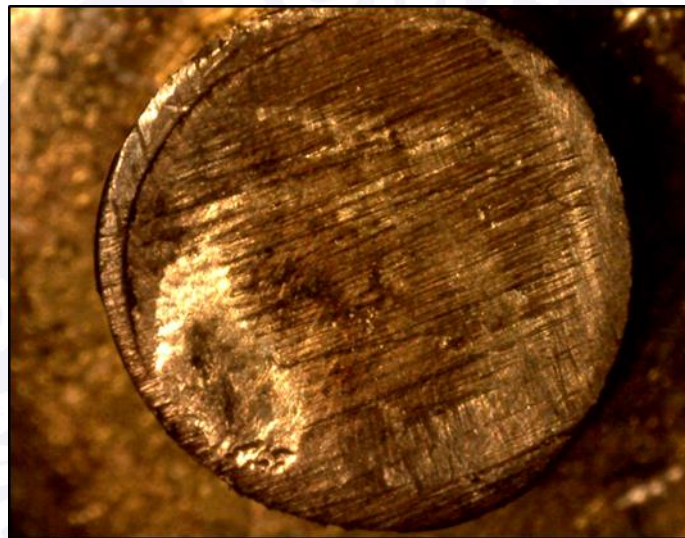
Figure 11 - Multidirectional marks found on the contact breaker of the right-hand magneto. Source: Robinson Helicopter Company.

In this component, it would be usual to find only unidirectional marks. The multidirectional marks suggest the possibility that some material (such as sandpaper) was used for cleaning the circuit-breaker contacts.

In the laboratory, one identified that the contact breaker that generated the electrical signal for the governor controller presented multidirectional scratches on the pads. Such condition was not allowed because it could lead to degradation of the signal generated for the governor controller.

**NOTE: Do not attempt to burnish, stone or dress contact points. Do not clean contact points with emery cloth. If the contact assembly points appear to be unserviceable, replace the entire contact assembly.**

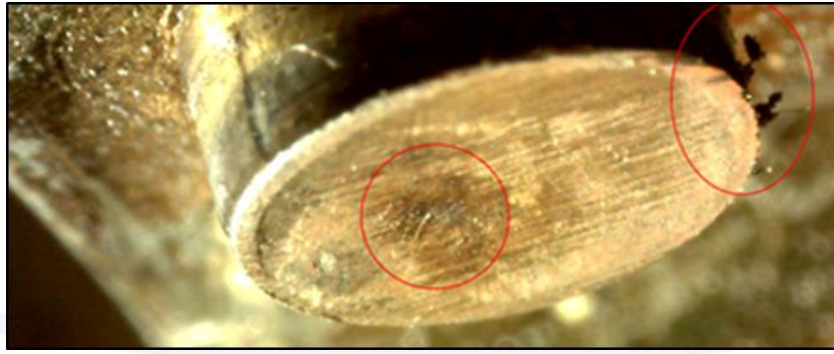
Figure 12 - SN E091A073 Magneto. Source: Robinson Helicopter Company.

In addition to the marks, one also observed that there was a small smooth and shiny area, occupying approximately 20% of the contact surface. There were cavities and a narrow ledge near the edge.

There was also a small dark area between the smooth area and the center of the circuit breaker, appearing to be some sort of substance. A dark, grainy pasty substance on the inner side of the part was also found (Figure 12).

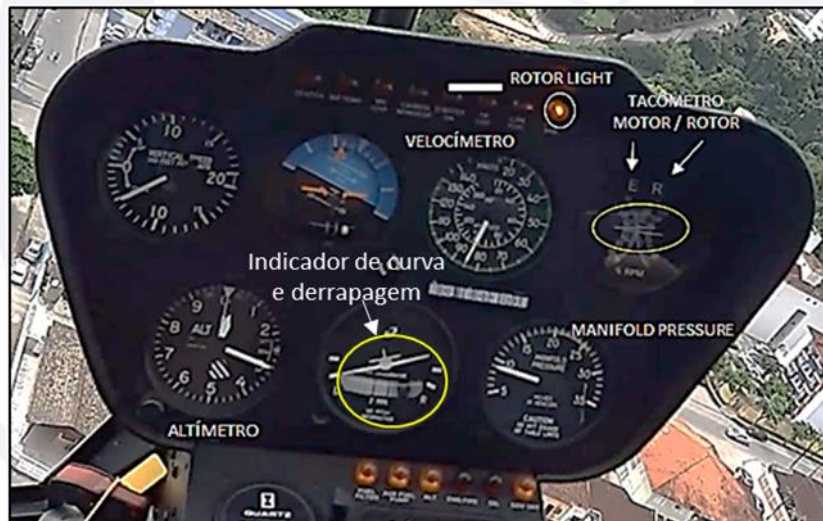
A few seconds after the horn sounded, an image of the PR-RMZ panel was recorded indicating a drop in rotation of both the engine and rotor. The condition of the "little ball" indicating a skidding to the right-hand side is an indication of reduced engine power. (Figure 17).

Figure 17 - Image captured by the passenger's camera, moments after activation of the low rotor rotation alarm.

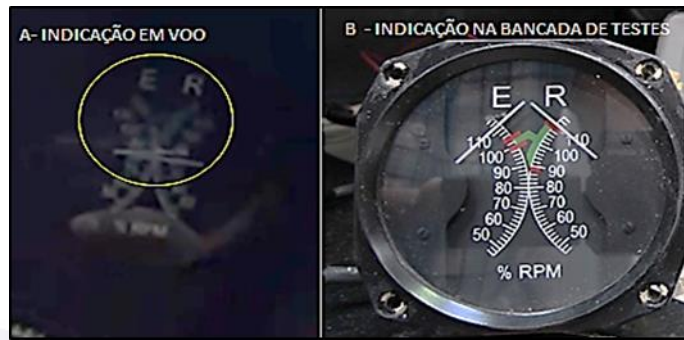
When comparing the PR-RMZ tachometer indications in flight (Figure 18A) with those of the RHC laboratory, in Torrance (Figure 18B), one sees that the rotor and engine indications initially fell to approximately 80% during the occurrence of the failure.

Figure 18 (A and B) - Comparison between the PR-RMZ tachometer indications.

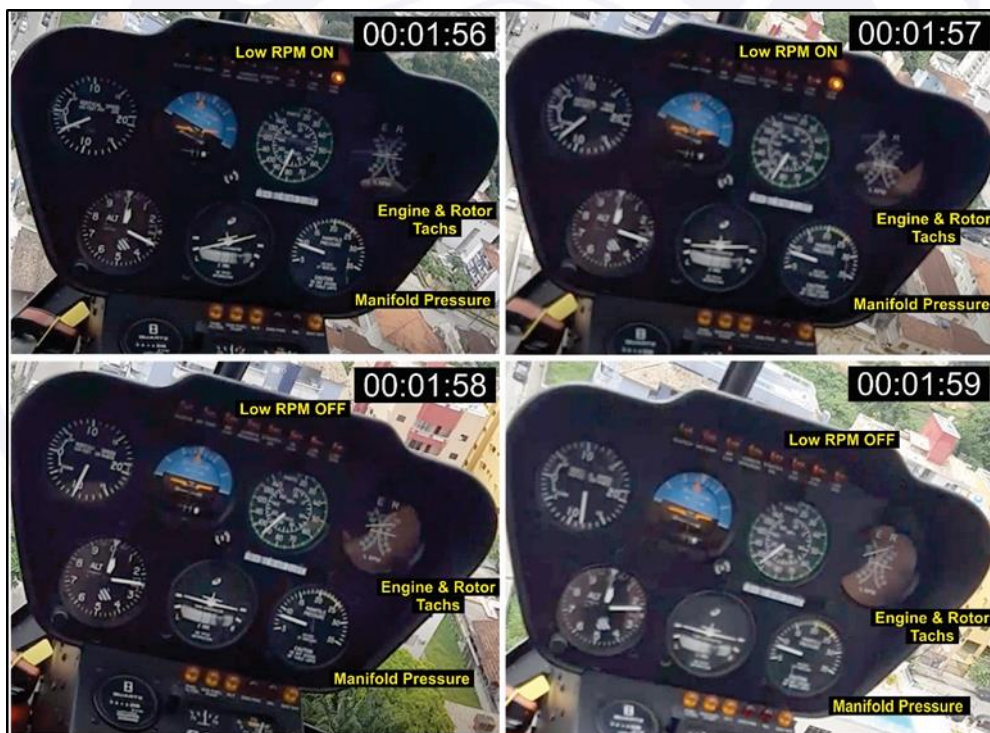
Figure 19 - Variation in engine RPM, while the rotor remains constant at 80%, and low RPM light "cycling".

The images in Figure 19 were obtained in the time interval recorded in the upper quadrant of each frame, demonstrating the high oscillations in the engine RPM indication in that short period of time. The time elapsed from the moment of the audible alarm until the first collision was 13 seconds.

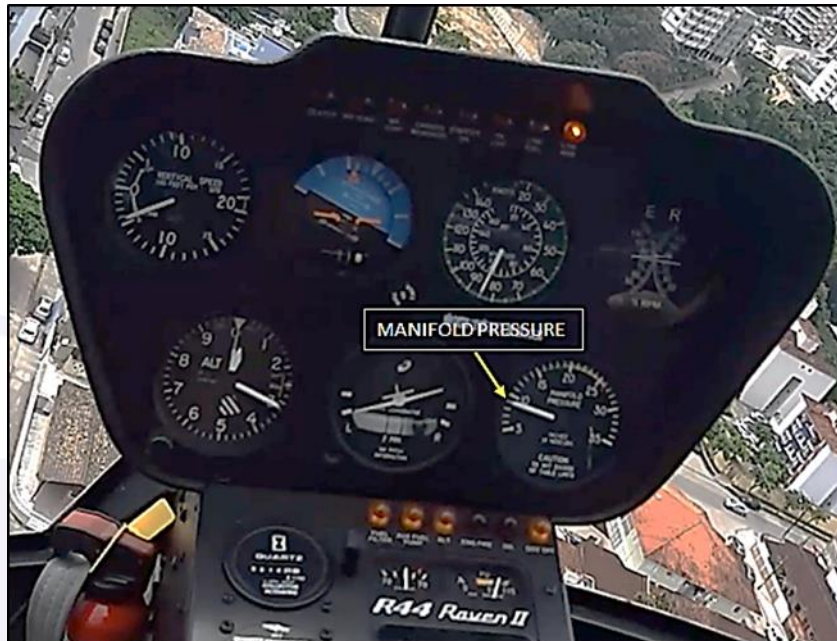
In addition to the facts mentioned above, based on the images, it was evident that the manifold pressure dropped excessively during the attempt to perform the autorotation procedure, remaining between 8 and 9 inHg, a value corresponding to operation of the engine at IDLE (Figure 24).

Figure 24 - Indication of the intake pressure of the PR-RMZ engine.

The position of the “ball” to the right indicates a left yaw of the helicopter, corresponding to a reduction in power.

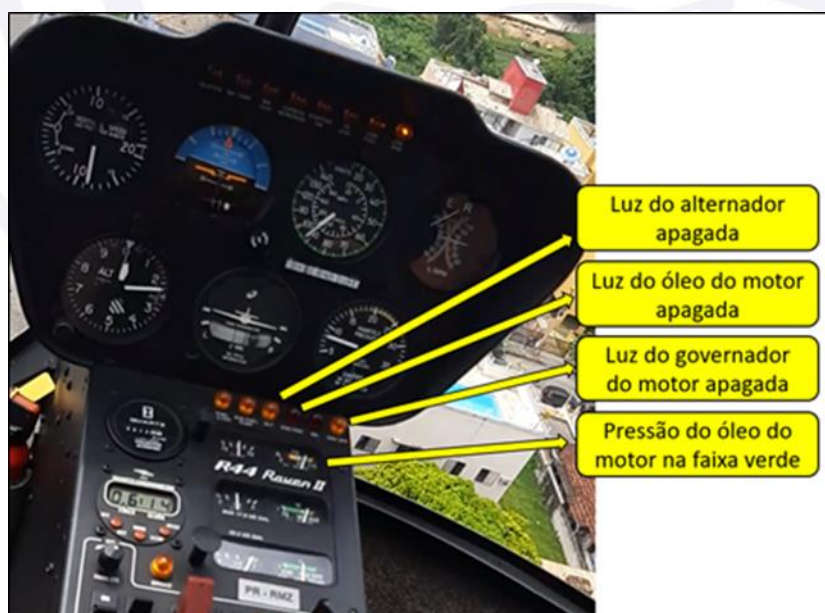
With the exception of the illumination of the low rotor RPM caution light, no drop in engine oil pressure or illumination of the low engine oil pressure light in the alternator were observed in the images, something that would be expected in the event of engine failure in flight (Figure 25).

Figure 25 - Video recording of the cabin made during the emergency.

Likewise, the engine's intake pressure, as shown in Figure 25, indicated that the engine was developing power at idle.
