COMANDO DA AERONÁUTICA
CENTRO DE INVESTIGAÇÃO E PREVENÇÃO DE
ACIDENTES AERONÁUTICOS

FINAL REPORT
A-112/CENIPA/2017

OCCURRENCE:	ACCIDENT
AIRCRAFT:	PR-RSP
MODEL:	S2R-H80
DATE:	06SET2017

This is the Final Report of the 06 September 2017 accident with the S2R-H80 aircraft, registration marks PR-RSP. The accident received the typification of “[SCF-PP] Engine failure or malfunction”.

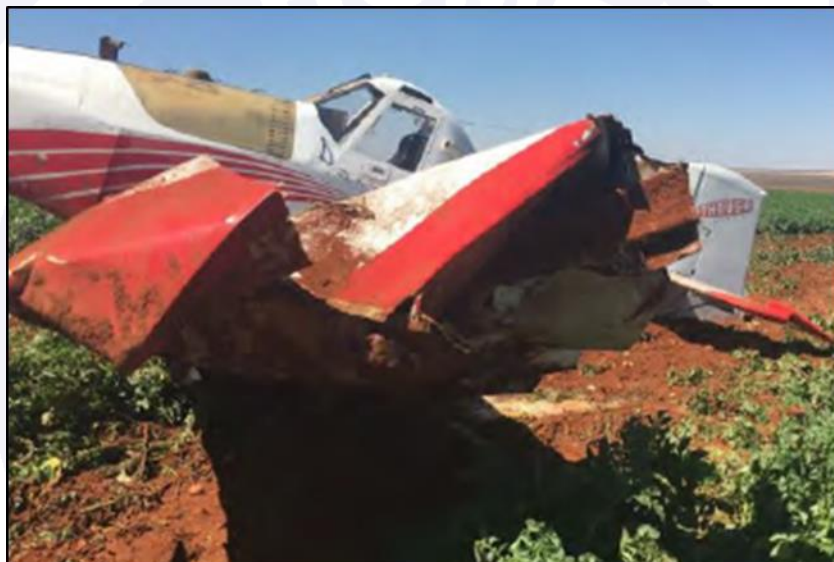
The aircraft sustained substantial damage.

Figure 1 - Image of the aircraft at the location of the final stop.

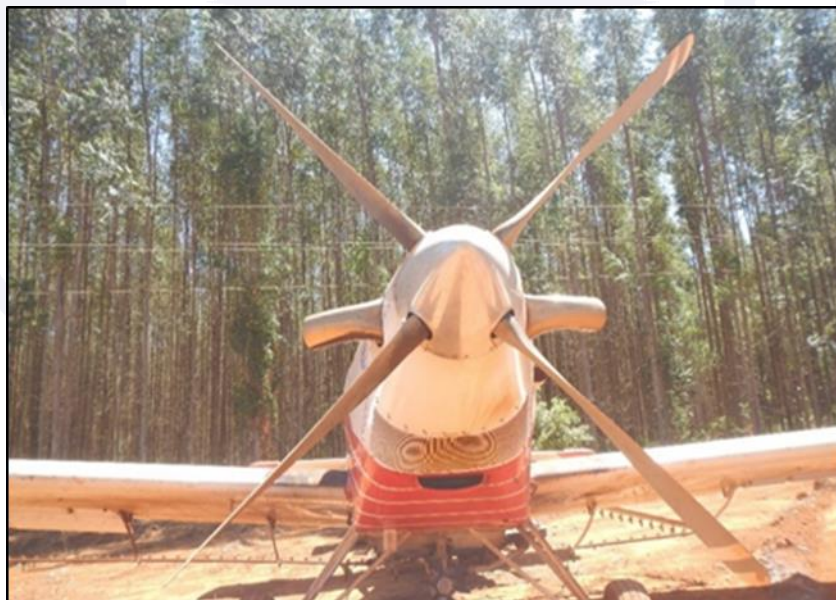
The propeller had fully feathered blades, and showed no apparent damage, indicating that the impact occurred with the engine not functioning (Figure 4).

Figure 4 - Image of the aircraft propeller with the blades in the feathered position.

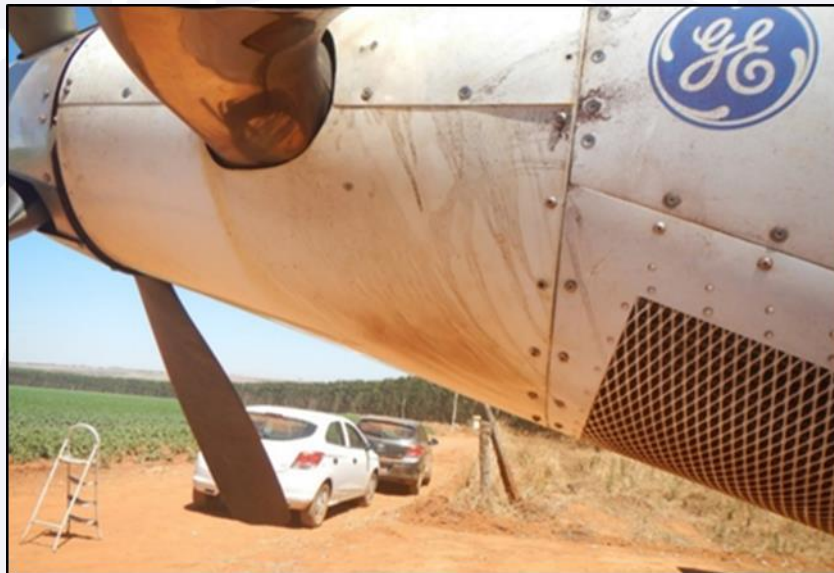
During the initial investigation, marks of oil leakage were observed on the engine cowling, around the exhaust gas pipe. The marks extended backwards, indicating that there had been an in-flight oil leakage (Figure 5).

Figure 5 - Oil marks on the engine cowling.

- j) during the initial action of the investigation, marks of oil leakage were observed on the engine cowling, around the exhaust gas pipe, which extended backwards;

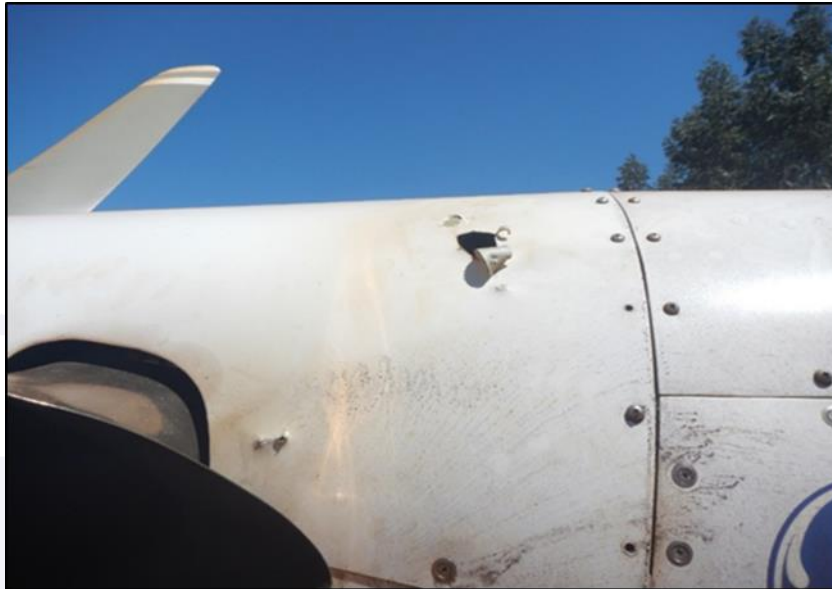
The engine cowling also had, on the left-hand side of its upper part, a hole made from the inside to the outside of the compartment, showing that an object had come loose that passed through this component (Figure 6).

Figure 6 - Damage with perforation on the left side of the engine cowling.

- k) the engine cowling had, on the left side of its upper part, a hole made from the inside to the outside of the compartment, showing that an object had come loose that had passed through the component;

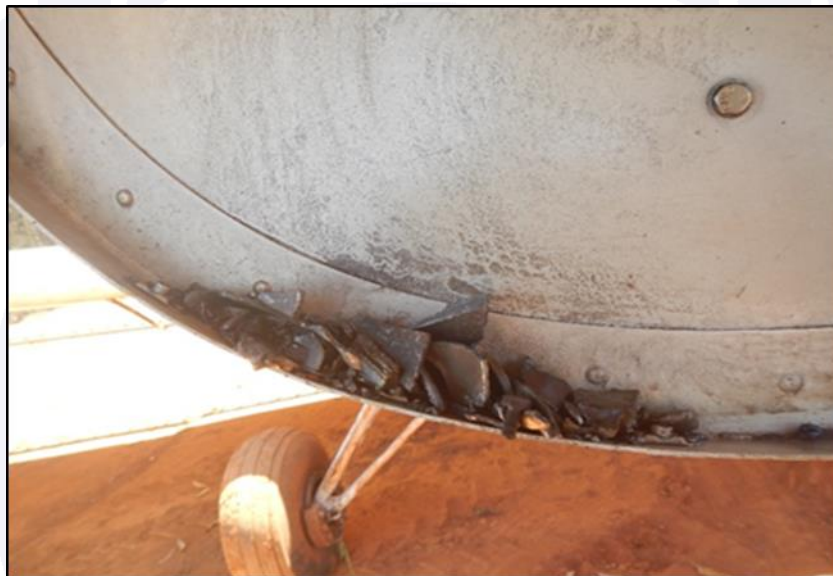
Figure 7 - Debris found inside the engine compartment.

- l) after removal of the cowling, one was able to identify evidence of severe damage to the engine and the presence of a lot of debris inside the engine compartment;

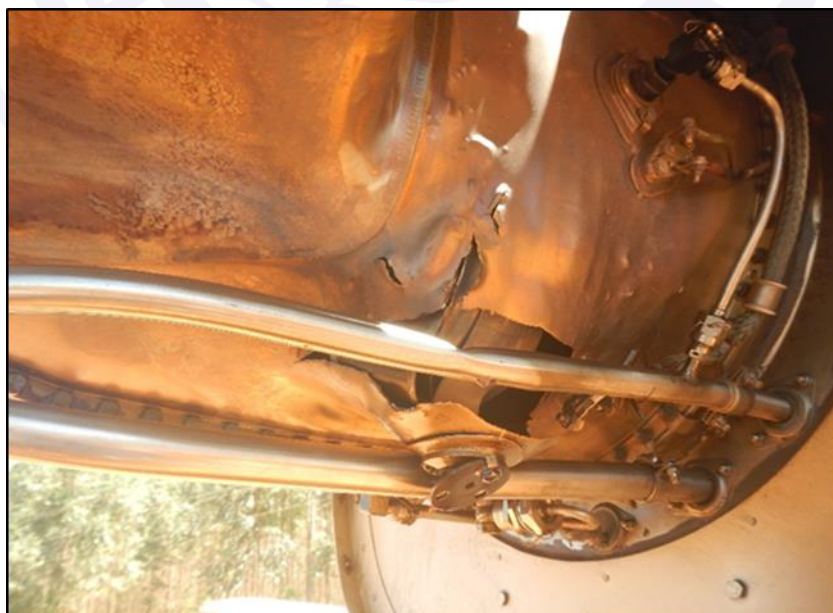
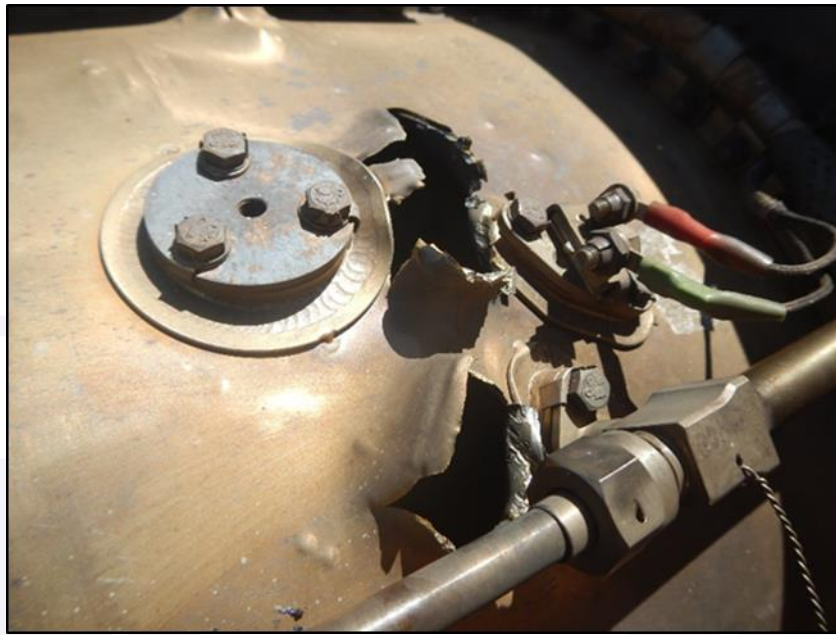
Figure 8 - Evidence of severe internal damage to the engine.

Figure 9 - Evidence of severe internal damage to the engine.

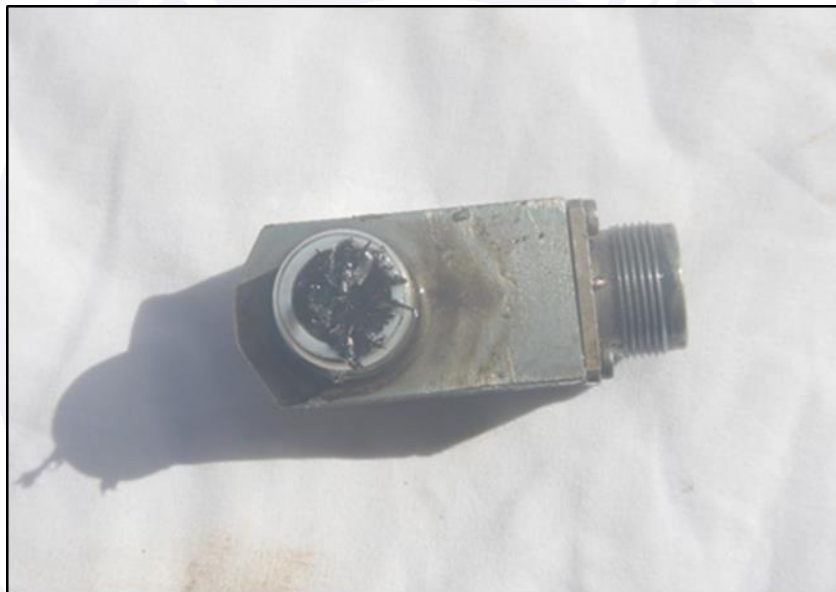
The magnetic plug of the engine's filing detection system was contaminated and had lots of metal particles (Figure 10).

Figure 10 - Magnetic plug of the engine filing detection system contaminated with metal particles.

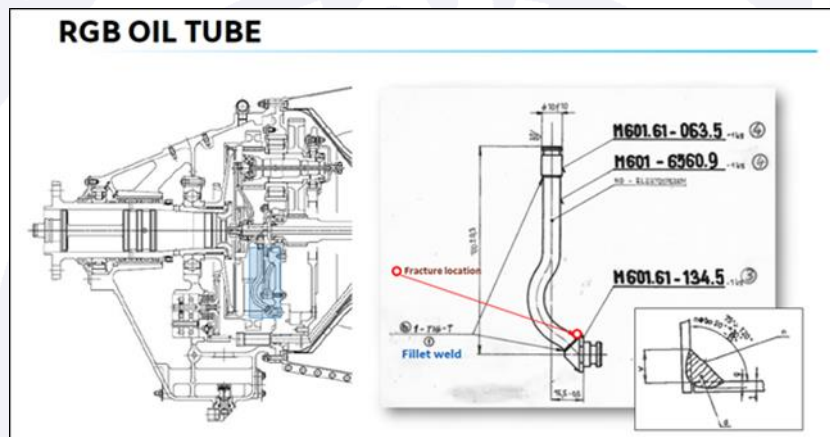
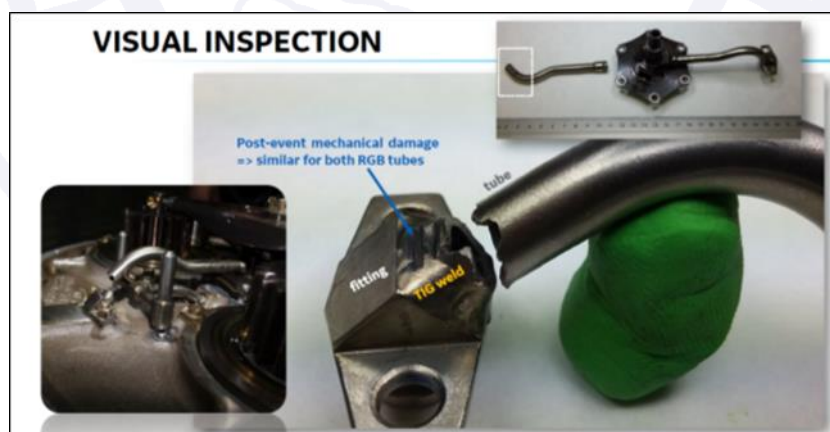
After disassembling the engine, one observed a fracture in the Reduction Gear Box (RGB) Oil Tube, which provided information to the engine torque indicator in the region of the flange, which was screwed to the pseudoplanetary stator body (Figures 12 and 13).

Figure 12 - Location of the RGB Oil Tube, with the point of fracture in highlight.
Source: Investigation Report GEAC.

Figure 13 - Images of the fractured RGB Oil Tube obtained at the engine disassembly. Source: Investigation Report GEAC.

The exams and tests revealed that the loss of torque-adjustment information that occurred at the end of the first flight of the day was due to the rupture of the RGB Oil Tube.

- m) at the disassembly of the engine, a fracture was observed in the Reduction Gear Box (RGB) Oil Tube that provided information for the torque indicator;

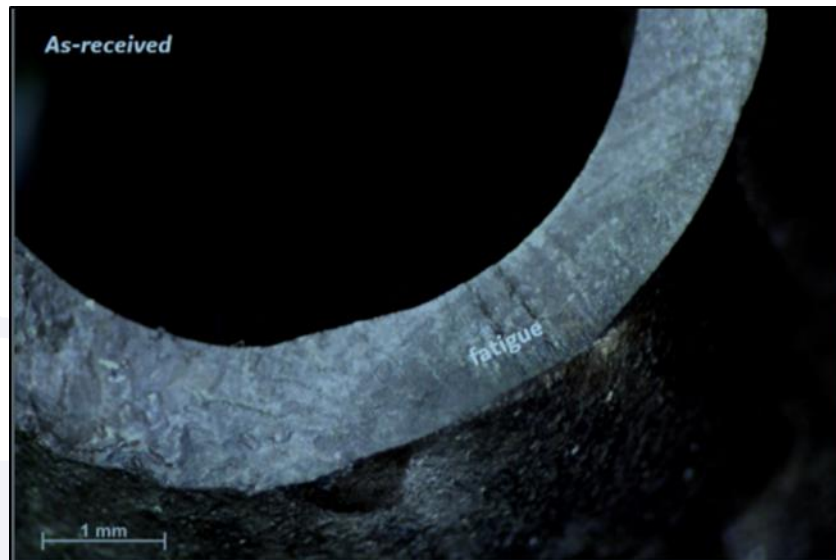
By means of metallographic analysis, it was possible to identify cracks and “beachmarks”, typical characteristics of the mechanism of material failure due to fatigue. The cracks progressed along the entire length of the tube wall, allowing part of the oil to leak (Figure 14).

Figure 14 - Metallographic analysis image showing cracks and “beach marks”, typical characteristics of the material-failure mechanism due to fatigue.

Considering that the analyses demonstrated that the referred fracture was caused by a fatigue process beginning with cracks that progressed until crossing the tube wall, allowing oil to leak, it is likely that such failure was already interfering with the torque indications even before the rupture of the pipe, due to the resulting loss of pressure.

It is possible that the natural vibration of the engine, exacerbated by operation at power regimes above those permitted, accelerated the propagation of the crack that resulted in the fracture of the RGB Oil Tube.

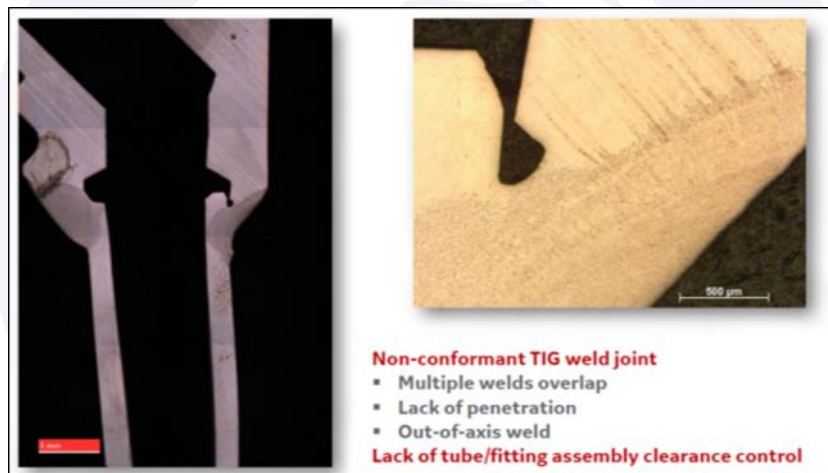
The assembly included two M601-626.9 RGB Oil Tubes. The one not damaged was sectioned for more in-depth analysis, which made it possible to identify that the Tungsten Inert Gas (TIG) weld presented characteristics different from those required, such as multiple overlapping layers, lack of penetration, and direction not corresponding to the expected axis (Figure 15).

Figure 15 - Image obtained during the metallographic examination of the sectioned tube, highlighting welding characteristics different from those required.

With respect to the fracture of the Reduction Gear Box (RGB) Oil Tube, the non-conformities identified in the TIG weld, which presented characteristics different from those required, such as multiple overlapping layers, lack of penetration, and direction outside the expected axis, indicated the participation of manufacturing process of the component, since the cracks, which progressed until crossing the tube wall and caused the component to rupture, began close to this region of the flange that was screwed to the pseudoplanetary stator body.

The non-conformities identified in the TIG weld of the Reduction Gear Box (RGB) Oil Tube, which presented characteristics different from the ones required, such as multiple overlapping layers, lack of penetration, and direction outside the expected axis, indicated the participation of the manufacturing process of this component, since the cracks that progressed until crossing the tube wall and caused the component to rupture began close to this region of the flange, which was screwed to the pseudoplanetary stator body.

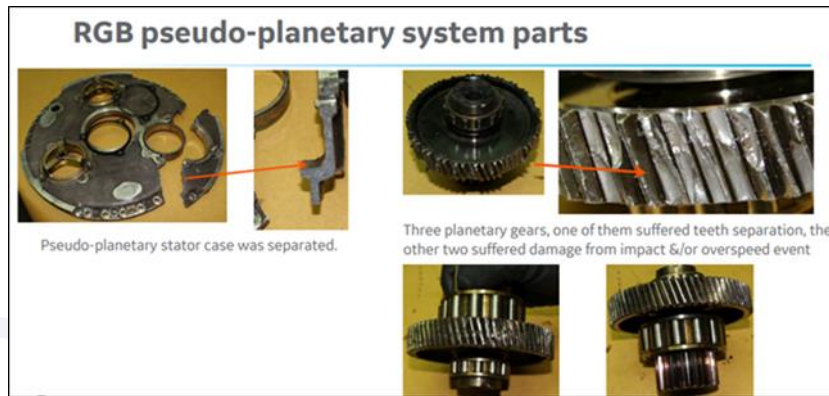
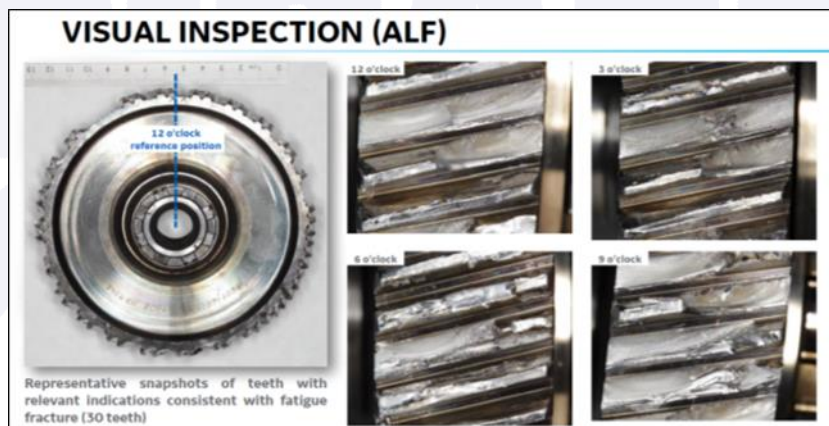
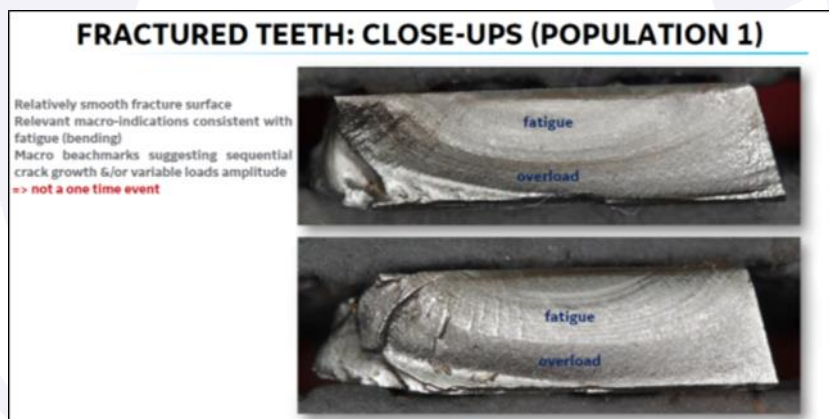
The planetary gear of the 1st RGB reduction stage was found damaged. The analyses identified typical characteristics of material failure due to fatigue followed by overload in thirty teeth (Figures 16 to 18).

The examinations identified that the fatigue could have been caused by the fact that the engine had operated with power above the limit established in the certification (*overtorque*).

Figure 16 - Damaged planetary gears.
Source: Investigation Report GEAC.

Figure 17 - View of the RGB gear showing fractured teeth.
Source: Investigation Report GEAC.

Figure 18 - Stereoscopic image of one of the gear teeth showing characteristics of material failure due to fatigue and overload.
Source: Investigation Report GEAC.

The observed “beach marks” (Figure 18) demonstrated that there was a sequential increase in the amplitude of the cracks and that the structure was subjected to efforts of varying intensity, not being a single event.

Furthermore, the fact that the analyses of the planetary gear of the first stage of the RGB identified characteristics typical of material failure due to fatigue followed by overload on its teeth, also directed the conclusions towards continued operation with power above the certification limits.

- n) the planetary gear of the first RGB reduction stage was found damaged and had fractured teeth;
- o) the Power Turbine rotor had severe damage and lost all of its blades;

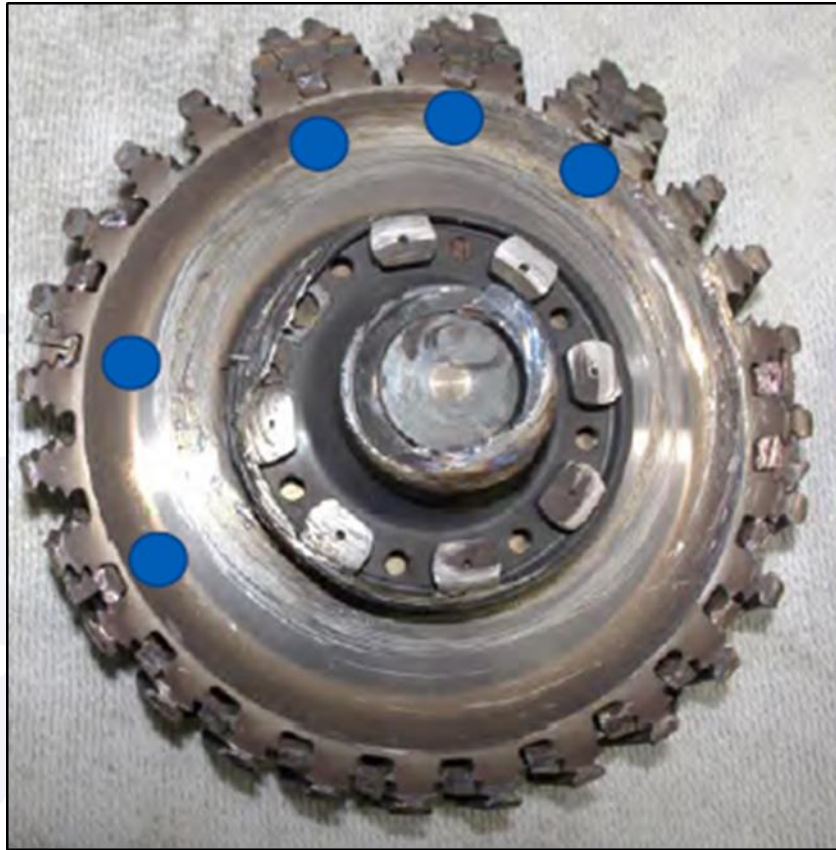
The rotor of the Power Turbine (PT) sustained severe damage and lost all of its blades (Figure 19).

Figure 19 - PT Image. Source: Investigation Report GEAC.

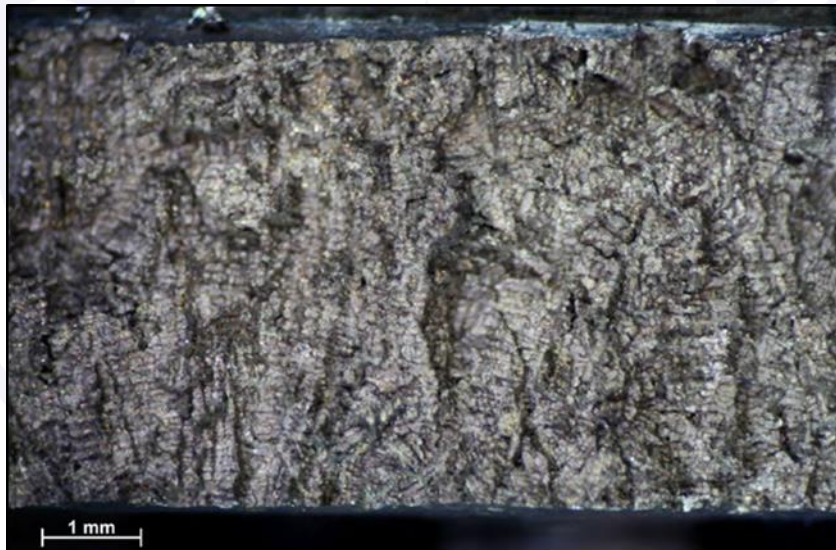
Examination of the region of separation of the blades showed features consistent with overload fractures (Figure 20).

Figure 20 - Image showing the fracture region on a PT blade.
Source: Investigation Report GEAC.

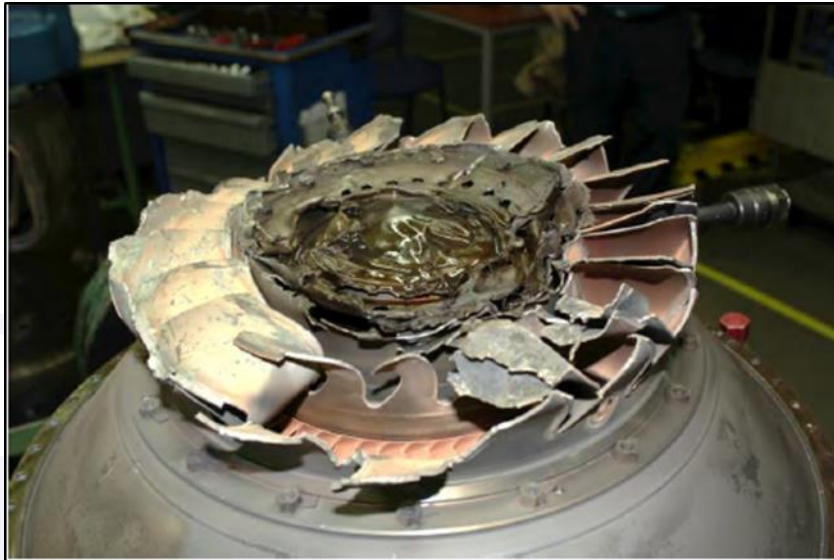
The Power Turbine Guide Vane Ring (NGVR) also showed severe damage resulting from impact against the PT (Figure 21).

Figure 21 - Image showing the damage to the NGVR.
Source: Investigation Report GEAC.

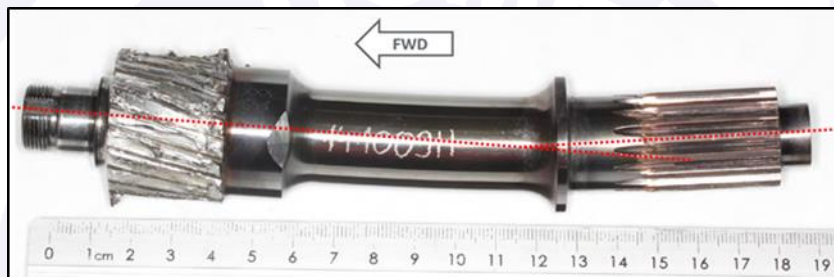
The Quill-Shaft also showed severe damage. The teeth on the edge that connected to the RGB sustained severe mechanical damage and the shaft got bent. (Figure 22).

Figure 22 - Image showing damage to the Quill-Shaft.
Source: Investigation Report GEAC.

- p) the Quill-Shaft sustained severe damage to its end connecting to the RGB, to the point of getting bent;
- q) the aircraft sustained substantial damage; and
- r) the pilot was uninjured.

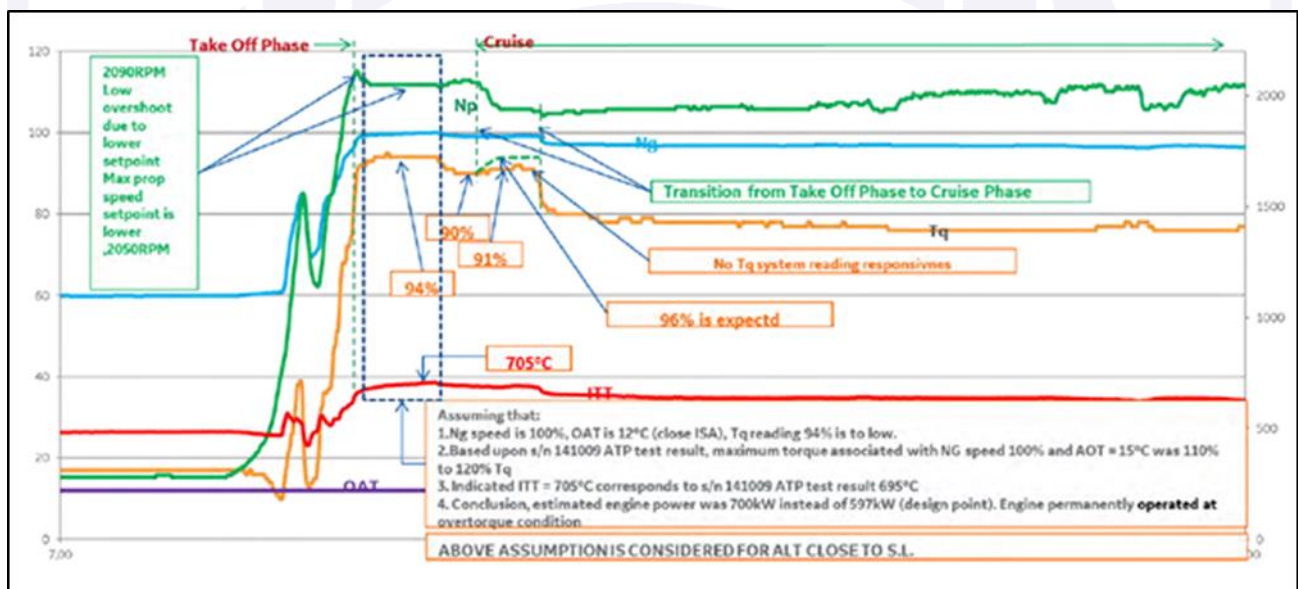
According to calculations, in that phase of the flight (takeoff), the power developed was 700 KW, in contrast to the 597 KW of the design.

Based on the results obtained, the manufacturer's representatives concluded that the engine was being operated in an overtorque condition (Figure 25).

Figure 25 - Diagram showing the aircraft engine parameters during the takeoff and cruise phases of the first flight. Source: Investigation Report GEAC.

This hypothesis is corroborated by the fact in that phase of the flight the power developed by the engine was calculated to be 700 KW, in contrast with the 597 KW of the design.

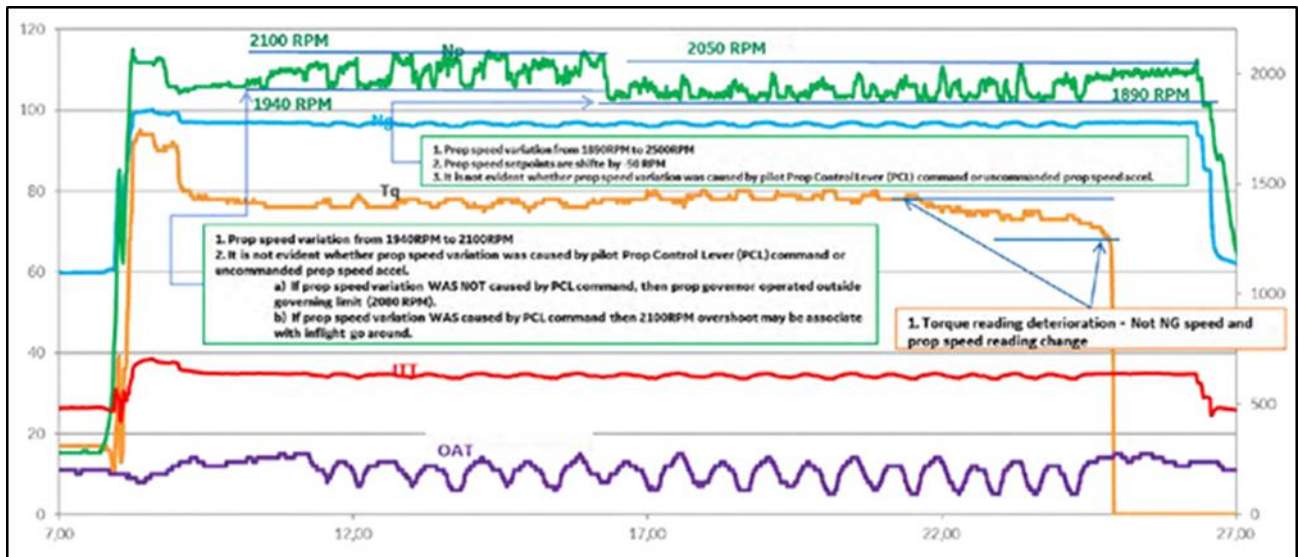
Near the end of the first flight, one observed a drop in value and total loss of torque indication without the corresponding change in the parameters of the NG, NP, and ITT.

In the sequence, all parameters decreased. That was the moment at which the landing to replenish the aircraft with the product occurred, without shutting down the engine (Figure 26).

Figure 26 - Diagram of aircraft engine parameters in the first complete flight.
Source: Investigation Report GEAC.

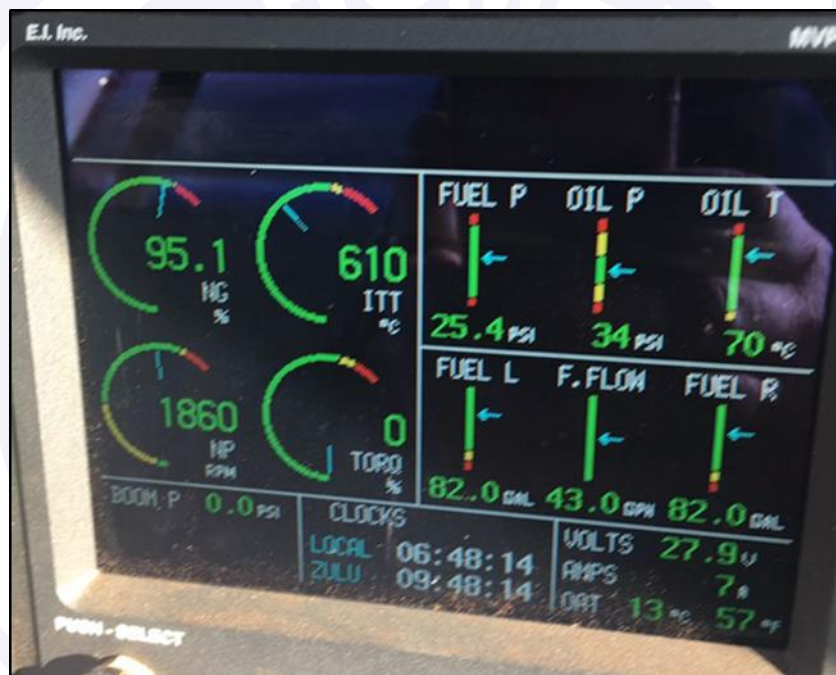
The moment at which the torque indication “zeroed out” was recorded in an image obtained with a cell phone by the PIC (Figure 27).

Figure 27 - Image recorded by the PIC showing the torque indication on the MVP-50T screen.

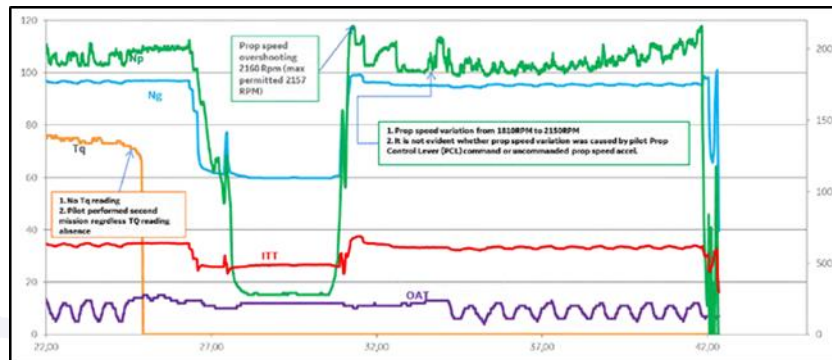
In the diagram showing the data from the end of the first flight to the second flight until the moment of engine failure, one verified that the second flight began without indication of torque and that, at takeoff, there was a slight excess of the propeller RPM, since the limit was 2,157 RPM, and it reached 2,160 RPM.

The flight continued until the occurrence of the catastrophic engine failure, with feathering of the propeller and loss of all parameters after the collision with the ground. The temporary increase in NG may have been the result of the pilot's attempt to restart the engine after the failure (Figure 28).

Figure 28 - Diagram showing data from the end of the first flight and data of the second flight until the moment of engine failure.
