**COMANDO DA AERONÁUTICA**  
**CENTRO DE INVESTIGAÇÃO E PREVENÇÃO DE**  
**ACIDENTES AERONÁUTICOS**

**FINAL REPORT**  
**IG-063/CENIPA/2020**

<b>OCCURRENCE:</b>	<b>SERIOUS INCIDENT</b>
<b>AIRCRAFT:</b>	<b>PR-SCL</b>
<b>MODEL:</b>	<b>AS 350 B2</b>
<b>DATE:</b>	<b>11MAI2020</b>

This Final Report refers to the serious incident involving the AS 350 B2 aircraft, registration PR-SCL, on 11 May 2020. The occurrence was typified as "[UIMC] IMC unintentional" and "[AMAN] Abrupt Maneuver".

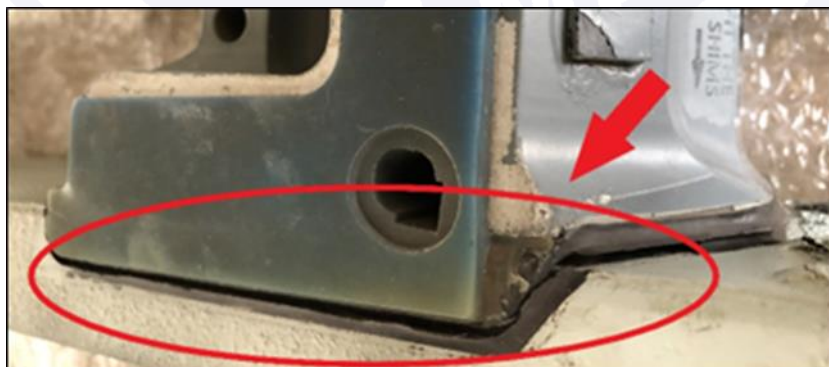
During the maneuver, the main rotor speed reached 493 RPM. There was high vibration, and the Emergency Locator Transmitter automatically activated.

The visible damage was limited to detachment of the seals from the three main-rotor blades frequency adapters (Figure 1).

Figure 1 – Detachment of the frequency-adapter sealant.

Due to the overspeed condition event (493 RPM), the maintenance staff removed the main- and tail-rotor blades, and sent them to the manufacturer for analysis and repair.

It was necessary to discard some of the components described in the AS350 05-53-00-601 Maintenance Manual, page 603, version 2019.09.26, as determined by the manual.
