COMANDO DA AERONÁUTICA
CENTRO DE INVESTIGAÇÃO E PREVENÇÃO DE
ACIDENTES AERONÁUTICOS

FINAL REPORT
A-006/CENIPA/2022

OCCURRENCE:	ACCIDENT
AIRCRAFT:	PR-SOD
MODEL:	PA-25-260
DATE:	15JAN2022

This is the Final Report of the 15 January 2022 accident with the PA-25-260 aircraft, registration marks PR-SOD. The accident was typified as “[LOC-G] Loss of control on the ground and [RAMP] Ground operations”.

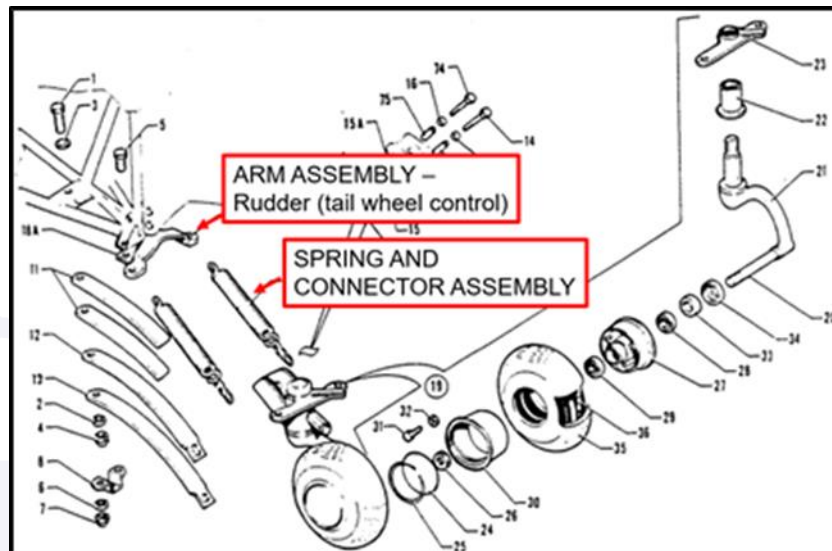
The aircraft had a conventional landing gear, consisting of two main legs and a tailwheel. The latter was normally connected to the rudder for directional control by means of the pedals (Figure 1).

Figure 1 - Pictographic description of the tailwheel assembly, highlighting the set of springs, connectors, and arm connection to the steering rudder, extracted from the IPC (Illustrated Parts Catalog).

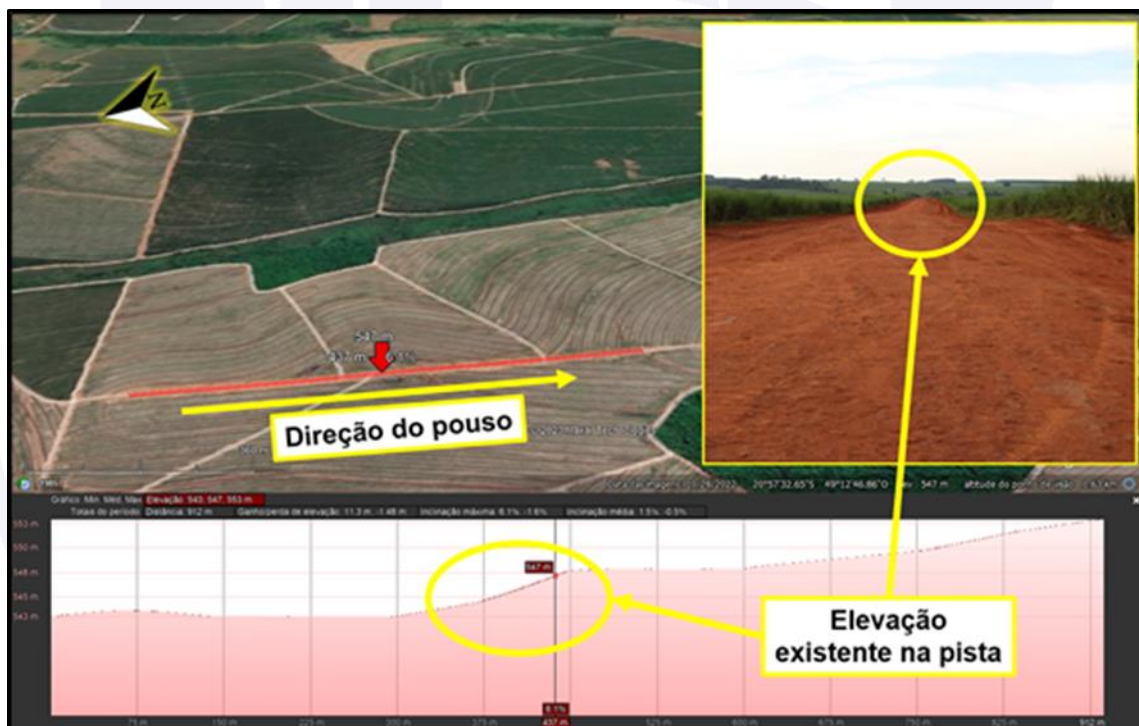
Threshold 01 had an elevation of 1,814 ft, while threshold 19 was at 1,781 ft. The gradient between the thresholds was 1.1%, with slope variations from -0.4% to 6% along its length.

Approximately halfway between the thresholds, there was an elevation of land noticeable to the naked eye, with an estimated slope of 24°.

Figure 3 - Estimated vertical profile of the landing area, highlighting the elevation close to midpoint. Source: adapted from Google Earth.

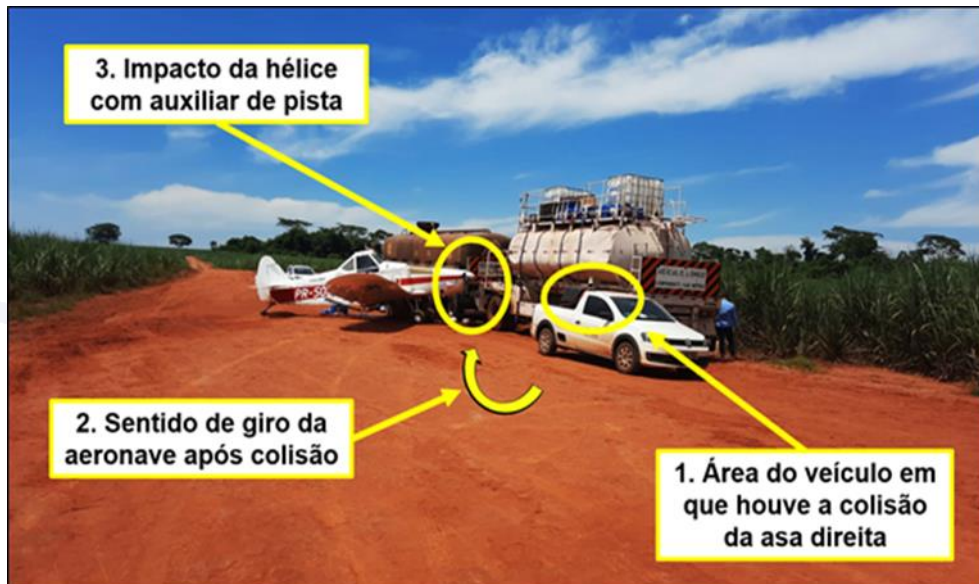
As the aircraft's right-hand wing hit the fuel supply vehicle (a pick-up truck), the aircraft rotated approximately 120° around its vertical axis, still at forward speed, resulting in collision of the left-hand wing with the truck, while the propeller hit the airstrip assistant, who was standing between the two axles of the truck (Figure 4).

Figure 4 - Pictographic representation of the impact dynamic.

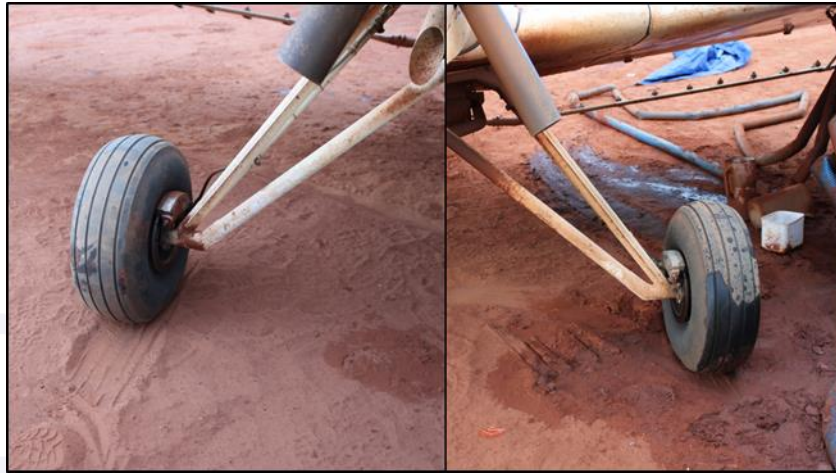
The main landing gear was undamaged, and its general condition was good. The braking system had no apparent damage. However, the region of the brake disk contained dirt, which resulted from the accumulation of the fine dust that covered the landing area (Figure 5).

Figure 5 - Main landing gear legs, wheels and brakes.

It was not possible to rule out, however, that the dirt found in the brake assembly of the main landing gears may have contributed to a reduction of the braking efficiency or even to a possible intermittent failure of brake system - even though its functionality was tested during the initial action. If the airstrip were in good condition, the distance available after the central unevenness (around 450 m) would be enough for a complete landing of the airplane.

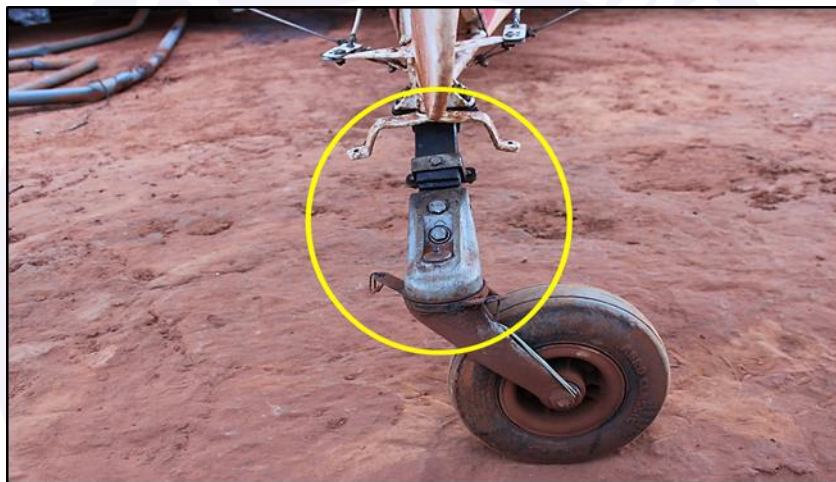
The auxiliary landing gear was moving freely, showing no signs of locking. During the initial action, one found that the springs of the rudder/tailwheel connection were missing, as shown in Figure 6.

Figure 6 - Auxiliary landing gear, highlighting the absence of springs of the connection with the steering rudder.

During the initial action, one found that the aforementioned connection was missing. When connected, the springs would restrict the aircraft's turning radius on the ground to the limits of the rudder stops. Once absent, directional control was achieved through alternate application of the main landing gear brakes.

- p) the brake system was tested for functionality, and showed no abnormalities;
- q) the tailwheel was moving freely, with no signs of locking;
- r) the connection between the tailwheel and the steering rudder was missing at the initial investigation action;

Also due to the lack of control relative to compliance with the equipment's operating manual, in view of the missing connection between the tailwheel and the steering rudder, as well as practices aimed at optimizing operations, the investigation demonstrated the existence of inadequacies in the oversight processes put in place by the management staff.

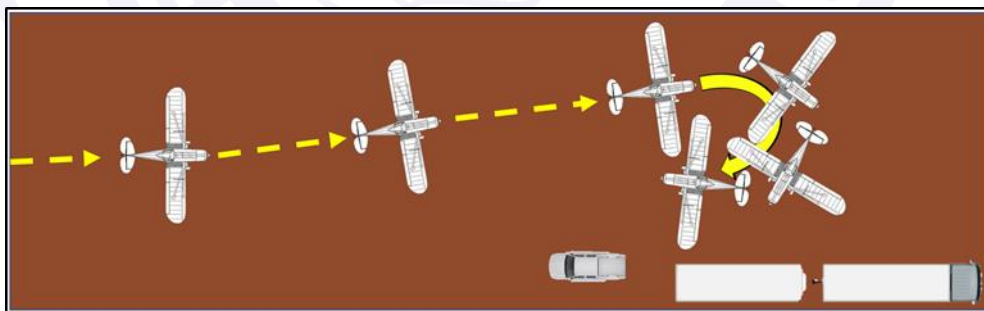
The parking of vehicles within the limits of the landing area and the execution of backtrack aimed at optimizing the operations, reducing the aircraft's ground time between applications (Figure 7).

Figure 7 - Representation of the aircraft's usual path after landing.

The positioning of vehicles within the limits of the landing area, specifically at the threshold in use for takeoffs, also proved to be inadequate and risky. This procedure, which aimed to allow rapid replenishment of the aircraft, which would execute a backtrack maneuver close to the vehicles, denoted an attempt to optimize operations as much as possible, despite the associated risks.

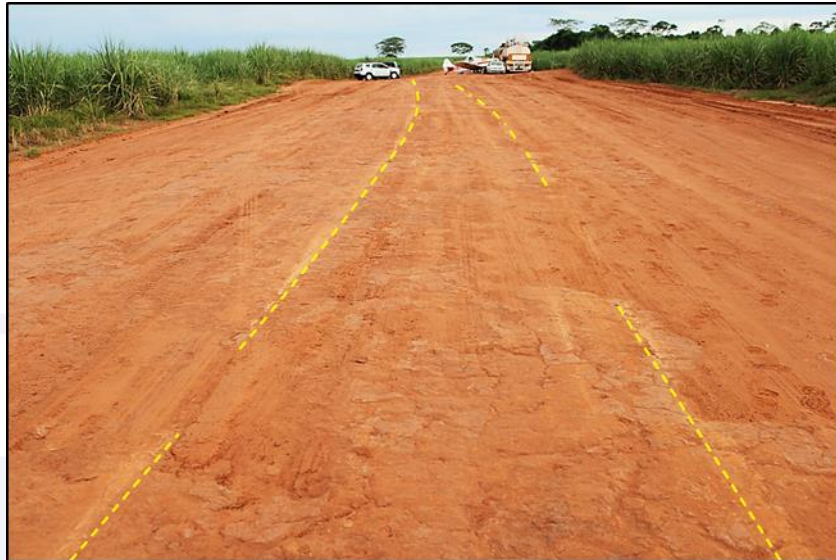
The marks indicated locking of the wheels, showing that the left brake was more used than the right one (Figure 8).

Figure 8 - Braking marks left by the aircraft in the moments before the collision with the vehicle, highlighted by dotted lines.

The consistency of the marks resulted from the fact that it had rained the night before the flight, the landing area was covered with a layer of dust, and there had not been any operations before or after the occurrence.

In fact, the braking marks observed in the 115-meter segment preceding the point of collision with the ground-vehicle showed an attempt of deviation to the left, with the wheel locking in the left direction more frequently than in the right direction. However, the attempt at directional control by the use of differential brakes proved fruitless, as there were both a residual forward speed and a low-grip landing area - which only resulted in the aircraft skidding on the airstrip surface.
