COMANDO DA AERONÁUTICA
CENTRO DE INVESTIGAÇÃO E PREVENÇÃO DE
ACIDENTES AERONÁUTICOS

FINAL REPORT
A-013/CENIPA/2017

OCCURRENCE:	ACCIDENT
AIRCRAFT:	PR-SOM
MODEL:	C90GT
DATE:	19JAN2017

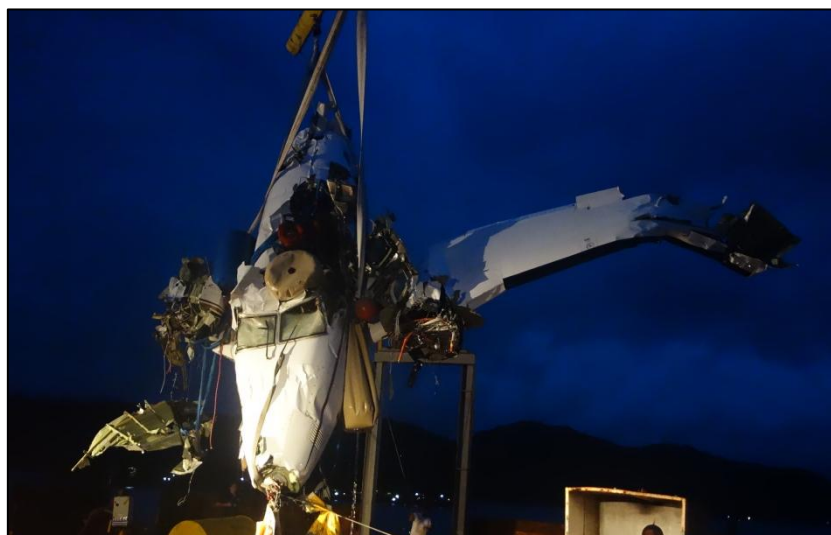
The damages observed on the left side of the fuselage were manually made during rescue operations.

Figure 1 - Condition of the aircraft at the time of lifting.

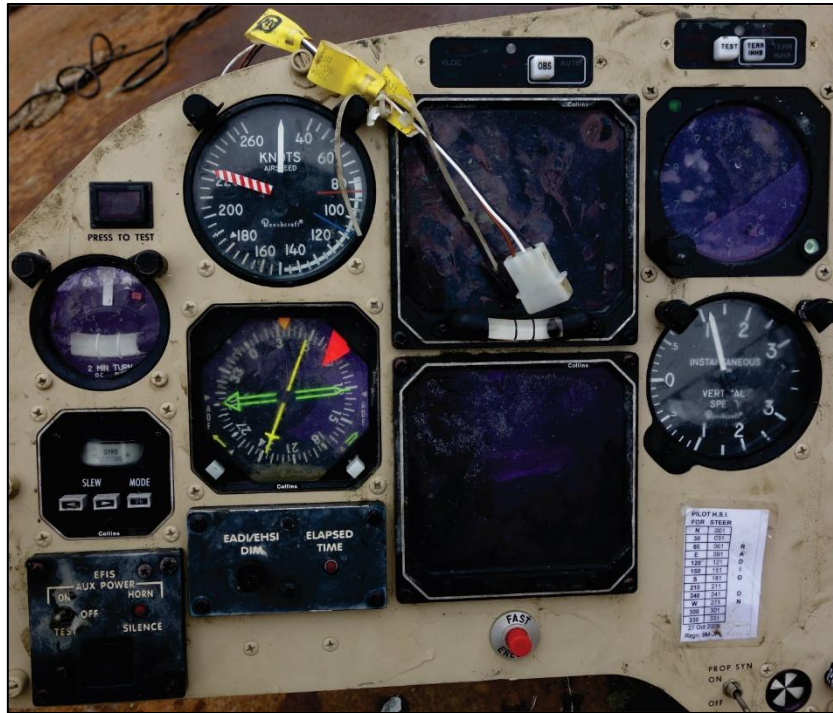
It was found that the Instrument panel of the left station had no damage due to the impact of the aircraft (Figure 31).

The propeller synchronization switch (PROP SYN) was in the OFF position.

Figure 31 - Left-hand station instrument panel.

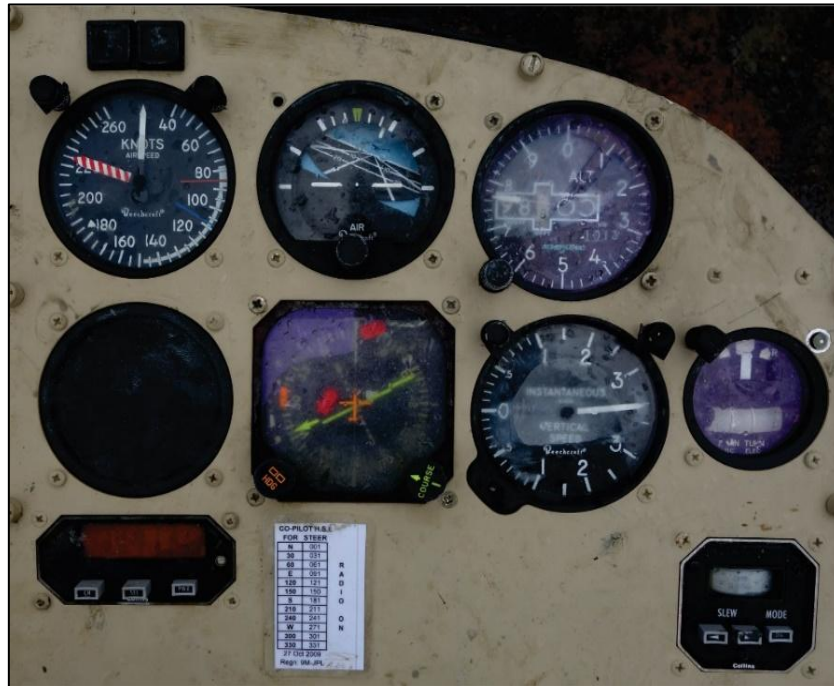
On the instrument panel of the right station (Figure 32), it was found that, similar to the panel of the left station, the airspeed indicator and the VSI had no readings indicating the aircraft's flight parameters at the time of impact.

The HSI indicated the magnetic bow corresponding to 030°.

Figure 32 - Right-hand station instrument panel.
