COMANDO DA AERONÁUTICA
CENTRO DE INVESTIGAÇÃO E PREVENÇÃO DE
ACIDENTES AERONÁUTICOS

FINAL REPORT
A-036/CENIPA/2020

OCCURRENCE:	ACCIDENT
AIRCRAFT:	PR-SPI
MODEL:	AS-350 B2
DATE:	09MAR2020

This is the Final Report of the 09 March 2020 accident with the AS-350 B2 aircraft, registration marks PR-SPI. The occurrence received the typification of “[CTOL] Collision with an obstacle during takeoff and landing”.

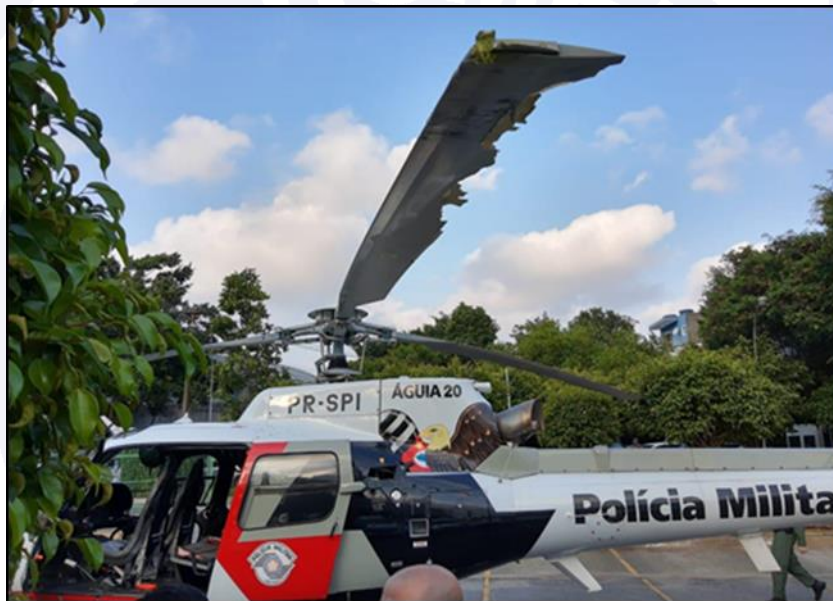
Figure 1 - View of the damage sustained by the PR-SPI at the accident site.

The aircraft sustained substantial damage to the mast, blades and main-rotor head.

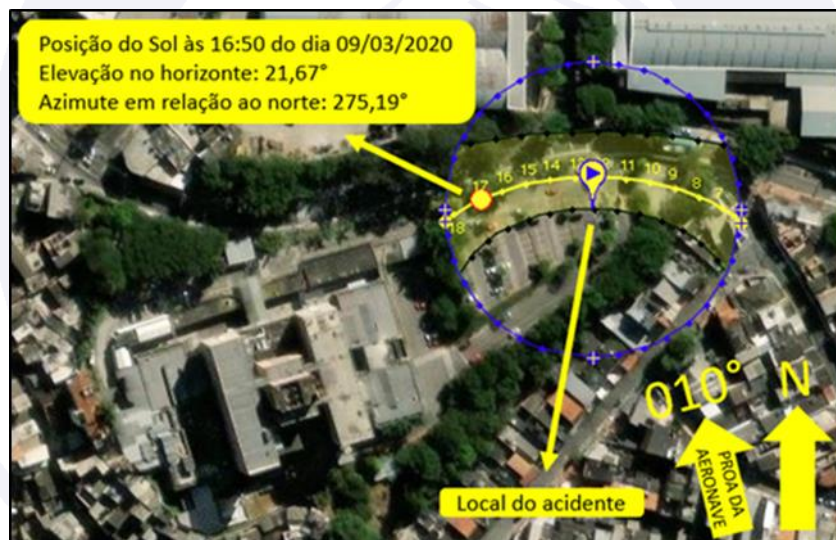
On the day of the accident, the sunset was forecast for 21:28 UTC, and the accident occurred around 19:50 UTC. The position of the sun in relation to the aircraft at the time of the accident was approximately 21° above the horizon in the azimuth 275° (Figure 2).

Figure 2 - Position of the sun at the time of the accident (the numbered arc represents the hours of the day and the respective position of the sun in relation to the accident site).

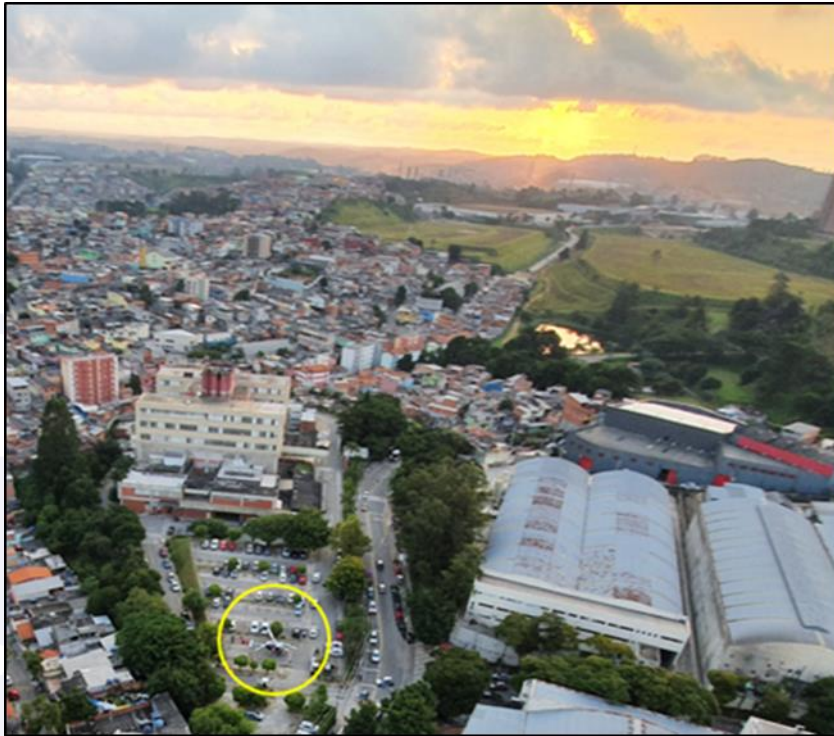
Figure 3 shows the position of the sun in relation to the aircraft (highlighted with a circle in yellow). This aerial photograph was taken in the area of the accident, moments after it had occurred.

Figure 3 - Aerial photograph of the sun's position taken moments after the accident.

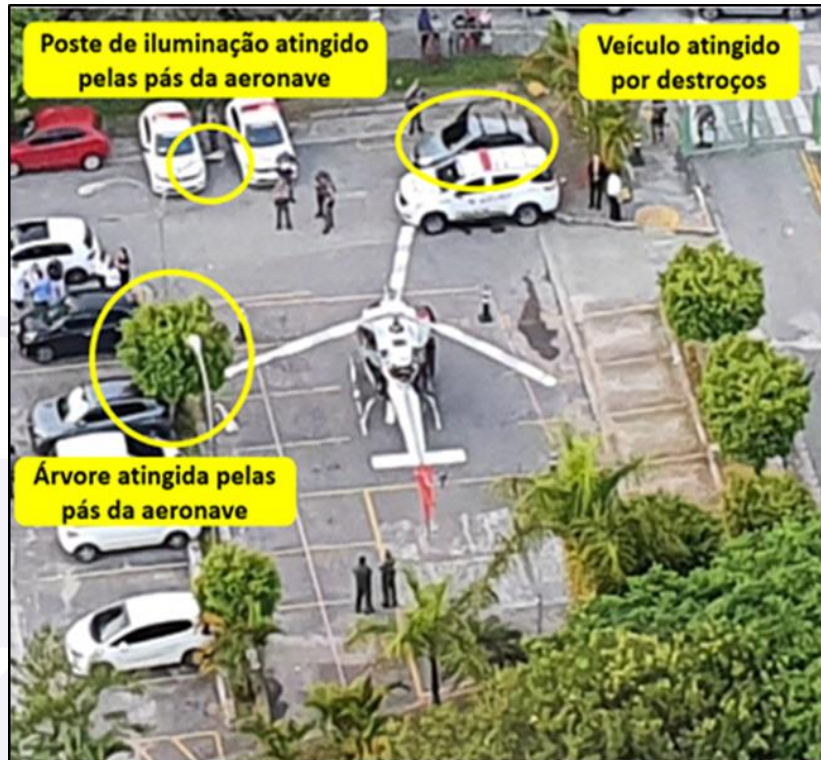
The main rotor blades collided with one of the lampposts, and all three of the blades were substantially damaged. Debris from the impact hit two passersby and a vehicle parked near the landing site (Figure 4).

Figure 4 - Accident spot and objects hit by the aircraft and its debris.

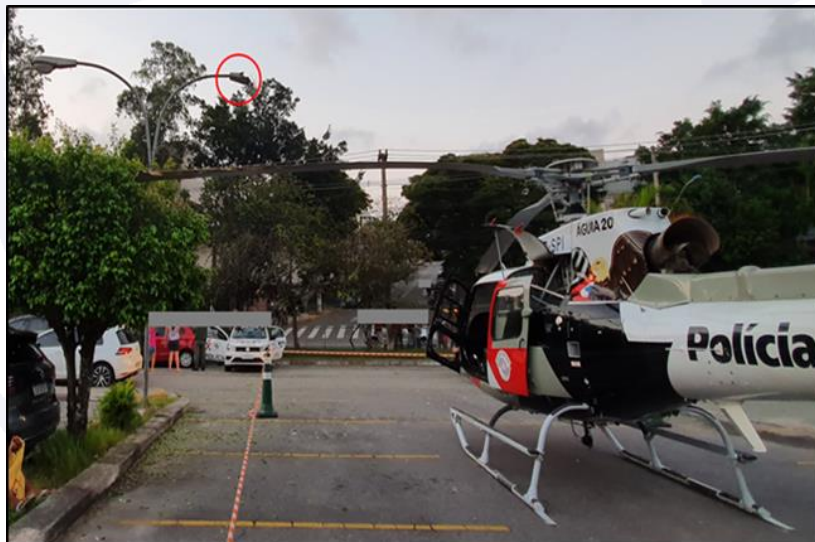
After the impact, the PIC managed to keep control of the aircraft in flight. Subsequently, the SIC took over the aircraft controls and decided to reposition the aircraft for another landing attempt. In this second attempt, the main rotor blades collided with a tree located immediately next to the affected lamppost (Figure 5).

Figure 5 - View of the PR-SPI, after collision with the public lamppost and the tree.

After the collision with the lamppost, the SIC took over the flight controls and quickly landed the aircraft, without comprehensive guidance from the crew, making the helicopter's main rotors collide with a small tree located to the left of the aircraft.

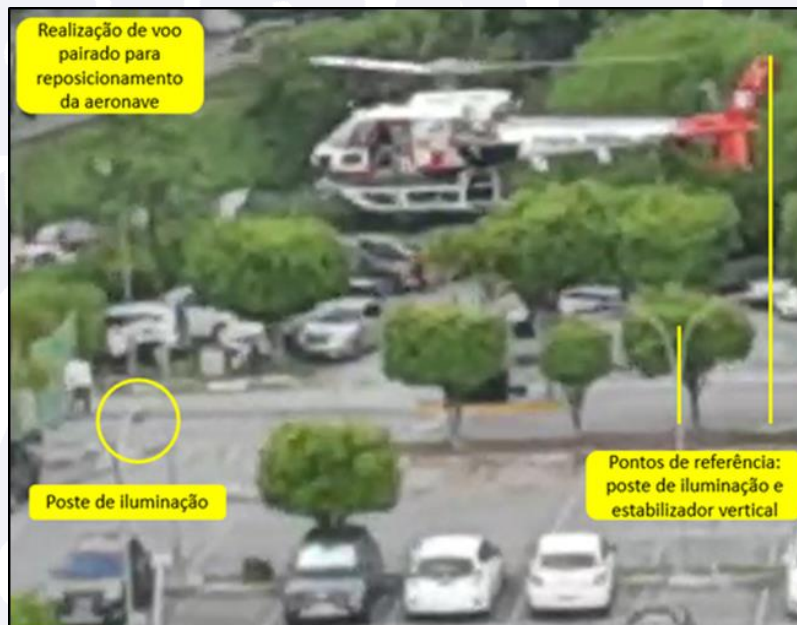
By means of video images recorded by an observer, it was possible to notice a forward movement concomitantly with a vertical descent when the helicopter was overhead the intended landing site (Figures 7 and 8).

Figure 7 - Image of the PR-SPI captured as it was hovering outside of ground effect.

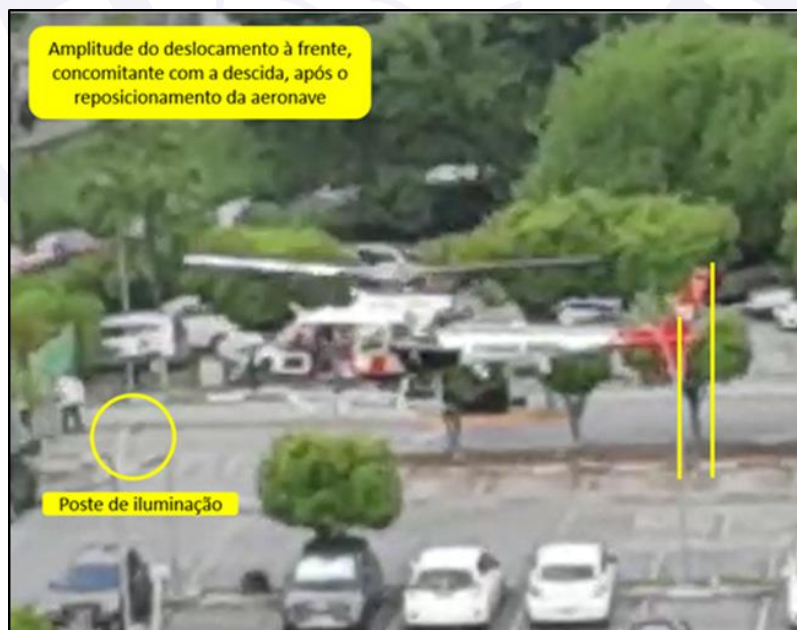
Figure 8 - Moment subsequent to the previous image, referencing the forward displacement in relation to the terrain. Source: Image captured from video provided by an observer of the accident.

At the moment depicted in Figure 8, the PIC was carrying out a more prolonged hovering flight, in which there was cabin coordination to check the position of the lamppost located in the left-hand front sector of the aircraft.

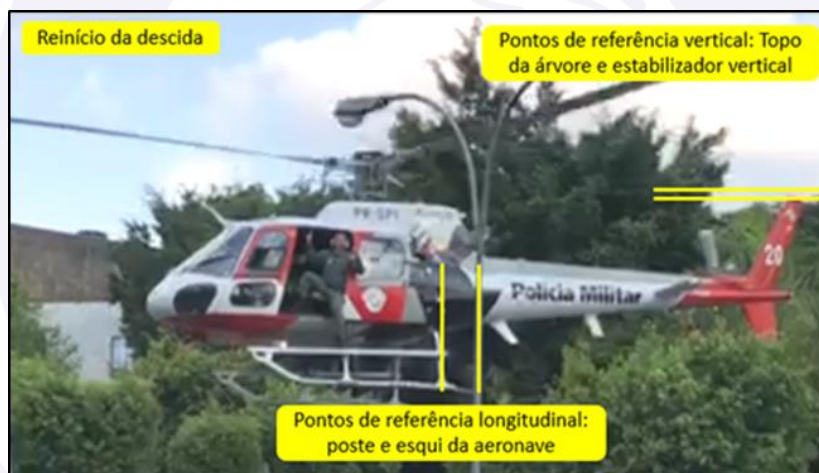
Figure 9 shows the moment at which the PIC restarted descent after having performed a prolonged hover and after the crew performed cabin coordination relative to the positioning of the aircraft in the restricted area. The crewmember on the left-hand side was looking at the obstacle.

Figure 9 - Restart of descent. Source: Video image captured by an observer of the accident.

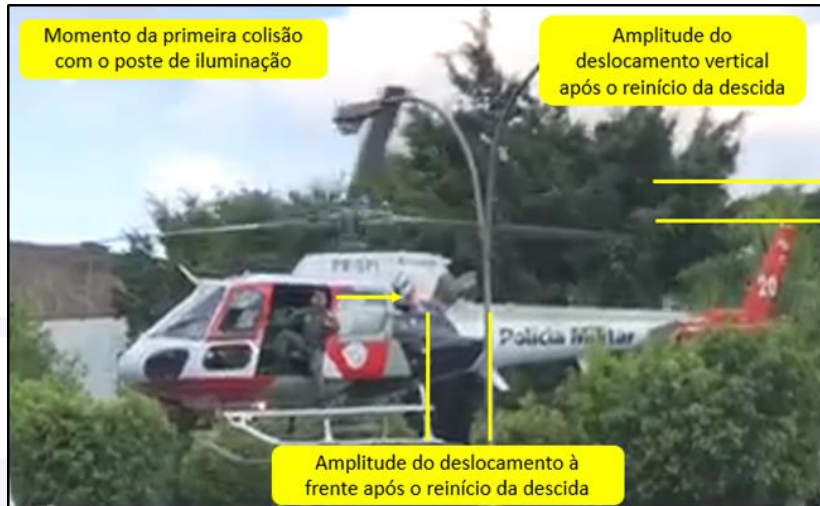
Figure 10 shows, just seconds after the preceding image, the exact moment of the first collision of the main rotor against the lamppost. The figure depicts the forward movement of the aircraft and the crew member's gaze at the tail of the aircraft at the moment of the impact.

Figure 10 - Precise moment of the first collision of the main rotor against the lamppost.
Source: Image captured from video provided by an observer of the accident.

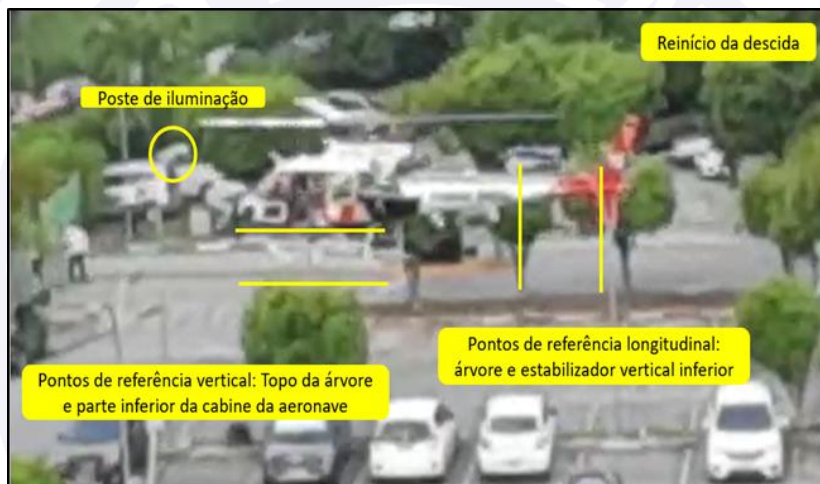
From the perspective of another camera located at the hospital, Figure 11 shows the moment in which the PIC performed a prolonged hover, and the crew did the cockpit coordination on the position of the aircraft in the restricted area.

Figure 11 – Moment at which the PIC was performing a prolonged hover. Source: Image captured from a video provided by an observer of the accident located at the hospital.

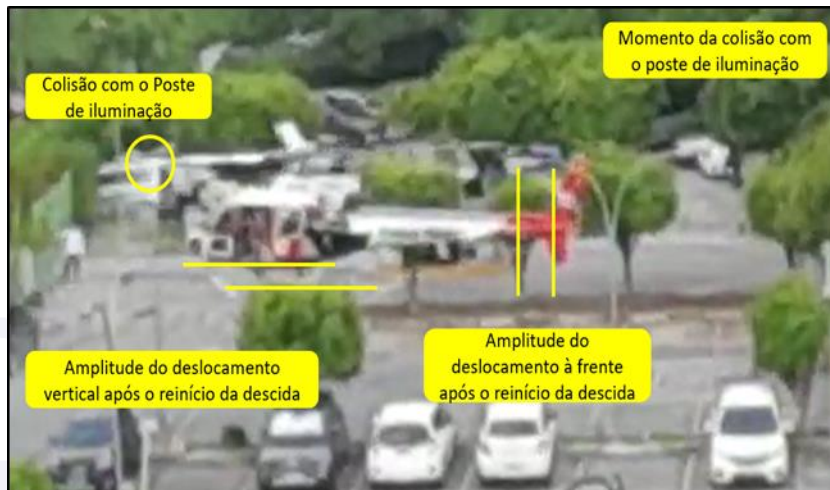
Figure 12 also shows the moment of the collision of the main rotor blades against the lamppost.

Figure 12 - Moment of collision of the main rotor with the lamppost. Source: Image captured from video provided by an observer of the accident located at the hospital.

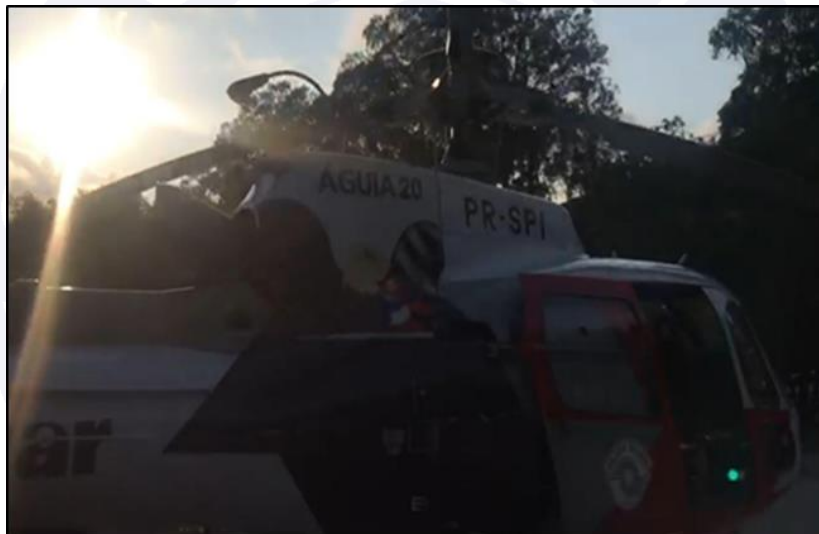
Shortly after the accident, a video was recorded where one can see that the sun was positioned on the left-hand forward sector in relation to the aircraft (Figure 13).

Figure 13 - Position of the sun relatively to the aircraft, immediately after the accident.

It is worth mentioning that the position of the sun in relation to the aircraft at the time of the accident may have influenced the perception of the TOE when looking at the lamppost. The sun was approximately 21° above the horizon and to the left of the aircraft, a condition that may have generated a false perception of the obstacle's depth for the TOE and/or a possible glare condition for his eyes.
