FINAL REPORT
IG - 505/CENIPA/2021

OCCURRENCE:	SERIOUS INCIDENT
AIRCRAFT:	PR-SSK
MODEL:	A109E
DATE:	20FEB2011

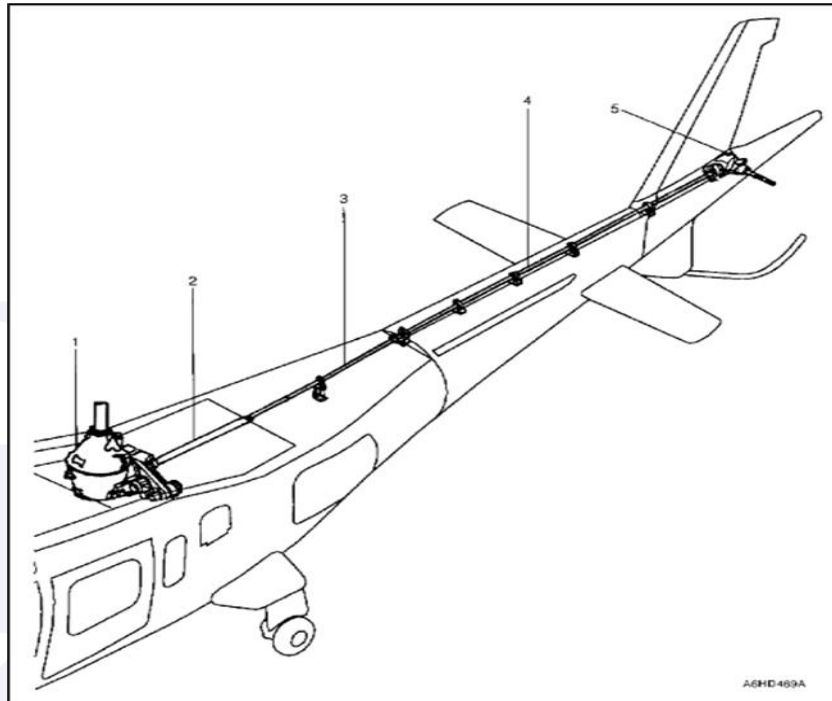
Figure 1 - Tail rotor drive system components: (1) Main Transmission; (2) Forward Section; (3) Middle Section; (4) Long Section and (5) 90° Gearbox.

In this case, the failure occurred at the end of the Long Section, where the adapter was installed. The adhesive was not able to maintain the rigidity of the fixture and allowed the shaft to rotate in relation to the adapter, also causing the pin to split.

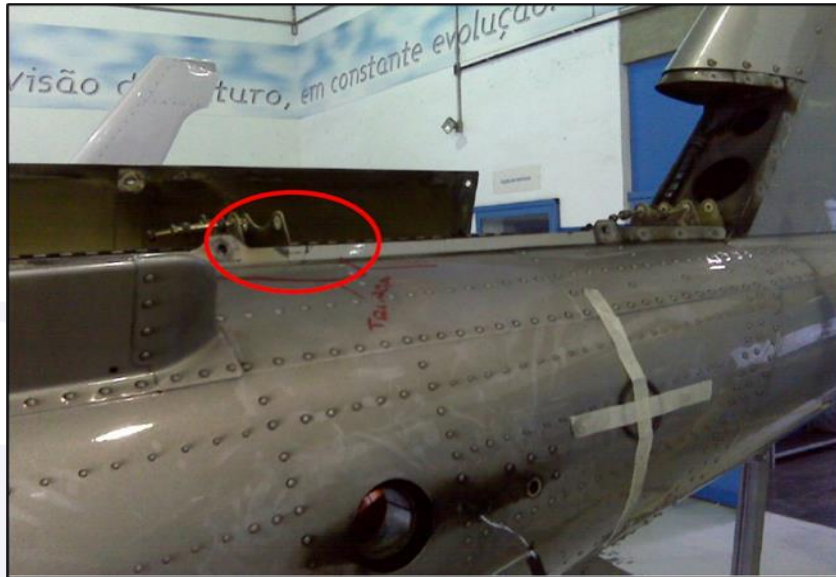
In November 2009, with the aircraft at 1.608 hours and 48 minutes and 8.825 cycles, during the second inspection of 800 hours, which took place at the facilities of the Maintenance Organization (OM) AgustaWestland do Brasil (AWdB) - manufacturer representative, damage to the Tail Boom, below the support of bearing nº 4 of the tail rotor drive shaft was identified (Figures 2 to 5).

Figure 2 - Tail Boom region where the crack was found.

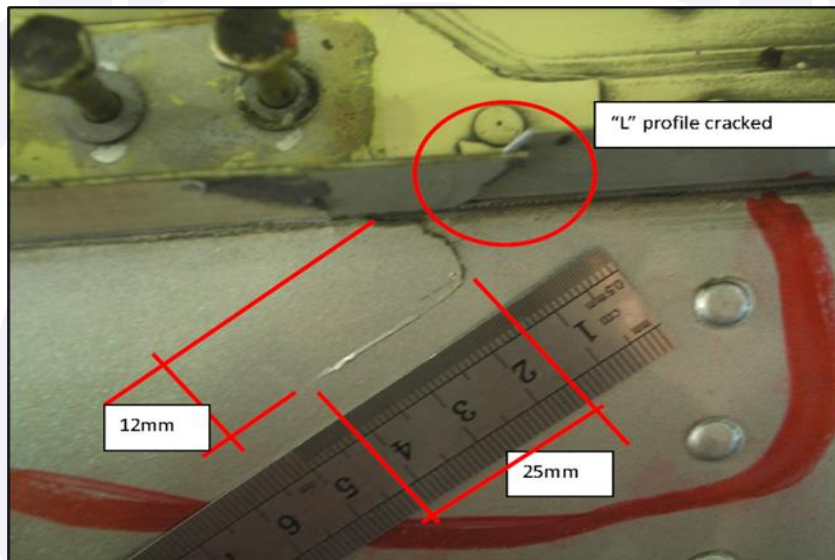
Figure 3 - "L" profile and cracked tail boom surface.

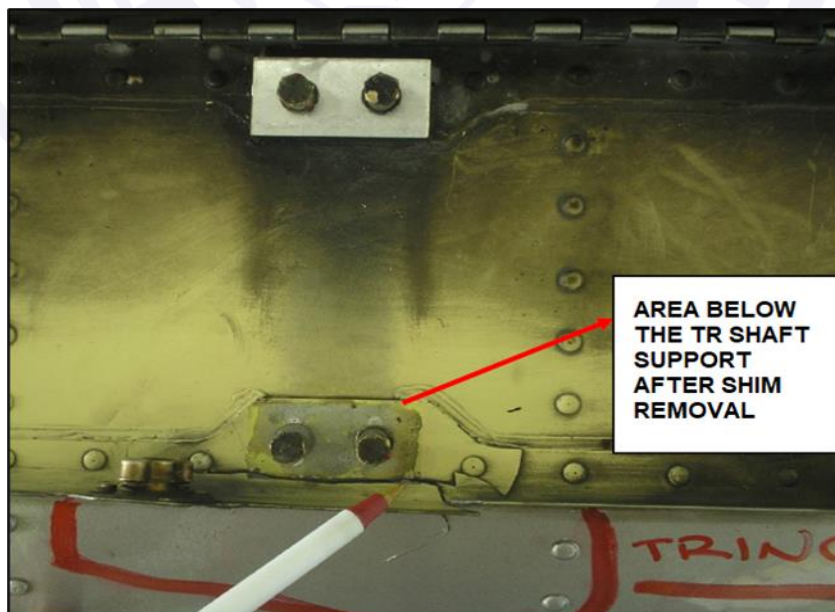
Figure 4 - Crack located below the tail rotor drive shaft support.

During the investigation of the noise's origin, the mechanics identified that it came from the friction between the parts of the crack below the support of bearing n° 4, and it was not possible to determine the beginning of the crack or the time of its propagation.

Thus, it was concluded that the cracks on the surface of the Tail Boom, in the region of bearing nº 4, allowed an unforeseen movement of the support, which may have allowed an orbital movement of the shaft.

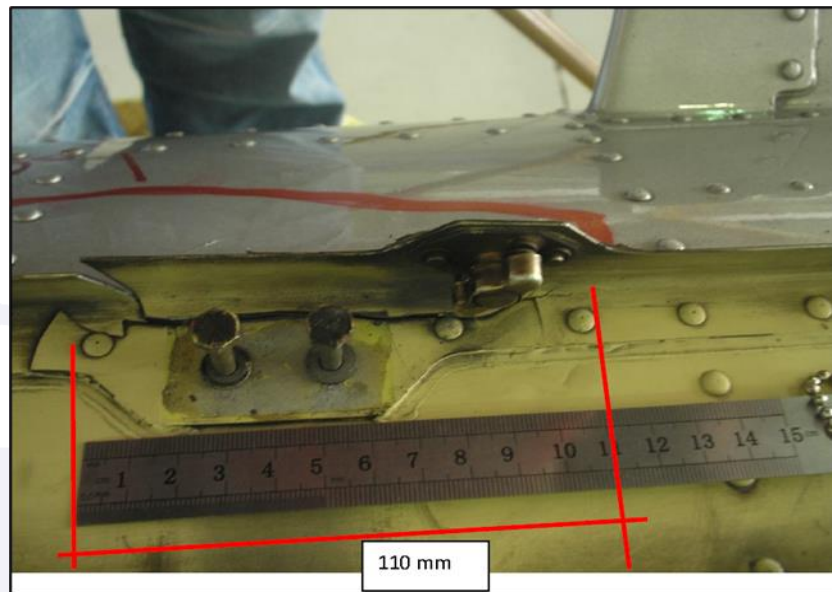
Figure 5 - Crack length along the longitudinal axis.

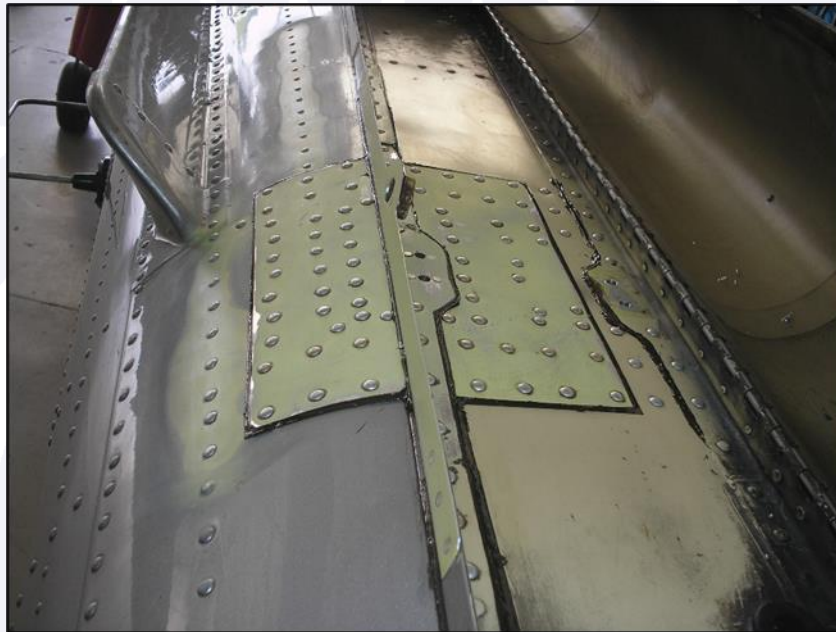
Figure 7 - Repair performed in accordance with the manufacturer's authorization.

It is important to mention that section 4-2-26 of the SRM was developed for a typical repair on the Tail Boom surface and not for a region where the tail shaft bearing support was fixed and, also, the mentioned repair did not foresee the cutout of the plate where there was the crack.

The repair procedure prevised in the SRM consisted of placing a plate above and another below the crack, as shown in Figures 6 and 7.

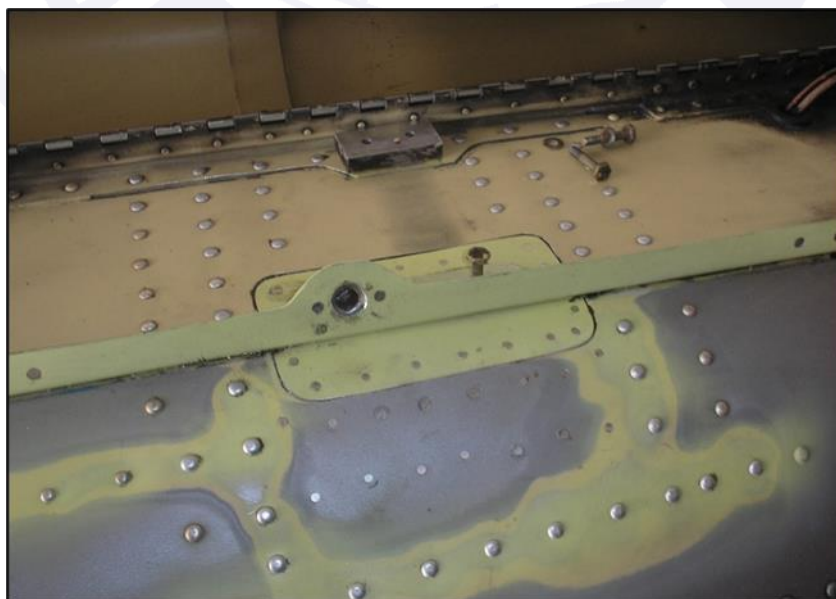
Figure 8 - Image of the external view of the redone repair.

This type of repair was initially followed by maintenance and, later, it was redone, cutting the damaged area and replacing part of the sheet. No documentation was presented authorizing the modification of the procedure that had been previously agreed between the OM and the manufacturer, nor was this recorded in the aircraft's records.

The service was likely redone due to the repaired area being located exactly where the support was supported, thus making axle alignment difficult, due to the unevenness caused in the Tail Boom surface.

Among other procedures, a cut was made on the surface of the Tail Boom, which was replaced by a new metal plate (Figures 8 and 9).

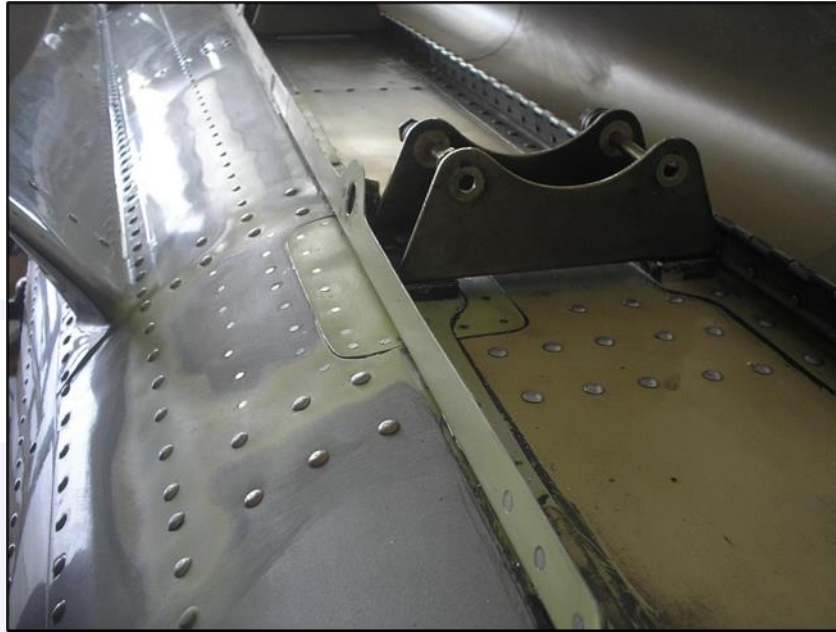
Figure 9 - Repair modified by maintenance.

It is also possible that, after the alignment service performed during the Tail Boom repair, the plate installed to replace the area with the cracks had worked, moving and misaligning the support nº 4.

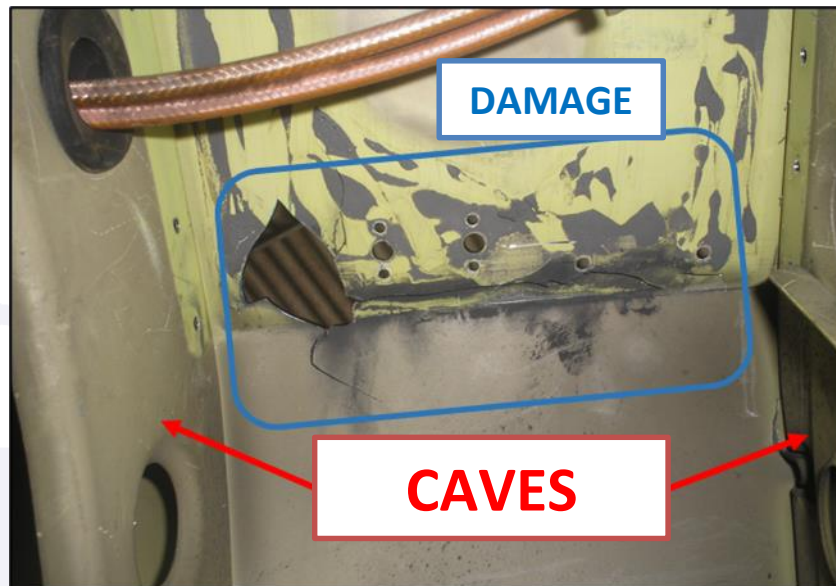
In the event, the fissure boundary was less than 20 mm from two of the Tail Boom caves (Figures 11 and 12).

Figure 11 - Internal image of the Tail Boom showing the damage, highlighting the position of the caves.

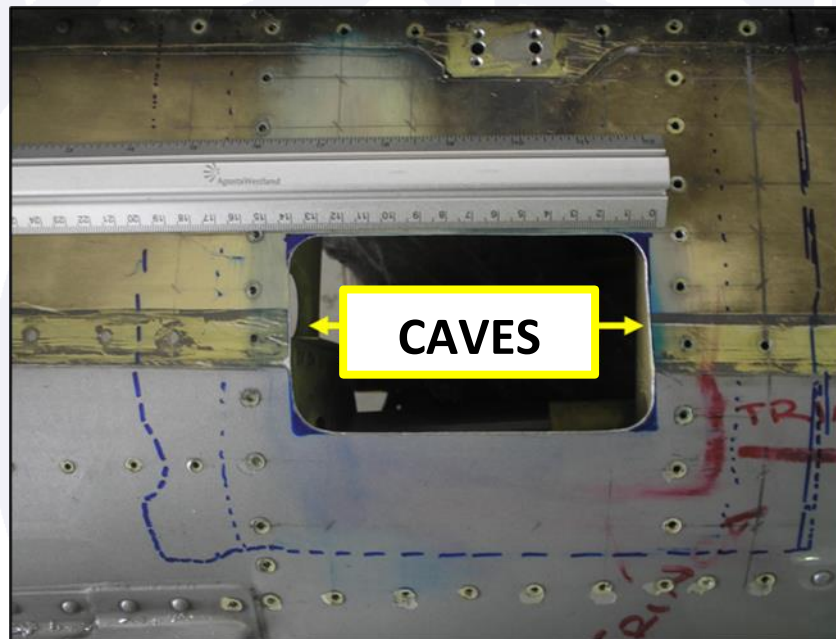
Figure 12 - Image of the cutting in the Tail Boom, highlighting the position of the caves.

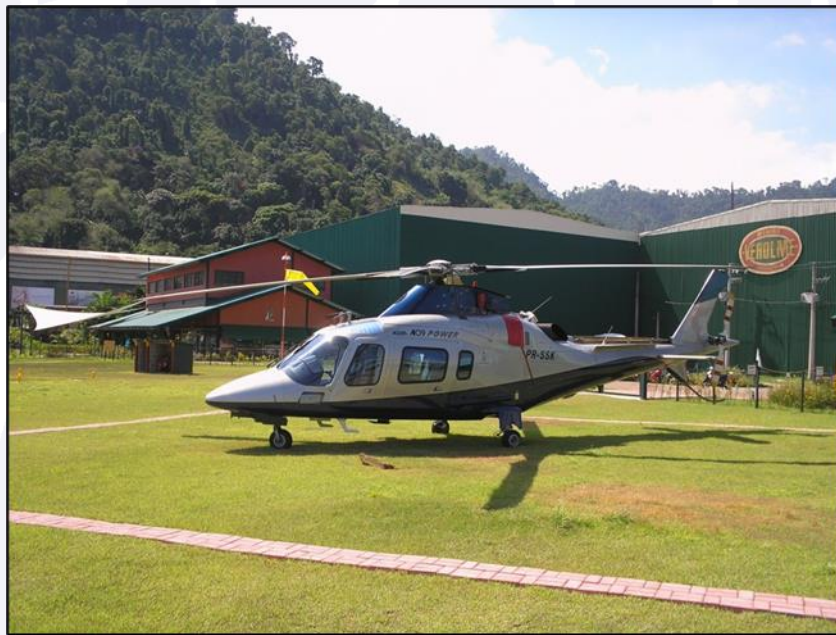
The damage to the aircraft was restricted to the internal parts of the tail rotor drive shaft, without the visual presentation of wreckage (Figure 13).

Figure 13 - Aircraft after the occurrence.

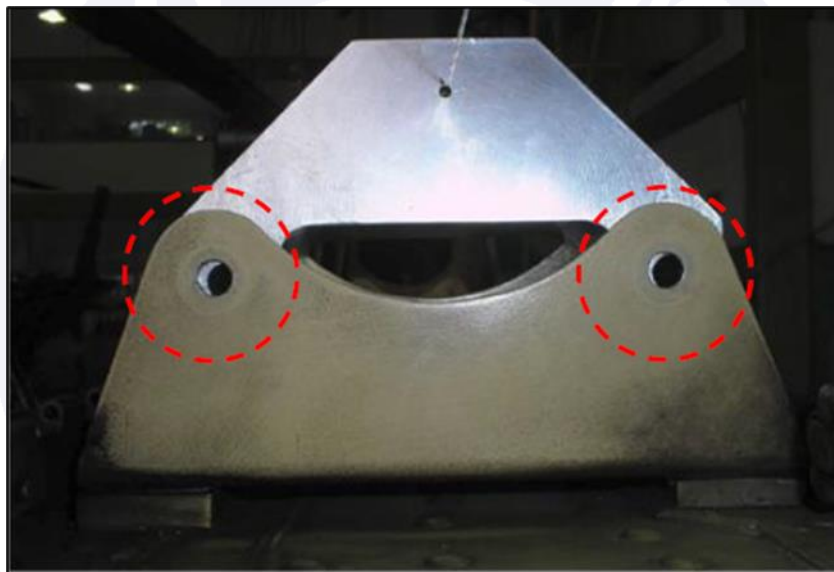
On 02MAR2011, a check of alignment of the Tail Boom supports was carried out. Bearing support n°4 was found to be 1 mm out of alignment, despite having been aligned in November 2009 (Figure 14).

Figure 14 - Bearing support n°4 out of alignment.

On that occasion, a discrepancy in the torques applied to the support screws was observed, which were approximately twice the predicted value of 20 to 25 lb/in².
