COMANDO DA AERONÁUTICA
CENTRO DE INVESTIGAÇÃO E PREVENÇÃO DE
ACIDENTES AERONÁUTICOS

FINAL REPORT
A-015/CENIPA/2021

OCCURRENCE:	ACCIDENT
AIRCRAFT:	PR-STO
MODEL:	A188B
DATE:	01FEV2021

This Final Report refers to the 01 February 2021 accident with the A188B aircraft, registration marks PR-STO. The occurrence was typified as “[SCF-PP] Engine failure or malfunction | Engine failure in flight.”

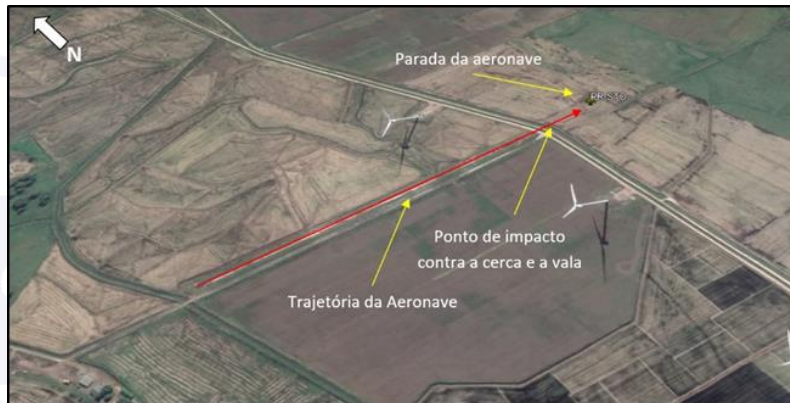
The aircraft impacted a fence located past the departure end of the runway, during takeoff. Subsequently, the aircraft's left-hand wing collided with a ditch (Figures 1, 2 and 3).

Figure 1 - Aircraft takeoff croquis.

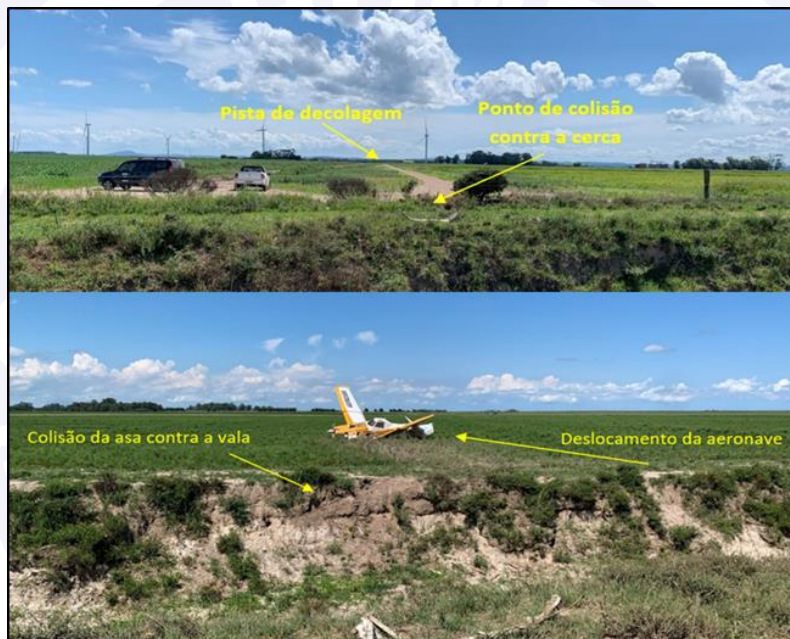
Figure 2 - Points of impact.

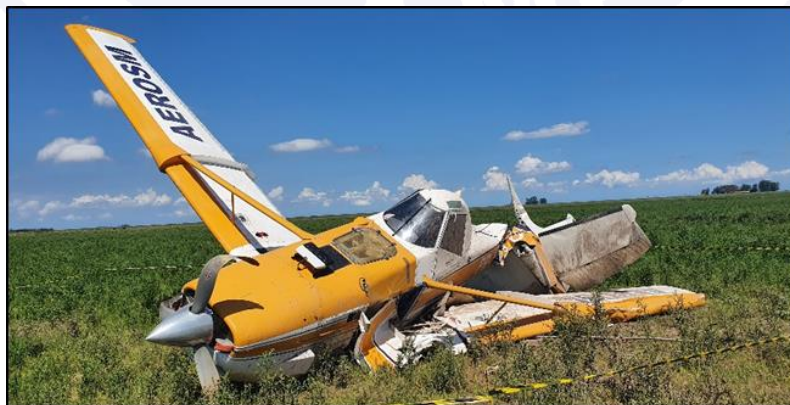
Figure 3 - Final position of the aircraft after the collision with the fence and the ditch.

After the second impact, the aircraft rotated 90° counterclockwise relatively to the axis of the airstrip, skidding for approximately 115 m before coming to a complete stop.

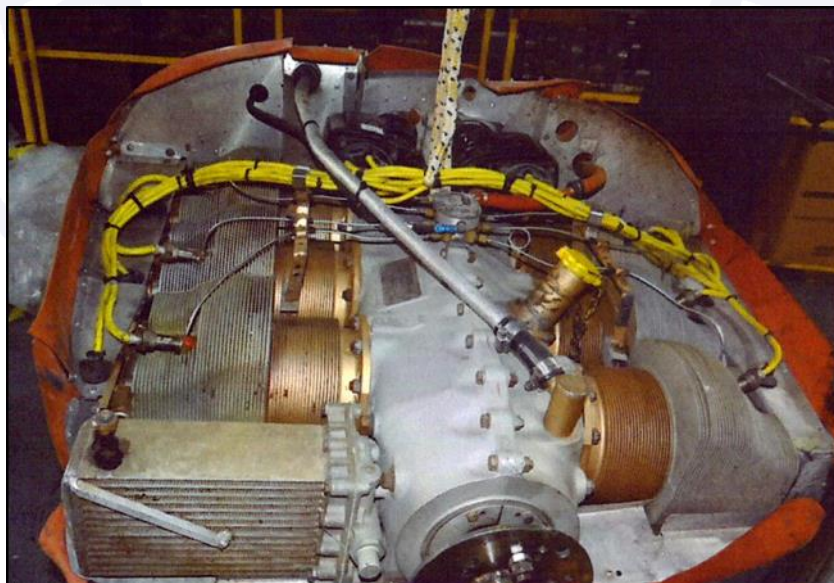
Initially, one observed that the engine had not sustained severe damage resulting from the accident (Figure 4). Even when the engine was turned, one found that it was not stuck. However, due to some dents and deformations that prevented verification on a test bench or in another similar aircraft, the engine was subject to disassembly for analysis of its internal parts.

Figure 4 - View of the engine from above.

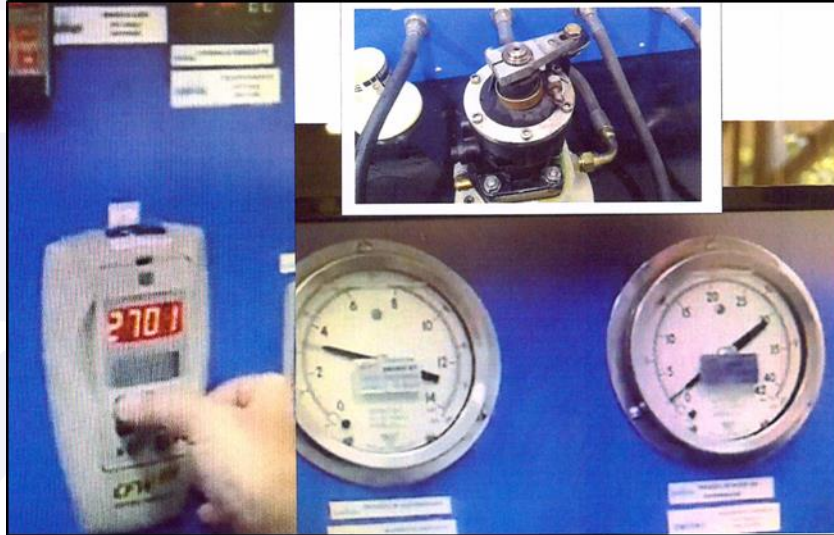
The propeller governor underwent test on the bench. Upon adjusting it at 2,700 RPM, the pressure gauge on the right-hand side indicated normal internal leakage, that is, within the limits of acceptance (Figure 5).

Figure 5 - Propeller governor test at 2,700 RPM. The pressure gauge on the right-hand side indicated normal internal leakage.

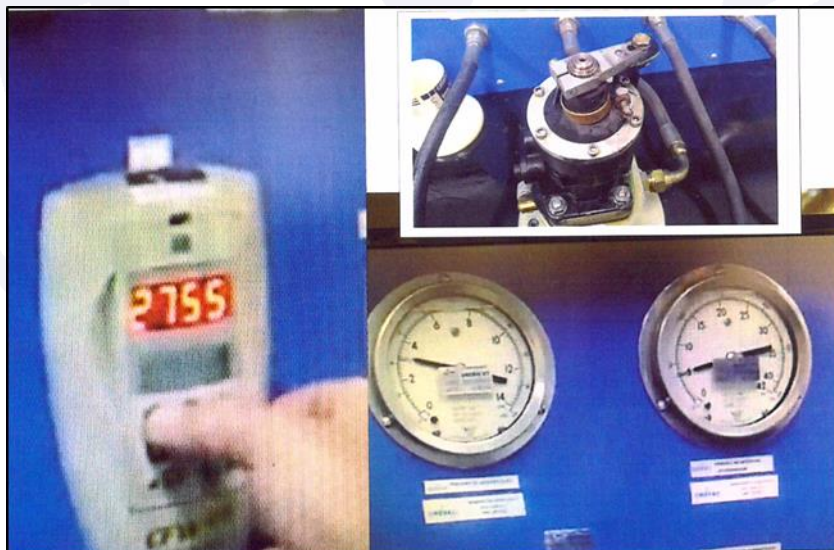
However, upon adjusting the governor to a value of 2,755 RPM, the pressure gauge on the right-hand side indicated maximum internal leakage, exceeding the acceptance standards, showing that the equipment was releasing oil at an RPM value that was 100 RPM lower than the one expected.

Fig. 6 - Propeller governor test at 2,755 RPM. The right-hand side pressure gauge indicated maximum internal leakage, with an RPM value of approximately 100 RPM below the expected one.

However, according to verification, such discrepancy would not result in loss of power either during or after takeoff.

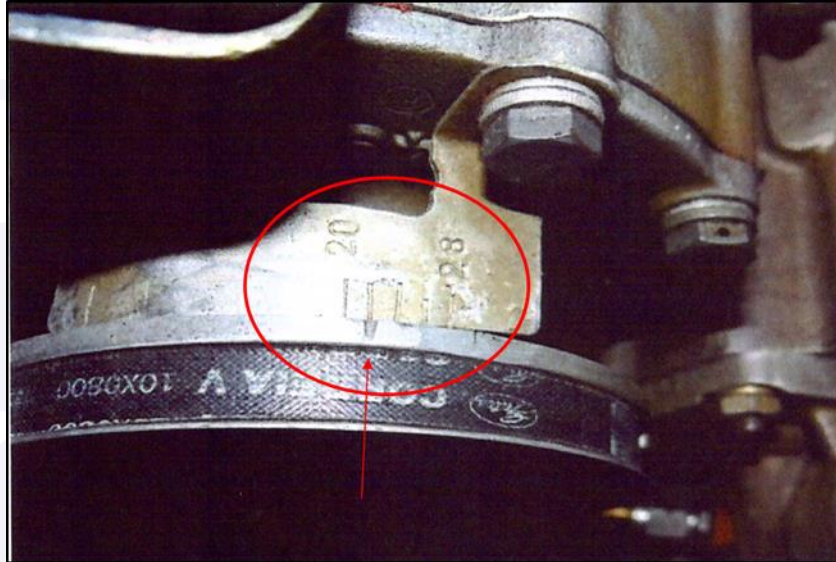
According to the engine identification plate, the timing light, corresponding to the operation of the two magnetos, should illuminate at the mark of 22° before the top dead

center. This angle would be the correct one specified by the manufacturer for the spark from the spark plugs to start burning the air/fuel mixture.

Figure 7 - Marking on the rear pulley with 22° as per the ignition advance engraved on the engine identification plate. At this marking, the timing light should illuminate.

The timing plate on the rear of the engine shown in the pictures. Continental has a service bulletin that is obsolete (M84-8) recommending it being removed because the starter adapter had to be timed when installed. If not, the information could be inaccurate. I noticed the Timing note was way outside the specification. The photo showed them using the plate.

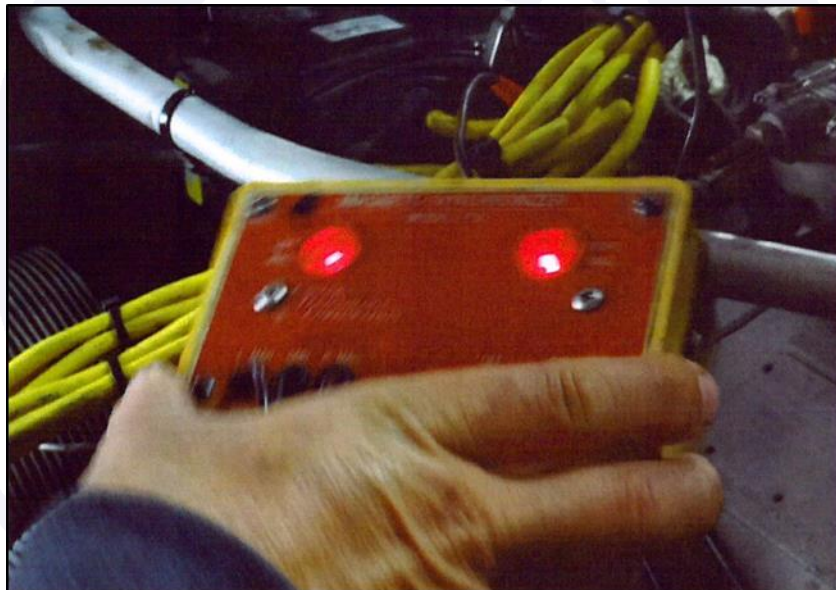
During the analysis with the equipment, one verified that the initial ignition advance (*calibration of the magnetos*) was correct; however, the magnetos sparking occurred around 14° after the top dead center of the piston, as shown in Figures 7 and 8.

Figure 8 – Moment at which the timing light came on, with the ignition advance marking approximately 14° after the top dead center.

Such fact indicated that the burning of the air/fuel mixture was starting with the piston moving towards the bottom dead center.

As a general rule, the consequences of the discrepancies would be loss of engine power, increased exhaust temperature, and possible damage to the exhaust valve over time.

The sparking at the 14°- position after the top dead center indicated that the burning of the mixture occurred when the piston was already moving towards the bottom dead center. This could cause loss of power, increase the exhaust temperature and, over time, damage the exhaust valve.

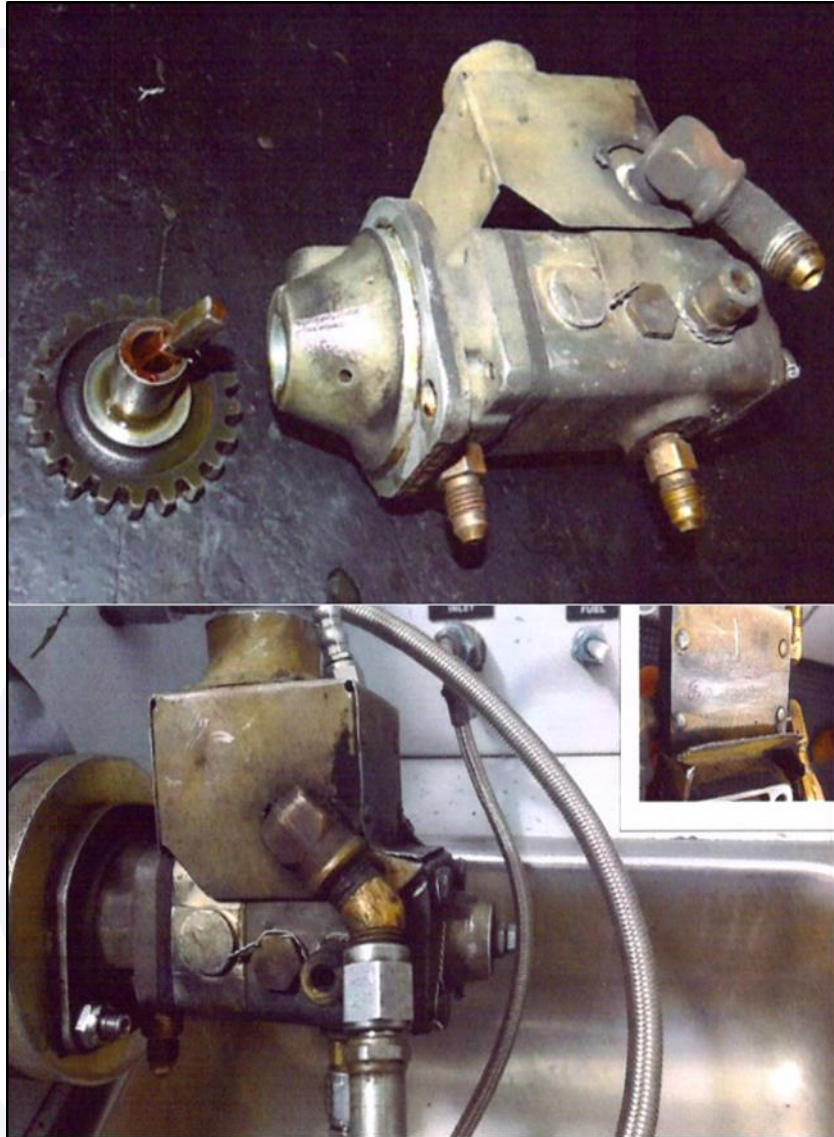
The analysis of the fuel pump demonstrated that it was intact and without damage. Thus, the referred pump was subject to bench tests, as shown in Figure 9.

Figure 9 - (Above) View of the fuel pump and intact accessories.
(Below) View of the fuel pump on the test bench.

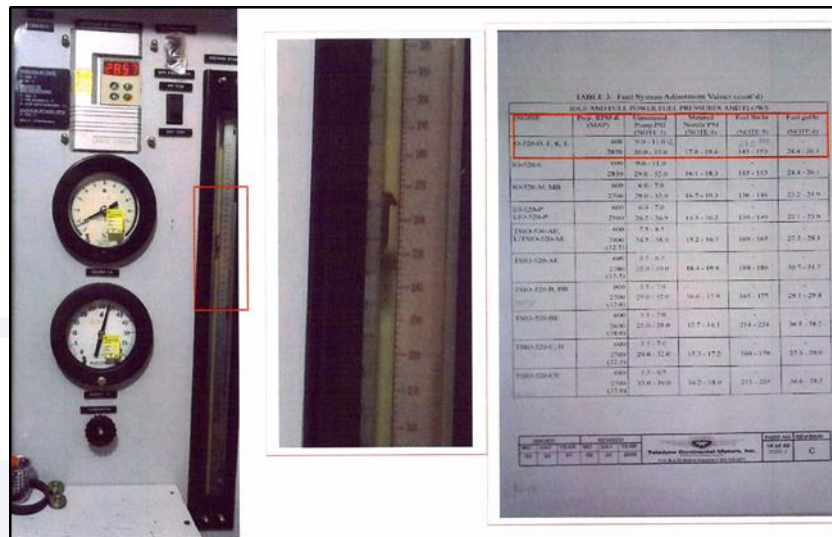
During the analysis of the pump on the bench, the rotameter indicated a flow rate of 270 PPH, well above the one specified for the engine model, while the maximum limit would be 153 PPH (Figure 10).

Considering normal flow rates for the operation, one found that this excess fuel could cause a loss of power or even engine shutdown.

Figure 10 - (Left) Fuel pump test; (Center) Rotameter indicating the flow obtained in the test; and (Right) Table 3 of the engine manual showing the fuel system flow-settings.

would be 153 PPH. Regarding these values, it is known that excess gasoline driven by the fuel pump can cause a loss of power or even engine shutdown.

Work with *Aerovaley Manutenção e Comércio de Aeronaves Ltda*, so that the referred organization demonstrates to possess and to apply all the necessary resources for the adequate provision of maintenance services on Cessna A188B aircraft, and on Continental IO-520 -D engines, as recommended by the legislation in force, the respective technical manuals, and the company's List of Capabilities.
