**COMANDO DA AERONÁUTICA**  
**CENTRO DE INVESTIGAÇÃO E PREVENÇÃO DE**  
**ACIDENTES AERONÁUTICOS**

**FINAL REPORT**  
**A-020/CENIPA/2022**

<b>OCCURRENCE:</b>	<b>ACCIDENT</b>
<b>AIRCRAFT:</b>	<b>PR-TAR</b>
<b>MODEL:</b>	<b>AT-502B</b>
<b>DATE:</b>	<b>09FEV2022</b>

This is the Final Report of the 09 February 2022 accident involving the AT-502B aircraft of registration marks PR-TAR. The accident was typified as “[CTOL] Collision with obstacle during takeoff and landing”.

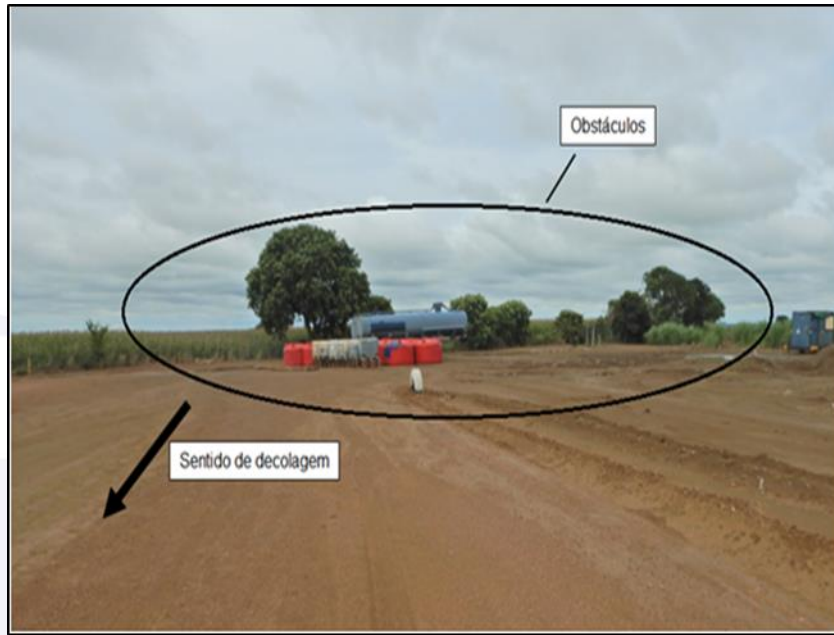
The airstrip for agricultural aviation use had a length of 1,100 m and, in relation to the gradient, there was an elevation difference of approximately 3 m between the thresholds. According to the PIC, takeoffs were always performed from the lower to the higher threshold (positive gradient), due to the presence of obstacles near the lower threshold, and landings were made in the opposite direction.

Figure 1 - Obstacles near the threshold used for takeoff.

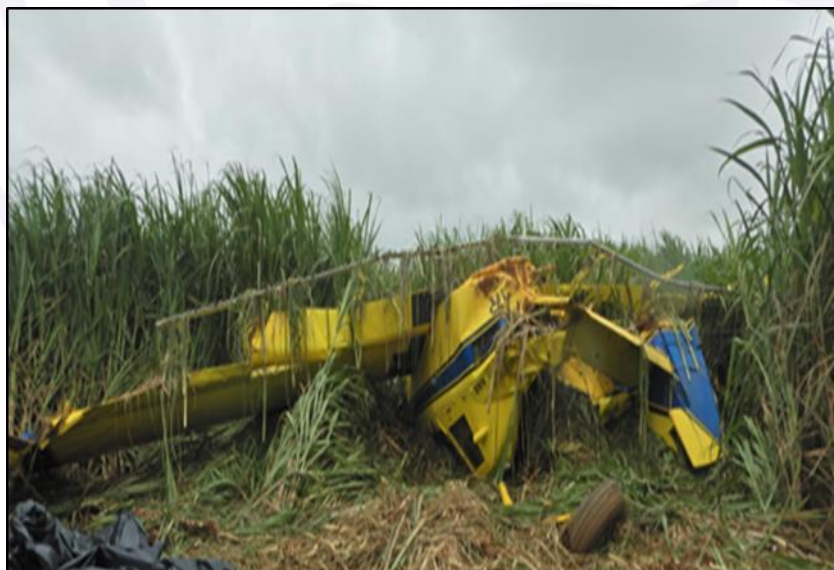
The landing gear, propeller, vertical stabilizer, horizontal stabilizer, elevator, and rudder of the aircraft were destroyed.

The aircraft suffered substantial damage to the fuselage, wings, flaps, ailerons, and to most of its structure.

The aircraft flew approximately 150 m after getting airborne, maintaining a height of approximately 5 ft. above the terrain. Such height that was not sufficient for the aircraft to fly over the sugarcane plantation lying ahead. The airplane initially hit the crop with the main landing gear wheels and the spray bar, returning to the ground and travelling for about 100 m in contact with the plantation, after which it flipped over and rotated 180° in relation to its original direction of flight before coming to a complete stop (Figure 2).

Figure 2 - Final position of the aircraft.

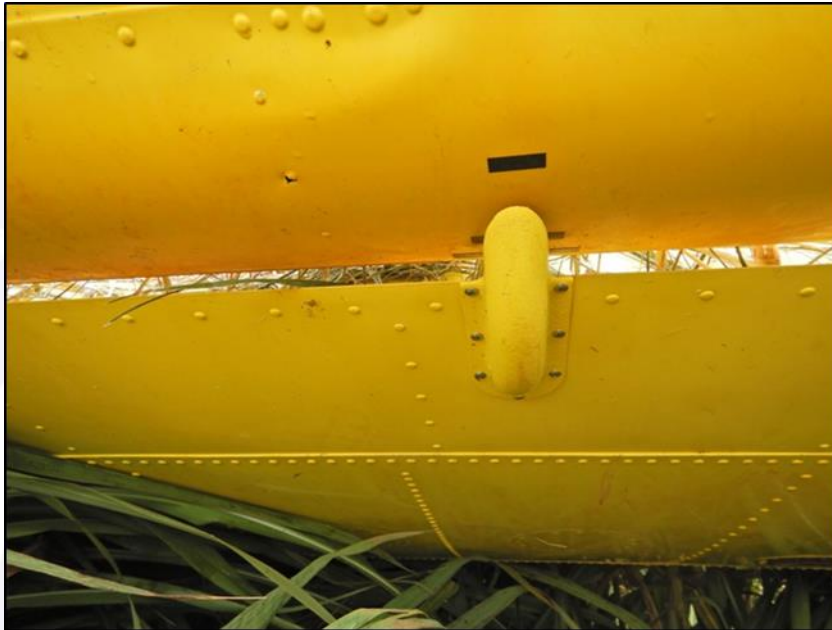
The Investigation Committee found that it had rained heavily the previous day and in the early morning of the day of the occurrence. According to a report from the PIC, the ground surface was wet and this condition was evident in the maneuvers of the aircraft on the ground, for example, during the backtracking on the airstrip, the "aircraft moving with difficulty and skidding". Despite these conditions, the airplane took off with flaps at 10° (Figure 3).

Figure 3 - Indication of the position of the flaps, at the accident site, in an intermediate position between 10° and 20°.

Furthermore, the PIC reported that he had performed a normal takeoff (with flaps positioned at 10°, without holding the aircraft with the brakes at the departure runway threshold during the application of power) and that the wind had changed direction. Therefore, since the takeoff configuration was not in accordance with the parameters prescribed by the manufacturer, there was not a way to ensure that the aircraft's takeoff performance would correspond to the one expressed in the Takeoff Distance table, a fact that compromised the aircraft performance issue even further.

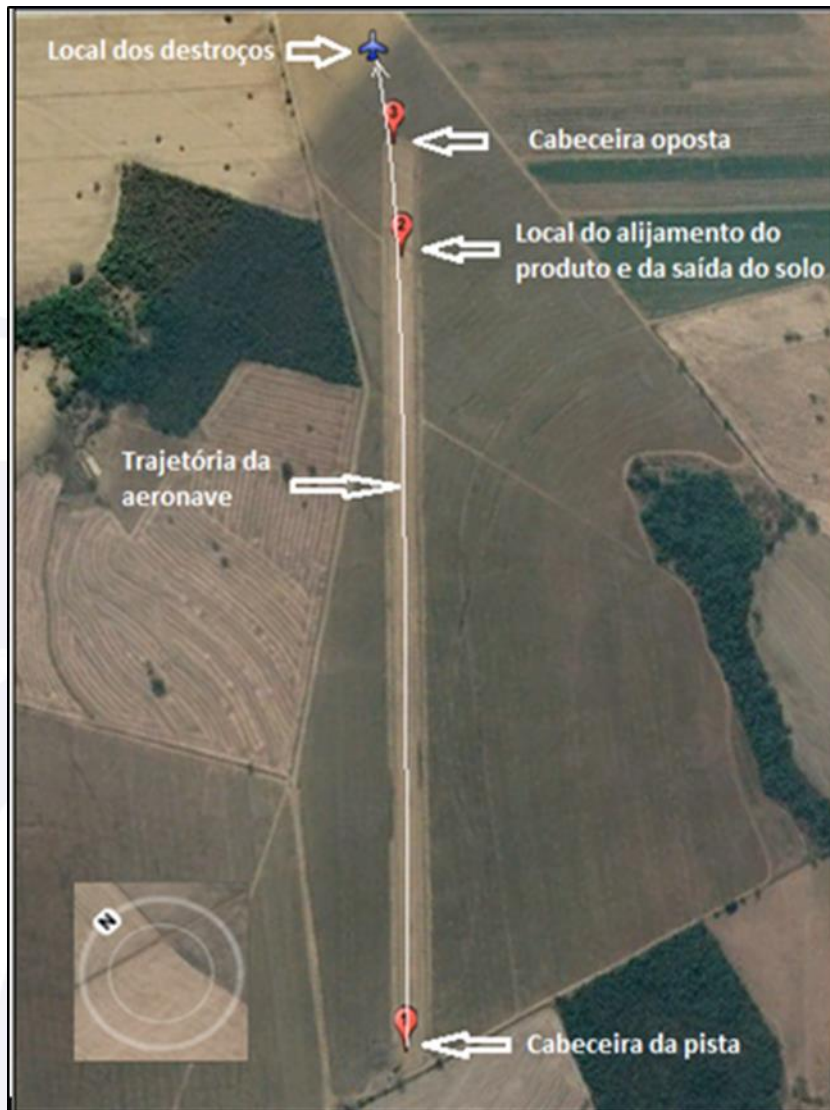
The PIC reported that he, subsequently, jettisoned the agricultural product and finally managed to get off the ground after having traveled approximately 1,000 m on the airstrip. The aircraft left the ground precariously, destabilized and unable to gain altitude, losing the takeoff axis to the left, crossing the departure end with approximately a 5-degree lateral offset (Figure 4).

Figure 4 - Trajectory of the accident aircraft until coming to a complete stop.
