**COMANDO DA AERONÁUTICA**  
**CENTRO DE INVESTIGAÇÃO E PREVENÇÃO DE**  
**ACIDENTES AERONÁUTICOS**

**FINAL REPORT**  
**A - 002/CENIPA/2021**

| <b>AIRCRAFT:</b> | <b>PR-TCE</b> |
| <b>MODEL:</b> | <b>PA-25-235</b> |

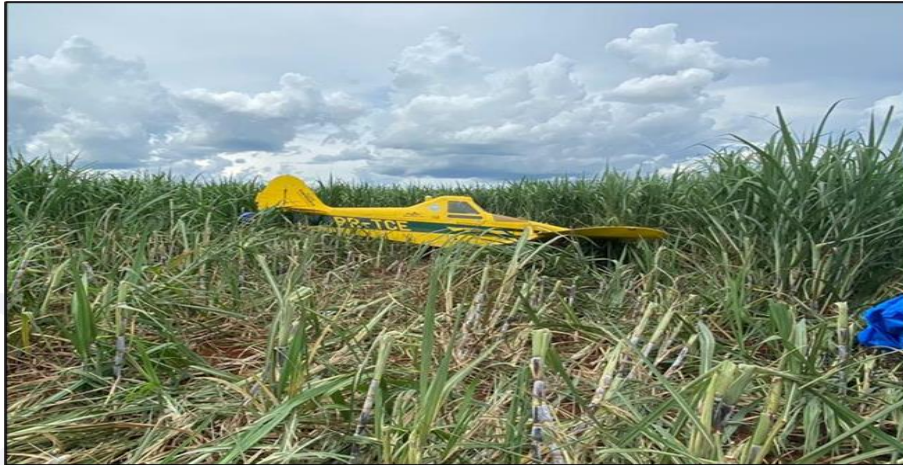
The aircraft had substantial damage to the propeller, engine, lower fuselage, both wings and the landing gear.

After touching the ground, the aircraft traveled around 10 meters, turning approximately 90 degrees to the right with the approach axis.

Figure 1 - Side view of the aircraft after impact.

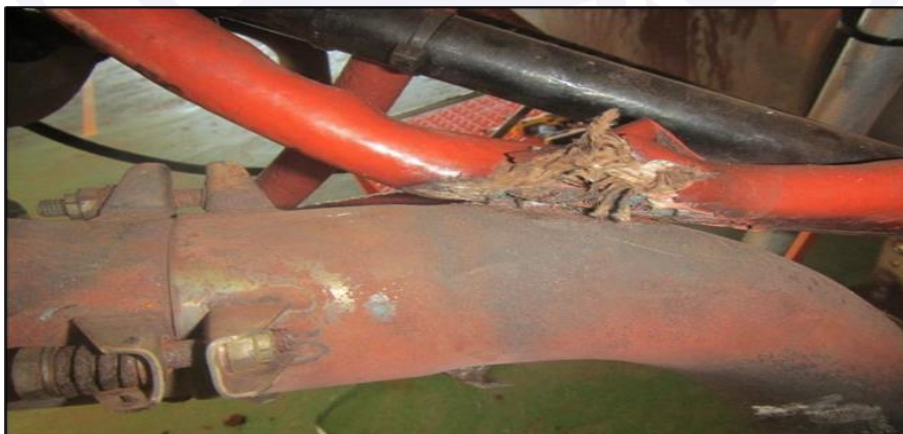
During the beginning of the analysis of the powerplant, soon after removing the seals, it was observed that the electrical wiring of the engine, where the cables of the starter engine and magnetos were located, was leaning against the exhaust pipe on the left side. It showed deterioration in its protection and internal components due to friction and heating, as shown in Figure 2.

Figure 2 - Damaged engine electrical wiring, leaning against the exhaust.

According to the analysis presented, the damage observed in the electrical wiring of the engine deteriorated by friction and heating, and the contact of the magnetos wiring with the exhaust, caused the magnetos to be grounded inadvertently and, consequently, the engine shutdown during flight.

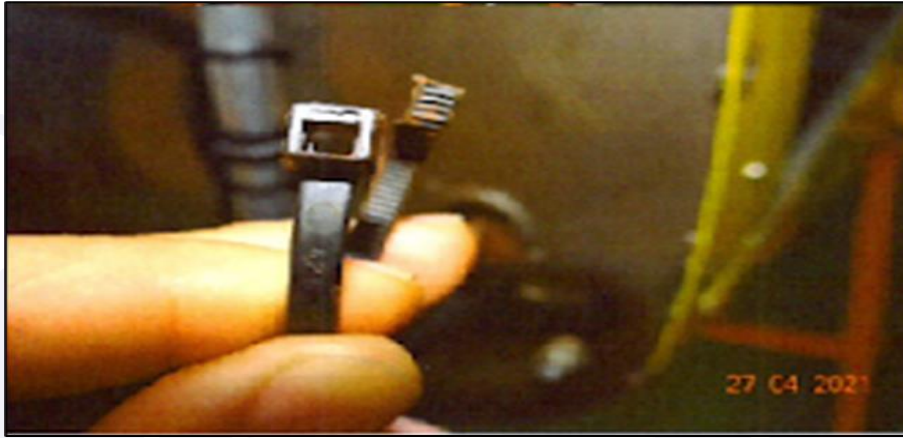
It was found that the electrical cabling would be attached to the engine cradle through a general-purpose plastic clamp without contact with the exhaust. The aforementioned plastic clamp was with the latch lock damaged and loose, yet still next to the engine cradle (Figure 3).

Figure 3 - Plastic clamp found on the engine cradle with the broken latch.

The plastic clamps that fixed the electric cabling to the engine cradle were considered inadequate, since they are fragile and get loose over time due to the vibration of the powertrain, leading to the possibility of this type of occurrence.

The use of plastic clamps to secure the electric cables to the magnetos and starter engine, which are susceptible to early deterioration from friction and heating, allowed them to come into contact with the exhaust ducts, causing inadvertent grounding of the magnetos and engine failure.

However, good aeronautical maintenance practices recommend that the fastening of electrical cables in the engine area, on the structure or cradle of the engine, should be done with metal clamps, fixed with screws and self-braking nuts, or that can be braided with stainless steel braiding wire.

The OM Tangará Aero center Ltd. performed maintenance on the other aircraft of the same model, operated by Aeroagrícola Chapadão Ltd., in order to improve the attachment of the cables to the engine cradle with the use of metal clamps.

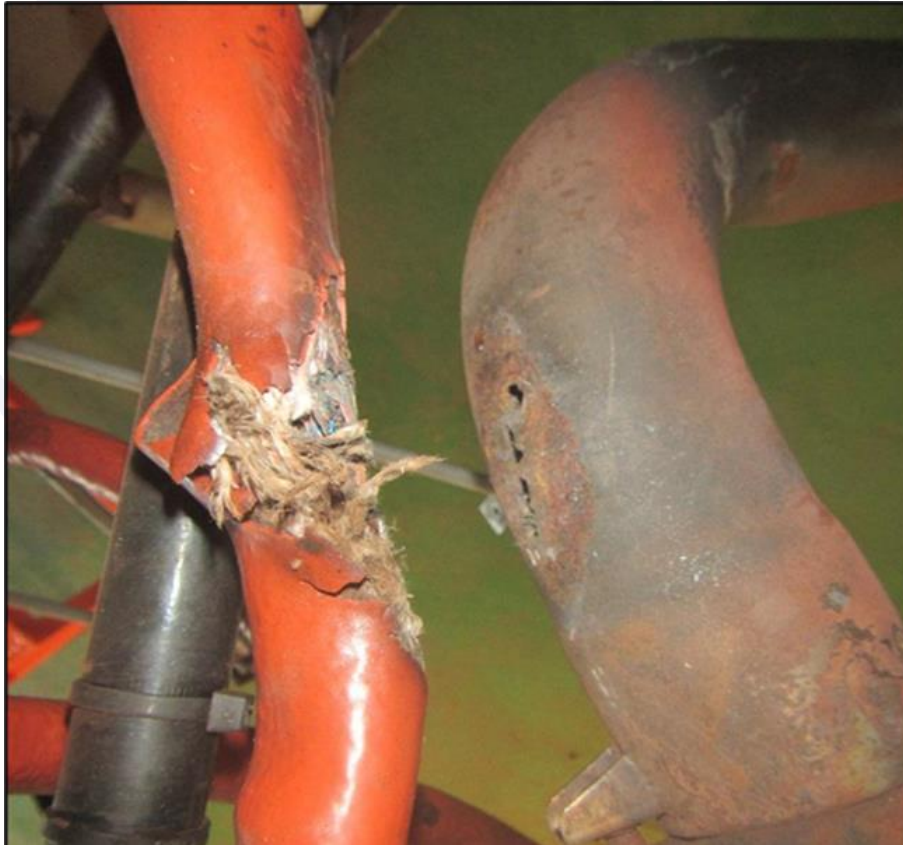
In this condition, the electrical cabling started to touch the engine exhaust, the heat and friction generated by its operation caused the damage observed in the cabling and in the exhaust itself (Figure 4).

Figure 4 - Damage generated in electrical cabling and exhaust.

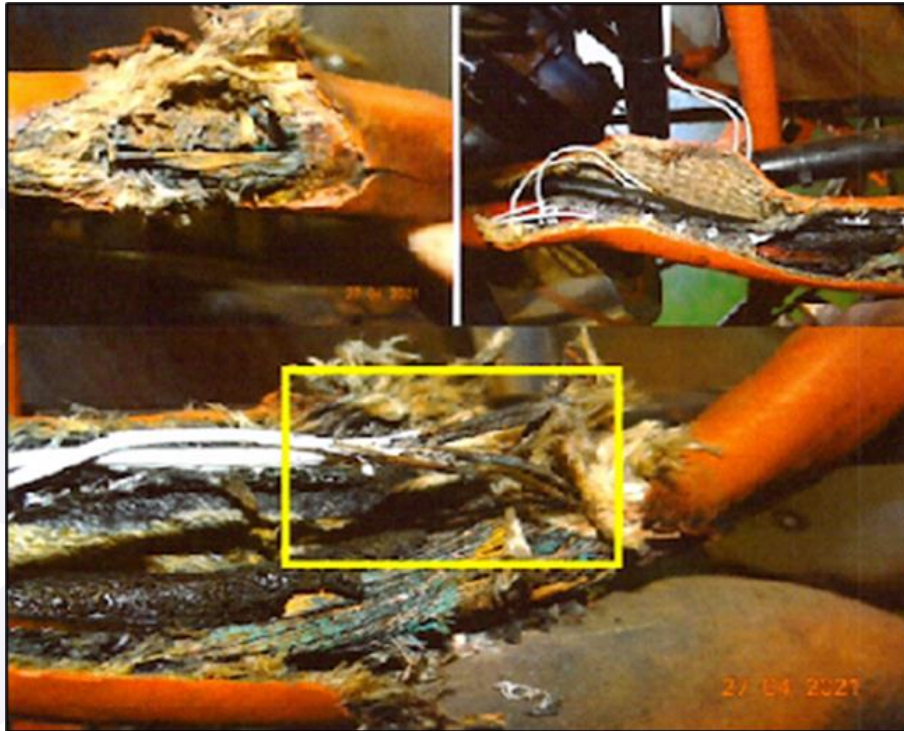
Digging deeper into the analysis, the wiring harness was opened, and the grounding wires of the magnetos were found to be damaged by heat-related melting (Figure 5).

Figure 5 - View of the inside of the damaged electrical wiring exposing the magneto ground wires, damaged by melting.

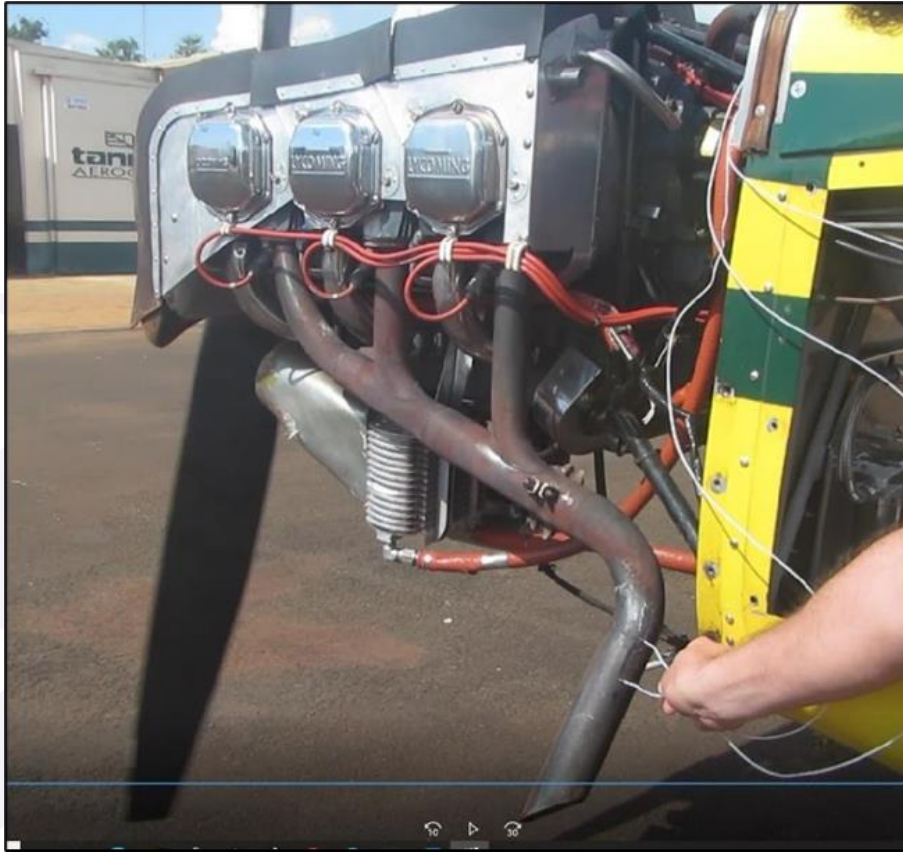
In the next step, the grounding wires of the magnetos were intentionally placed in contact with the structure of the aircraft's exhaust, simulating the discrepancy found at the beginning of the analysis, which resulted in the engine shutting down. (Figure 6).

Figure 6 - Ground wires of the magnetos being pressed against the exhaust, causing the engine to shut down.
