COMANDO DA AERONÁUTICA
CENTRO DE INVESTIGAÇÃO E PREVENÇÃO DE
ACIDENTES AERONÁUTICOS

FINAL REPORT
A - 053/CENIPA/2017

OCCURRENCE:	ACCIDENT
AIRCRAFT:	PR-TTH
MODEL:	ATR-42-500
DATE:	21MAR2017

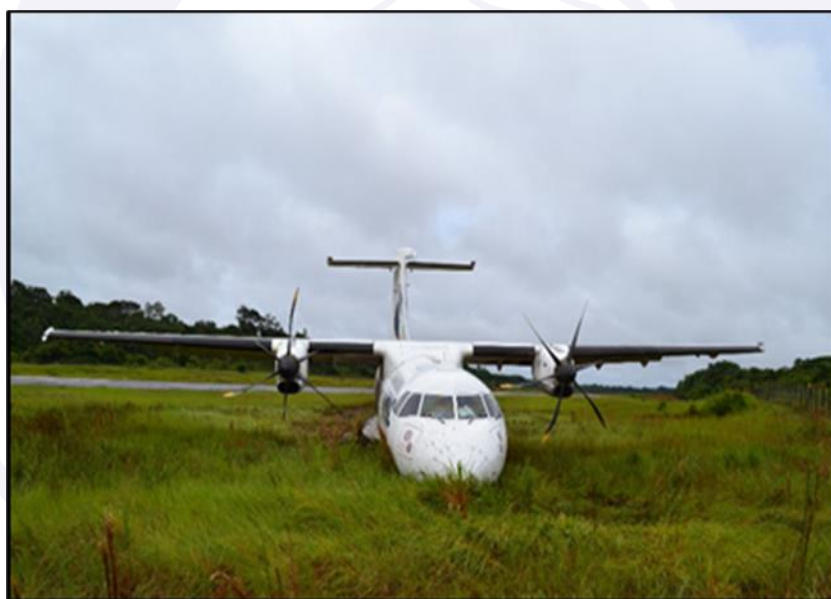
Figure 1 – Aircraft after the occurrence.

The aircraft had substantial damage. The most significantly affected parts were: the propeller and powerplant on the right side; the nose and main landing gears and the fuselage, mainly in the lower part of the forward sections.

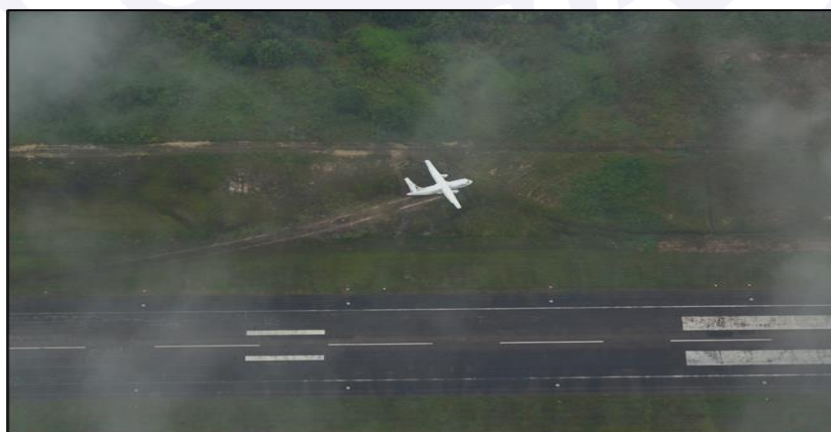
After leaving the runway, the aircraft traveled about 180m in a side area covered by grass. The aircraft stopped at a lateral distance of 60m from the center of the runway.

Figure 24 - Top view of the trajectory traveled by the aircraft on the ground.

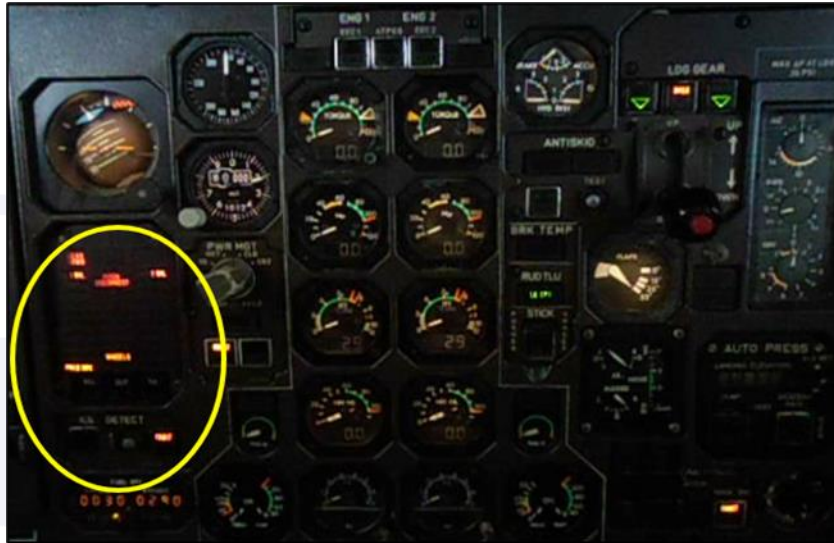
Figure 25 - Indications shown on the aircraft panel after the occurrence (highlighted).

In addition to these messages, the Fault light was observed on PEC n°1 (left) and the PWR MGT power selector in the CRZ (Cruise) position.

Throttle levers and condition levers were locked due to impact damage. Engines shutdown was carried out by the fire handles.

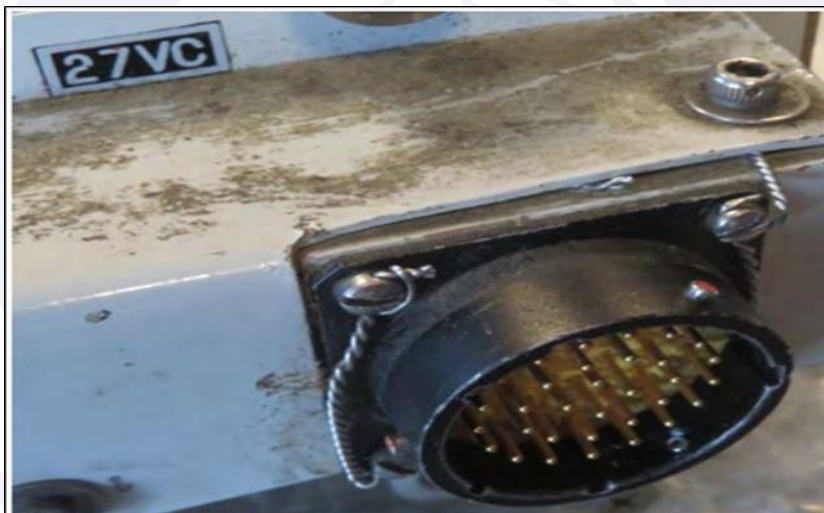
- External Component Inspection: the equipment had several non-standard conditions:
 1. Non-standard component connector and brake wires placed differently than expected (Figure 27).

Figure 27 - Brake Wire placed inside the housing and connector in a different pattern than expected.

Visual inspection showed signs that the Microswitch Box, PN 11S76180650-10, SN 0199, installed on the aircraft at the time of the occurrence, had been serviced outside the standards established by the component manufacturer.

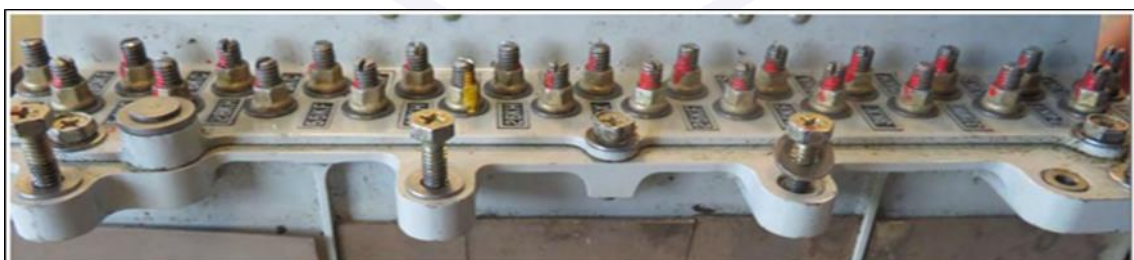
2. Misalignment of the adhesive markings on the Microswitch Box fixing screws (Figure 28).

Figure 28 - Misalignment between the adhesive markings on the Microswitches screws and nuts.

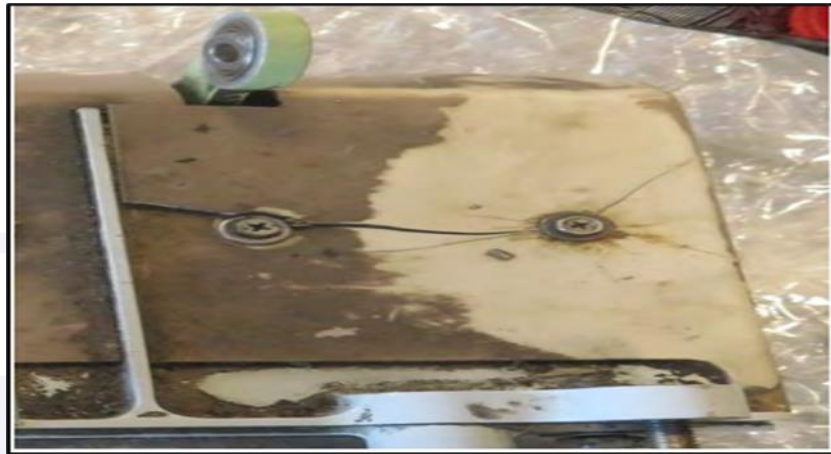
3. Damage to the Microswitch Box protective cover (Figure 29).

Figure 29 - Damage to the Microswitch Box protection cover.

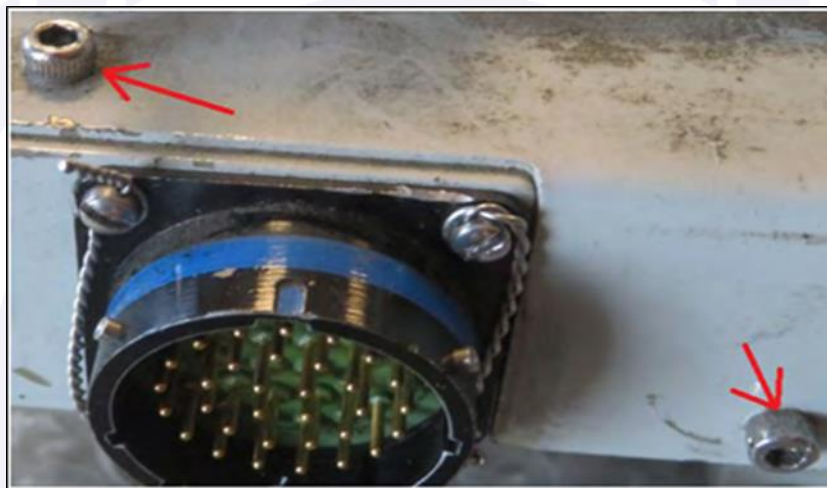
4. Missing brake wire (Figure 30).

Figure 30 - Missing brake wire.

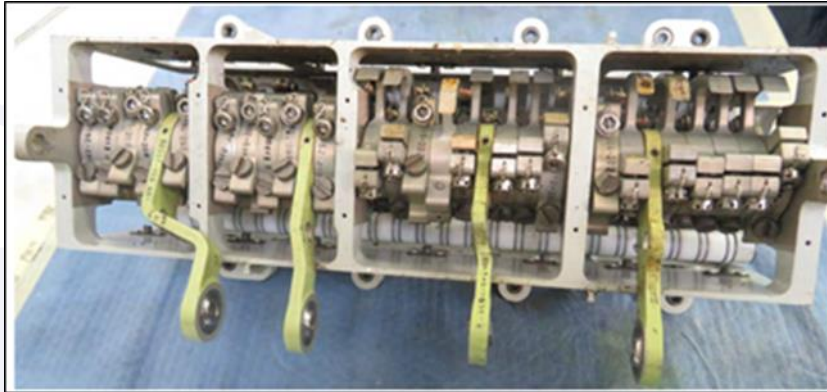
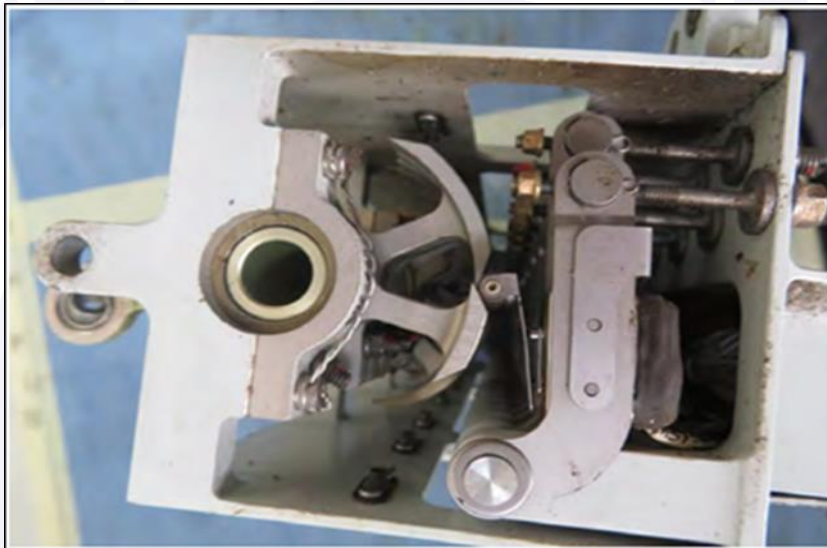
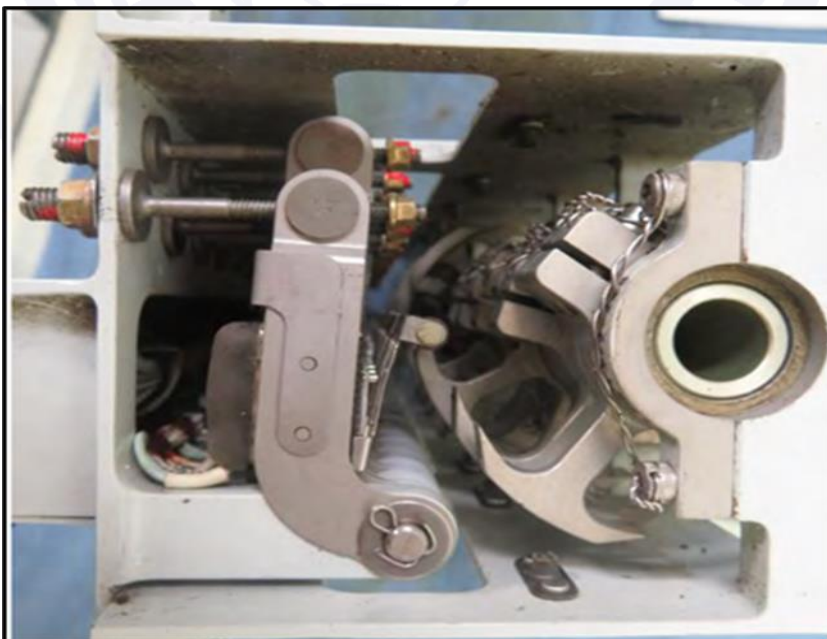
During the disassembly of the Microswitch Box, PN 11S76180650-010, SN 0199, no foreign objects or dirt were observed inside it that could indicate an intermittent operation of this component.

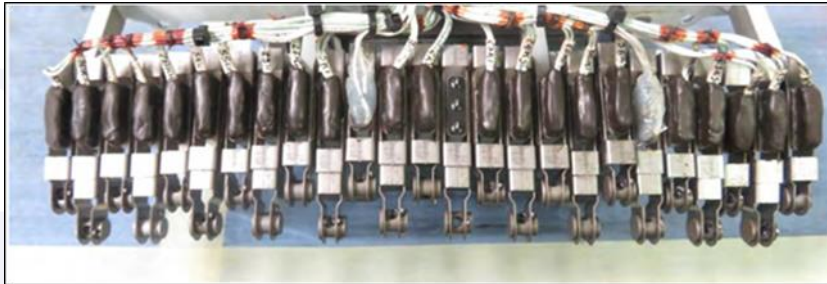
As shown in Figure 38, below, the presence of sealants (white color) different from the factory sealant (black color) was observed in the 25KH and 26KH microswitches.

Figure 38 - Microswitches installed in the Microswitch Box, PN 11S76180650-010, SN 0199.
