**COMANDO DA AERONÁUTICA**  
**CENTRO DE INVESTIGAÇÃO E PREVENÇÃO DE**  
**ACIDENTES AERONÁUTICOS**

**FINAL REPORT**  
**A-157/CENIPA/2016**

<b>OCCURRENCE:</b>	<b>ACCIDENT</b>
<b>AIRCRAFT:</b>	<b>PR-TUN</b>
<b>MODEL:</b>	<b>R44 II</b>
<b>DATE:</b>	<b>04DEC2016</b>

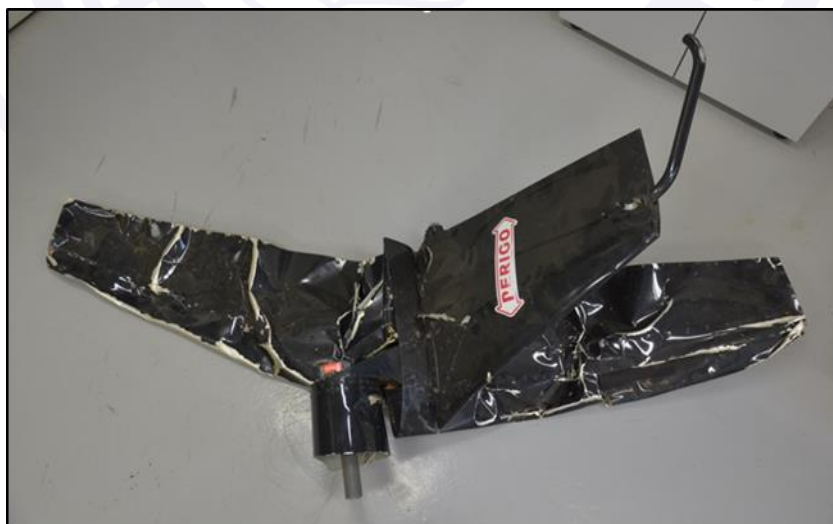
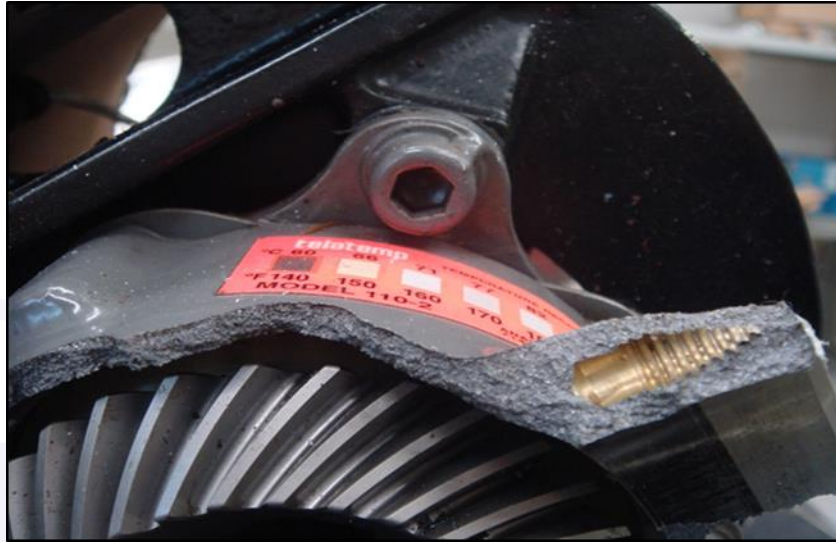
Overload damage was observed in the region where the tail rotor was separated from its fixation in the aircraft's tail cone (Figures 7 and 8). There was no evidence of fatigue or impact at the fracture place.

Figure 7 - Part of the tail of the aircraft.

Figure 8 - Surface of fracture with aspect of overload.

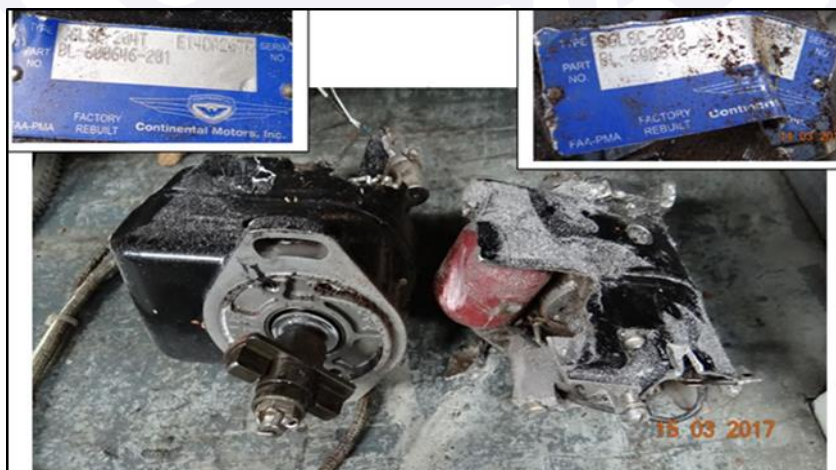
Figure 10 shows the engine magnetos. It was observed that they were damaged, which prevented bench tests.

Figure 10 - View of the engine magnetos with their respective identifications.

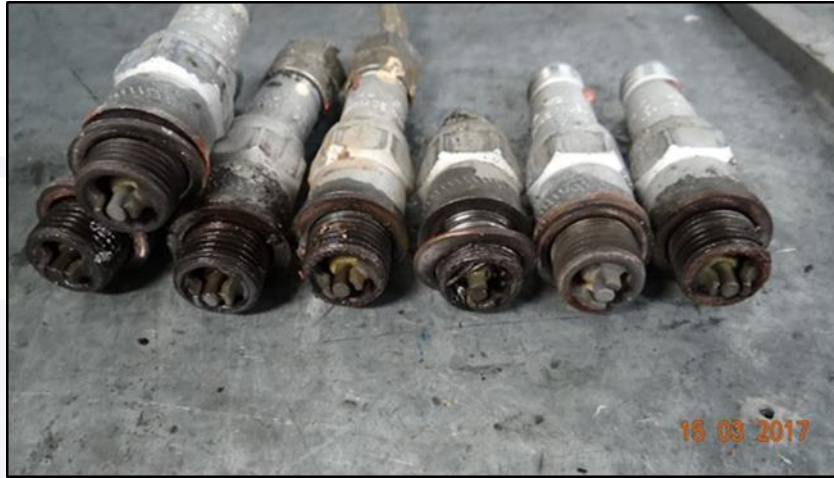
Control valves, hydraulic tappets, lubrication system and other internal engine components were inspected. It was found that the spark plugs presented evidence of normal operation (Figure 11).

Figure 11 - Spark plugs with normal operating color.

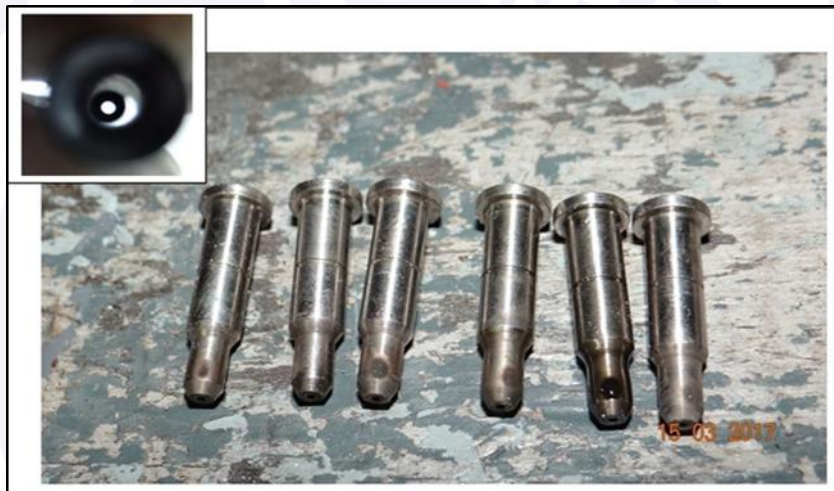
The injector nozzles were unobstructed (Figure 12).

Figure 12 - View of the nozzles. Highlights the clearing.

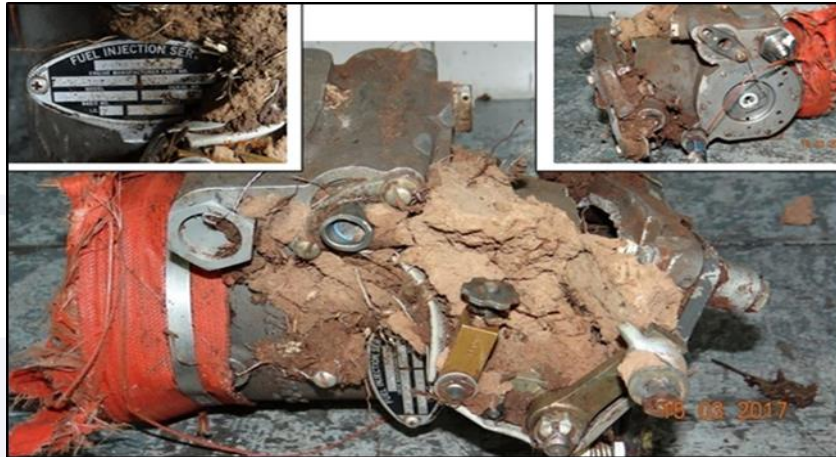
Figure 14 shows the servo fuel injector. This unit had serious faults as a result of the accident and was with dirt.

Figure 14 - Overview of the servo fuel injector. The highlights show their identification and the damages resulting from the accident.

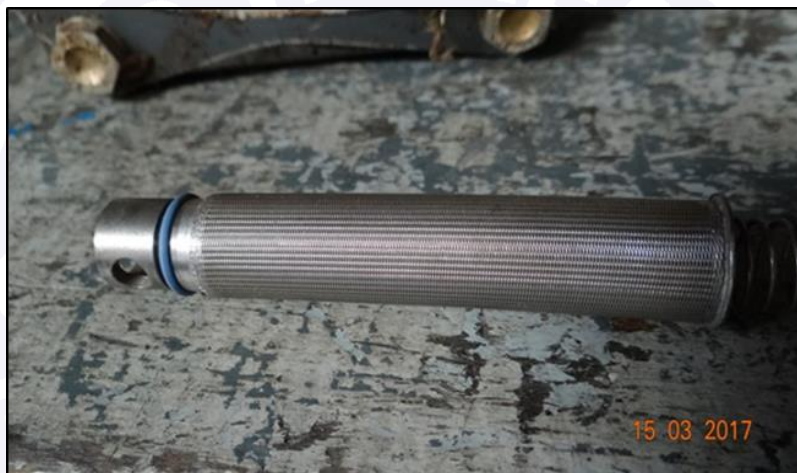
The fuel inlet filter was inspected (Figure 15). It was clean and uncontaminated, as it could be observed.

Figure 15 - View of the fuel filter at the inlet of the servo injector, with no contaminants.

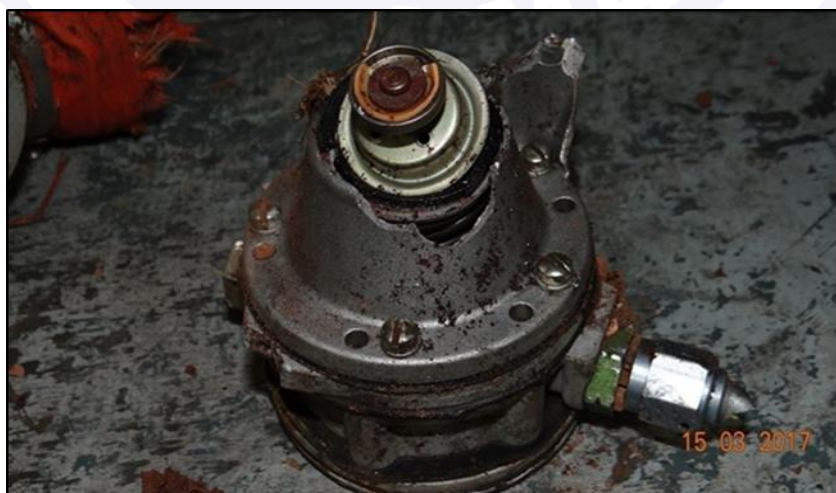
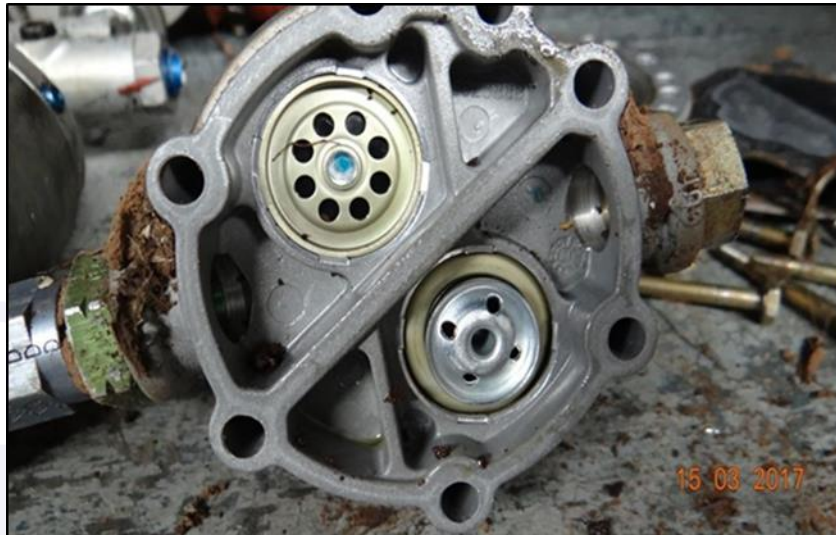
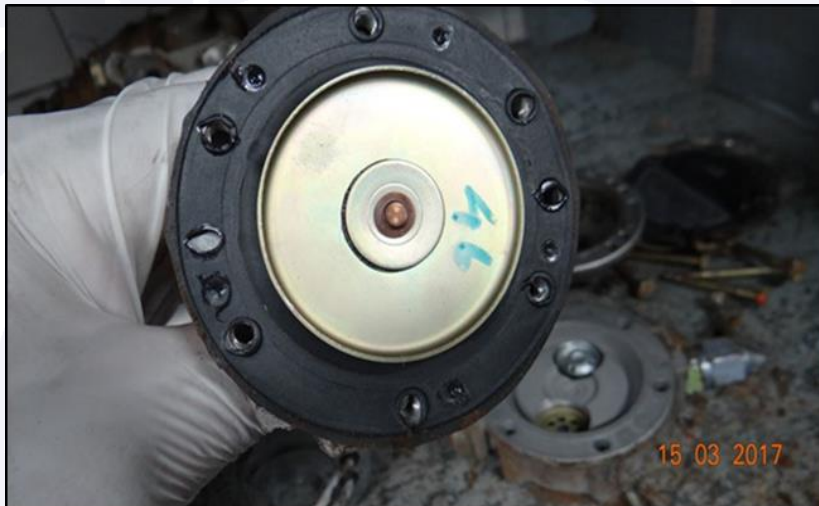
Figures 16 to 18 show the fuel pump. It was found fractured due to impact. In its internal components, no anomalies that showed a malfunction were found.

Figure 16 - Fuel pump view.

Figure 17 - View of the interior of the fuel pump, showing its valves.

Figure 18 - Clean fuel pump diaphragm view.

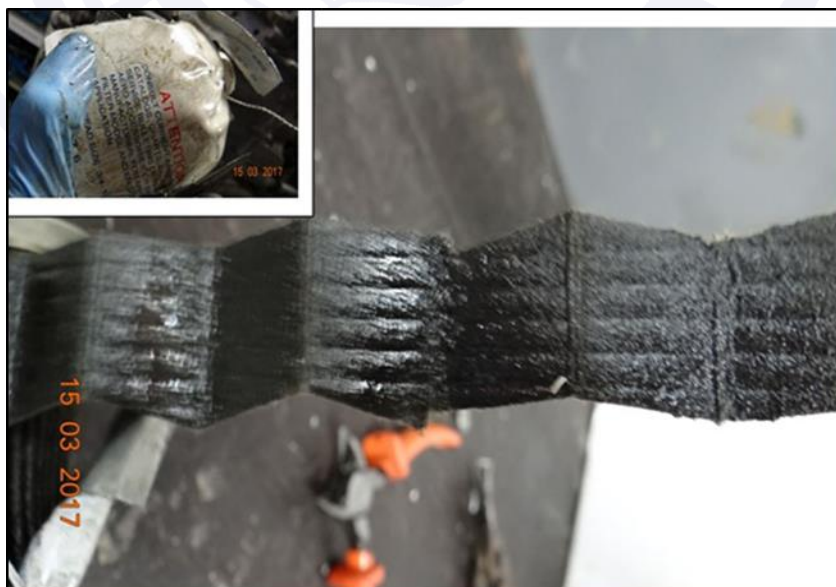
Figure 19 shows the filter element of the oil filter, without the presence of filings. The filter before its opening is shown in the highlight of the same figure.

Figure 19 – Oil Filtering element with no filings. Highlighted the oil filter before opening.

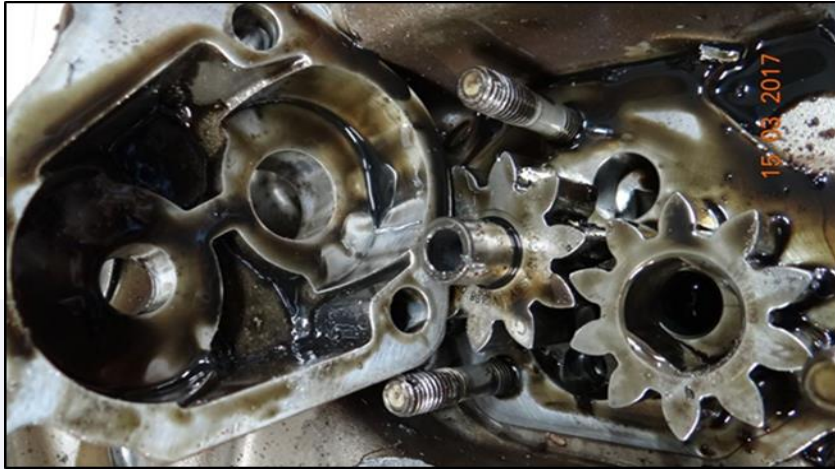
Figure 20 shows the oil pump as well as its gears, without operational damage. At the time of the accident, the engine of the aircraft had its crankcase and its primary oil filter ripped off. They were not located for analysis.

Figure 20 - Gears and housing of the engine oil pump without scratches.

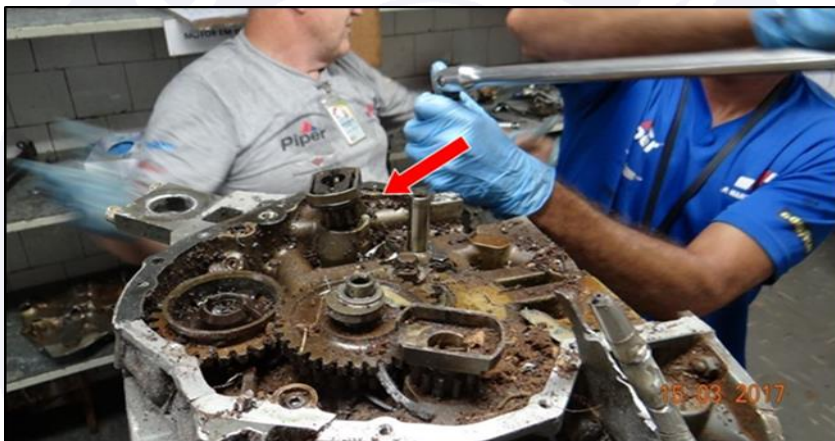
Figure 21 shows a view of the engine synchronizing gears. It is observed that the drive gear bearing of the right magneto was misaligned. The impact that the magneto suffered at the moment of the collision against the ground caused this misalignment.

Figure 21 – Gears of the accessory box. The arrow indicates misalignment of the drive gear of the right magneto.

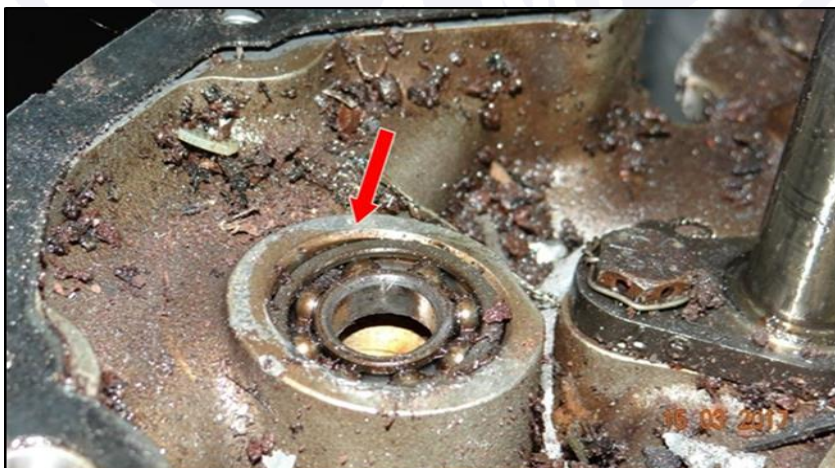
Figure 22 shows the detail of the misalignment with the bearing still assembled.

Figure 22 - Misalignment in the drive gear bearing of the right magneto.

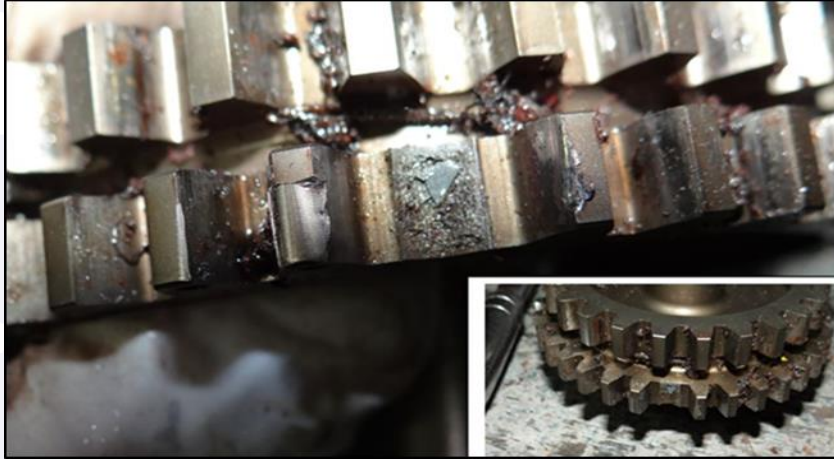
The intermediate gear, which drives the left magneto and the valve control, had a fractured tooth. The misalignment caused by the impact promoted the decoupling of the "teeth" and allowed the incorrect contact between them.

This caused the "tooth" fracture of this intermediate gear by overload and the contact marks observed in the ridges of the neighboring teeth (Figure 23). Such evidence corroborates that, at the moment of impact, the magneto was spinning, because more than one "tooth" of the gear was affected.

Figure 23 - View of the tooth fracture of the left magneto drive synchronizing gear and the valve control.

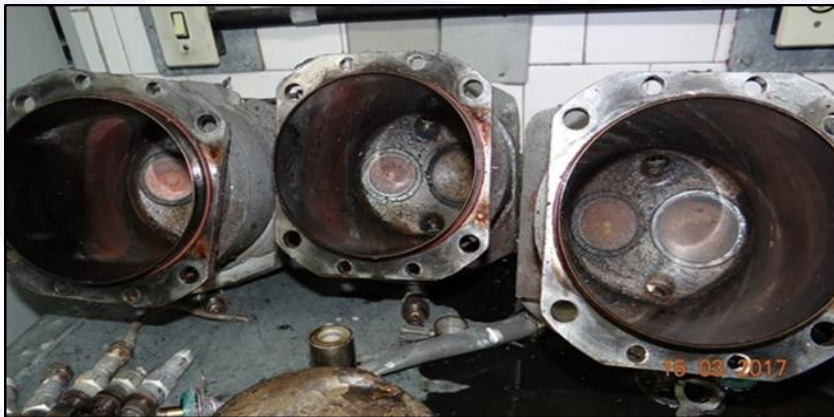
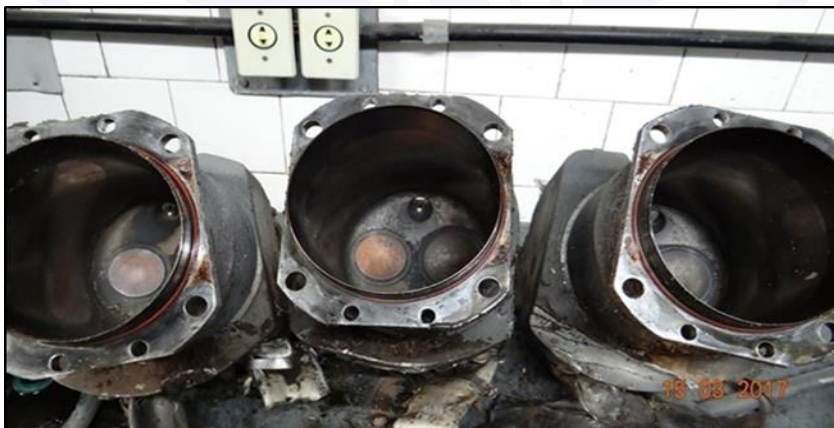
Figures 24 and 25 show the interior of the engine cylinders. There were no scratches, no evidence of detonation or signs of overheating that could indicate engine malfunction.

Figure 24 - View of cylinders 1, 2 and 3, with no operational damage.

Figure 25 - View of cylinders 4, 5 and 6, without operational damage.

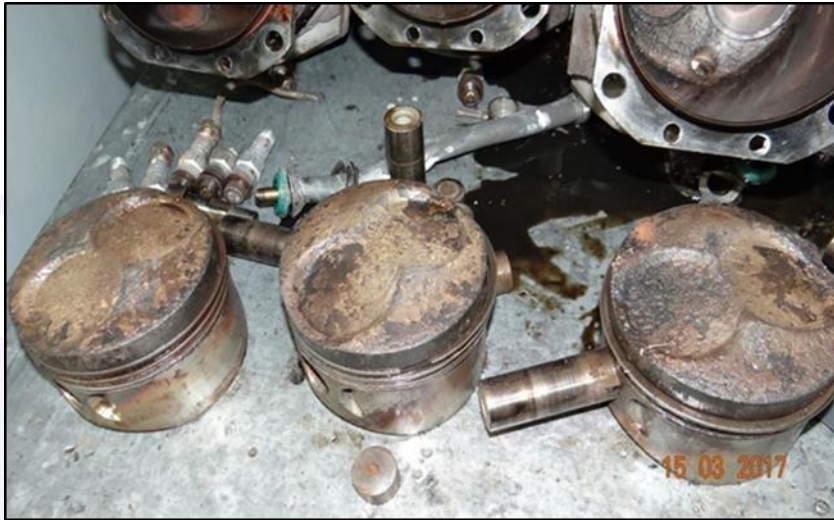
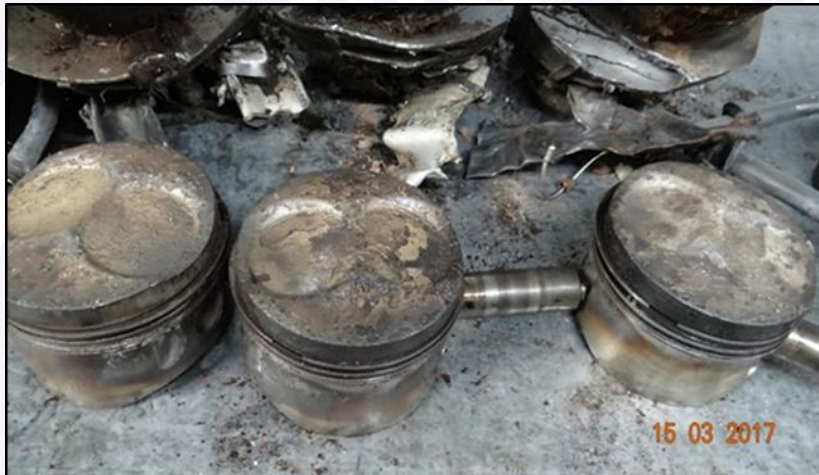
The same analysis procedure was adopted to inspect the pistons (Figures 26 and 27). No anomaly was found.

Figure 26 - View of the pistons 1, 2 and 3, with normal working color.

Figure 27 - View of the pistons 4, 5 and 6, with normal working color.

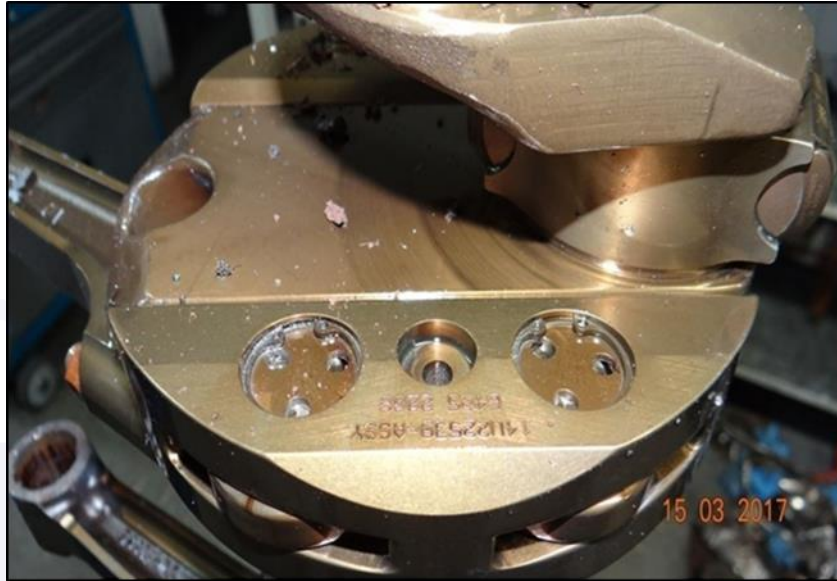
Figure 29 shows the dynamic counterweights of the crankshaft. They were normal and the pins were assembled correctly.

Figure 29 - Highlight for identification of the counterweight of the crankshaft.

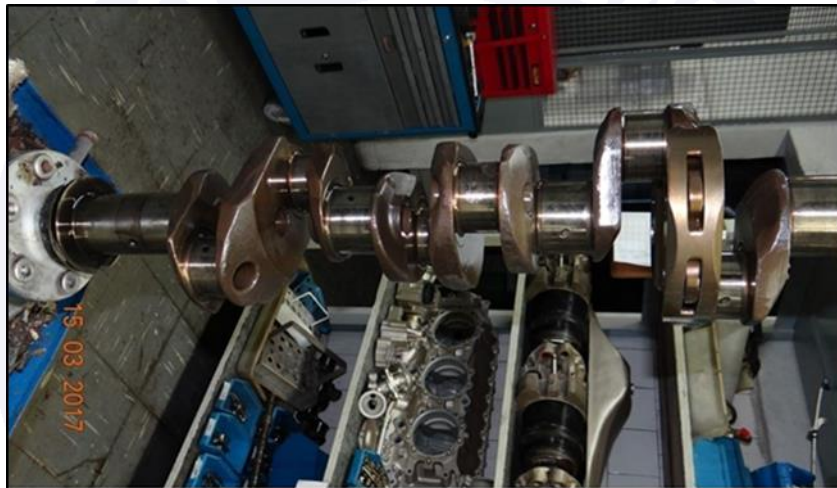
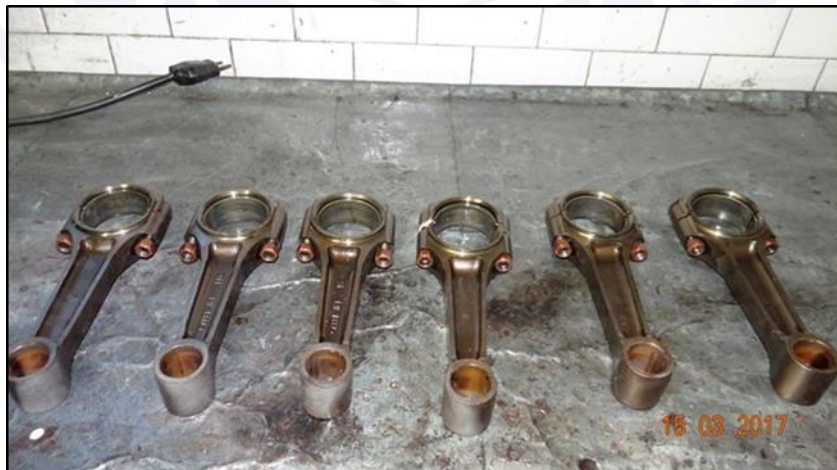
The crankshaft of the engine is shown in Figure 30. All connecting rods (Figure 31) were moved before disassembly and no jamming or signs of lack of lubrication were observed, which could compromise the operation of the engine.

Figure 30 - Engine crankshaft in good condition.

Figure 31 - View of the connecting rods in good condition.

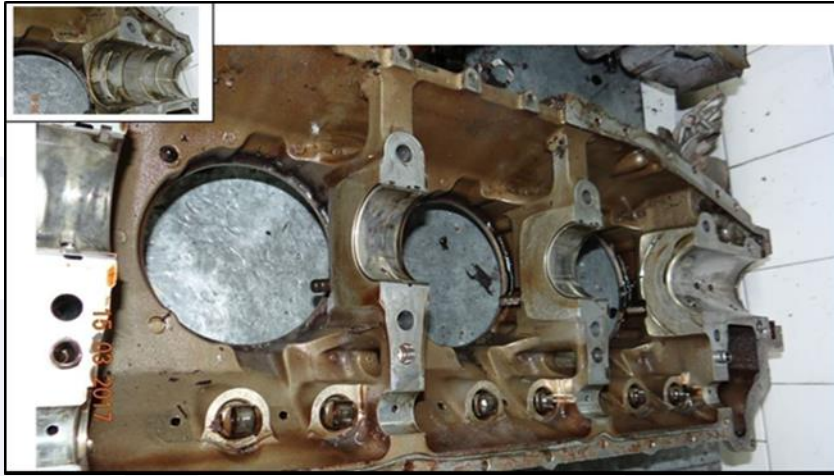
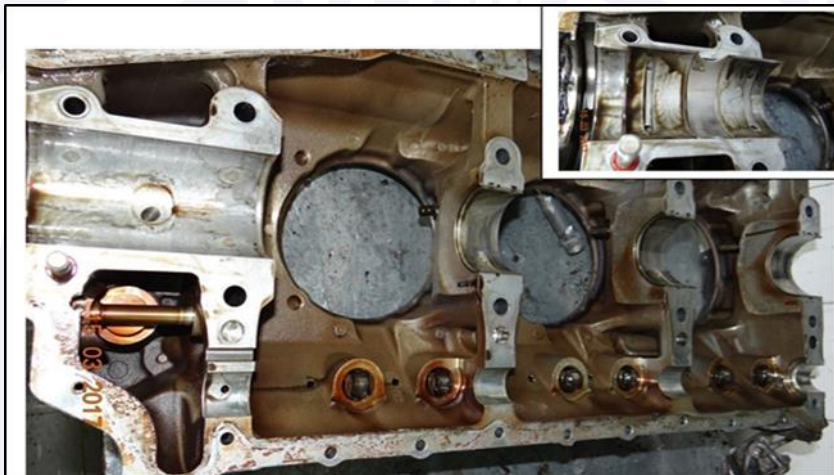
The semi-engine housings (Figures 32 and 33) were normal. No evidence of impact damage or bearing problems was found. The front connecting rod of the engine were normal and showed no evidence of abnormal wear or lack of lubrication.

Figure 32 - View of the right semi-engine housing and of the connecting rod in good condition.

Figure 33 - View of the left semi-engine housing and the connecting rod in good condition.

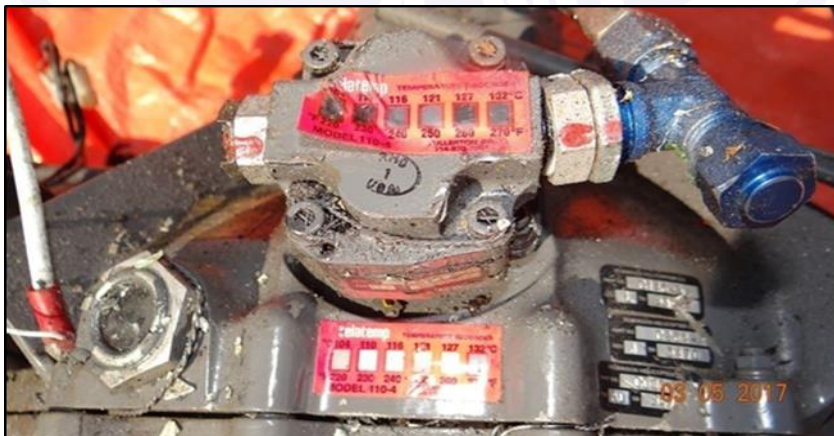
In Figure 34 we observe the local temperature indicator (Telatemp heat indicator) that indicated high temperature in the hydraulic pump. This is why the gearbox was disassembled.

Figure 34 - Temperature indicator (Telatemp) showing temperature increase in the hydraulic pump.

No abnormality was observed. Thus, it has been observed that the temperature excess observed in Telatemp was probably the result of heat irradiated by the engine after the accident.

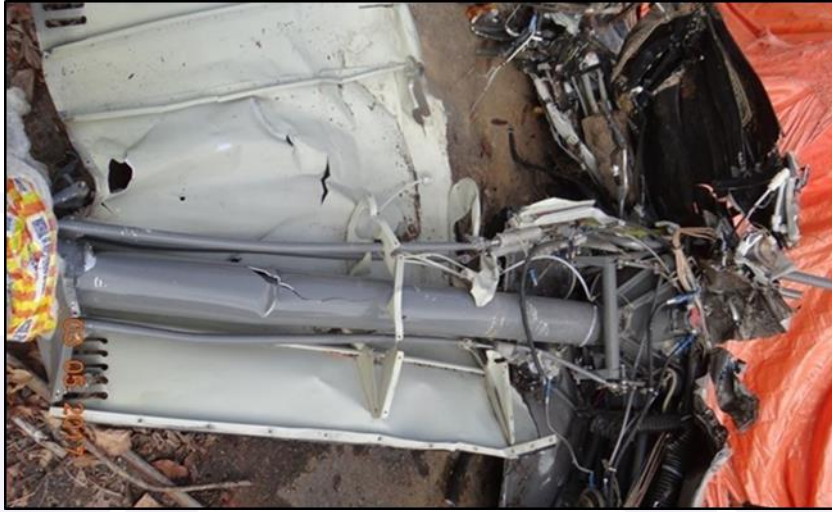
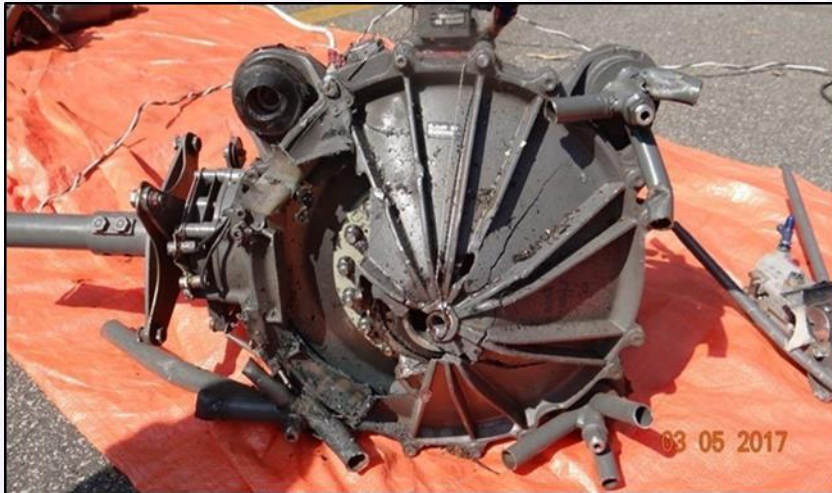
Figures 35 and 36 show the main rotor drive assembly after opening the fairing. A gearbox casing fracture was observed, due to the collision against the ground.

Figure 35 - Overview of the transmission assembly after opening the fairing.

Figure 36 - View of the transmission case crankcase fracture.

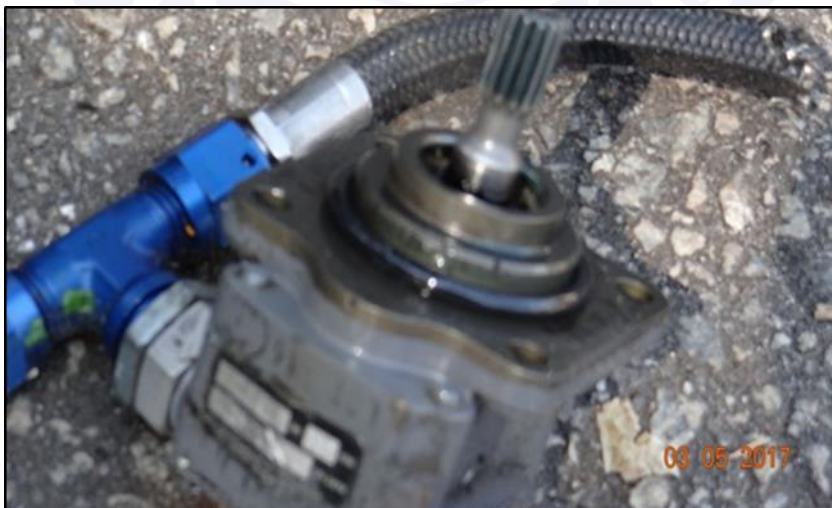
Figure 37 shows a view of the hydraulic pump, component that showed temperature increase indication (Telatemp tape).

Figure 37 - Main gearbox hydraulic pump.

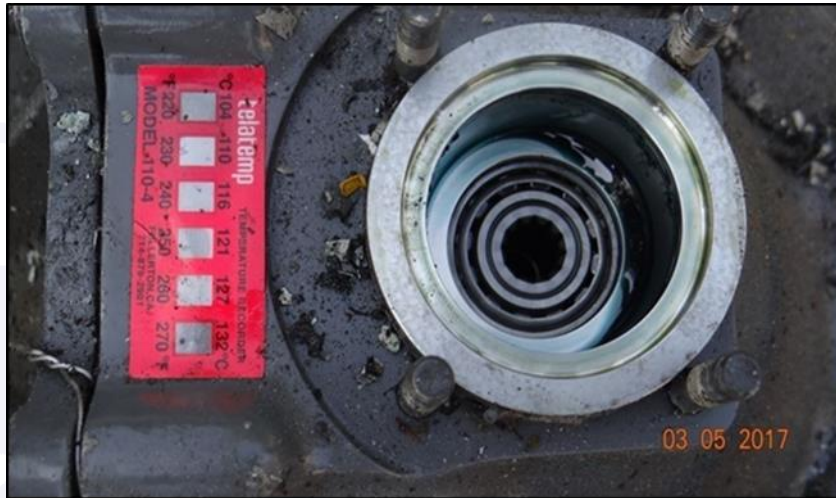
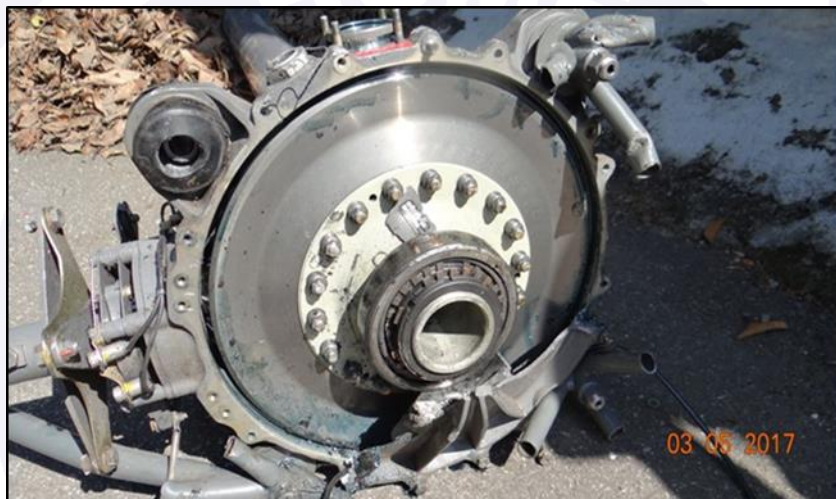
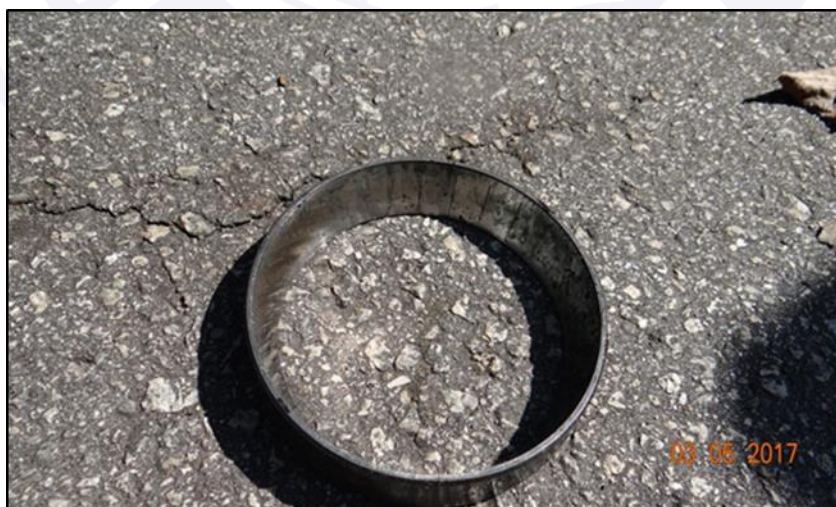
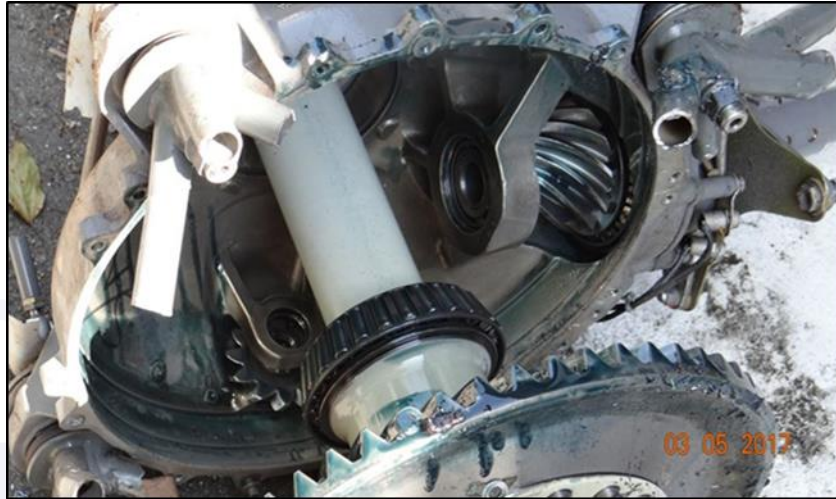
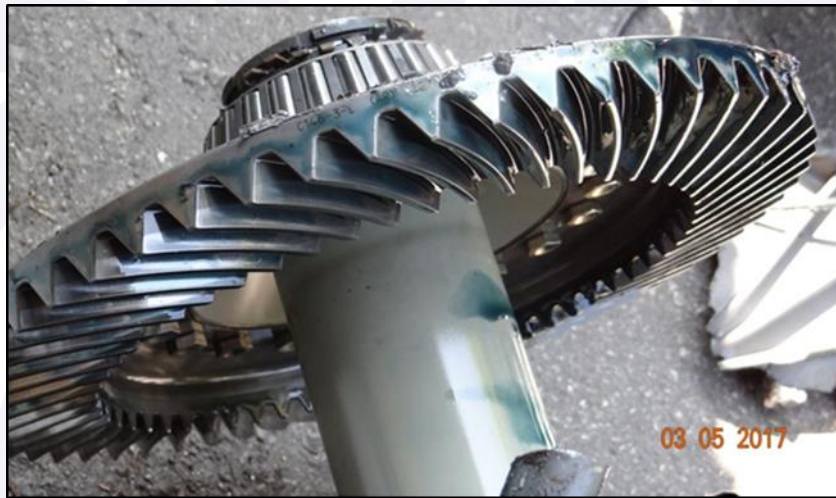
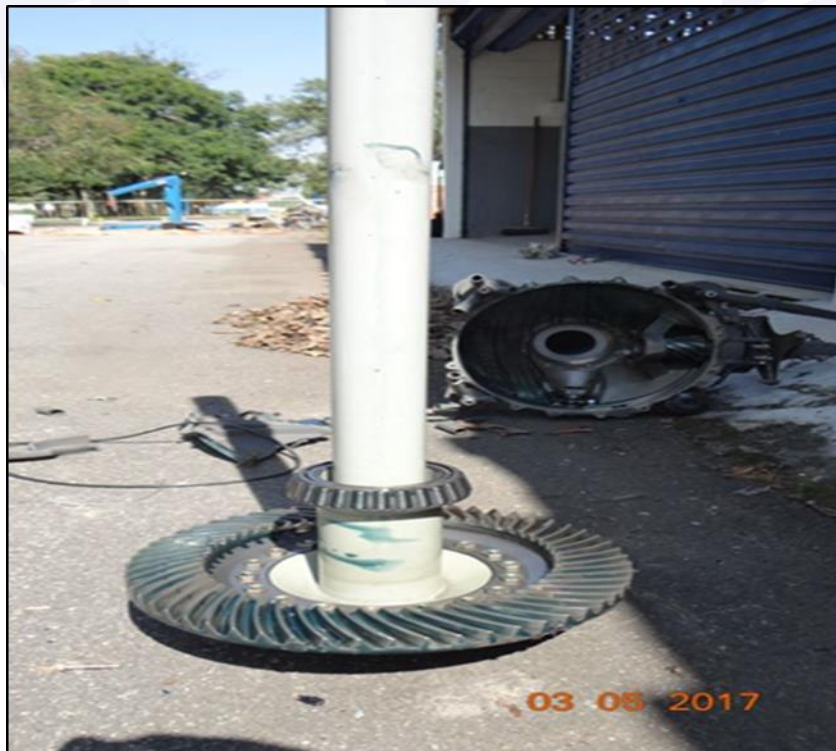
The interior of the transmission case and its components (rack, pinion, hydraulic pump gear, pump housing and bearings) did not present scratches and signs of overheating, due to lack of lubrication (Figures 38 to 46). No evidence of failure was found to compromise its operation.

Figure 38 - Housing of the hydraulic pump in the gearbox.

Figure 39 - Bottom view of the rack and bearing of the transmission box.

Figure 40 - Transmission case lower bearing outer race, undamaged.

Figure 41 - General view of the rack, the upper bearing and the gearbox pinion.

Figure 42 - Main gearbox rack.

Figure 43 - Top rack and top bearing of the main gearbox.

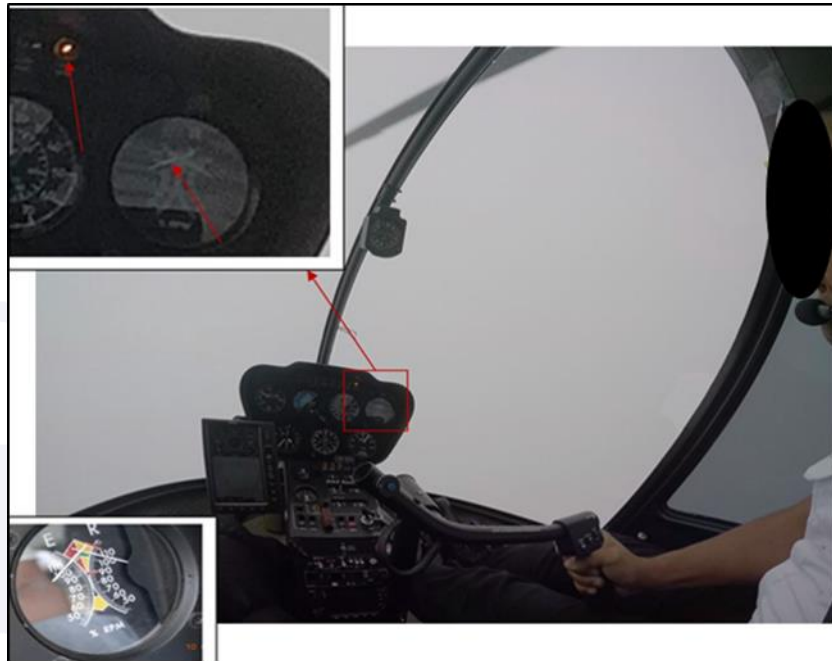
The lower highlight (Figure 47) shows an instrument similar to that of the aircraft panel. It was included, so that the reader could clearly observe the information provided by that instrument, that is, the engine and main rotor rotations in percentage.

Figure 47 - Low RPM Main Rotor Indicator Light. In the lower highlight, an indicator similar to that of the aircraft. In the top highlight, indication that the engine was powered.
