COMANDO DA AERONÁUTICA
CENTRO DE INVESTIGAÇÃO E PREVENÇÃO DE
ACIDENTES AERONÁUTICOS

FINAL REPORT
A-080/CENIPA/2018

OCCURRENCE:	ACCIDENT
AIRCRAFT:	PR-WBV
MODEL:	PC-12
DATE:	01MAI2018

This is the Final Report of the 01May2018 accident with the PC-12 aircraft, registration PR-WBV. The accident was typified as “[SCF-PP] Engine failure or malfunction | With propeller”.

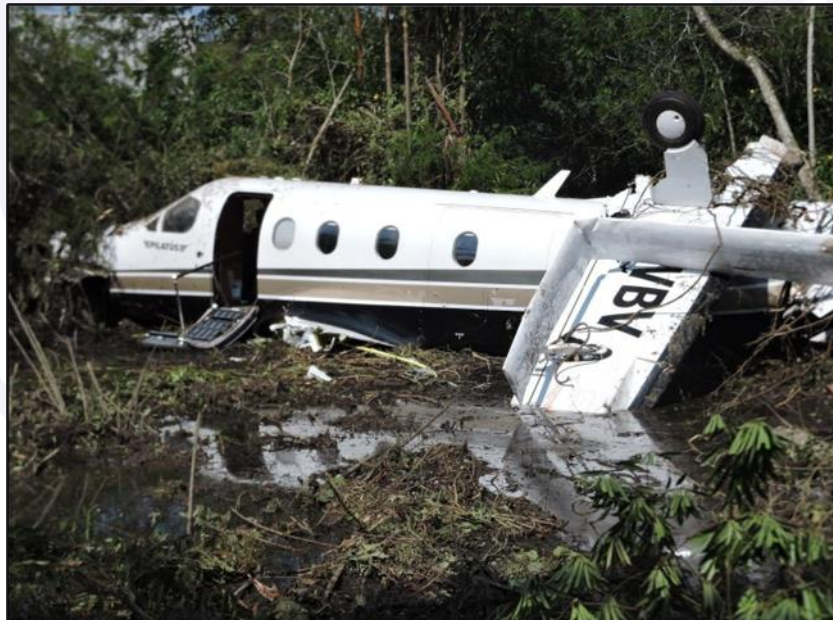
Figure 1 – View of the aircraft at the crash site.

The left wing broke up close to its root, and there was damage to the entire landing gear assembly. The empennage ruptured and detached completely from the fuselage. The horizontal and vertical stabilizers were destroyed. The right wing and the nose landing gear sustained severe damage.

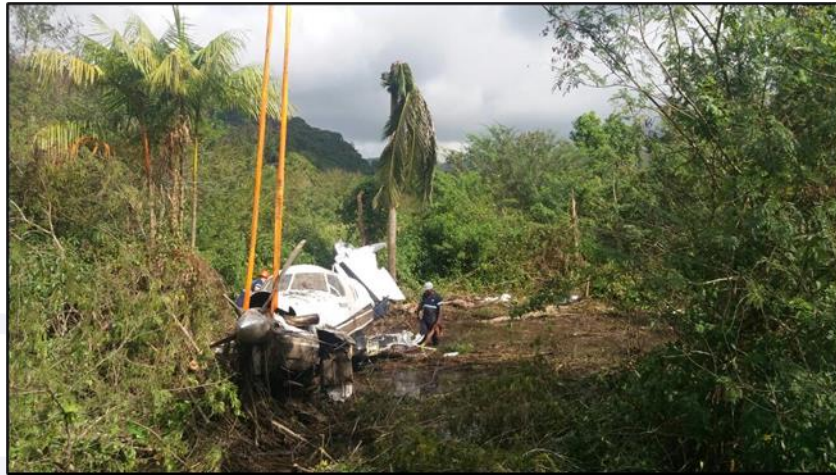
The area near the runway is swampy, featuring small trees and undergrowth. The evidence indicated a collision of the aircraft left wing against one of the trees on the ground, making it separate from the fuselage. The event also reduced the distance necessary for the aircraft to stop.

The right wing collided with the vegetation as well, but remained attached to the structure. Except for the aircraft occupants, there were no other observers of the crash.

. Figure 9 - Position of the wreckage at the removal.

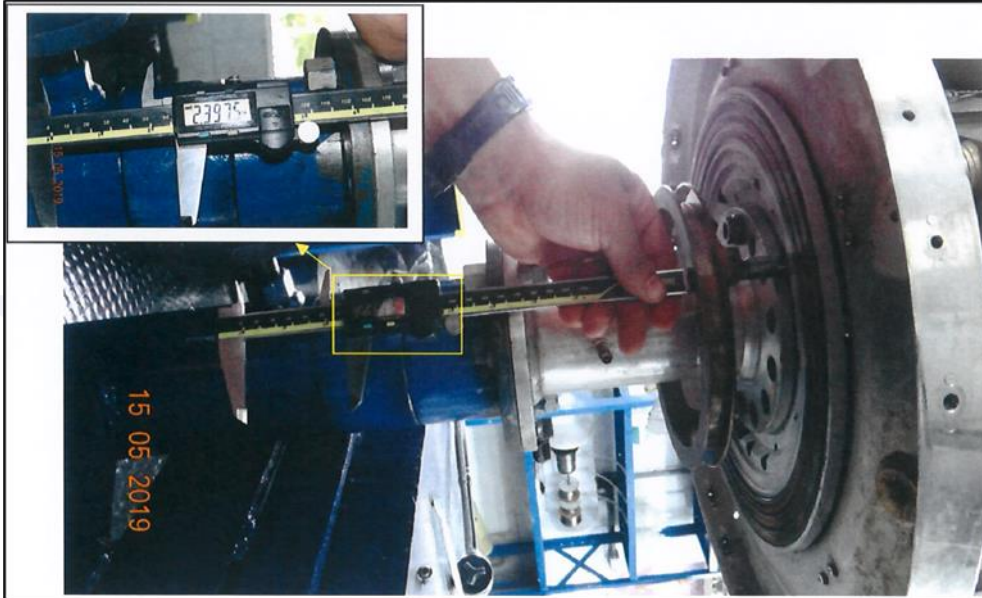
However, the measurement of the beta-ring distance indicated that the ring displacement was not within the manufacturer's prescribed limits (Figure 10). It was not possible to identify whether such displacement resulted from a maintenance action or from some event during the assembly of the ring upon replacement of the propeller. Nevertheless, one considered that such discrepancy might have occurred due to the impact sustained by the propeller blades in the emergency landing.

Figure 10 - Verification of the distance between the sliding ring and the propeller plate during the assembly process.

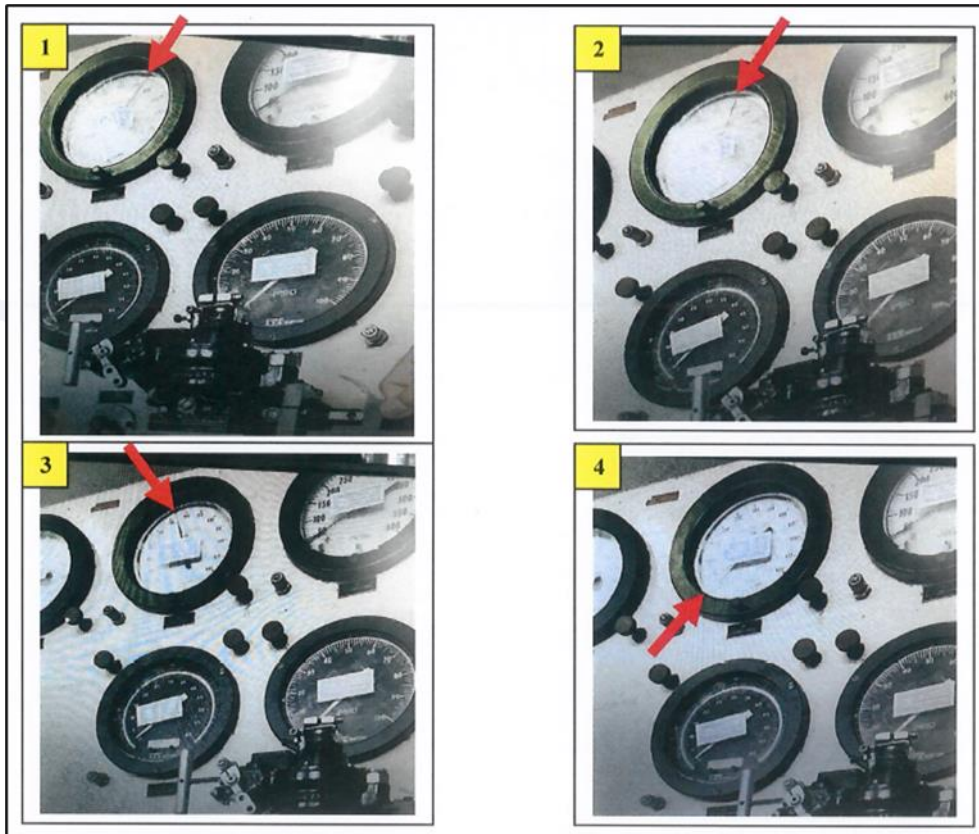
The test allowed verifying that, once the drop in oil pressure in the propeller hub started, it no longer recovered, until reaching values close to zero. The sequence of images depicted in Figure 11 shows the normal working pressure of the governor, followed by the drop in oil pressure until it reaches a zero value. There was no intervention by the bench operator after the start of the pressure drop. The instant the pressure reached zero, the beta valve locked.

Figure 11 - Test bench operation of the beta valve of the propeller-governor similar to the one of the occurrence aircraft, showing the drop in hydraulic pressure.

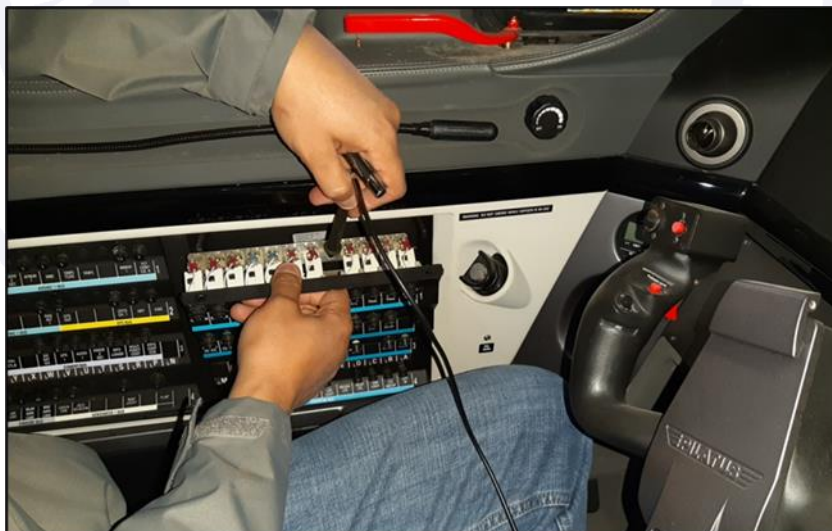
. Figure 12 - Conducting electricity tests on the aircraft.

The condition of continuity and isolation of the solenoid valve circuit did not present failures, except when one placed the CL in the Cut-Off/Feather position, and measured the isolation with other buses that did not feed the feathering solenoid valve.

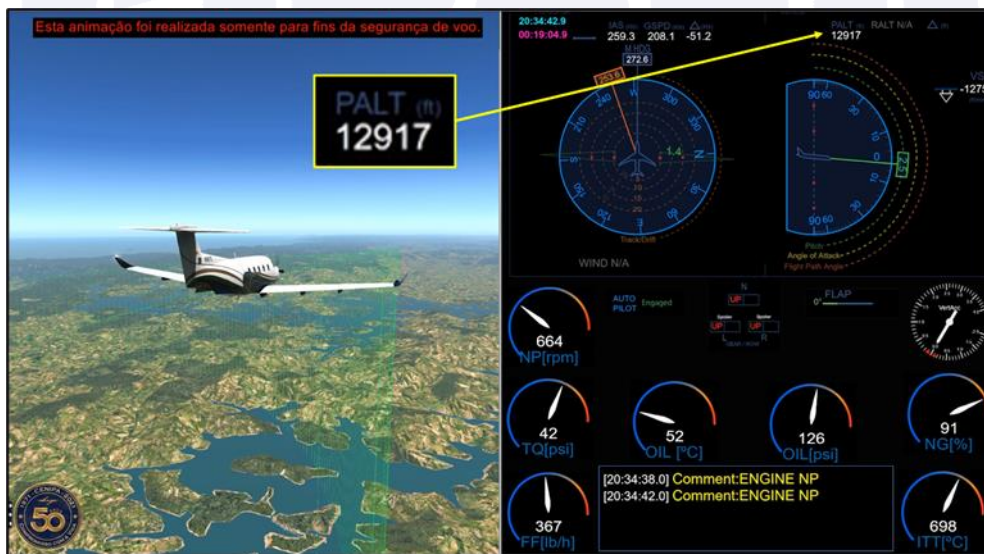
The pilots' report became easier to understand after the analysis of the data extracted from the ACMS, in which the investigators verified that at 20:33:50 UTC, 22 seconds after engine reduction, the propeller speed began to fall progressively. At 20:34:15 UTC, the first ENGINE NP warning appeared, followed 20 seconds later by another one, as seen in Figure 16 (extract from the animation based on the flight data).

. Figure 16 – Moment at which the abnormal condition appeared, on a Simulation based on the flight data retrieved. Source: LABDATA, CENIPA.

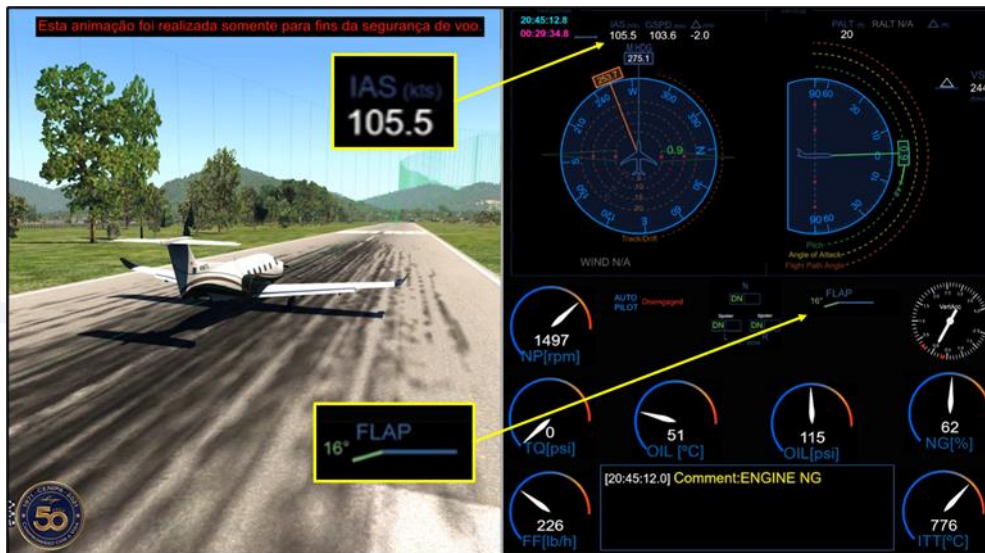
The aircraft passed over the threshold at a speed of 116 kt, with the landing gear down and with flaps at 16° still in motion. The crew realized that they had a lot of energy, "flying over the runway". The touchdown occurred at a speed of about 105 kt, between the middle and the last third of the runway, as shown in the static image extracted from the re-creation of the flight in the simulator (Figure 24).

Figure 24 - Touchdown of the aircraft on the SDUB runway.

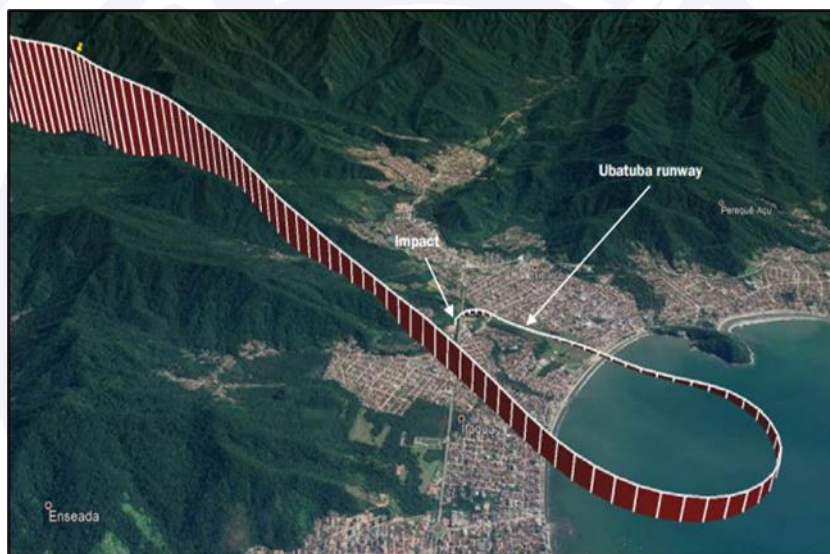
After the touchdown, according to the crew, upon seeing that there were houses and parked cars in the overshoot area of the runway, the PIC decided to exchange speed for height in order to deviate the aircraft to the left toward an unpopulated swampy area. Figure 25 depicts the final route taken by the aircraft (in highlight).

Figure 25 - Base turn, landing attempt, and final turn before impact.
