COMANDO DA AERONÁUTICA
CENTRO DE INVESTIGAÇÃO E PREVENÇÃO DE
ACIDENTES AERONÁUTICOS

FINAL REPORT
A-005/CENIPA/2021

OCCURRENCE:	ACCIDENT
AIRCRAFT:	PR-WVW
MODEL:	R44 II
DATE:	06JAN2021

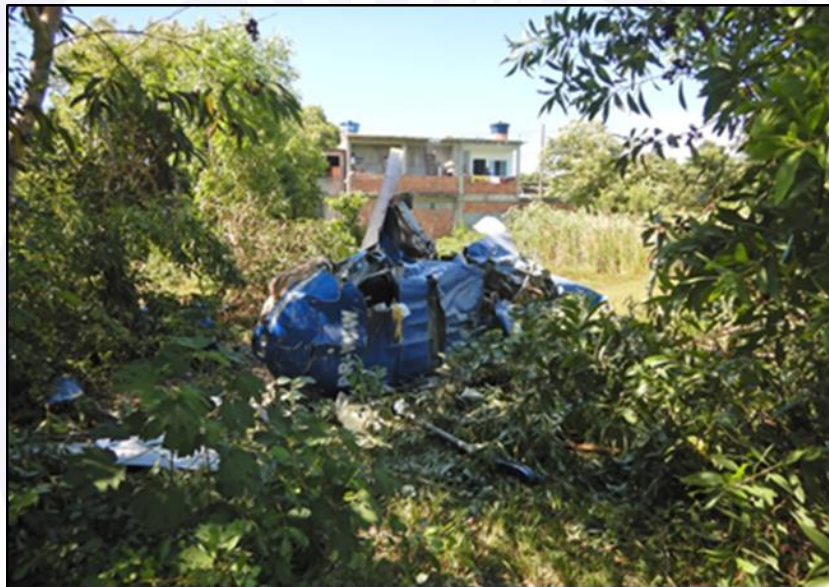
Figure 1 - View of PR-WVV helicopter at the accident site.

The aircraft sustained substantial damage to its entire structure, including the rotors and the tail cone, which was severed.

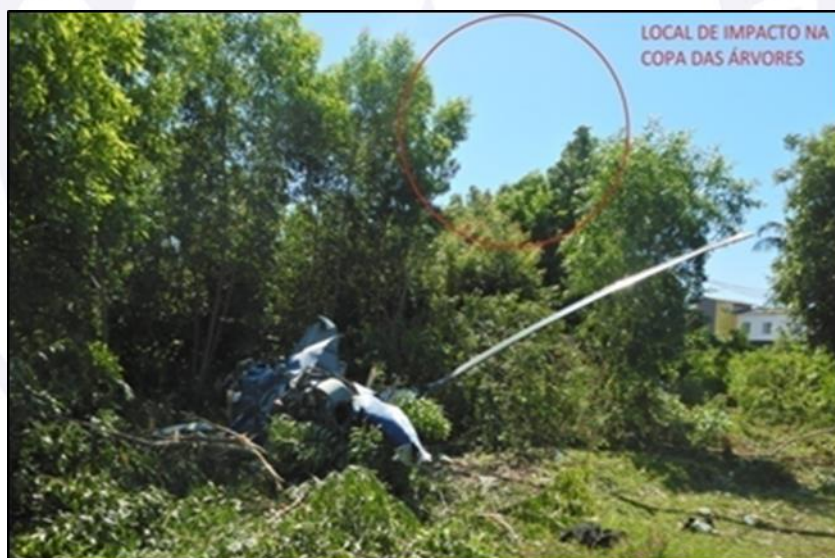
Members of the Investigation Committee identified the first point of impact in the treetops, at a height of approximately 10 m above the ground. The marks left by the aircraft at hitting the vegetation and subsequently the ground were concentrated, featuring a horizontal dispersion of approximately 5 m (Figure 2).

Figure 2 - View of the damage caused to the vegetation, from the opposite direction of the aircraft's movement.

Based on the arrangement of the wreckage, on the impact marks on the vegetation, and on the aircraft's resting point, it was possible to conclude that the collision with the terrain occurred with a high sink rate.

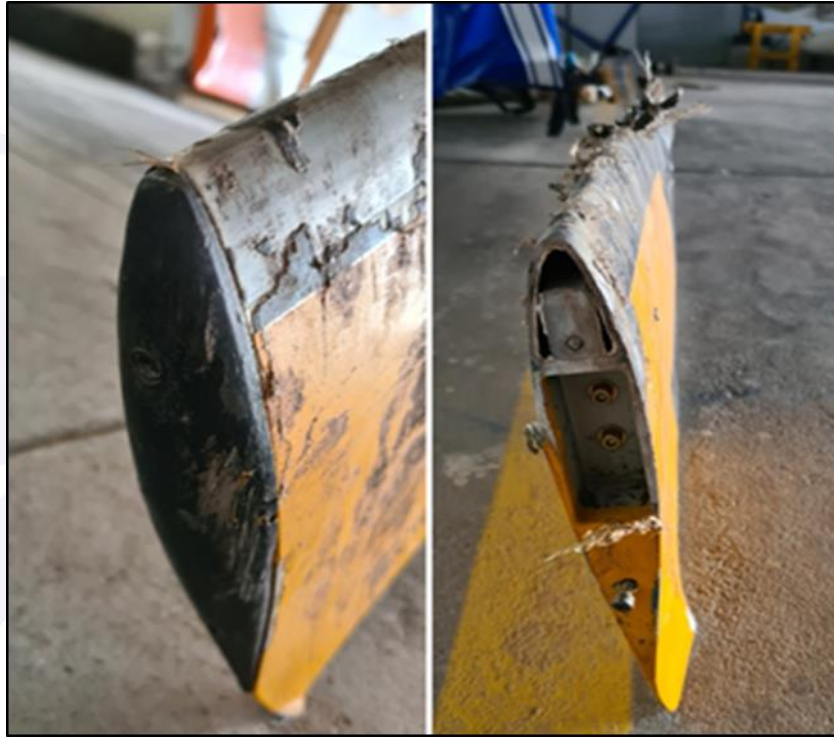
During wreckage assessment, investigators observed that the tip of one of the main rotor blades was damaged, and there were matching marks at the location where the tail boom was severed, suggesting that one of the blades struck the tail boom (Figures 3 and 4).

Figure 3 - View of the tips of the main rotor blades with one of them showing damage from the impact against the tail boom.

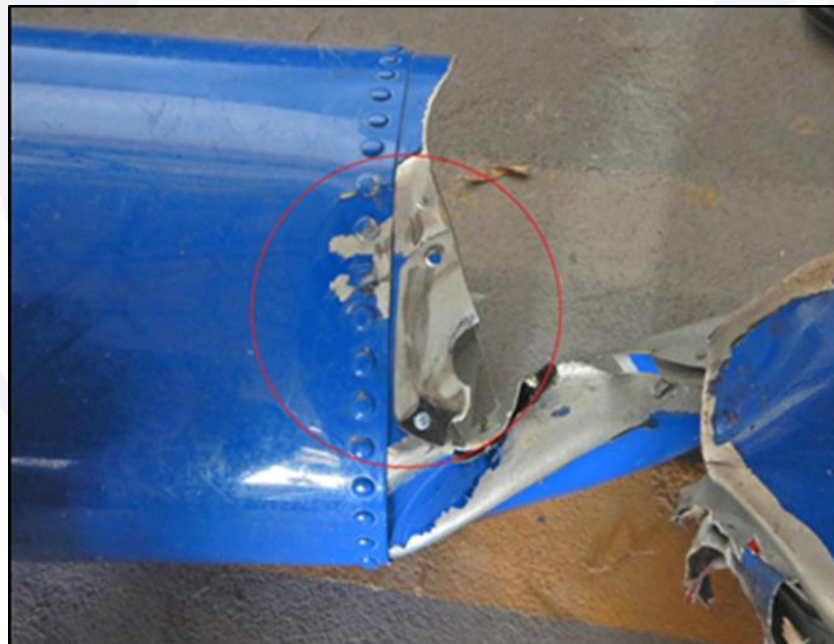
Figure 4 - Detail of the mark on the tail boom due to contact with one of the blades.

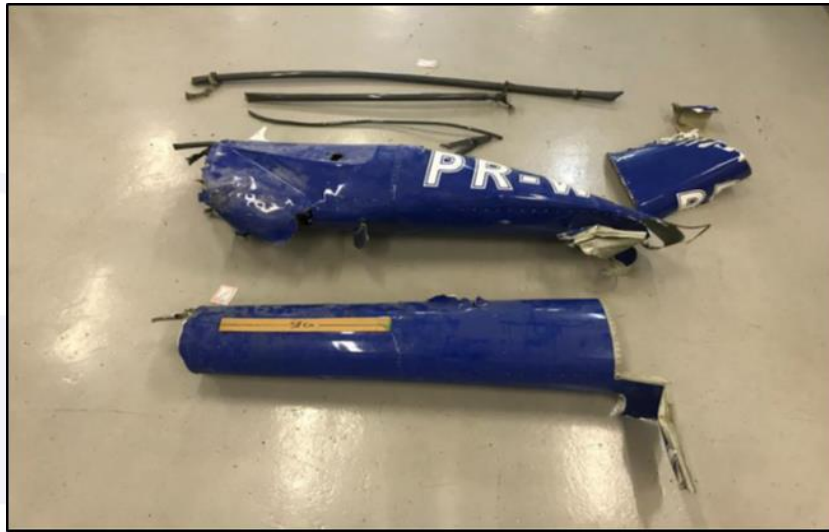
Visual examinations and stereoscopic analysis were conducted, and it was possible to identify that the material exhibited typical characteristics of failure due to overload, as shown in Figures 5, 6 and 7, below.

Figure 5 - Tail cone and rear drive shaft of the aircraft PR-WVV.

The analyzed material exhibited fractures consistent with overload caused by the aircraft's impact with the ground. Furthermore, no evidence of corrosion or fatigue was identified in the analyzed material.

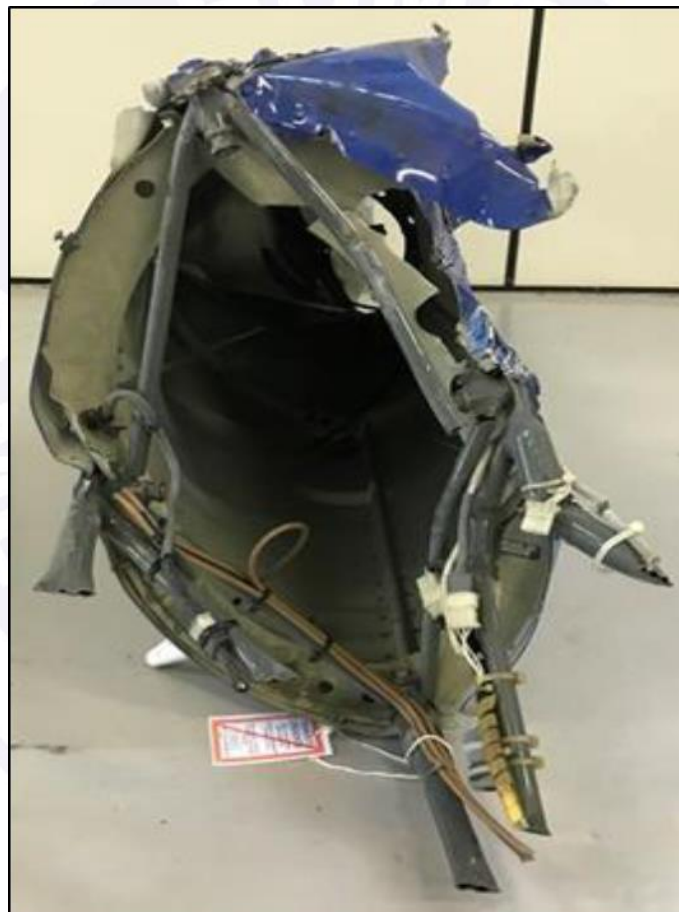
Figure 6 - Detail of the surface with a fracture typical of failure due to overload.

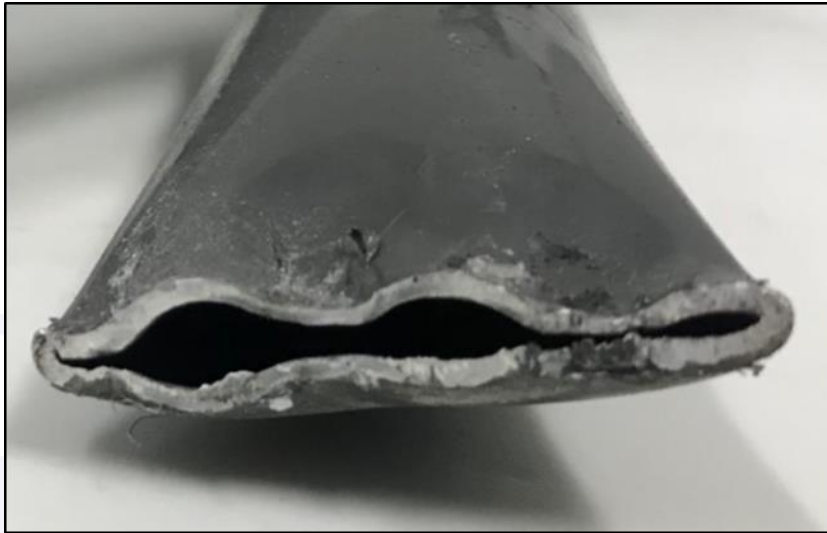
Figure 7 - Drive shaft with a “fish mouth” fracture, typical of failure due to overload.

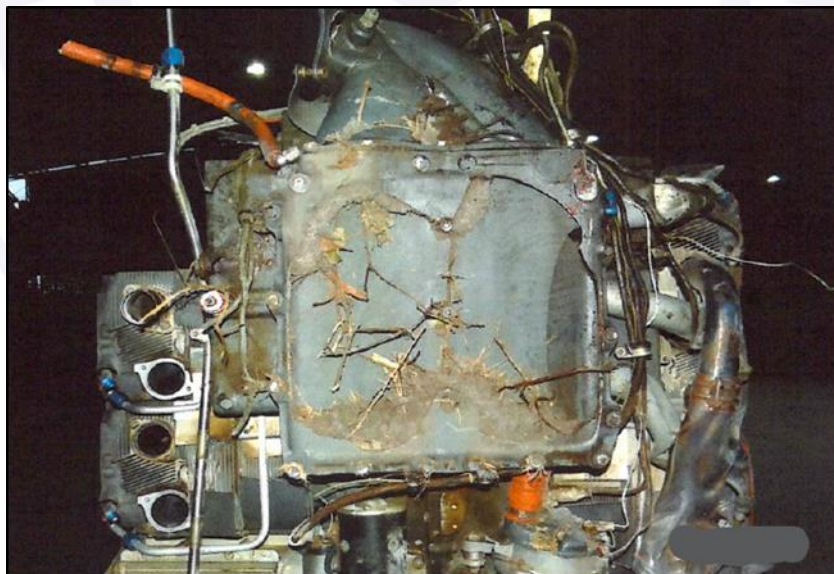
During the initial observations, it was noted that the engine had all its components and accessories intact. However, due to the damage resulting from the impact with the ground, the engine's dry sump was damaged, preventing functional testing on another aircraft, as well as bench-testing (Figure 8).

Figure 8 - View of the dry sump of the damaged engine.

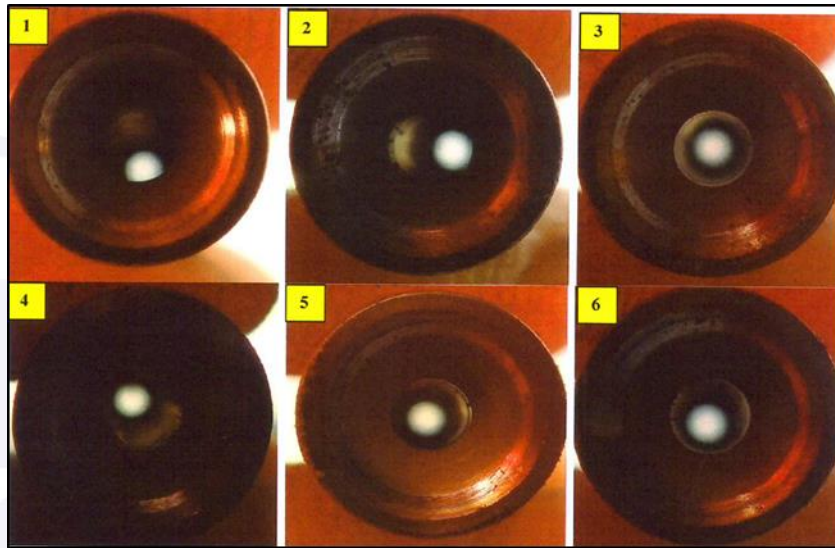
Continuing with the fuel supply system, the engine's fuel injectors were checked and all were found unobstructed. The fuel distributor was disassembled for diaphragm inspection, and was found to be in normal condition, without discrepancies or abnormalities that could compromise the fuel supply to the engine (Figure 9).

Figure 9 - View of the engine's injector nozzles.

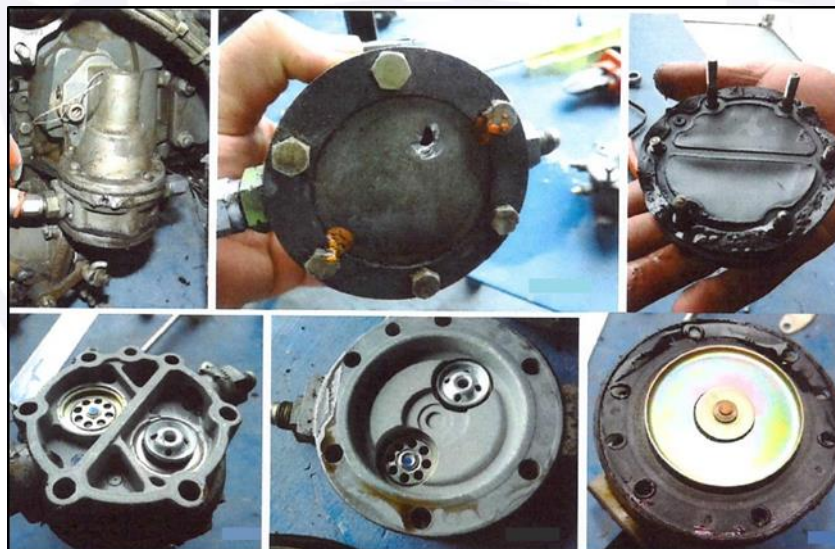
The fuel pump was not bench-tested nor operated manually by means of the rod, because the lower chamber was perforated, preventing fuel transfer to the upper chamber and hindering the test. It was disassembled, and the check valves were found to be normal and functioning correctly. No contamination was found inside the fuel chambers.

Figure 10 - Internal and external views of the engine's fuel pump.

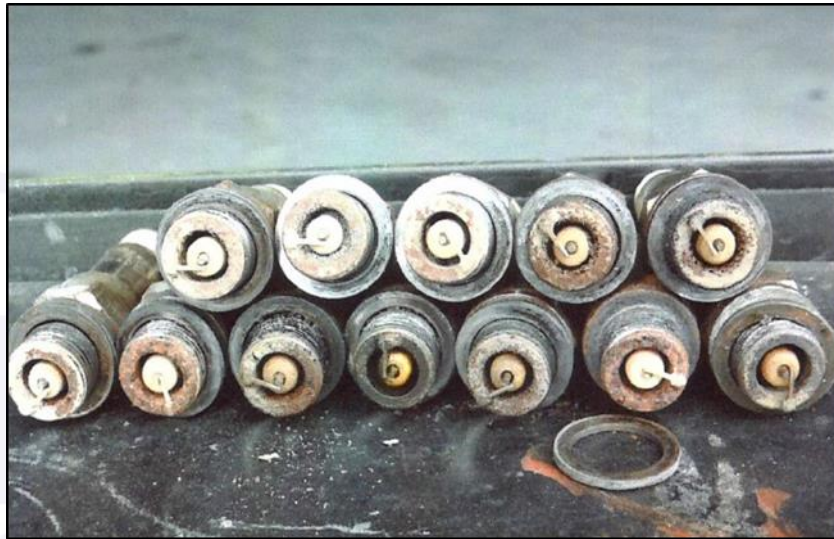
The spark plugs were examined, and signs of oxidation were observed. However, upon inspecting the central electrodes, they were found to have a normal coloration, indicating proper functioning (Figure 11).

Figure 11 - General view of the engine's spark plugs.

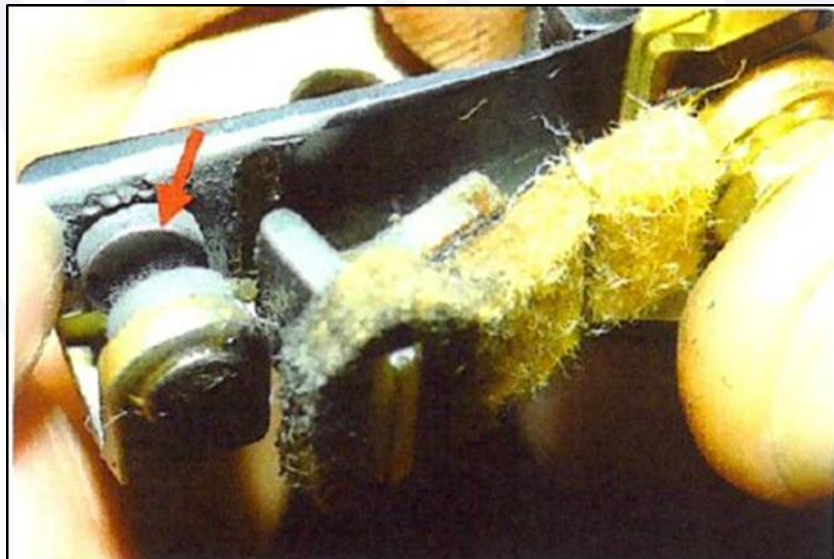
The magnetos were removed and bench-tested individually. During the test of the engine left magneto, it was observed that it did not operate normally, as the sparks produced were intermittent and random across all cylinders, even with variations in engine speed. Upon disassembly, it was found that the breaker points (contacts) were charred (Figure 12).

Figure 12 – Charring observed on the breaker points of the engine left magneto.

The combination of discrepancies observed in the engine right magneto and the intermittent sparking seen in the engine left magneto may have contributed to a failure, resulting in the loss of engine power.

During magneto testing, discrepancies were found, such as the presence of an unapproved washer and charring on the contact points, indicating possible flaws in the ignition system that could lead to irregular operation or engine power loss. Furthermore, there are indications that the PIC assumed maintenance responsibilities and made decisions that may have compromised the aircraft's integrity, such as using non-certified parts and making adaptations during repairs. Certain actions, aimed at cost-saving, may have introduced uncalculated risks to the aircraft's operability.

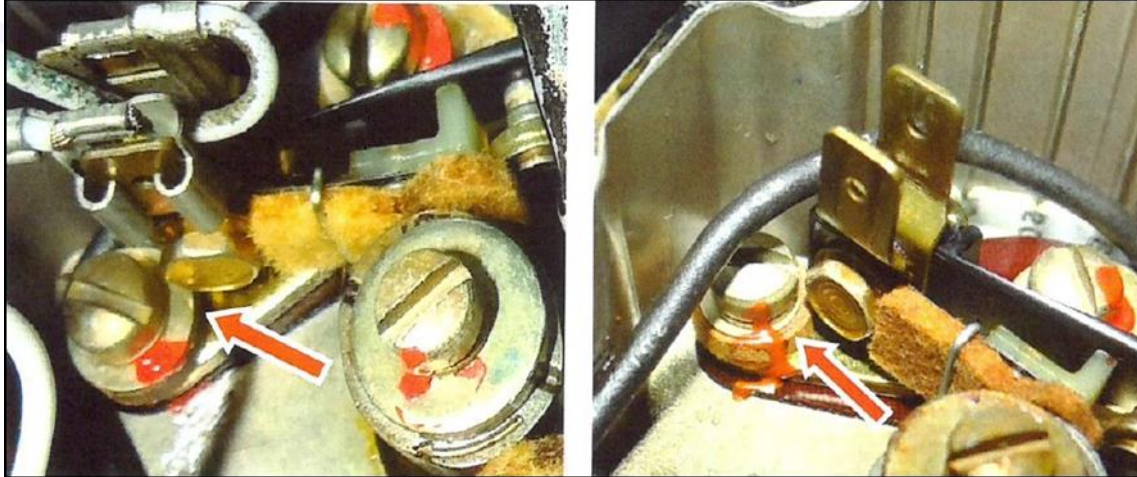
Continuing with the tests, the top part of the magneto was disassembled, and a discrepancy was observed in the breaker point responsible for generating the signal for the tachometer and governor controller. This breaker point worked completely insulated from the magneto housing (Celeron insulators were used for the insulation). However, the presence of a non-standard washer was noted, which was touching the screw that fastened the electrical terminals (Figure 13).

Figure 13 - Comparison between the assembly of the screw securing the electrical terminals of the engine right magneto (non-standard washer) and another similar magneto (correct washer).

The non-standard washer used in the assembly broke the insulation of the breaker point in question, potentially causing a degraded signal to the governor controller. Another discrepancy was observed in the breaker point contacts (pads), which were charred. This might also have contributed to the degradation of the electrical signal to the governor controller, indicating main rotor's low RPM.

During the course of the investigation, one observed the use of a non-standard washer that was in contact with the engine right magneto's electric terminal screw. This fact indicated inadequate maintenance performed on the aircraft, which may have contributed to a possible engine malfunction.

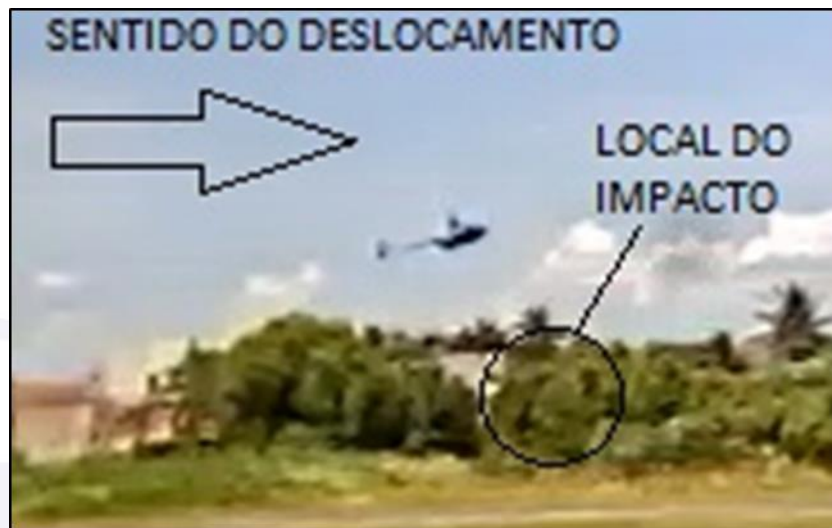
According to images captured by the security camera, at 10:27:48 a.m. (local time), the aircraft began its descent. After approximately six seconds, at 10:27:54 a.m. (local time), the aircraft initiated a movement similar to a flare, counteracting the high rate of descent at that moment (Figure 15).

Figure 15 - Aircraft PR-WVV moments before the impact with the ground.

The high rate of descent at which the aircraft impacted the ground, along with the left deviation in the final trajectory indicated improper use of the flight controls during a possible attempt to perform the autorotation procedure.
