COMANDO DA AERONÁUTICA
CENTRO DE INVESTIGAÇÃO E PREVENÇÃO DE
ACIDENTES AERONÁUTICOS

FINAL REPORT
A - 049/CENIPA/2016

OCCURRENCE:	ACCIDENT
AIRCRAFT:	PR-ZRA
MODEL:	CA-9
DATE:	19MAR2016

This is the Final Report of the 19MAR2016 accident with the CA-9 aircraft, registration PR-ZRA. The accident was classified as “[LOC-I] Loss of Control In-Flight”.

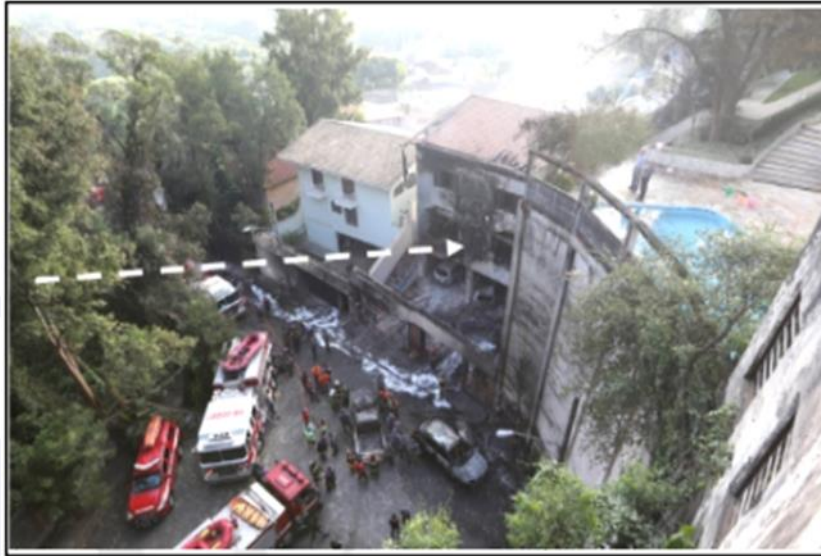
After takeoff, the aircraft did not gain altitude as expected and first collided against shrubs of a land, and later against a two-story residence, located about 240 meters to the right of the original threshold of SBMT runway 12 (Figure 8).

Figure 8 - Final trajectory and impact location of the aircraft.

The impact and fire that followed caused substantial damage to the front of this property.

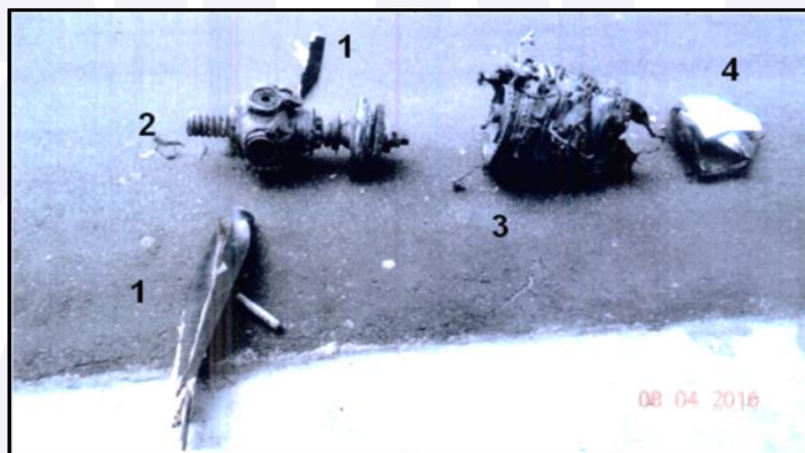
Only parts of the turbo propeller group and some accessories, damaged by impact and fire, could be recovered.

Fragments of the propeller blades were found 20 meters and 60 meters west of the impact site. These parts were on the roofs of houses near the one hit by the aircraft.

Figure 9 - Powertrain parts: 1) propeller blades; 2) reduction box; 3) hot section; 4) fairing.

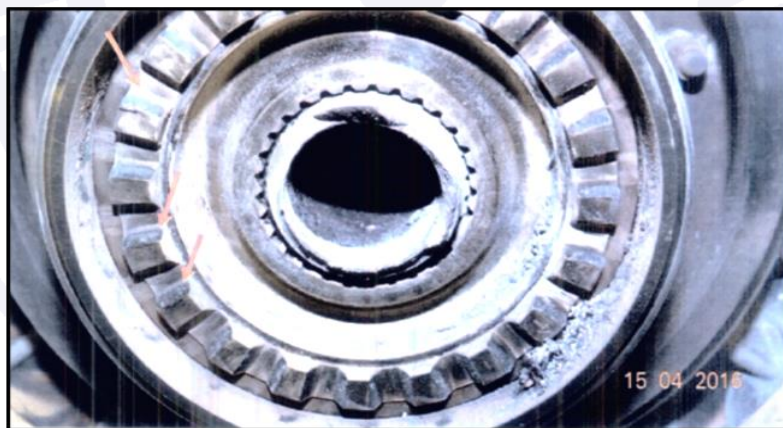
Friction marks in the compression centrifugal stage rotor and in the three turbine stages, the presence of superheated material deposited on blades and the existence of material that was ingested by the engine inside, among other aspects, corroborated to this conclusion.

Figure 10 - Centrifugal stage of the compressor showing damage to the trapezoidal teeth, sheared axis by overload and deposit of fragmented material.

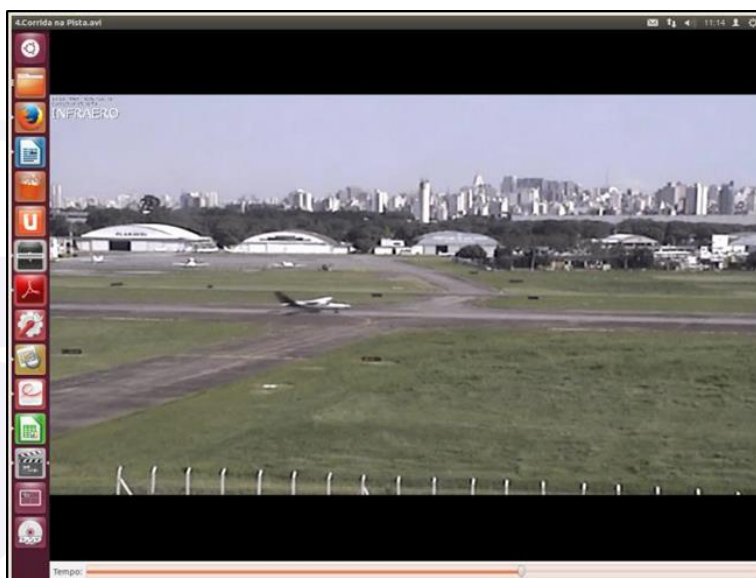
These images initially demonstrated an apparent normality at the start of the race on the runway.

Figure 11 - Takeoff run (view of the right side of the runway).

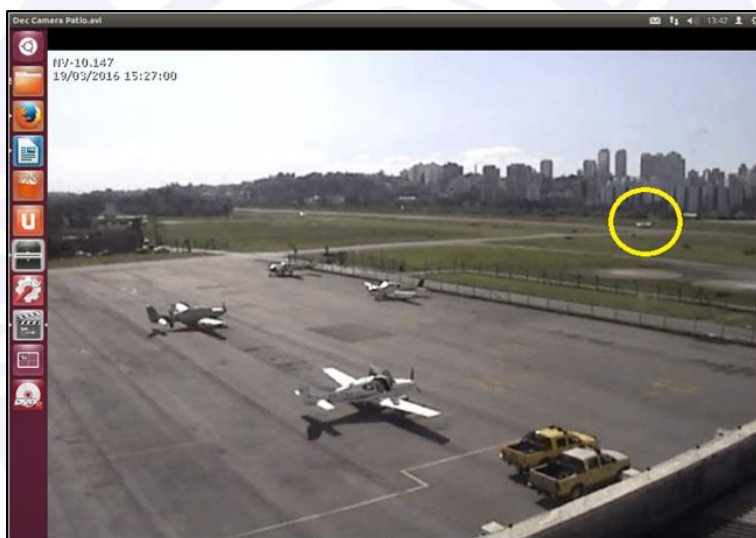
Figure 12 - Takeoff run (view of the left side of the runway).

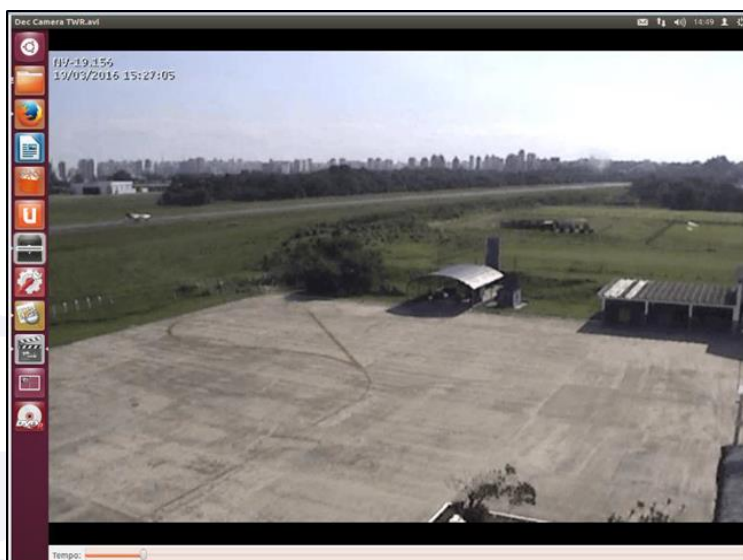
Figure 13 - Takeoff run (view of the right side of the runway).

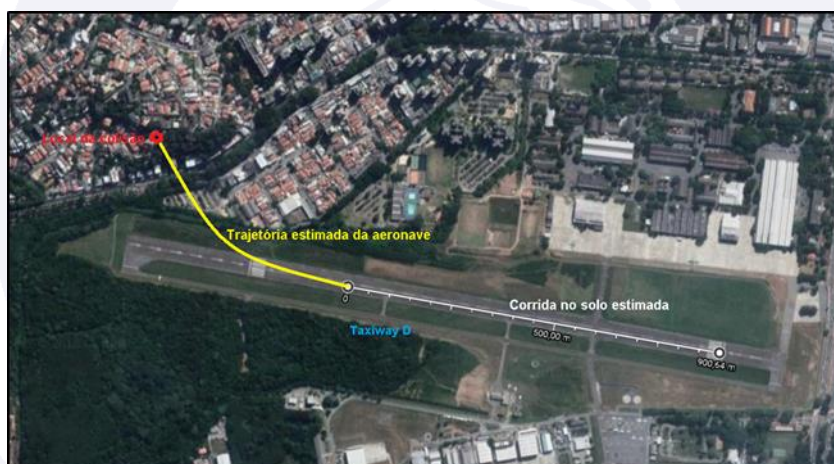
The images, made from points to the left and to the right of the takeoff trajectory, were digitally treated in a Computer Aided Design (CAD) program and georeferenced, from a high-resolution satellite image provided by the Aeronautics Institute of Cartography (ICA). This process allowed obtaining measurements of the distance covered by the aircraft during the takeoff run with a margin of error of 5 meters.

Thus, it was estimated that the ground exit occurred about 900 meters from threshold 30 and that during the race on the runway a speed of 87.47kt was reached.

Figure 14 - Sketch of the takeoff trajectory in SBMT.

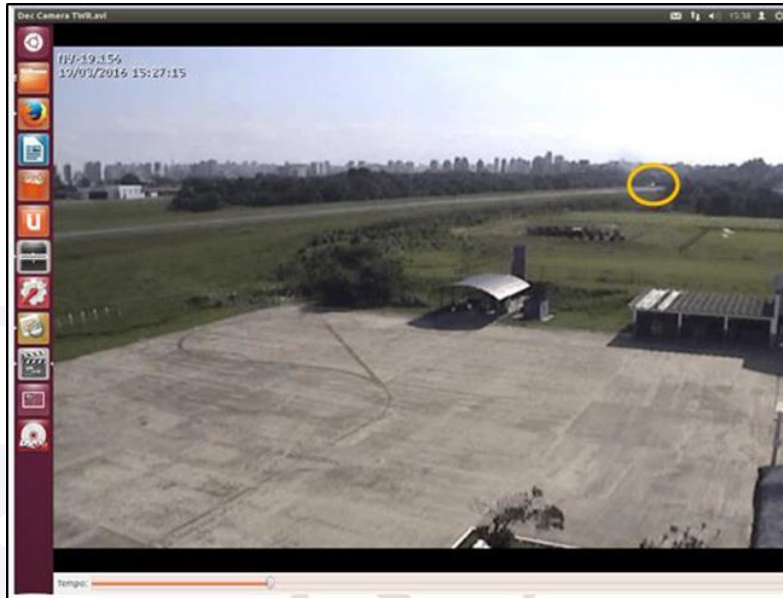
One of the last images of the takeoff, captured by the camera located in the Control Tower (Figure 15), suggests that by crossing the marks of the displaced threshold 12, the aircraft was still very close to the ground, corroborating the statements about the difficulty that the airplane demonstrated to gain height.

Figure 15 - Takeoff run (right view), ten seconds after Figure 13.
