FINAL REPORT
A - 168/CENIPA/2016

OCCURRENCE:	ACCIDENT
AIRCRAFT:	PR-AJF
MODEL:	AT-502B
DATE:	13DEC2016

This is the Final Report of the 13DEC2016 accident with the AT-502B aircraft, registration PR-AJF. The accident was classified as “[AMAN] Abrupt Maneuver and [SCF-NP] System/Component Failure – Malfunction Non-Powerplant / Loss of Component in Flight”.

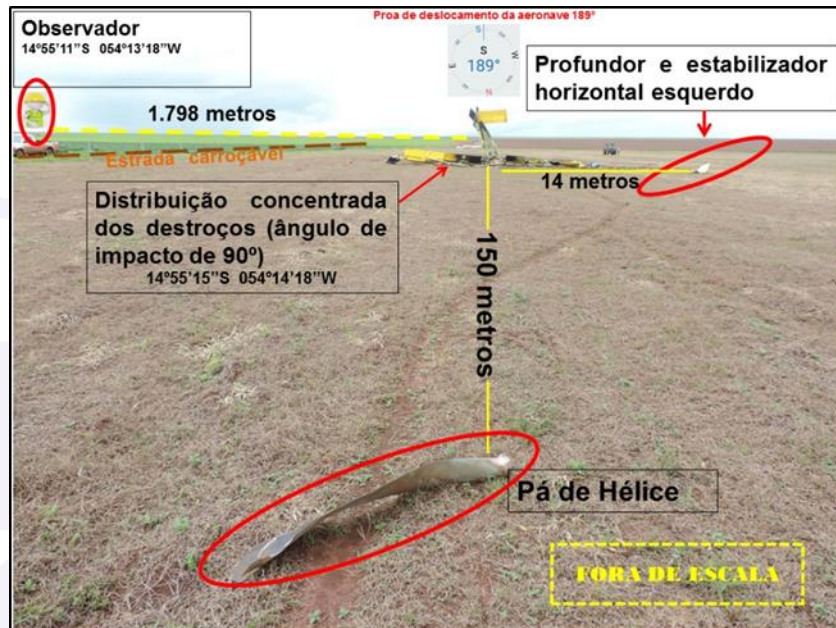
The distribution of the wreckage was of concentrated type. The nose of the aircraft was approximately pointed at the magnetic course 189°.

The impact occurred with the aircraft in a pitch down flight attitude (approximately 90° relative to the ground plane) and with high energy, causing a hole in the ground that housed the entire front section of the aircraft, up to the wings height.

Figure 1 - Distribution of the wreckage.

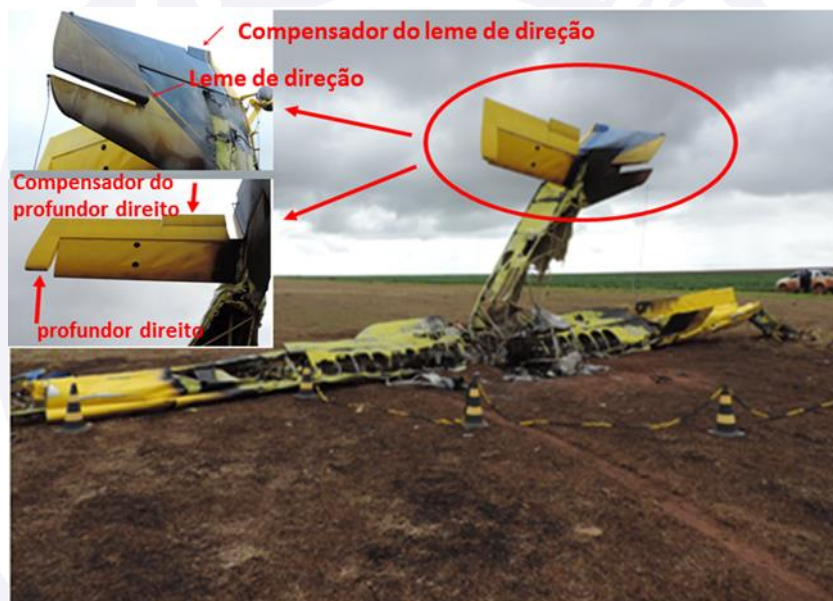
Figure 2 - Position of the command, control and trim surfaces.

Using as reference the aircraft direction of travel and its longitudinal axis, the steering rudder was deflected to the right and its associated trim tab was commanded to the left. The right elevator was deflected down and its associated trim tab was upward. The left horizontal stabilizer was fourteen meters from the wreckage site, indicating that it was detached in flight. The left elevator trim tab was in the neutral position.

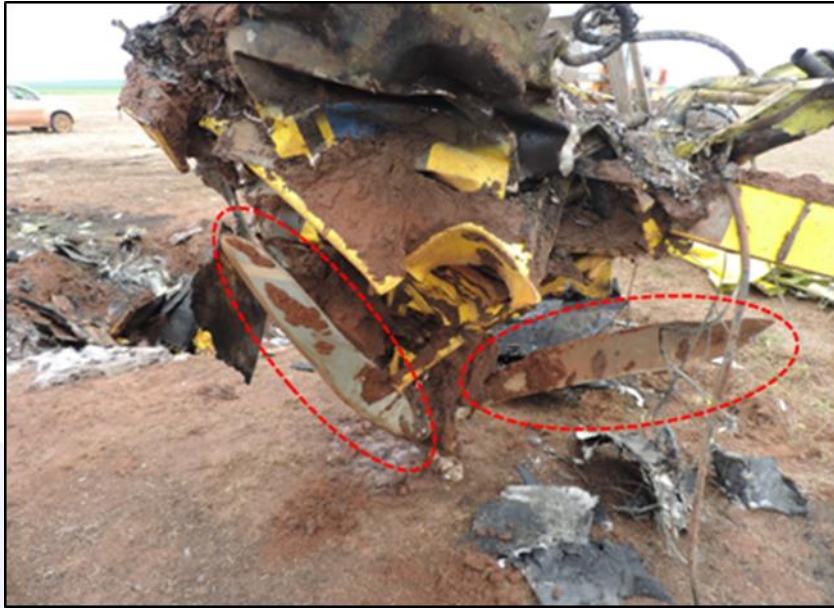
Components located in the tail cone section had substantial or minor damage. One of the three blades of the propeller assembly detached from its hub, due to the ratio of inertial and impact forces and was 150 meters from the wreckage site.

Figure 3 - Degree of the powertrain destruction and, in particular, only two of the three propeller blades.

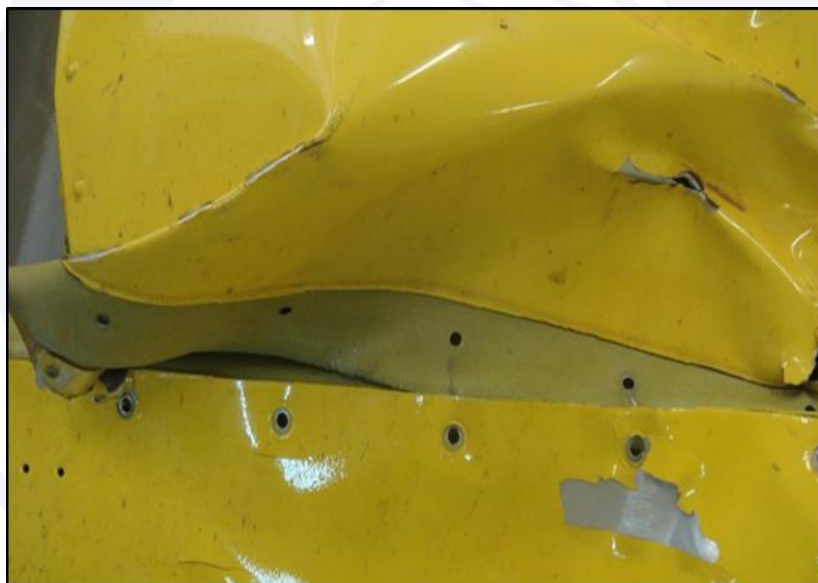
On visual examination, the surface of the left horizontal stabilizer could be observed with loss of rivets and plastic deformation of the coating (Figures 4 and 5).

Figure 4 - Loss of rivets on the left horizontal stabilizer surface.

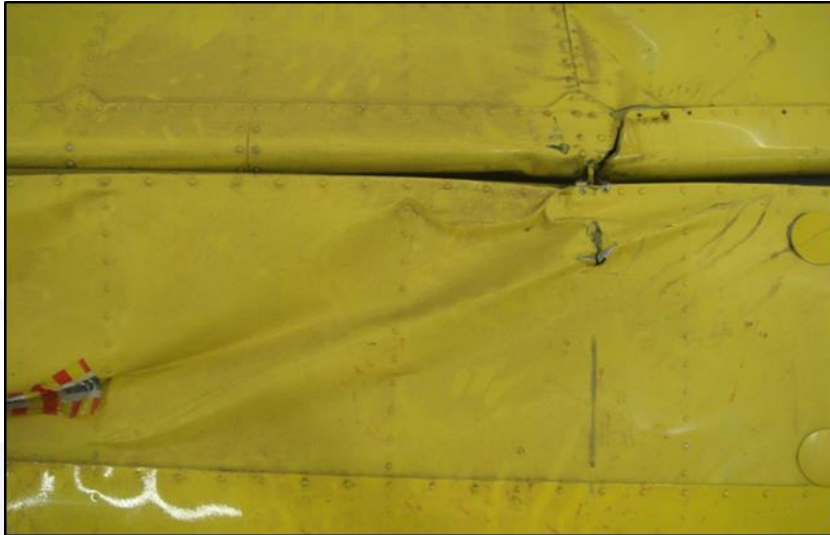
Figure 5 - Plastic deformation on the left horizontal stabilizer surface.

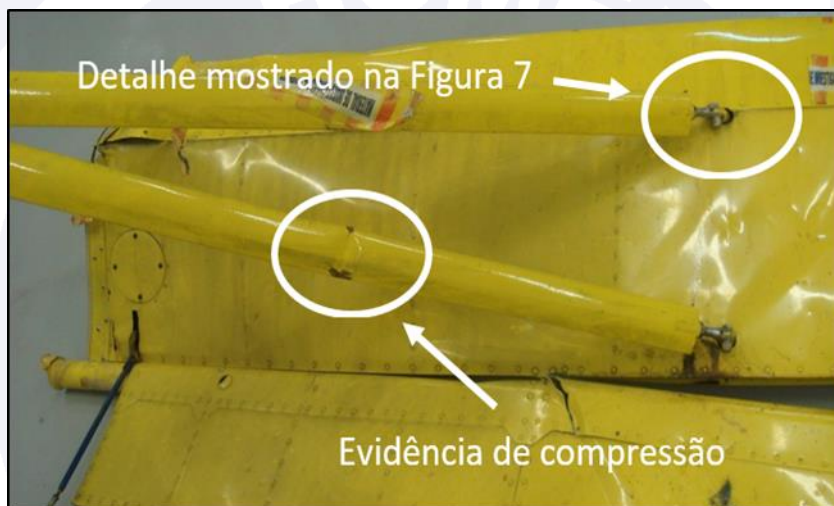
Stereoscopic examinations showed upstream overload by compression and tensile stresses (Figures 6 and 7), and it was also possible to observe fracture surfaces with typical overload characteristics (Figures 9 and 10).

Figure 6 - Overview of the brace strut and compression strain.

In the stereoscopic examinations performed on the left stabilizer / elevator assembly, there was overload in the amount of support by compression and traction efforts (Figure 6), and fracture surfaces with typical overload on the brace strut were also observed (Figures 9 and 10), corroborating the hypothesis of loss of control surface in flight, due to self-imposed overload.

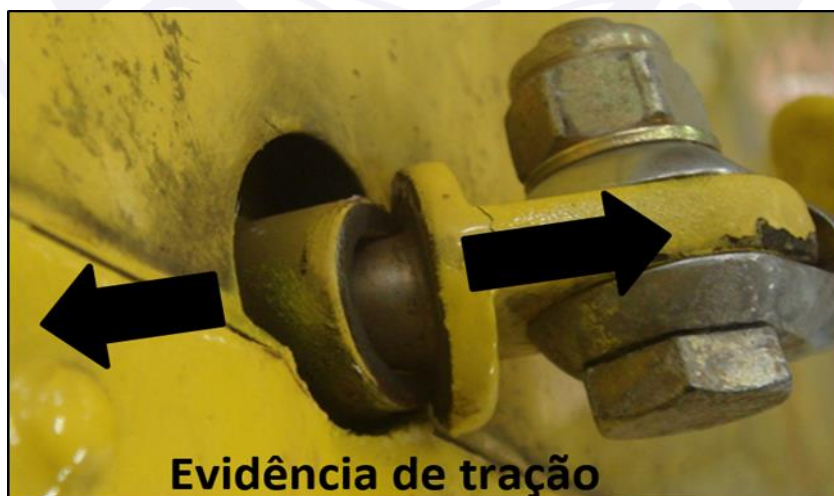
Figure 7 - Fastening of the brace strut with characteristic of overload and tensile deformation (detail of Figure 6).

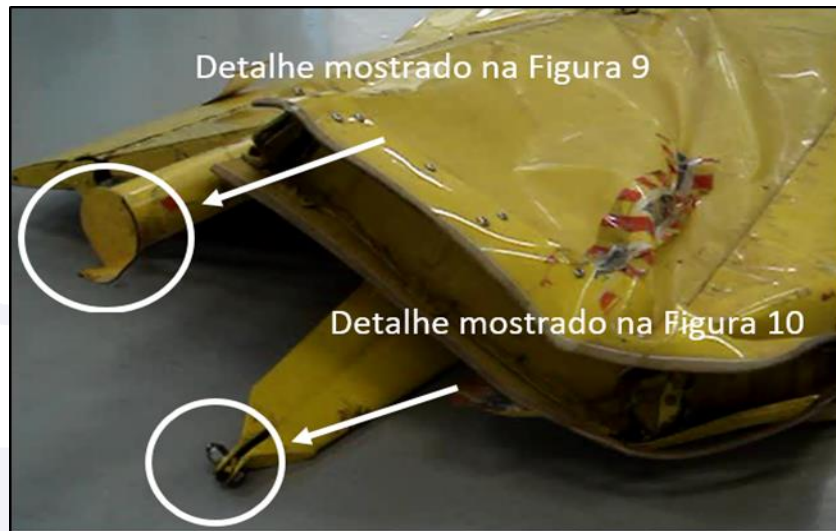
Figure 8 - End of the brace strut that was fixed to the aircraft structure.

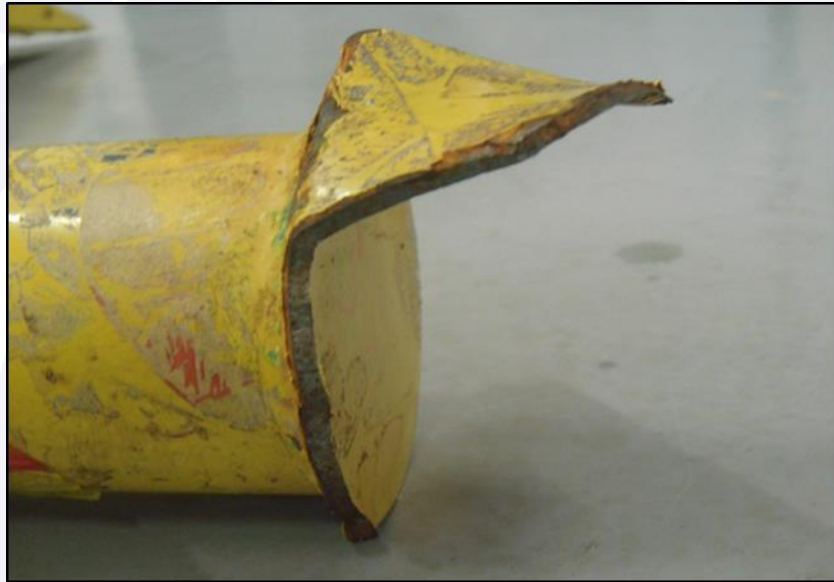
Figure 9 - Surface with typical characteristics of structure overload fracture (Detail of Figure 8).

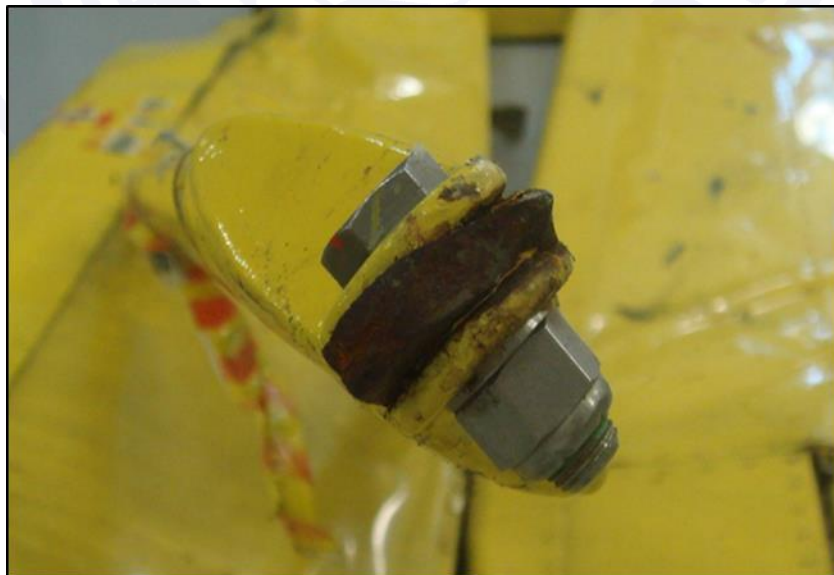
Figure 10 - Fracture surface with overload characteristic (Detail of Figure 8).

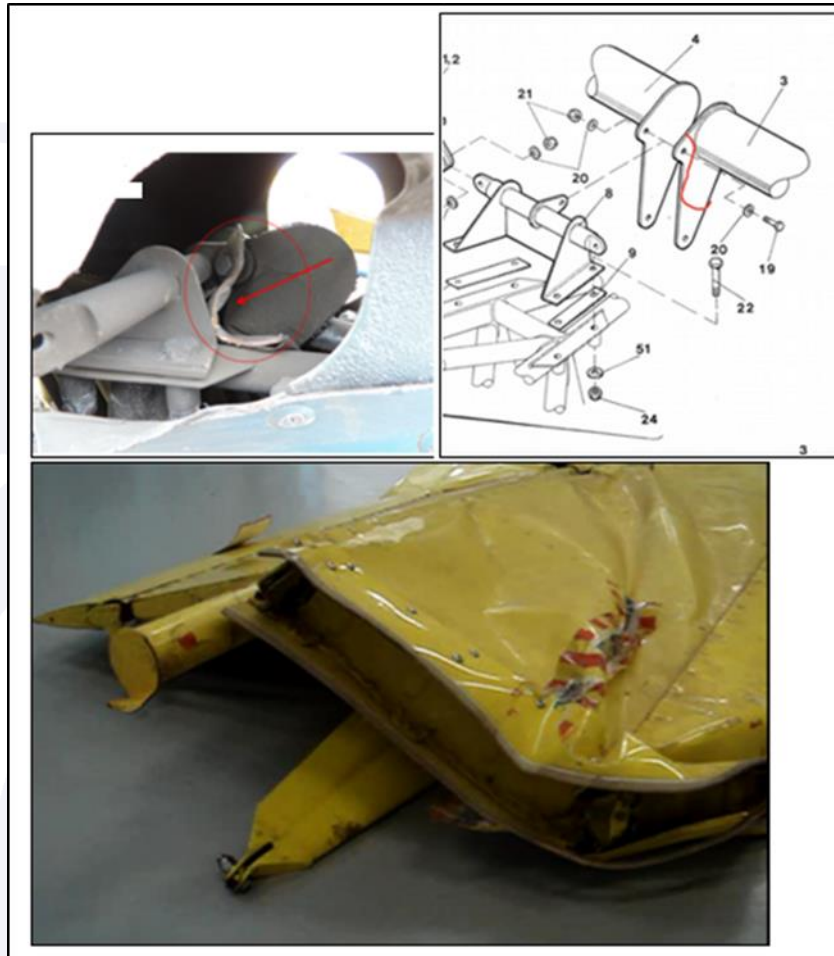
In addition, thinner metal sheets presented characteristics such as those found in Figure 11 below, indicating that they were subjected to excessive forces applied outside the sheet plane, where the junction surface of the elevator bar with the transfer bar, showed reversal of material on the edges, which is a characteristic of tear fracture.

Figure 11 - Tearing fatigue on the left elevator fixation frame.

In addition, thinner metal sheets presented characteristics such as those found in Figure 11, indicating that they were subjected to excessive forces applied outside the sheet plane, where the junction surface of the elevator bar with the transfer bar showed material reversal over the edges, which is a characteristic of tear fracture.

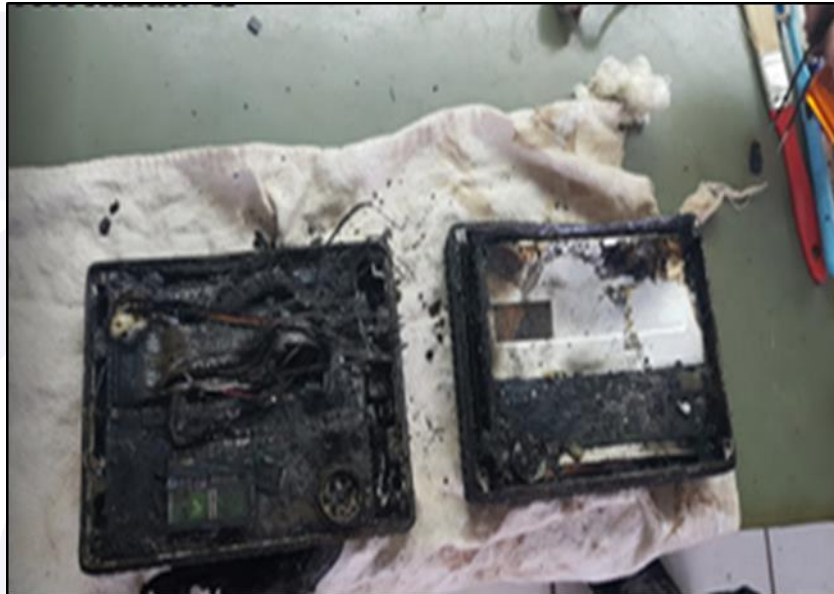
Despite the degree of carbonization and destruction of some of the internal components of the DGPS, the data extraction was successful and it was verified that the equipment had recorded information that corresponded to the accident flight with the PR-AJF aircraft, such as: day and hour; application area; flow rate of the applied product; magnetic heading; speed and altitude; etc.

Figure 12 - Physical conditions of the DGPS that equipped the PR-AJF aircraft upon its opening in a specialized laboratory.

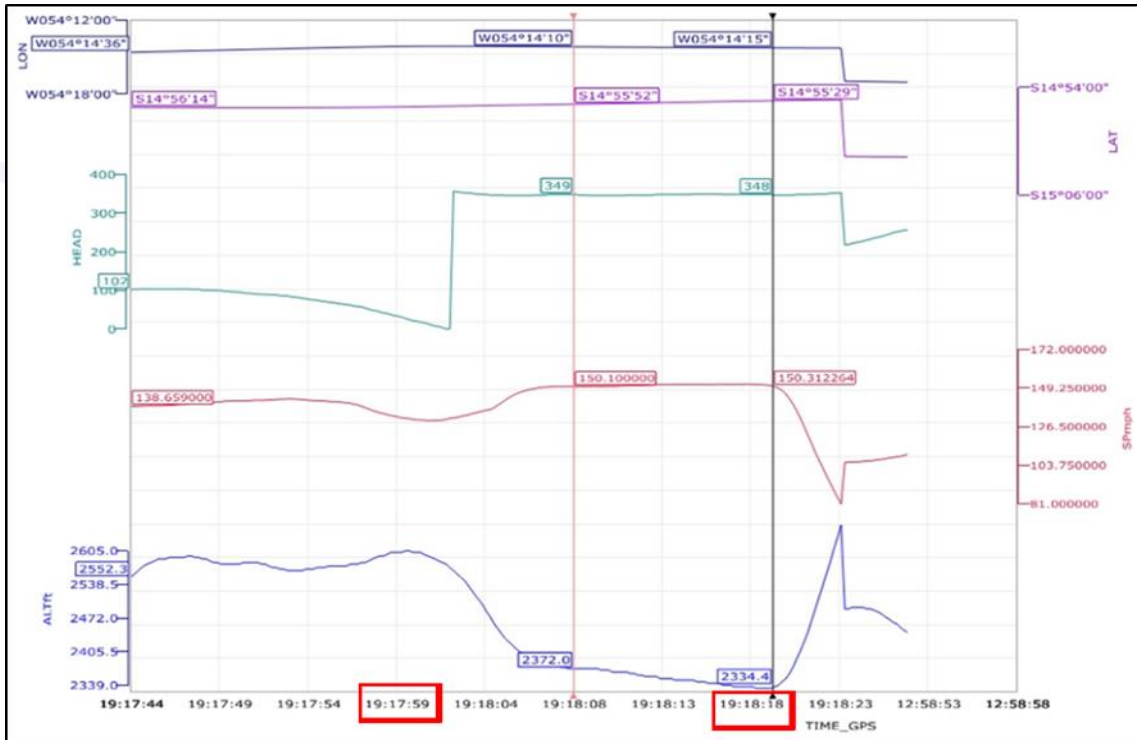
According to the DGPS transcribed data, at 19h17min59s (UTC) the PR-AJF maintained the flight with approximate values of magnetic heading 107°, 2,600ft of altitude and speed of 138 MPH (Figure 13), when it started a left turn downward, stabilizing at the magnetic heading 348°, an approximate altitude of 2,334ft, reaching and maintaining a

speed of 150 MPH at 19h18min18sec (UTC), spraying the final 70 liters of the remaining pesticide on the hopper.

Figure 13 - DGPS data during application.

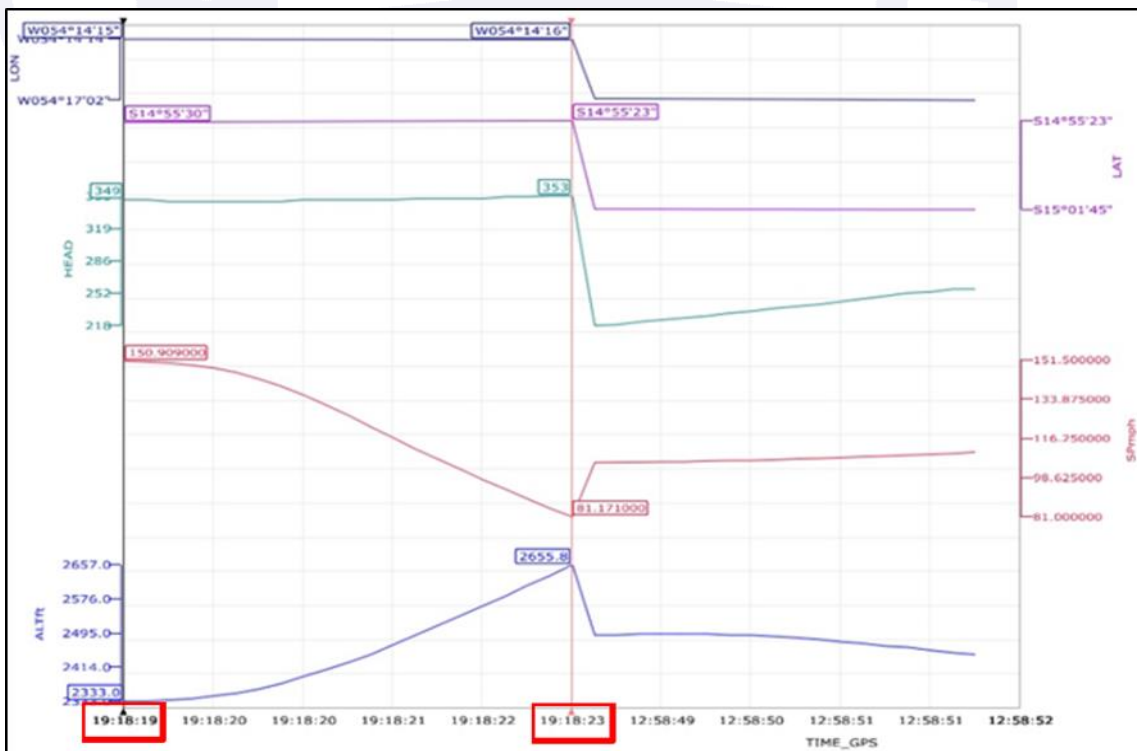
At 19h18min19s (UTC), the aircraft began an upward flight path (“recovery”), with a magnetic head ranging from 349° to 353°, reaching 2,655.8ft of altitude at its highest point, experiencing a speed reduction of 150 MPH to reach a minimum value of 81,17 MPH at 19h18min23s (UTC), that is, 4 seconds later. (Figure 14).

Figure 14 - DGPS data at the beginning of the change to a climb attitude (“recovery”) of the aircraft.

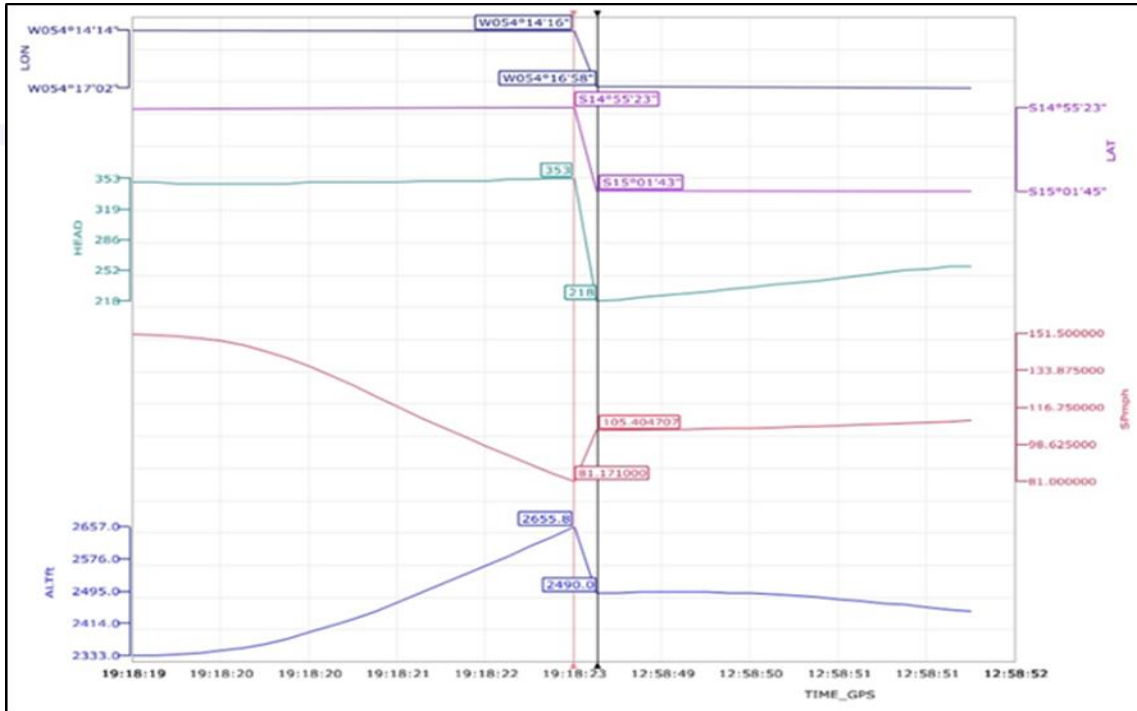
At this point (19h18min23s), the PR-AJF began a fast nose-left turn at a pitch down attitude, almost instantaneously reaching the magnetic heading of 219°, the altitude of 2,490ft and the speed of 105 MPH (Figure 15).

Figure 15 - DGPS data at the moment corresponding to an instantaneous change in the heading, speed and altitude values of the aircraft.

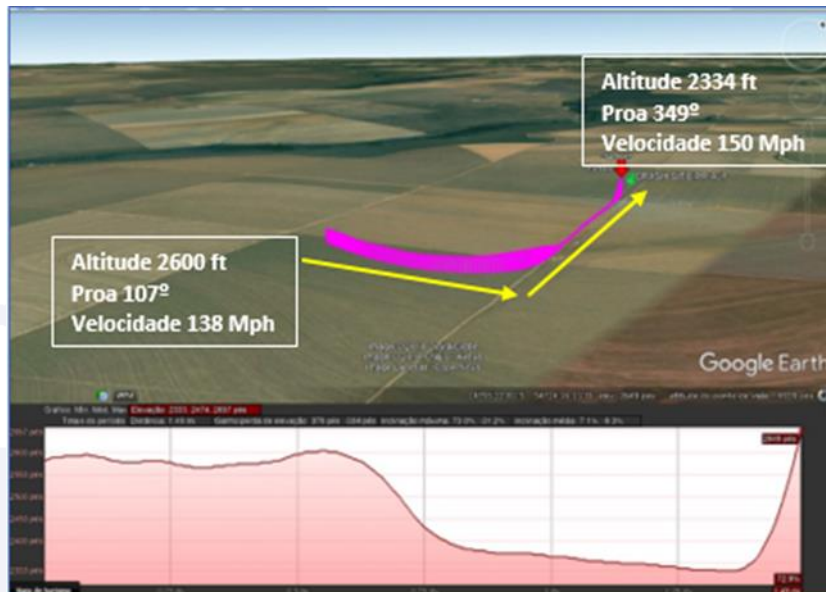
Figure 18 - Aircraft trajectory in the moments before the collision.

At 150 MPH (130kt CAS), the aircraft began a sudden maneuver that reached 2,655.8ft altitude at its highest point. The speed reached a minimum value of 81.17 MPH (70kt CAS) with magnetic heading of 353° at 19h18min23sec (UTC), that is, only 4 seconds after the start of the maneuver.

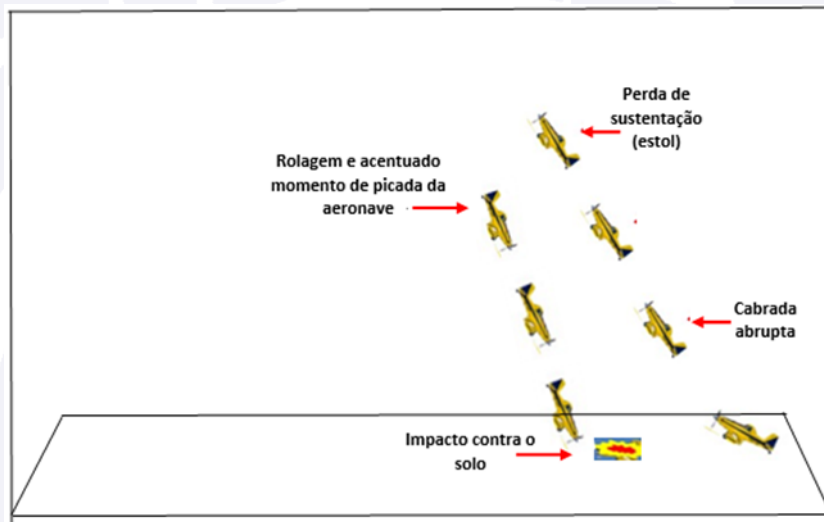
The left turn (fast nose turn) started at 19h18min23s (UTC) and the entry, then, in an attitude of pitch down flight to the collision against the ground, evidenced by the DGPS data, as shown in Figure 15, reveals a left head variation (from 353° to 218°), increase of longitude value W and increase of speed value.

Figure 19 - Lateral profile of the accident dynamics.
