COMANDO DA AERONÁUTICA
CENTRO DE INVESTIGAÇÃO E PREVENÇÃO DE
ACIDENTES AERONÁUTICOS

FINAL REPORT
A – 066/CENIPA/2014

OCCURRENCE:	ACCIDENT
AIRCRAFT:	PR-OAF
MODEL:	F28MK0100
DATE:	28MAR2014

This is the Final Report of the 28MAR2014 accident with the F28MK0100 aircraft, registration PR-OAF. The accident was classified as “[SCF-NP] System/Component Failure or Malfunction Non-Powerplant / With Landing Gear”.

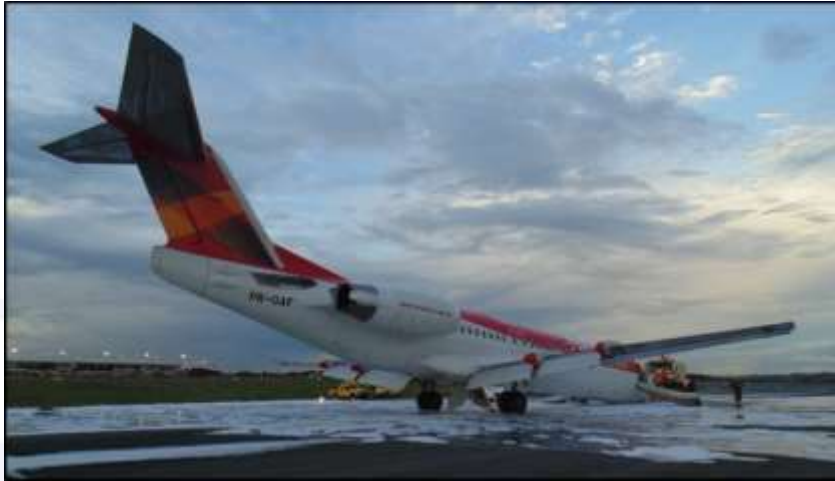
The aircraft had substantial damage to structural elements near the nose section.

Figure 1 - Aircraft after its stop on the runway.

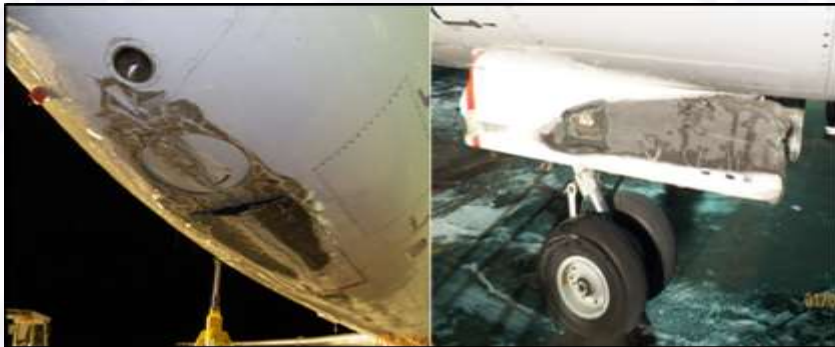
The coating of the nose landing gear doors and the surrounding area has been severely worn, eventually breaking up, due to friction against the runway surface.

Figure 2 - Detail of the damage after lifting the aircraft and lowering the nose landing gear.

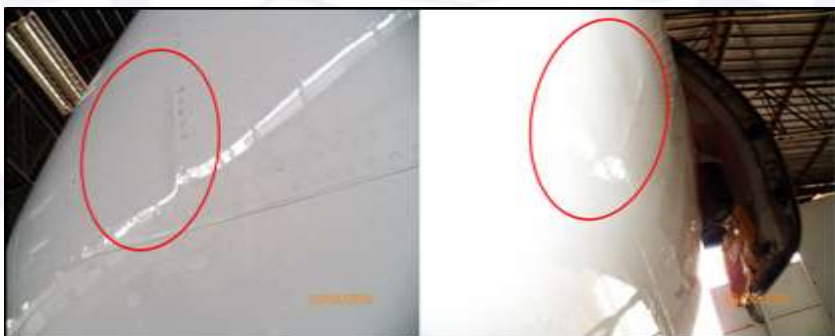
The fuselage coating, in an area in front of the passengers' door, was deformed and some rivets "worked".

Figure 3 - Detail of the deformation in the coating and deformed rivets.

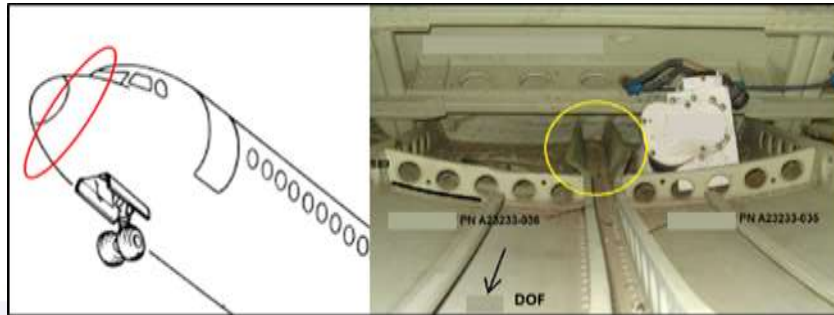
In the inner region of the fuselage, in front of the nose landing gear housing, there was the deformation of the structural elements (LH and RH stiffner), where the FWD pressure bulkhead skin was attached.

Figure 4 - Affected area and detail of the deformation in structural elements.

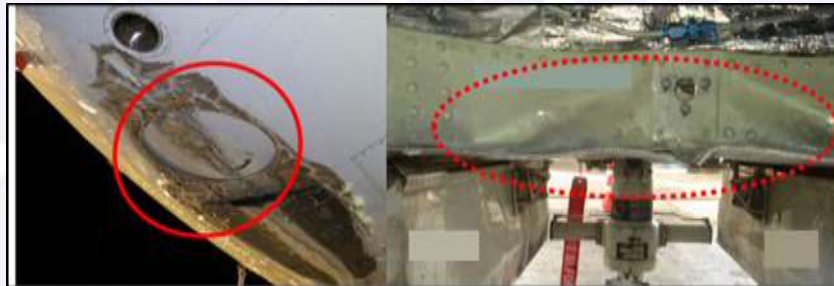
The surrounding frame of the fuselage access door, which was in front of the nose landing gear housing, was deformed.

Figure 5 - Door frame location and deformation detail.

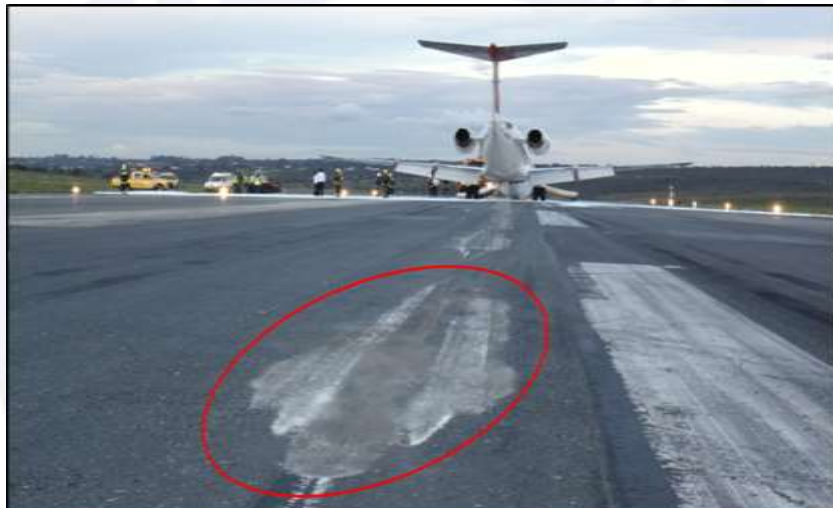
Due to the non-lowering of the nose landing gear, the impact of the fuselage occurred on the runway. The aircraft had substantial damage to structural elements near the nose section.

Figure 9 - Mark of the first fuselage impact.

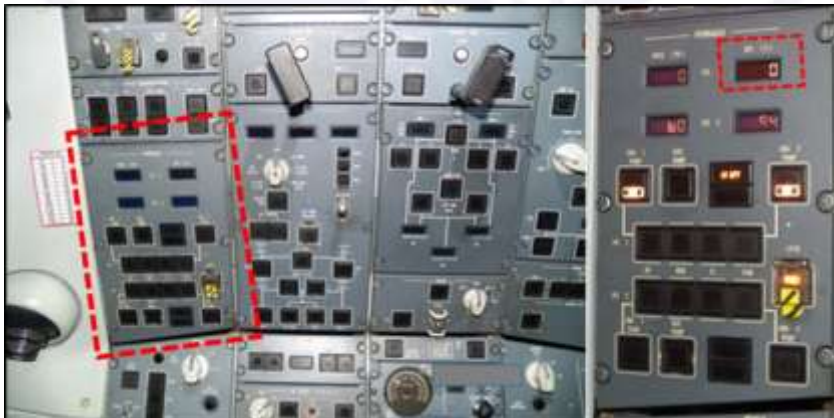
The amount of hydraulic fluid indicated on the panel above the pilots' head, in the upper left corner of the flight cabin, referring to system 1, was of 0%.

Figure 12 - Hydraulic panel detail and amount of fluid in the system 1.

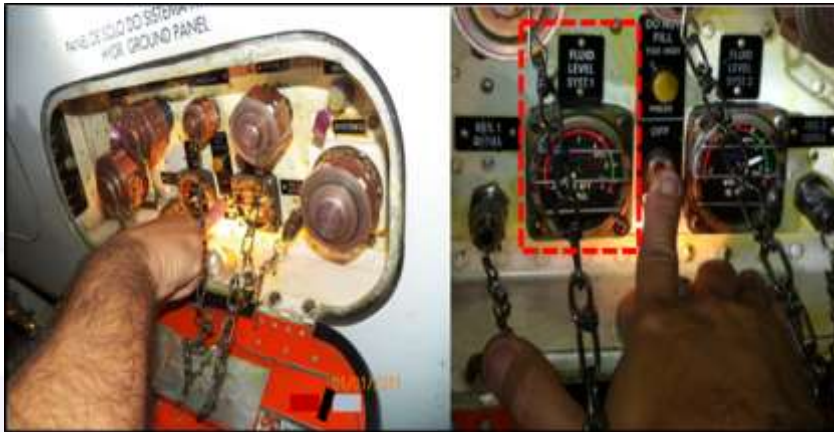
On the ground hydraulic panel, the indicated amount of fluid was in zero gallons.

Figure 13 - Hydraulic ground panel and fluid amount detail in system 1.

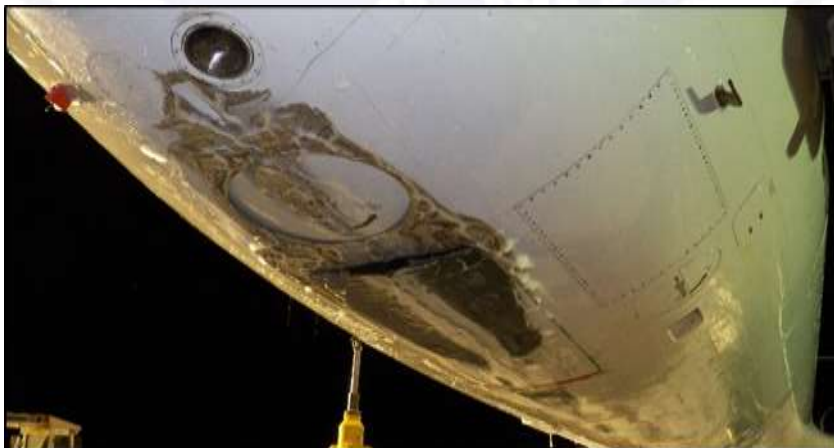
The nose landing gear was found unlocked and had started the lowering course. The wheels were propped on the inside of the doors, which were unlocked and had begun to open.

Figure 15 - Partially open landing gear doors.

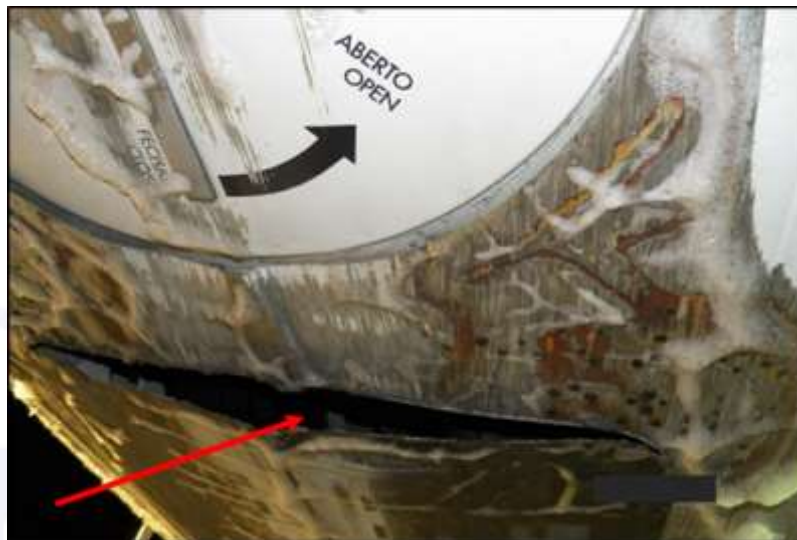
Figure 16 - Wheels resting on the doors.

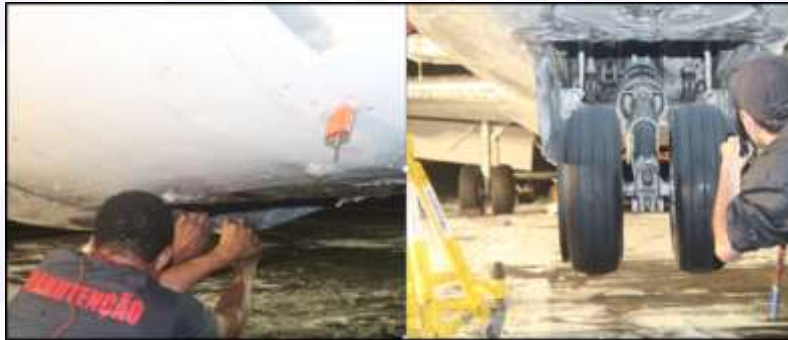
The doors were opened with great manual effort. After opening, the nose landing gear, which was resting on them, lowered by gravity.

Figure 17 - Opening of doors with manual effort and lowering by gravity.

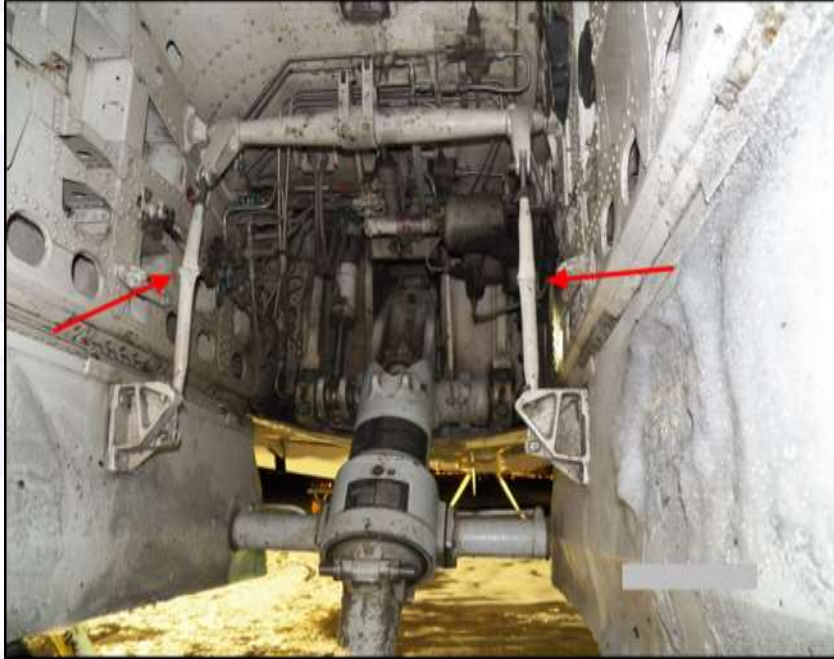
It was found that the rods responsible for opening and closing the landing gears doors suffered plastic deformation, caused by buckling, due to an axial compression effort. After lowering the nose landing gear, the rods separated into two sections each with slight manual effort.

Figure 19 - Deformed rods.

The deformation found was compatible with a dynamics in which the door mechanism acted to open them, imposing an axial effort on the rods. The doors, in turn, did not open completely and consequently produced a reaction force on the rods, resulting in

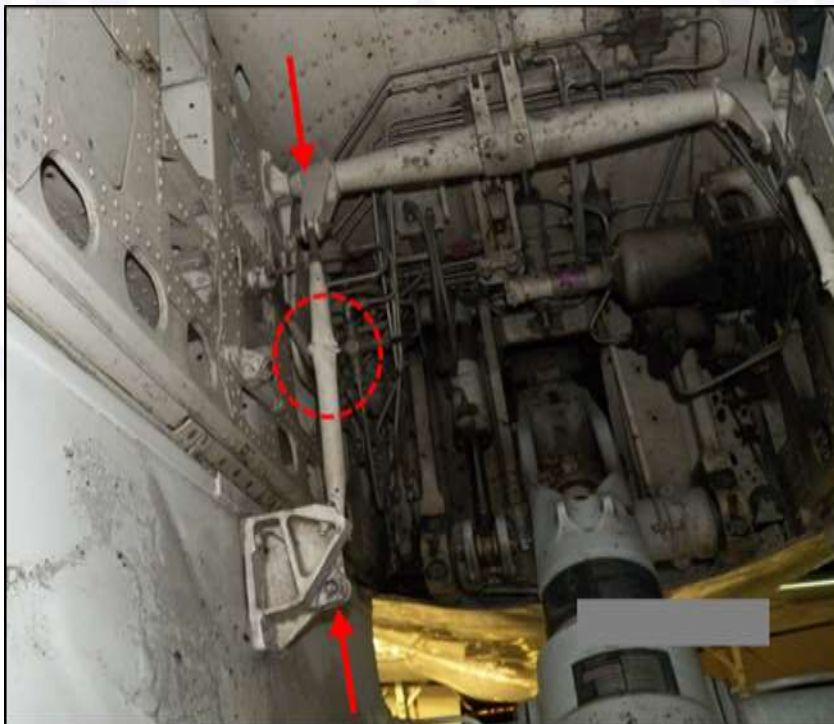
Figure 20 - Effort in the rod and bent area, partially sectioned.

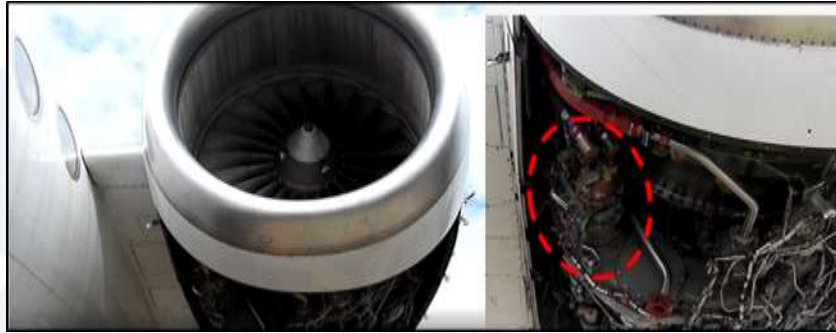
It was identified that the left engine EDP1 was experiencing hydraulic fluid leakage.

Figure 21 - Left engine and EDP1 detail.

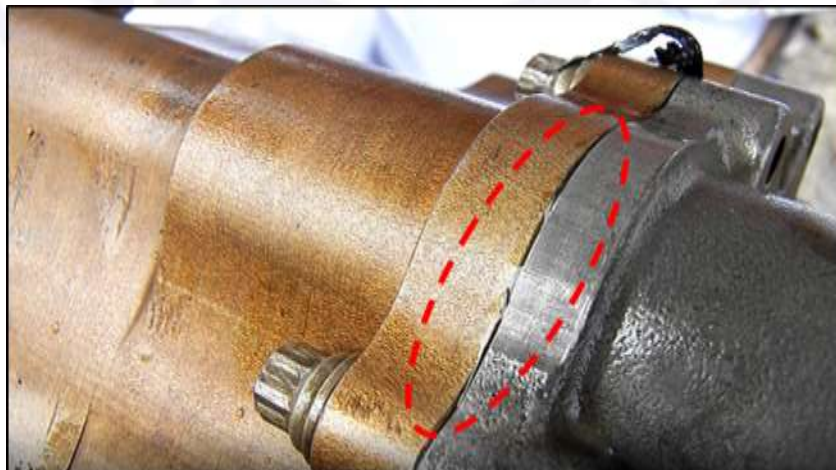
The EDP1 was removed and it was found that there was fluid leakage through the pump body, specifically by the gasket between the sections that make up the pump body, called mounting flange and housing.

Figure 23 - Detail of the gasket leak in the body of the EDP1.

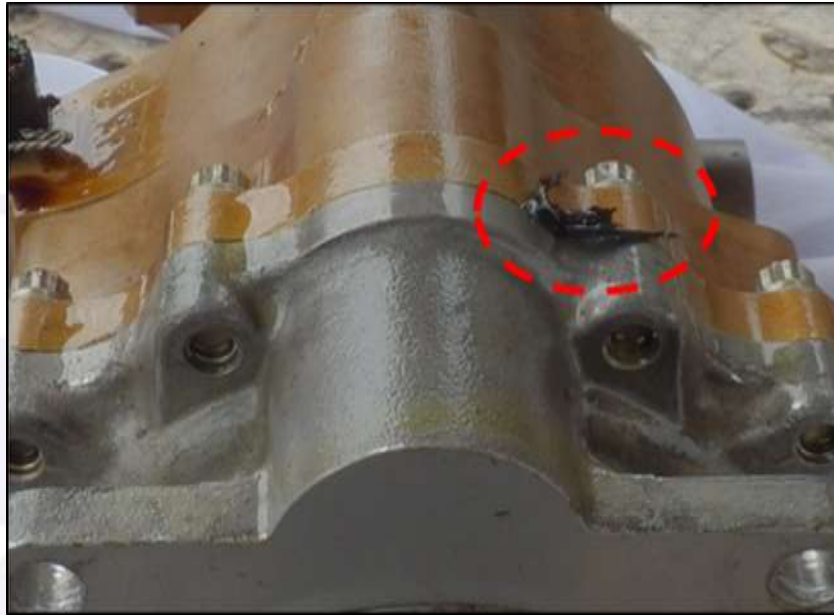
It was also found that the seal that was internally housed at the junction of the mounting flange and housing sections underwent an extrusion process.

Figure 24 - Detail of the seal that was extruded.

The hydraulic pump was taken to EATON Aerospace to investigate the cause of fluid leakage. Upon disassembly, it was confirmed that the molded gasket between the mounting flange and the housing had been extruded. PN 341185 identified the gasket. According to EATON Aerospace, the most frequent causes of gasket extrusion were related to pressure transients inside the pump casing.

Research conducted on the hydraulic pump was sufficient to identify that fluid leakage occurred due to extrusion of a molded gasket. This gasket was between two sections of the pump body in an area that was only worked on when the pump was submitted to repairs or overhaul.

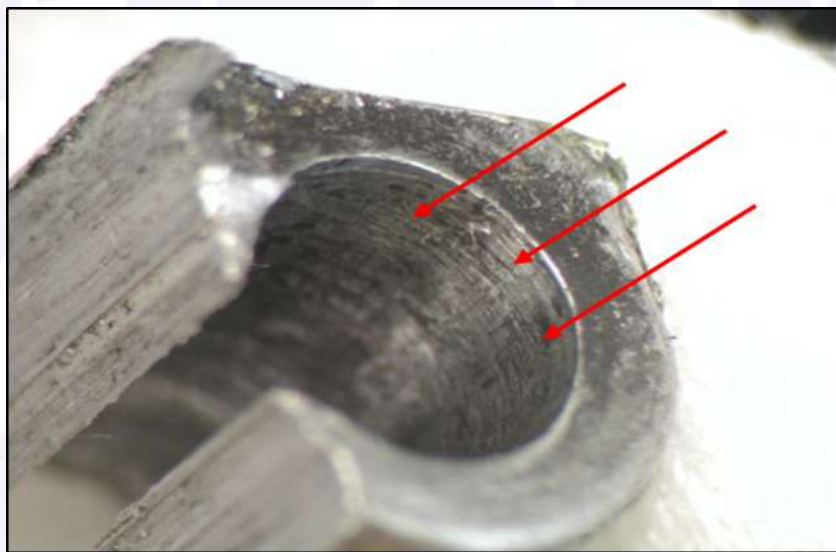
Figure 29 - Inner area of the right hinge front door lobe and detail of the scratches.

- the interference in the hinges movement was evidenced by the scratches on the hinges pins and on the internal area of the hinges lobes. This was observed on all right-door hinges;

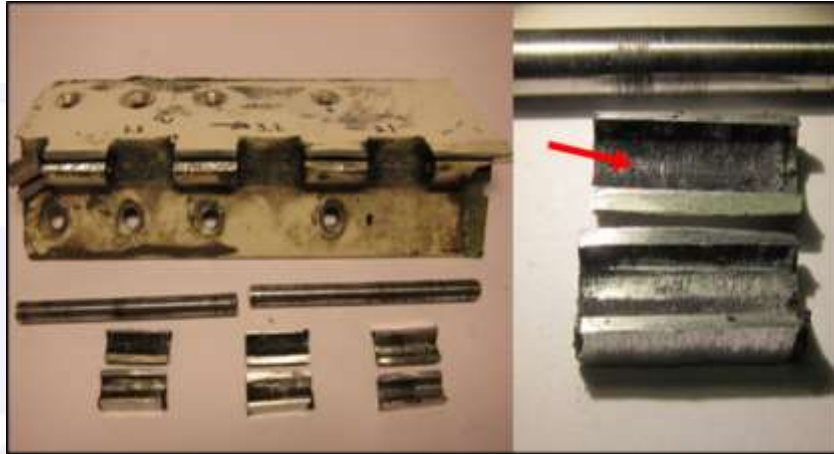
Further research was conducted so that the hinges were sectioned so that the internal relief of the lobe surface could be better observed. The result indicated that there was expansion of the superficial layers, due to an oxidation and corrosion process, which led to a decrease in the inner diameter of the lobes at some points and, consequently, a more intense rubbing of the inner area of the lobes with the pins.

Figure 30 - Sectioned hinges lobes and internal corrosion detail.

When the hinges were sectioned so that the internal relief of the surface of the lobes could be better observed, it was found that there was expansion of the superficial layers due to an oxidation and corrosion process.
