**COMANDO DA AERONÁUTICA**  
**CENTRO DE INVESTIGAÇÃO E PREVENÇÃO DE**  
**ACIDENTES AERONÁUTICOS**

**FINAL REPORT**  
**A - 036/CENIPA/2019**

<b>OCCURRENCE:</b>	<b>ACCIDENT</b>
<b>AIRCRAFT:</b>	<b>PR-OCW</b>
<b>MODEL:</b>	<b>A320-214</b>
<b>DATE:</b>	<b>03MAR2019</b>

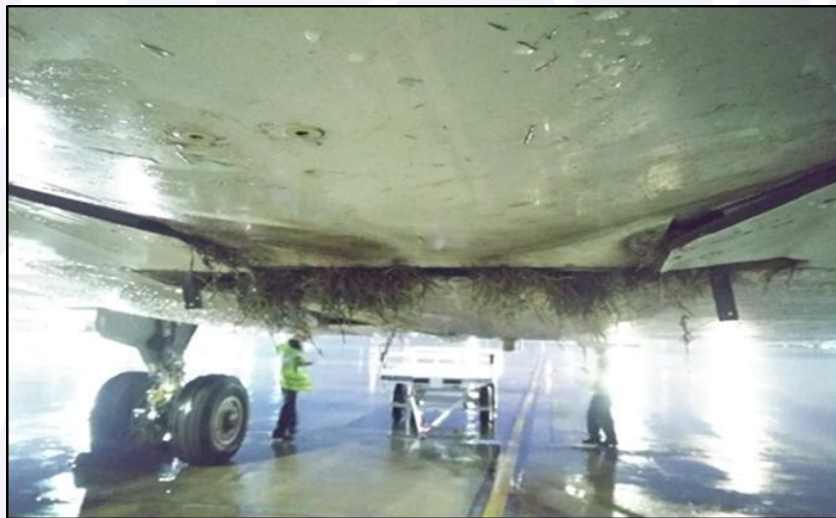
The supervision of aprons and runways, when receiving flight O66227 in position 20 at the apron 1, was communicated by the mechanic of the airline about the presence of grass stuck in the lower fuselage and landing gear of the PR-OCW aircraft.

Figure 3 - Lower fuselage of the aircraft with grass stuck in it.

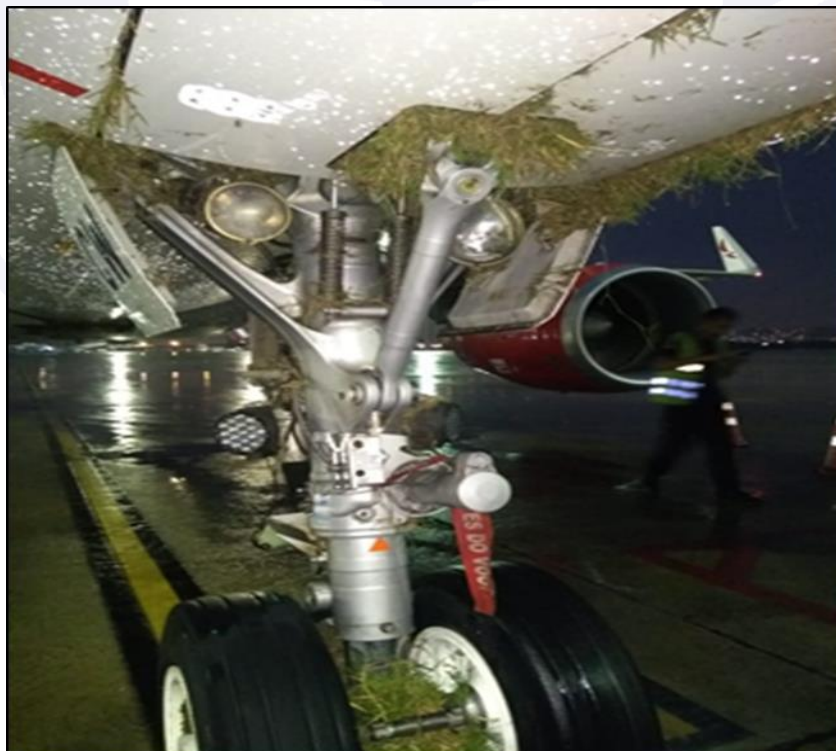
Figure 4 - Nose landing gear with grass stuck in it.

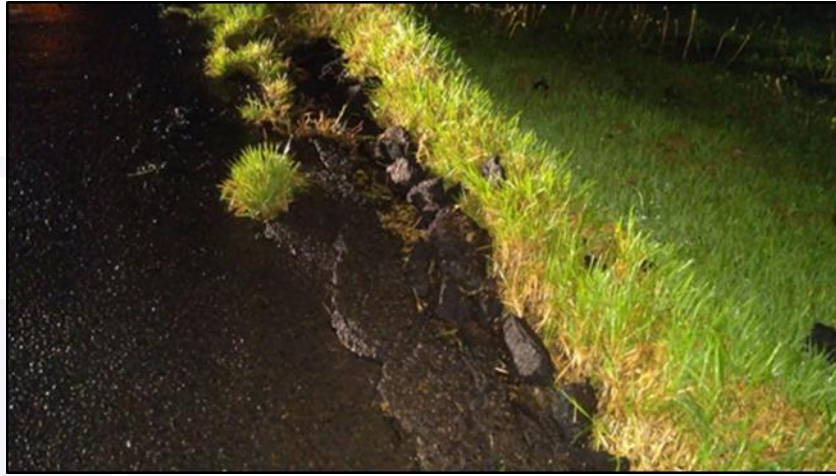
The supervision of aprons and runways requested the inspection of runways 10/28 and 15/33. The inspection located grass and pieces of asphalt on the right side of runway 15, between taxi lanes C and D, with the tire tracks of the aircraft.

Figure 5 - Runway 15 asphalt damaged by the passage of the aircraft's main landing gear.

After confirmation of the event by the supervision, the concessionaire proceeded to clean runway 15 according to the procedures prevised and normal operation was restored at 2100 (UTC) on 04MAR2019.

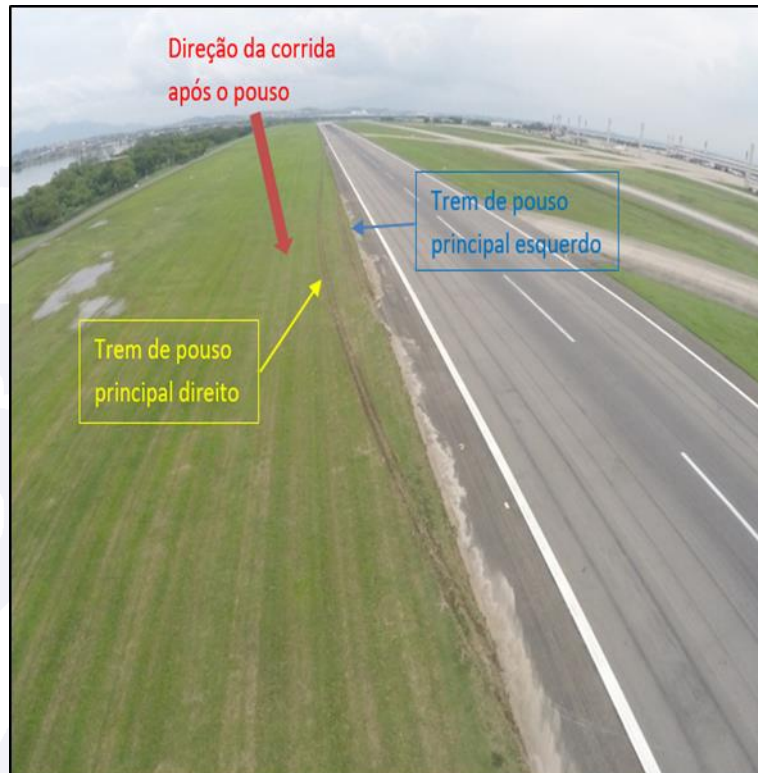
This last condition was proven by the fact that, despite having traveled about 660m outside the asphalt strip, the crew managed to return to the runway limits, complete the return taxi and safely disembark the passengers.

Figure 6 - Panoramic view of the aircraft's trajectory during the landing roll.

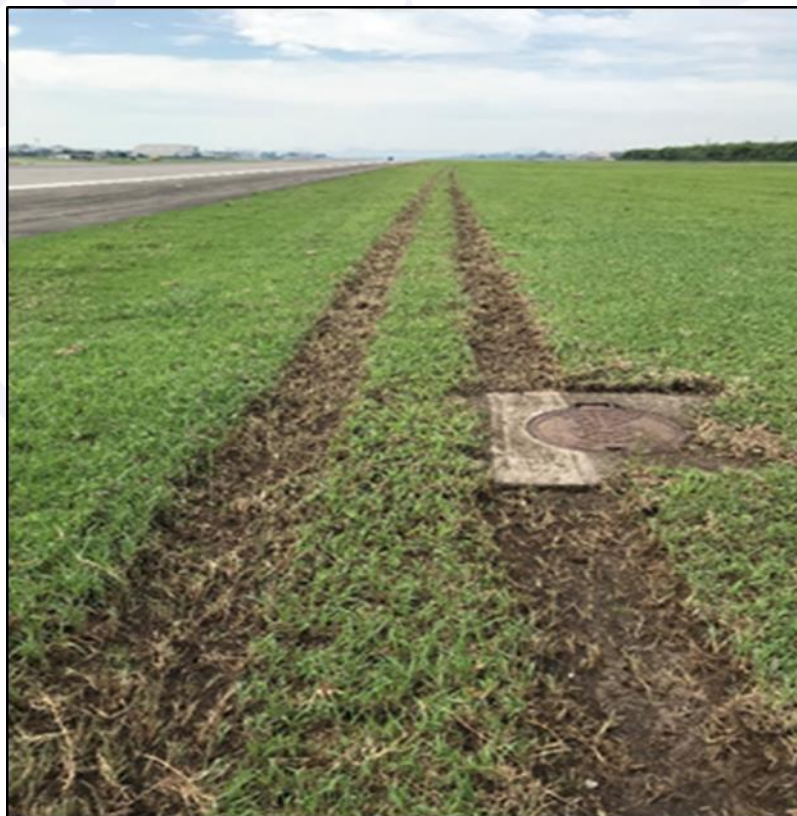
Figure 7 - Leveled concrete box in the strip area (lane 15/33).

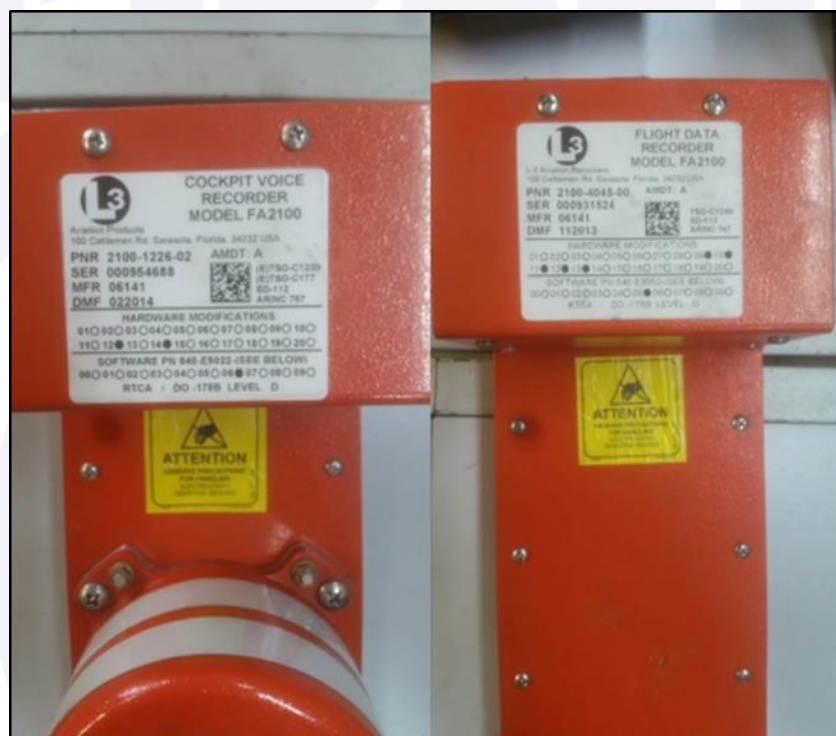
Both flight data and cabin voice recorders recorded data related to the occurrence (Figure 8).

Figure 8 - Flight recorders intact and in good condition.

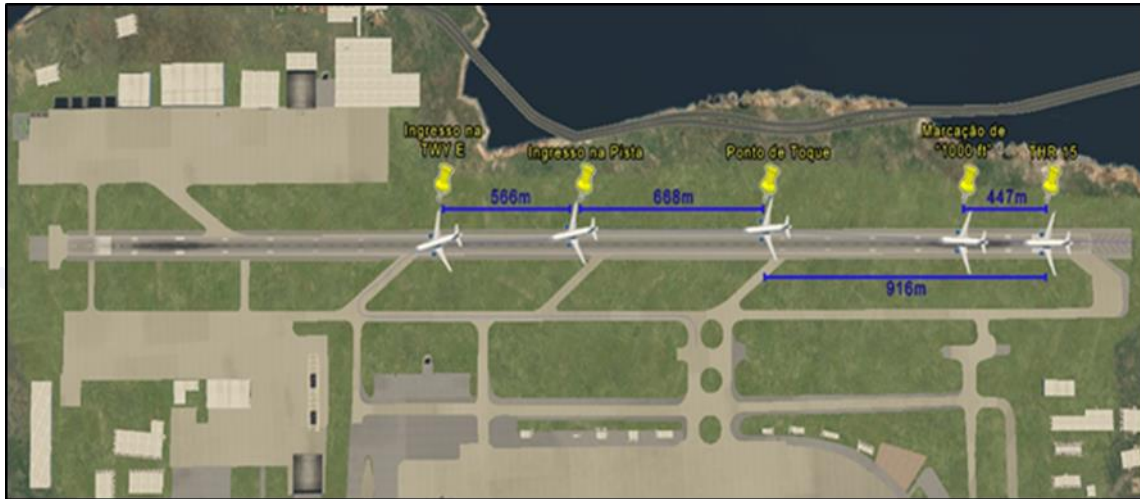
The contact of the aircraft with the ground occurred about 916m far from the threshold 15 with the right main landing gear completely outside the lateral limits of the runway, speed of 121kt, descent rate of 400ft / min, magnetic heading of 140° and flight path of 149°. After landing, the aircraft traveled 668m outside the runway. The pilot regained control of the aircraft and returned it to runway 15 (Figures 9 and 10).

Figure 9 - Place of the aircraft's first contact with the ground and trajectory after contact.

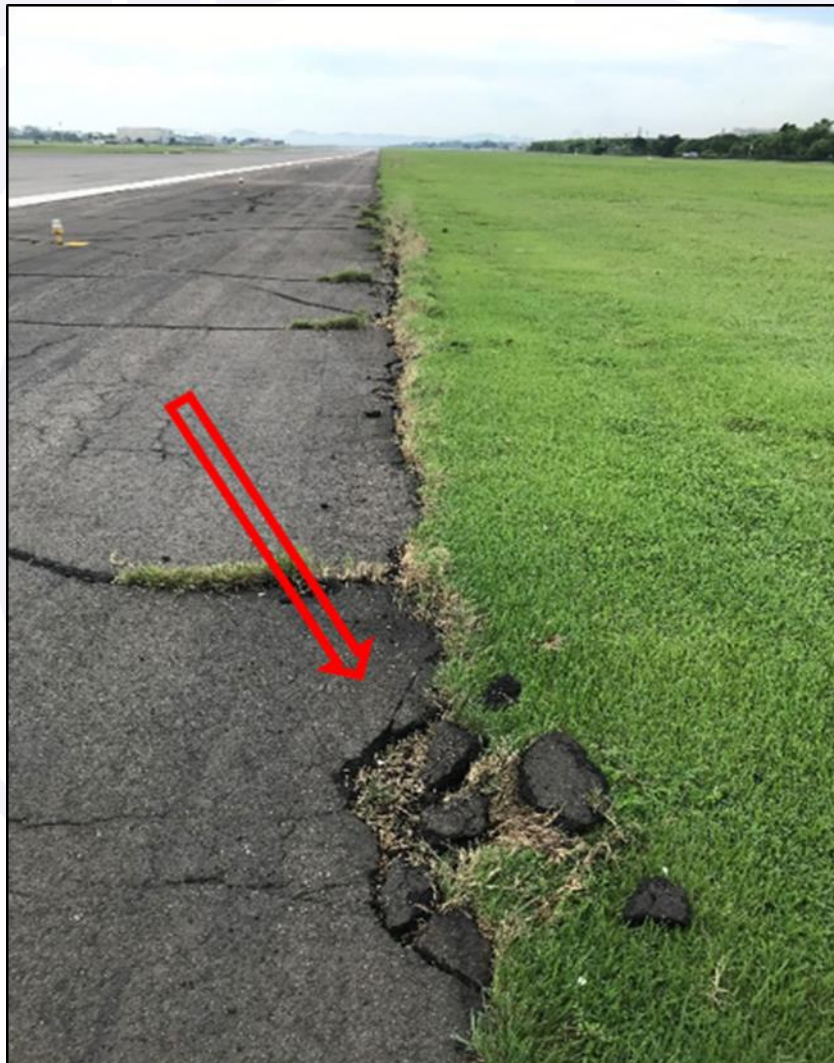
Figure 10 - Place of the first contact of the right main landing gear with the ground.

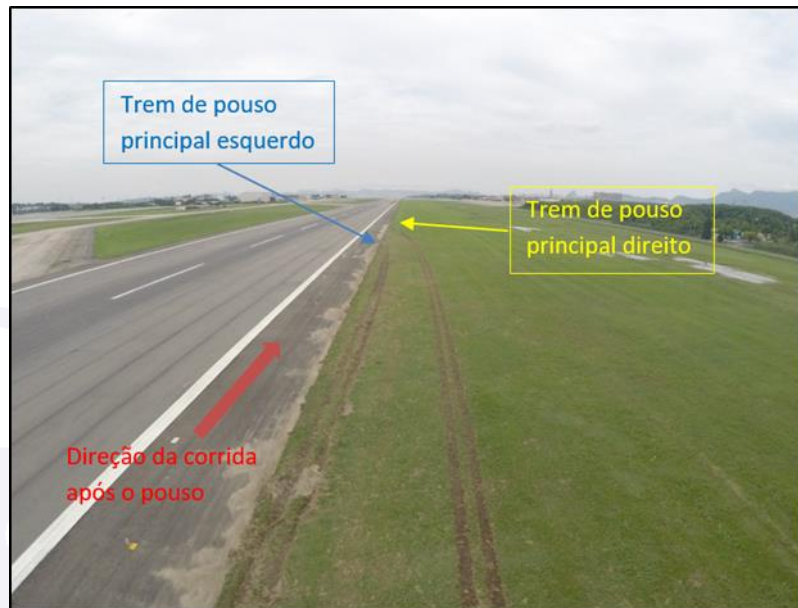
Along the aircraft's running path over the grassy area, various debris impacted the aircraft's fuselage and entered the aircraft's turbines. However, the damage that occurred did not cause an immediate impact on its operation, making it possible to travel to the apron area and shutdown the engines.

Figure 11 - Place where the aircraft returned to the runway.

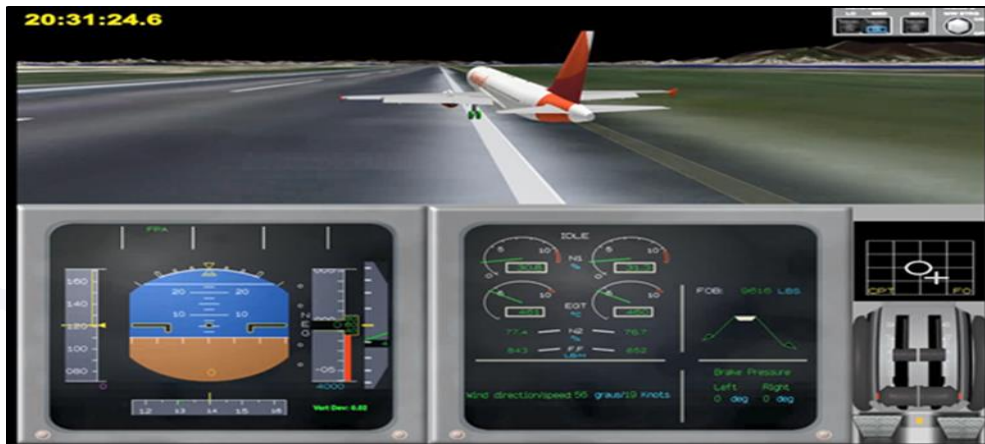
- At 20h31min24s (UTC), the aircraft touched the runway outside the central axis, 916m from threshold 15, with the right main landing gear touching the ground outside the runway's lateral limits. The wind was in the direction of 057° and 18kt of intensity. The touch occurred with 121kt speed, leveled wings and 140° magnetic heading.

Figure 22 - FDR - Exact moment when the aircraft touches the ground.
