FINAL REPORT
A - 137/CENIPA/2016

OCCURRENCE:	ACCIDENT
AIRCRAFT:	PR-STN
MODEL:	A300-B4-203
DATE:	21OCT2016

This is the Final Report of the 21OCT2016 accident with the A300-B4-203 aircraft model, registration PR-STN. The accident was classified as “[LOC-G] Loss of Control on the Ground” and “[RE] Runway Excursion”.

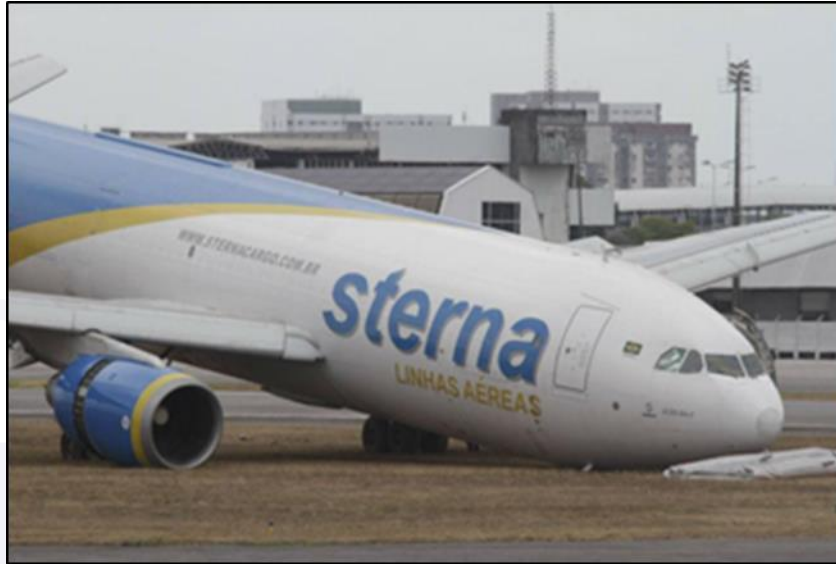
During the run after landing on SBRF runway 18, the aircraft drifted to the right, overpassed the runway lateral limit and stopped in the adjacent grassy area.

Figure 1 - View of the aircraft after stopping out of the runway.

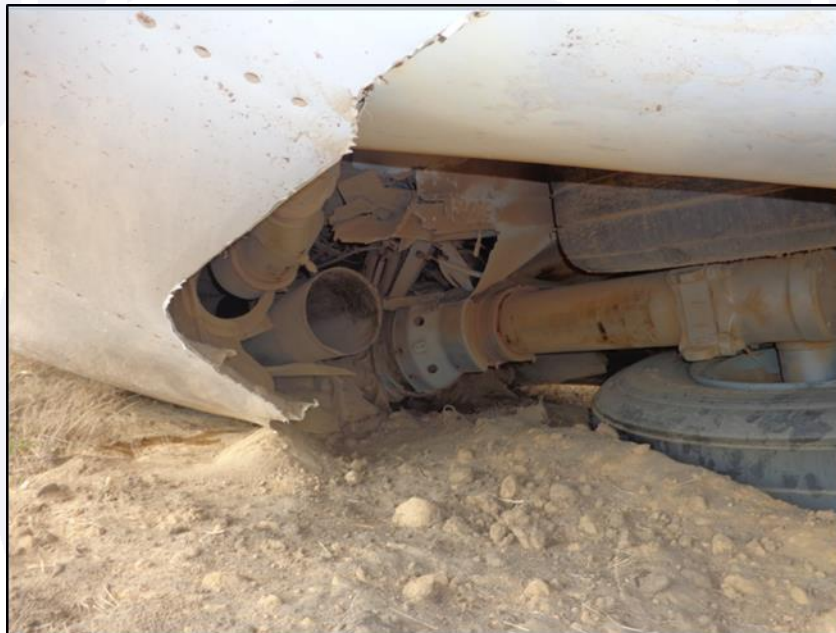
The nose landing gear turned left about 90° and retracted without command.

The nose landing gear collapsed and retracted, due to fractures in the steering, lowering and locking mechanisms.

Figure 2 - Detail of damage to the nose landing gear.

Based on the laboratory tests performed, it was concluded that the fractures observed on the nose landing gear occurred due to overload. Thus, its collapse probably occurred because of the effort due to misalignment in relation to the displacement of the aircraft, aggravated by the entry of the plane on soft ground. The breaking of this component possibly resulted in the pitch being reduced to -9.6° .

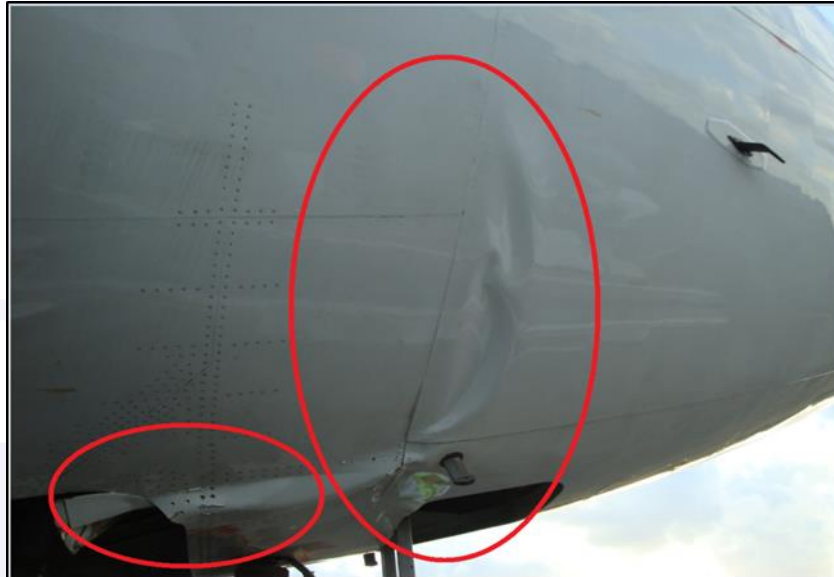
The aircraft structure was compromised in the region where the nose landing gear was attached. Structural damage has occurred, which has spread to the outer area of the fuselage adjacent to the nose landing gear housing.

Figure 3 - Details of fuselage damage.

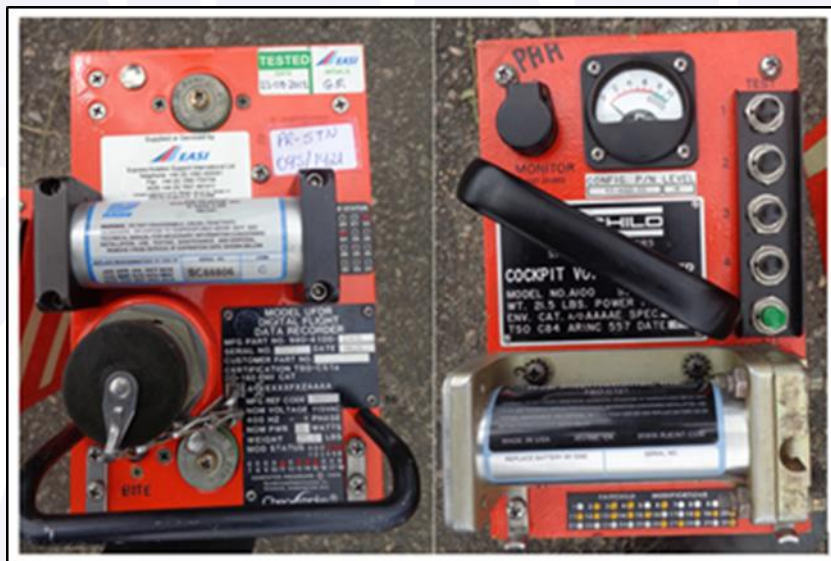
Externally, the voice recorder looked in good condition, but internally the tape reel engine (recording media) was locked. The content recorded referred to a flight made in French territory, near the Charles de Gaulle Aerodrome, Paris - France, in that country's language.

Figure 14 - FDR and CVR after the aircraft removal.

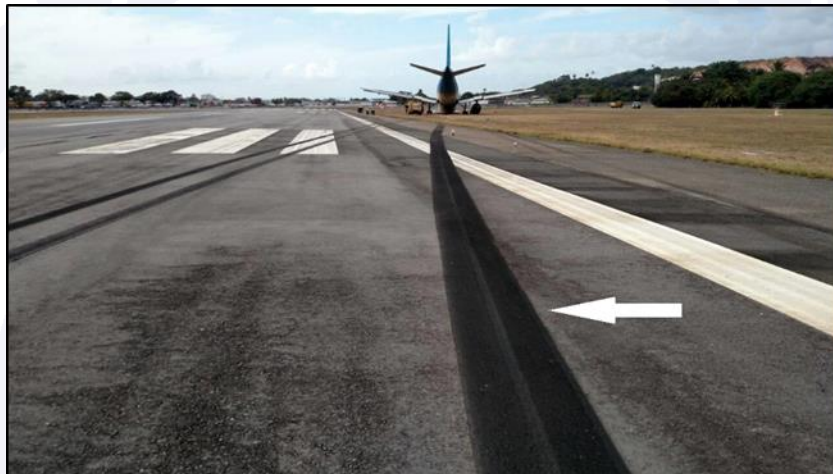
The overlapping tire marks left on the paved area prior to the runway excursion demonstrated that, due to the trajectory described by the plane, the wheels of the nose landing gear were skidding.

Figure 15 - Overlapping nose landing gear tire markings (white arrow).

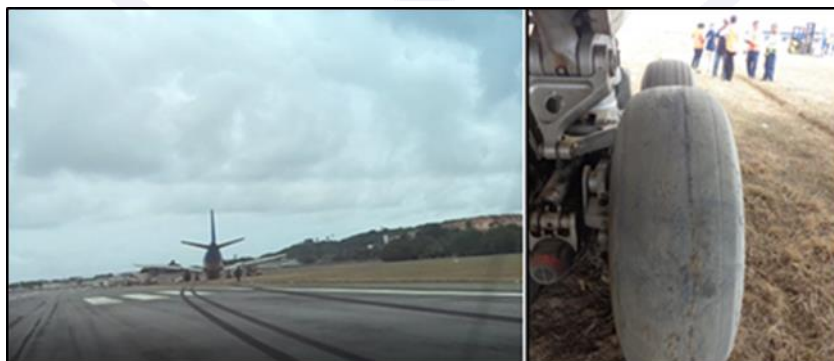
The markings found on the runway, as well as the changes observed in the brake assemblies and tires, indicated that braking had occurred with a large amount of energy dissipation. The brakes were darkened and the tires were heavily worn. The marks left by the tires of the left main landing gear were more evident.

Figure 16 - Marks of the left main landing gear. On the detail, the wear observed on the tires of this landing gear.

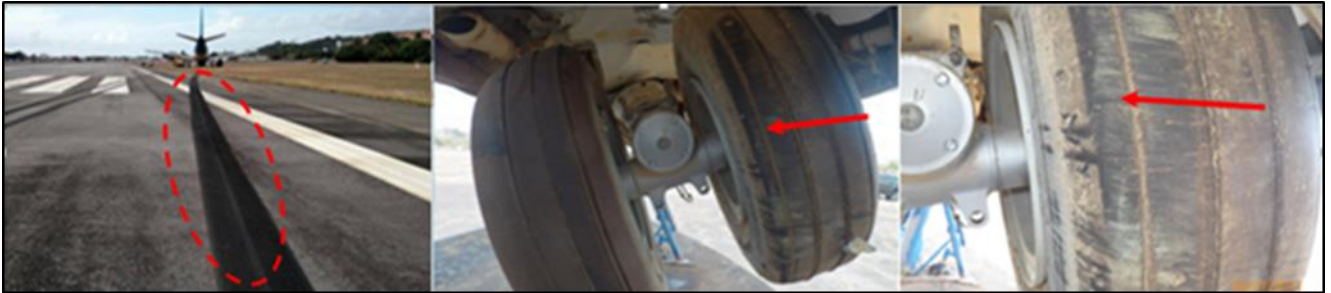
The rubber trail left by the nose landing gear tires indicated that they had skidded as the aircraft drifted off the runway.

The wear diagonally to the groove direction was most pronounced on the outside of the right tire.

Figure 17 - Nose landing gear marks and tire wear indicating skidding.

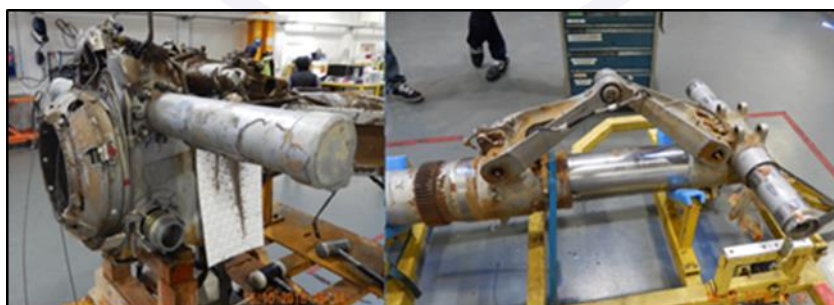
The set was partially disassembled so that the fractured parts could be subjected to laboratory tests, in order to know the mechanism that led to the failures. The disassembly also made it possible to check if there were any nonconformities in the parts, seals, fluids and other components that constituted this landing gear.

Figure 18 - Landing gear undergoing disassembly for Safran exams.

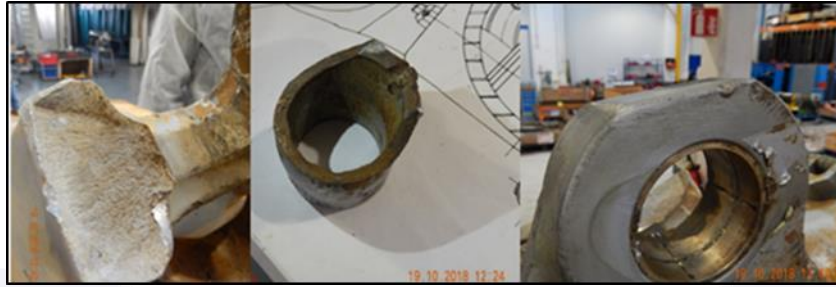
Figure 19 - Details of the fractures analyzed.

At the end of the examinations and tests, it was found that the fractures observed in components of the nose landing gear occurred due to overload. It was not found any component incompatible with the manufacturer's specifications and there were no contaminants in the fluids, except for dust residues collected during the runway excursion.
