### **FINAL REPORT A - 086/CENIPA/2016**

<b>OCCURRENCE:</b>	<b>ACCIDENT</b>
<b>AIRCRAFT:</b>	<b>PR-TAC</b>
<b>MODEL:</b>	<b>PA 25-235</b>
<b>DATE:</b>	<b>17MAY2016</b>

This is the Final Report of the 17MAY2016 accident with the PA 25-235 aircraft model, registration PR-TAC. The accident was classified as “[LOC-I] Loss of Control in Flight”.

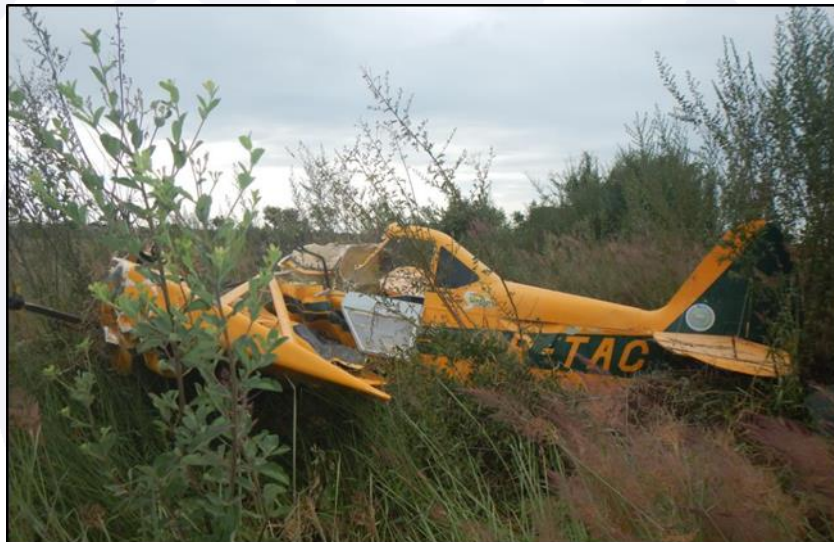
Figure 1 - Aircraft after the occurrence.

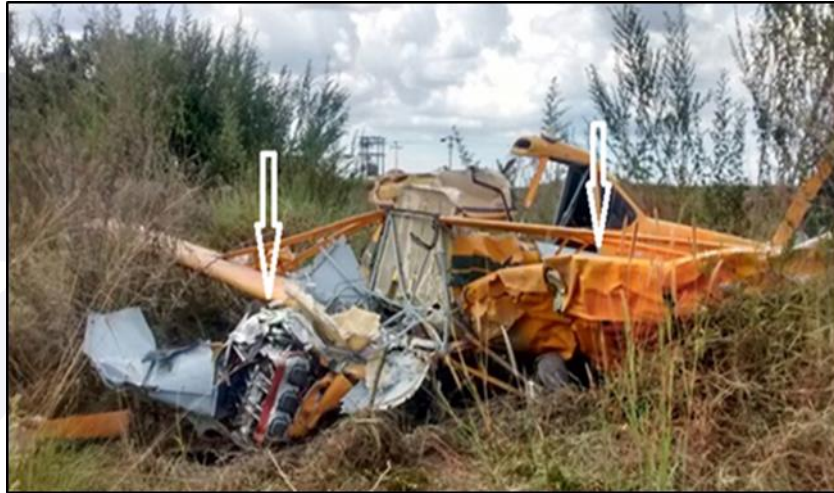
There were no signs of horizontal displacement of the wreckage in the vegetation, as can be observed in figures 2, 3 and 4.

Figure 2 – View of the wreckage at the crash site, with indication of the most affected areas.

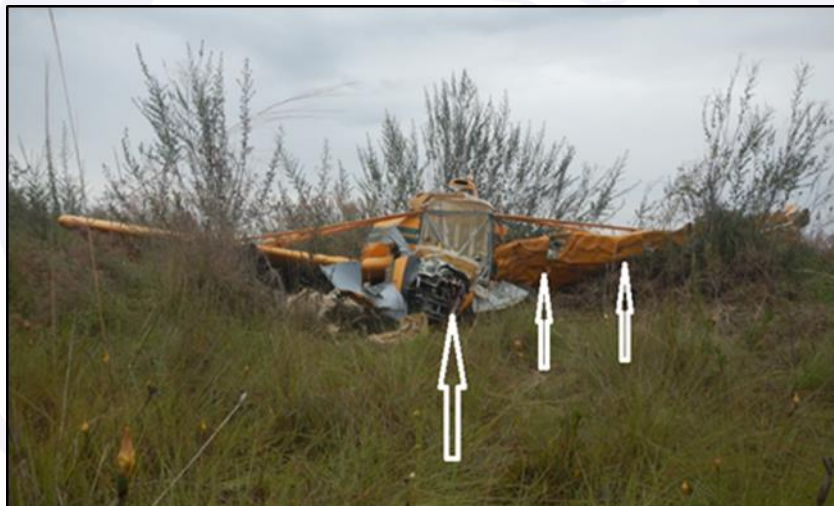
Figure 3 – Front view of the aircraft, with indication of the most severe damaged areas.

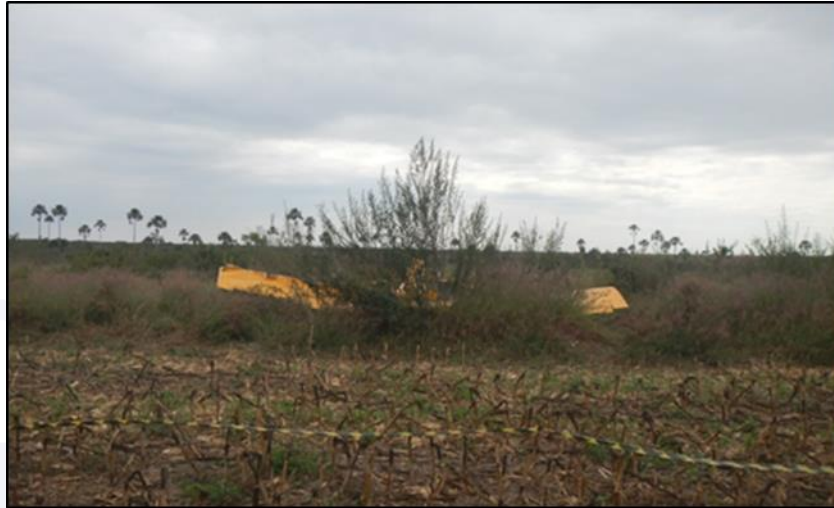
Figure 4 – Rear view of the aircraft, showing absence of signs of horizontal displacement of the wreckage on the ground.

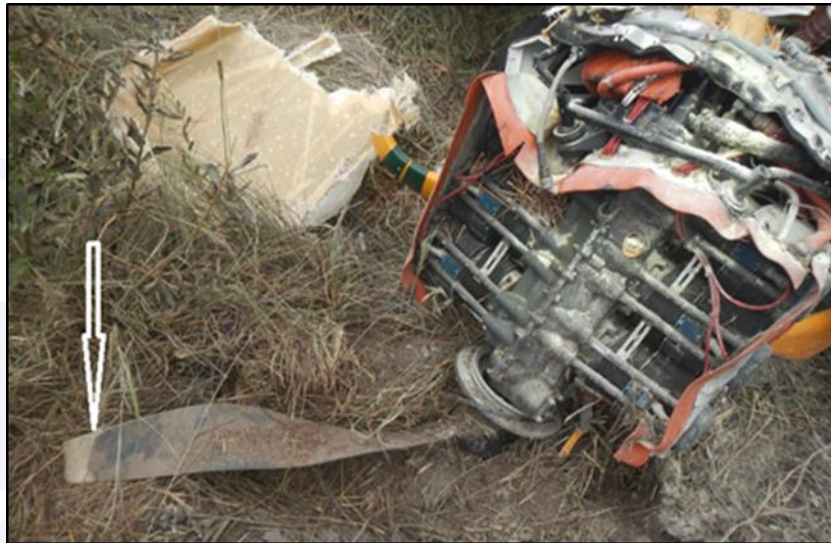
Damage observed on the propeller blades were compatible with a power development condition at impact. This condition was evidenced by the twisting and the slight forward bending of one of the propeller blades, as can be seen in Figure 5.

Figure 5 - View of one of the propeller blades, indicating the twisting and folding of the end of the blade forward.
