COMANDO DA AERONÁUTICA
CENTRO DE INVESTIGAÇÃO E PREVENÇÃO DE
ACIDENTES AERONÁUTICOS

FINAL REPORT
IG-083/CENIPA/2023

OCCURRENCE:	SERIOUS INCIDENT
AIRCRAFT:	PS-CGF
MODEL:	AT-502B
DATE:	16MAI2023

This is the Final Report of the 16 May 2023 serious aeronautical incident with the AT-502B aircraft, registration marks PS-CGF. The occurrence was typified as “[LOG-G] Loss of control on the ground and [RE] Runway excursion”.

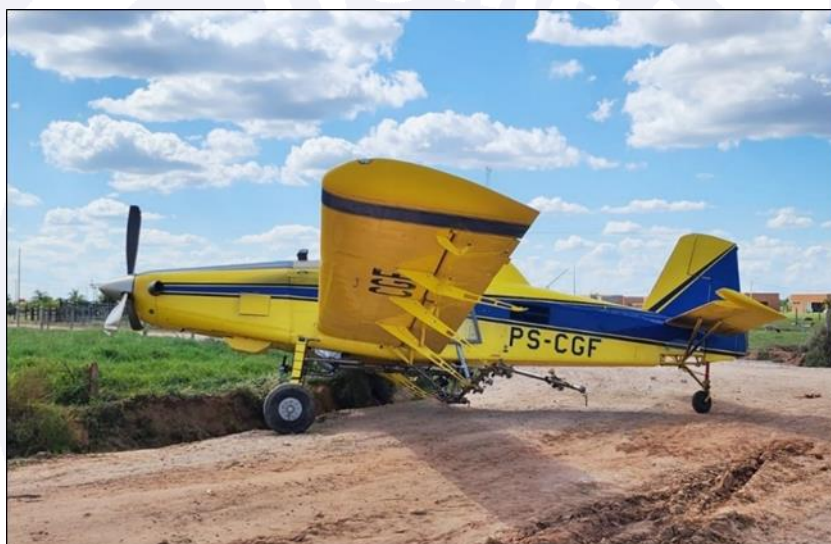
Control of the aircraft was lost during the landing run, and it exceeded the left-hand side limits of the airstrip.

After colliding with a fence, the aircraft abruptly rotated to the left and came to a stop.

Figure 1 - View of the aircraft at the location of the serious incident.

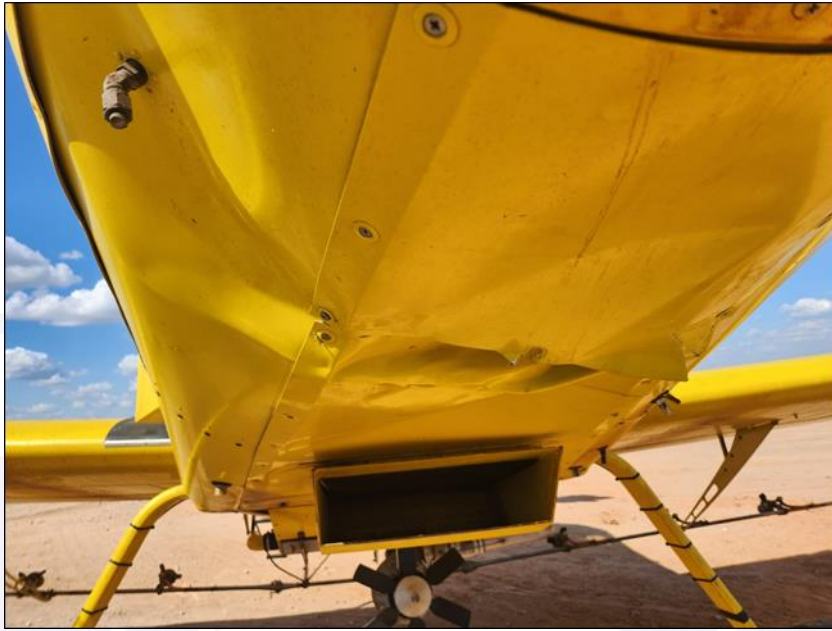
The aircraft suffered minor damage, restricted to the fuselage, wings, and propeller blades.

Figure 2 - Damage to the fuselage.

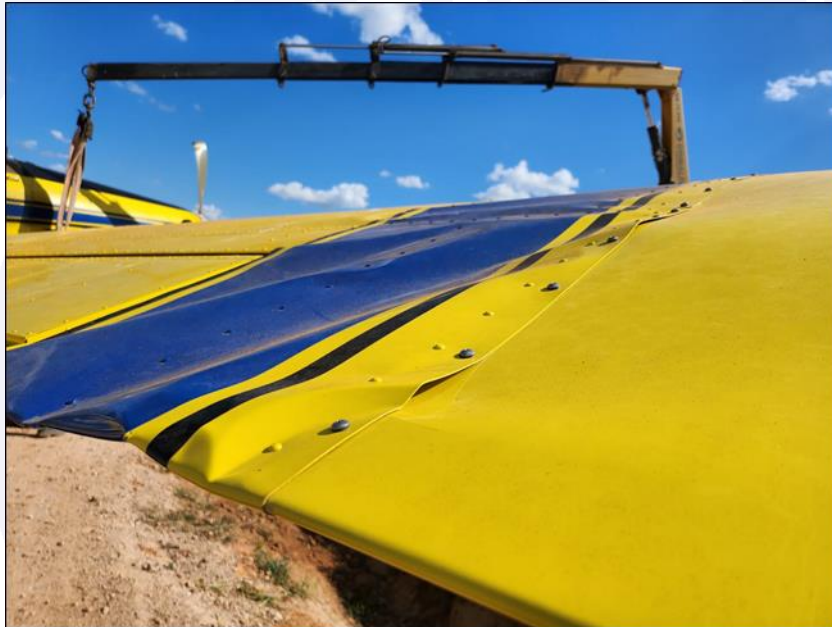
Figure 3 - Damage to the right-hand wing.

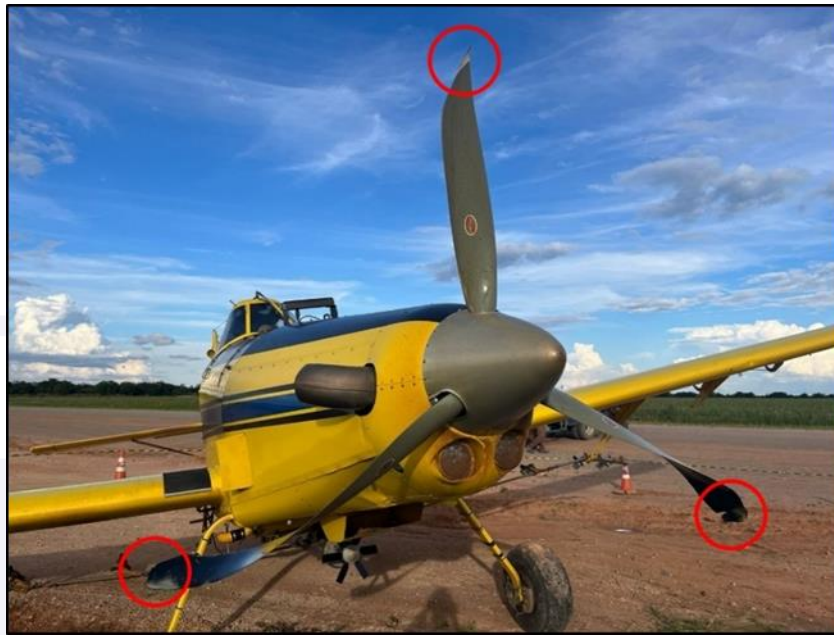
Figure 4 - Damage to the propeller blades.

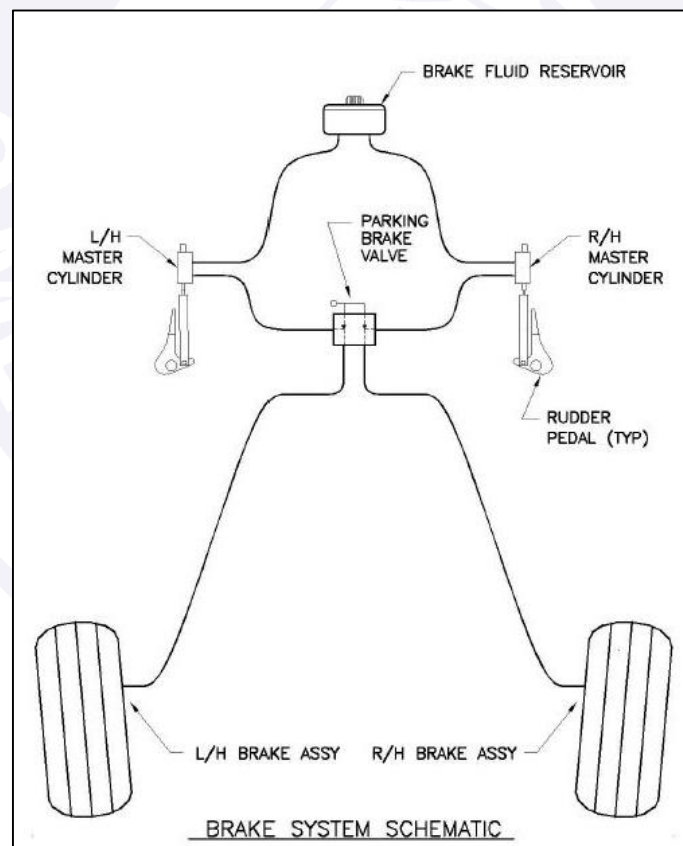
Figure 5 - Scheme of the AT-502B brake system.
Source: AFM AT-502B.

The Investigation Committee observed that all components of the braking system were in good condition, including the level of hydraulic fluid, which led to the conclusion that the runway excursion was related to the loss of effectiveness of the right-hand brake assembly, possibly due to air entering the system.

The runway excursion in question may be related to the loss of effectiveness of the right-hand brake set, possibly due to air entering the system during provision of some maintenance action.

The Investigation Committee advised the aircraft operator to be especially aware of any signs of loss of effectiveness of the brake system, and to inspect the referred system in order to identify a contingent presence of air.

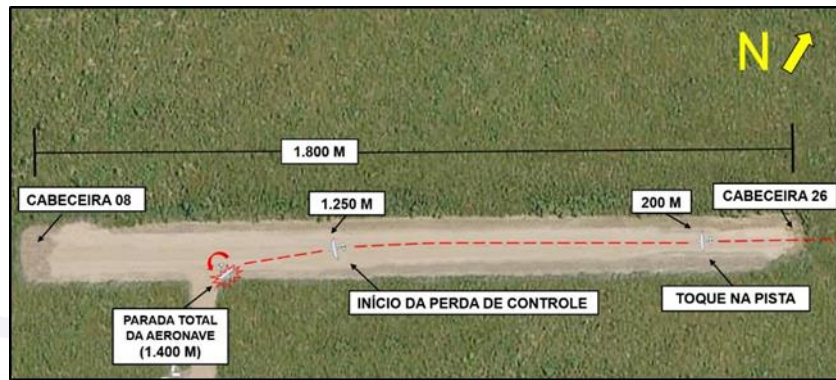
The aircraft approached the threshold 26 for landing, and touched down approximately 200 m beyond the threshold. The aircraft traveled approximately 1,050 m during the landing run, and then began to lose the airstrip centerline, eventually exceeding the left-hand side limit of the runway.

The aircraft hit a barbed-wire fence that delimited the perimeter of the aerodrome, made an abrupt rotation to left, and came to a complete stop at a distance of 1,400 m from the threshold 26.

Figure 6 - Croquis of the occurrence.

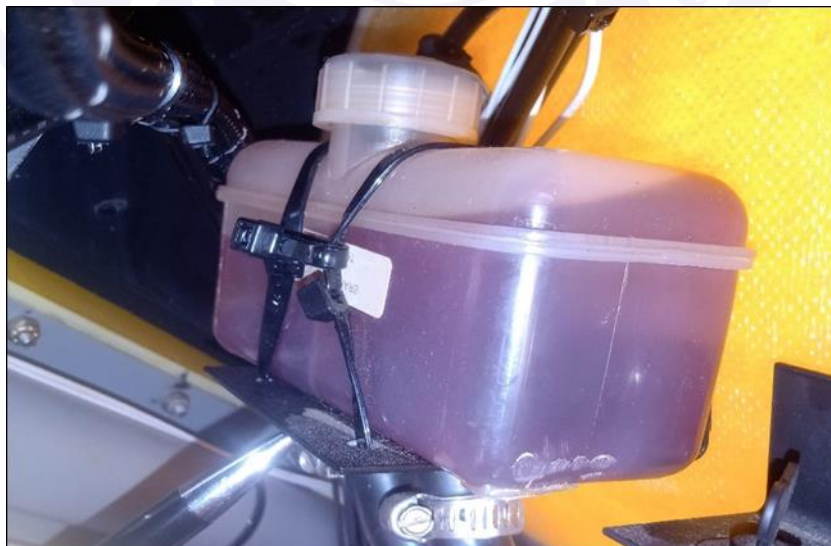
With such checking, one observed that the aforementioned reservoir had an adequate supply of fluid (Figure 7) and that the left- and right-hand brake sets were working without apparent alterations.

Figure 7 - Reservoir with a full supply of brake fluid.
