COMANDO DA AERONÁUTICA
CENTRO DE INVESTIGAÇÃO E PREVENÇÃO DE
ACIDENTES AERONÁUTICOS

FINAL REPORT
A-104/CENIPA/2021

OCCURRENCE:	ACCIDENT
AIRCRAFT:	PS-CSM
MODEL:	B200GT
DATE:	14SET2021

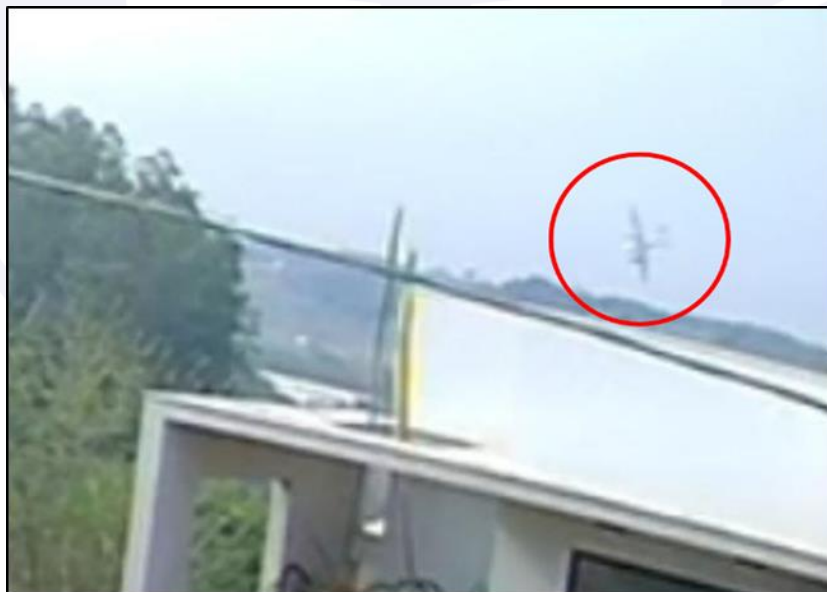
The impact of the aircraft into the terrain was one of high-energy, mainly due to the high rate of descent performed in the final moments of the flight (Figure 12).

Figure 12 - Image of the aircraft in the moments preceding the impact, obtained from a video captured by a Closed Circuit Home Surveillance System (CCTV).

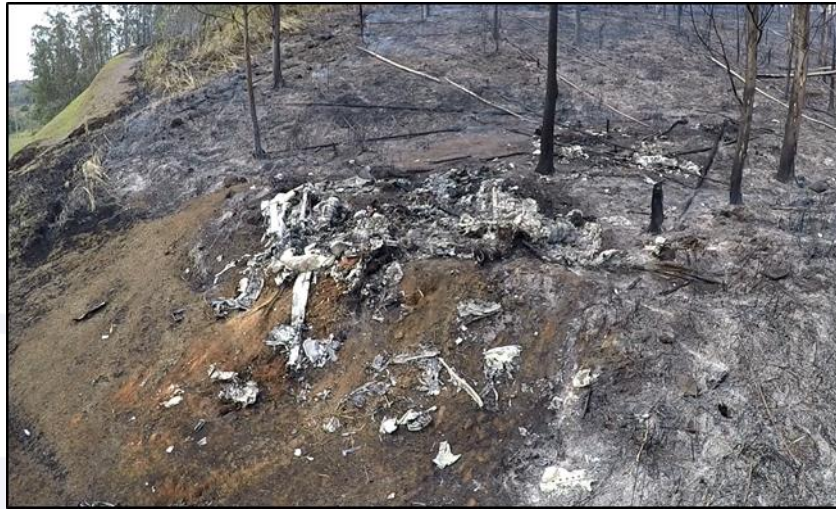
Since the aircraft had taken off with its tanks full of fuel, the impact was followed by an explosion, which set the wreckage and surrounding terrain on fire (Figure 13).

Figure 13 - Aerial image of the wreckage obtained during the Initial Action.

The degree of destruction and charring of the aircraft made it difficult to check pieces of equipment and instruments, also rendering it impossible to observe the throttle pedestal.

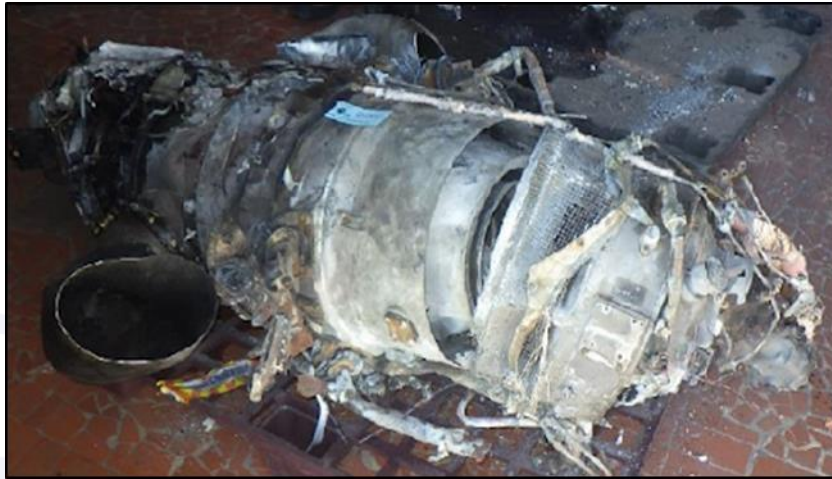
The left-hand engine was fractured by the impact energy, and its air intake was partially separated. The right-hand engine was also fractured at its reduction gearbox housing, separating into two parts. Both propellers had all blades fractured close to the hubs of each of these components, due to the impact.

Figure 14 - Left-hand engine (SN RX0972) damaged by impact and fire, showing fracture and partial separation of the air intake.

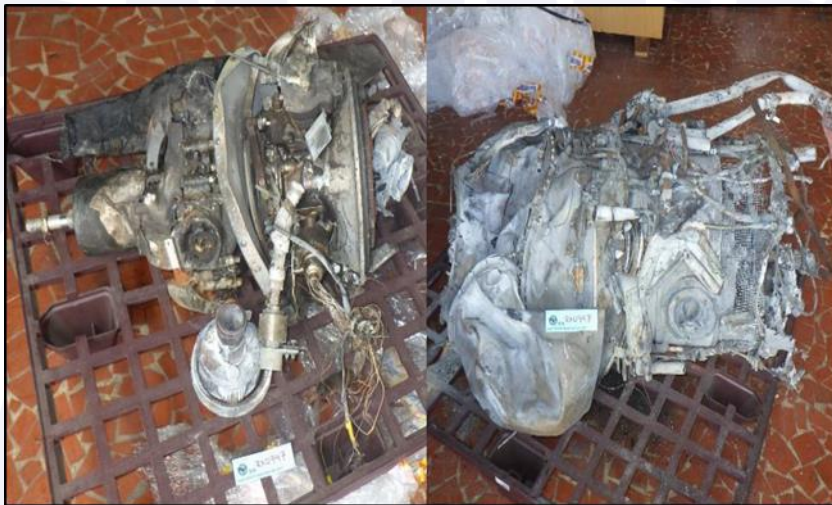
Figure 15 - Right-hand engine (SN RX0947) damaged by impact and fire, separated into two parts at the reduction gearbox.

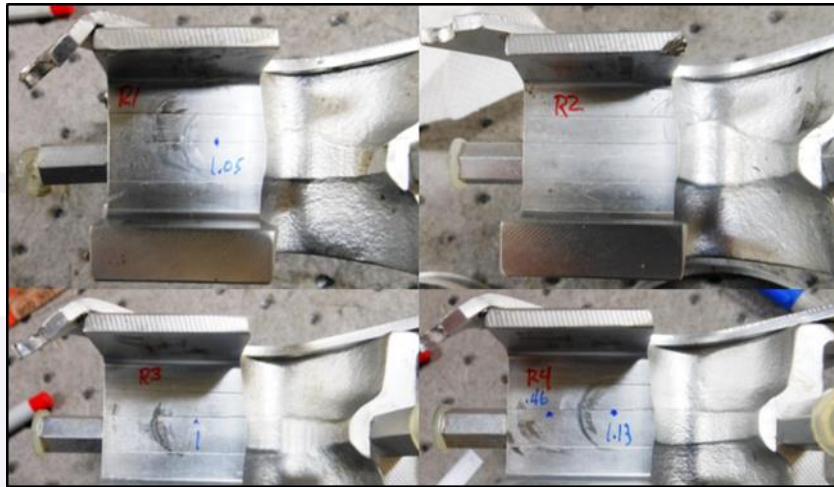
The impact signatures on the notches of the left propeller's forks indicated that it was operating at a higher RPM compared to the right propeller.

The notches on the right propeller's forks had impact marks on the blade's eccentric pins (knobs), suggesting that the blades were operating in the 60° to 78° range at the moment of impact, which would be consistent with a feathering process (Figure 18).

Figure 18 - Impact marks on the notches of the right-hand propeller forks.

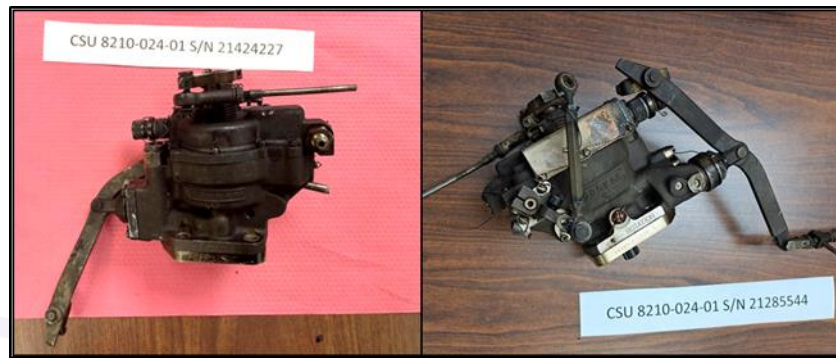
During the inspection of the SN 21424227 and SN 21285544 CSUs, it was found that the lockwires of the eccentric bolt, the maximum and minimum RPM stops, the speed lever, and the control lever stop were not of the Woodward manufacturer's standard (non-Woodward lockwires).

Figure 19 -SN 21424227 and SN 21285544 propeller governors (CSU), during visual inspection.

This condition indicated that adjustments had been made to the components, which could have occurred either during their integration with other aircraft components or during their operational cycle. It should be noted that there were no maintenance records related to these adjustments, nor was there any requirement for them.

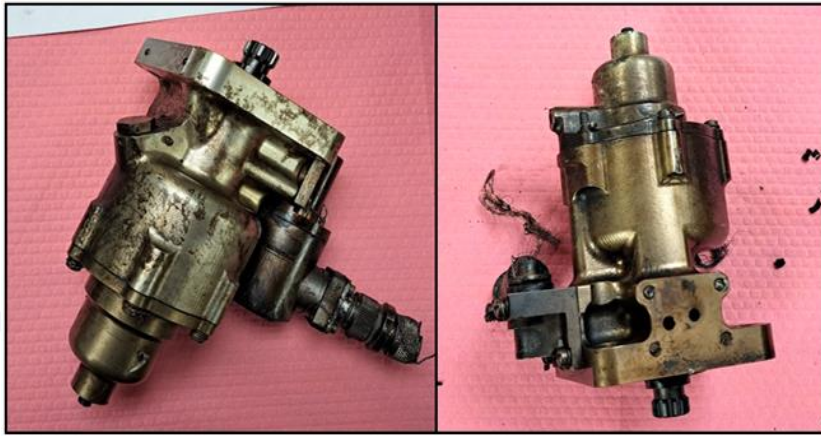
The OSGs underwent visual inspection and showed signs of charring, consistent with exposure to intense fire after the impact with the ground (Figure 20).

Figure 20 - SN 21873538 and SN 21873533 overspeed governors.

Both units lacked the tamper-proof sealant on the maximum speed adjustment screw, indicating that the original sealant might have been removed after leaving the factory.

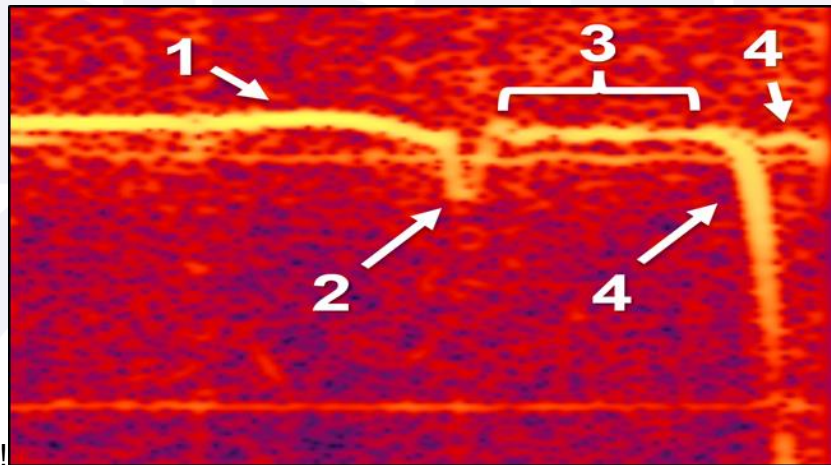
1. Approximately 16 seconds before impact, there was an increase in propeller rotation to 2,025 RPM (101.25% N2);
2. About 12 seconds before impact, the propeller rotation decreased to 1,830 RPM (91.5% N2), which represents a 9.75% drop within a 4-second interval;
3. Approximately 10 seconds before impact, the propeller speed returned to 2,000 RPM (100% N2) for 6 seconds; and
4. About 4 seconds before impact, the speed of one of the propellers oscillated slightly, while the other one dropped abruptly.

Figure 21 - Pictographic representation of the sound spectrum obtained from the CVR audio recordings.

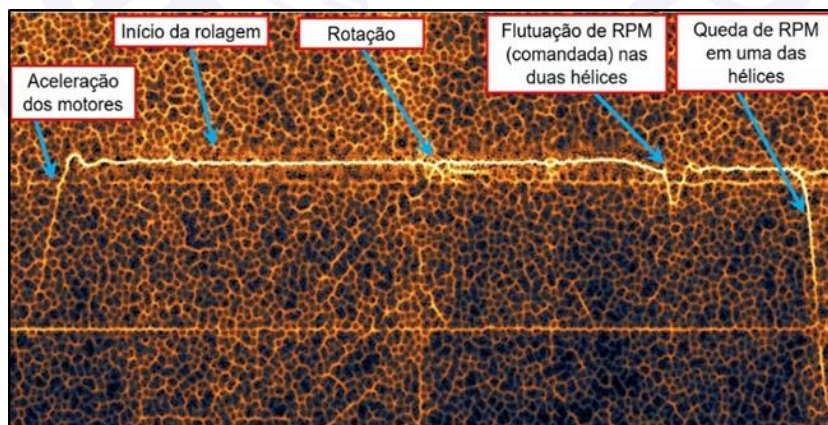
Figure 22 - Pictographic representation of the acoustic spectrum of the entire accident flight, obtained by the NTSB.

In accordance with the report produced by the propeller manufacturer, the noise signal that rapidly dropped just before impact is consistent with the feathering of one of the propellers.

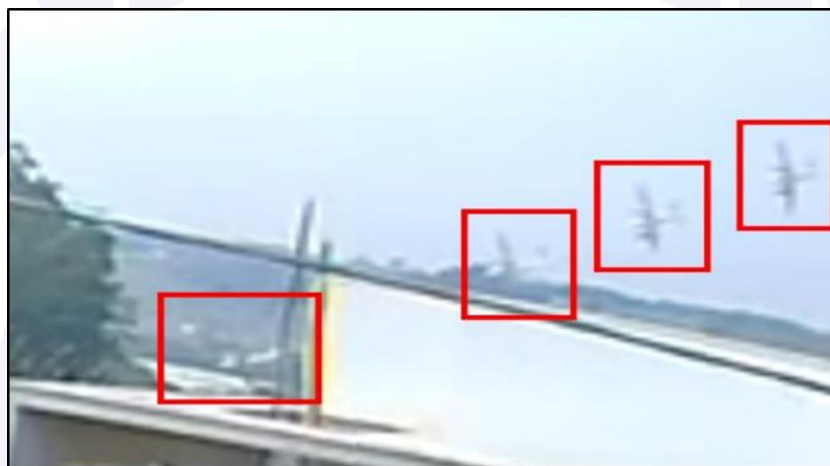
In another video, recorded by a residence security camera system, the aircraft was seen at a 90° angle-of-bank to the right, in a steep descent (Figure 28).

Figure 28 - Aircraft footage captured by a CCTV camera.

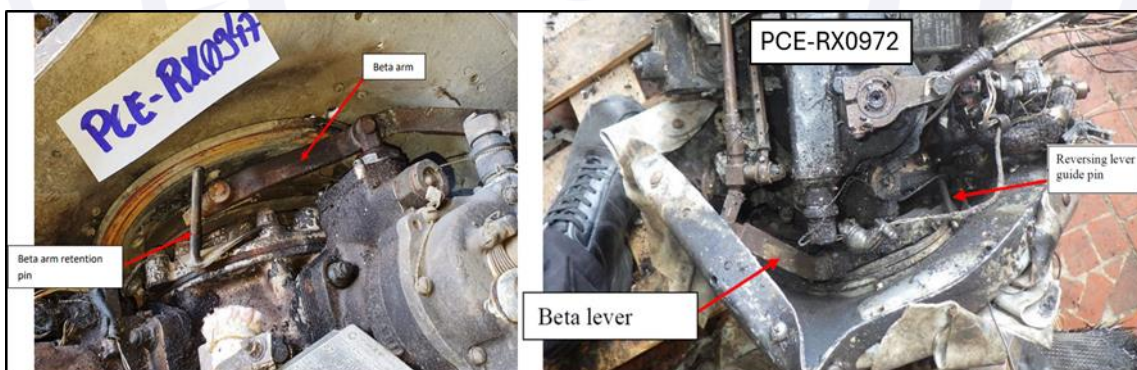
During the analyses conducted on the engines of the PS-CSM airplane, it was found that both beta arms were in the correct position (Figure 32).

Figure 32 - Positioning of the guide pins in relation to the beta arms on both engines of the PS-CSM airplane.
