**COMANDO DA AERONÁUTICA**  
**CENTRO DE INVESTIGAÇÃO E PREVENÇÃO DE**  
**ACIDENTES AERONÁUTICOS**

**FINAL REPORT**  
**IG-065/CENIPA/2022**

<b>OCCURRENCE:</b>	<b>SERIOUS INCIDENT</b>
<b>AIRCRAFT:</b>	<b>PS-CTN</b>
<b>MODEL:</b>	<b>AT-502B</b>
<b>DATE:</b>	<b>19MAI2022</b>

This is the Final Report of the 19 May 2022 serious incident involving the AT-502B aircraft, registration PS-CTN. The occurrence was typified as “[LALT] Operation at Low Altitude”.

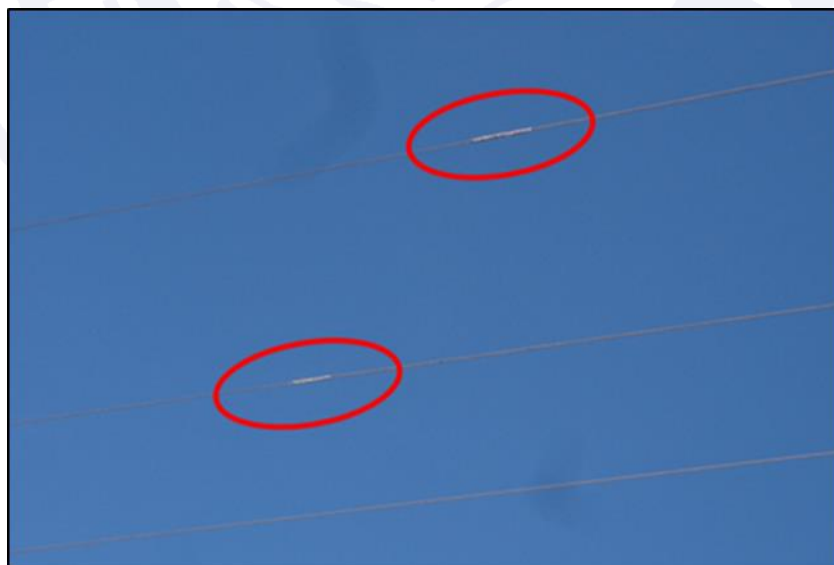
There was damage to the cables of the low-voltage electric-power transmission network of *Fazenda Cambará I* (Figure 1).

Figure 1 – Low-voltage network, repaired after the occurrence.

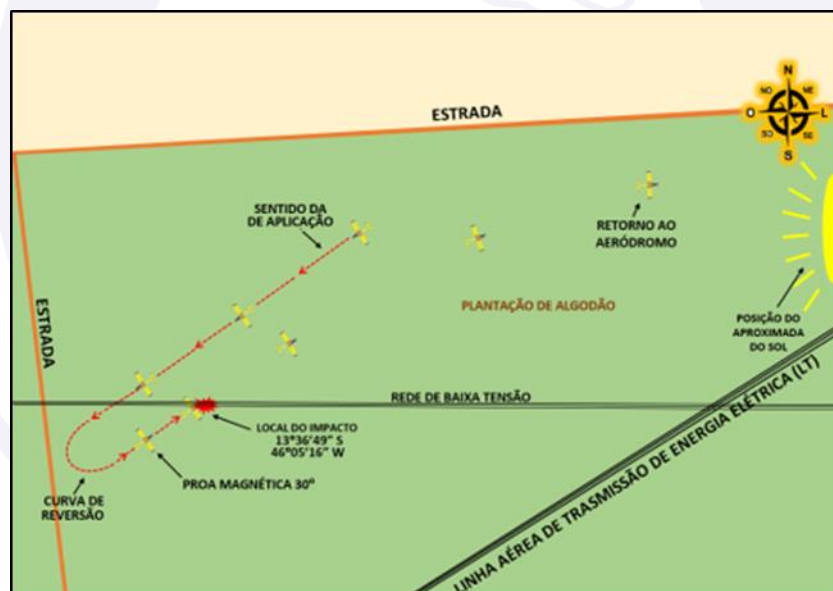
Regarding the circumstances, the PIC reported that he was focused on stabilizing the aircraft along the correct axis, something which distracted him from the power lines further ahead. He added that, on top of that, his vision was glared by the position of the rising sun.

Thus, the collision with the power lines occurred seconds after the pilot prepared the aircraft equipment for a new pass, with the sun ahead, diagonally to the right-hand side in relation to the flight path (Figure 2).

Figure 2 - Sketch of the occurrence.

Furthermore, the PIC reported that his eyes became temporarily blinded by the rising sun. Thus, it is possible that such glare impaired the sighting of the electric-power lines, to the point of hindering a successful evasive maneuver.

The pilot was advised to condition the execution of aero agricultural operations to the following requirements: visual on-the-ground reconnaissance of the areas to be overflown; planning of the flight, establishing risk management, involving aspects, such as, the currency of the information concerning the existing obstacles on his maps/charts; and the circumstances which may lead to the occurrence of glare resulting from the sunlight.
