COMANDO DA AERONÁUTICA
CENTRO DE INVESTIGAÇÃO E PREVENÇÃO DE
ACIDENTES AERONÁUTICOS

FINAL REPORT
IG-029/CENIPA/2025

SERIOUS INCIDENT

737-8 MAX

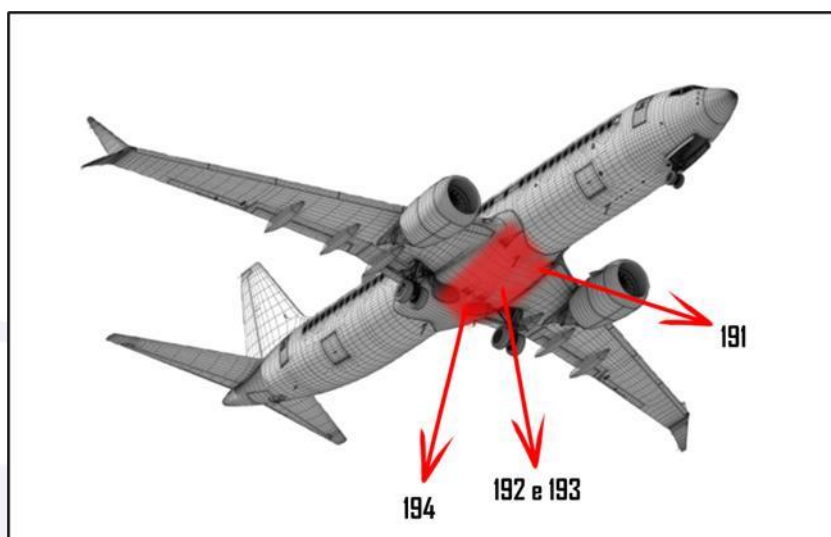
As for the airframe structure, the damage was primarily concentrated in sections 44 and 46, particularly in the wing-to-fuselage junction area. The fairings located in zones 191 to 194 sustained significant damage, including structural panels and brackets that required replacement or repair, as prescribed in the Boeing 737-800 Aircraft Maintenance Manual (AMM).

Figure 1 - Fairings damaged by the collision with the vehicle, located in zones 191 to 194.
Source: adapted from the AMM.

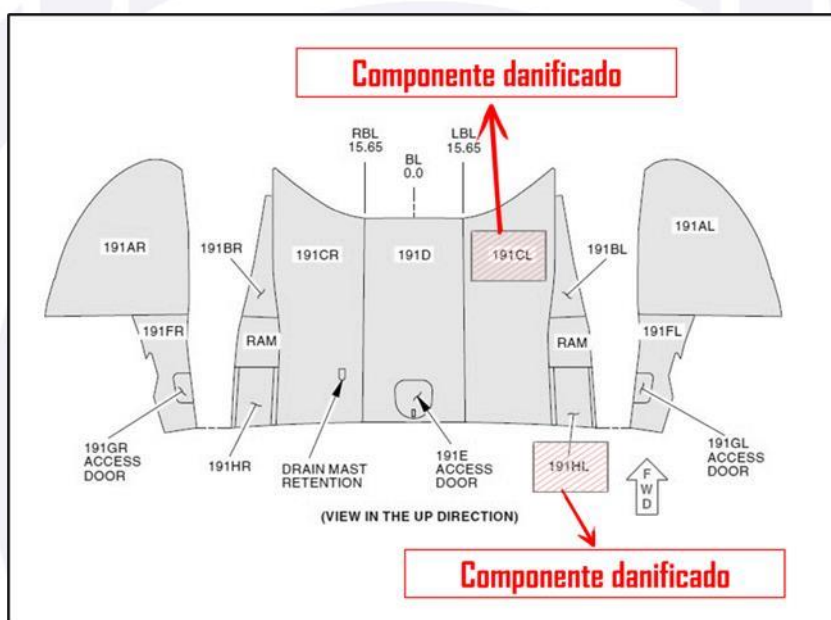
Figure 2 - Fairings damaged by the collision with the vehicle, located in zone 191.
Source: adapted from the AMM.

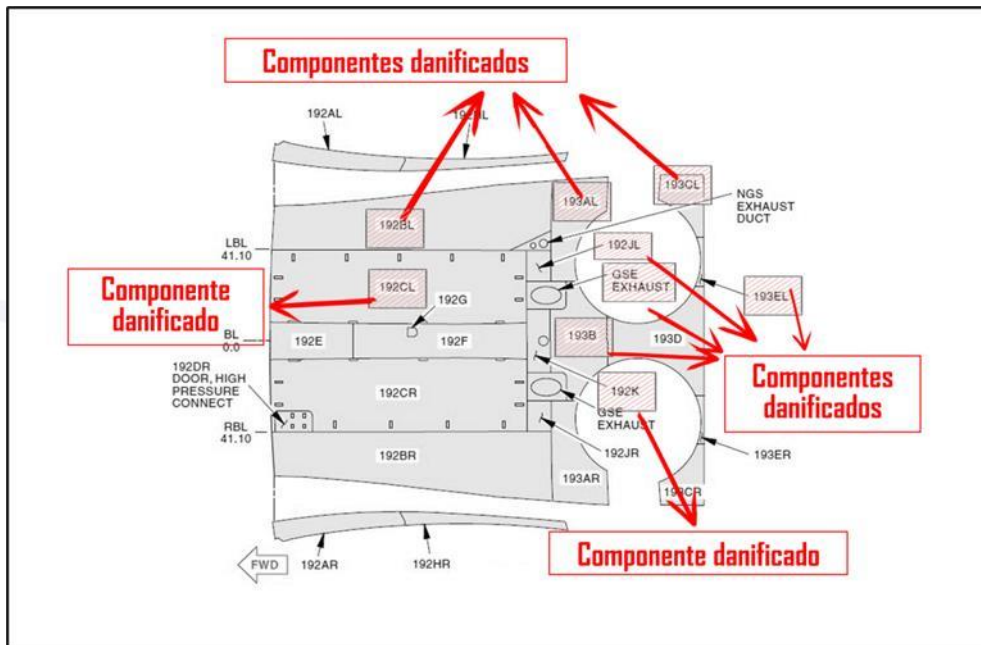
Figure 3 - Fairings damaged by the collision with the vehicle (zones 192 and 193).
Source: adapted from AMM.

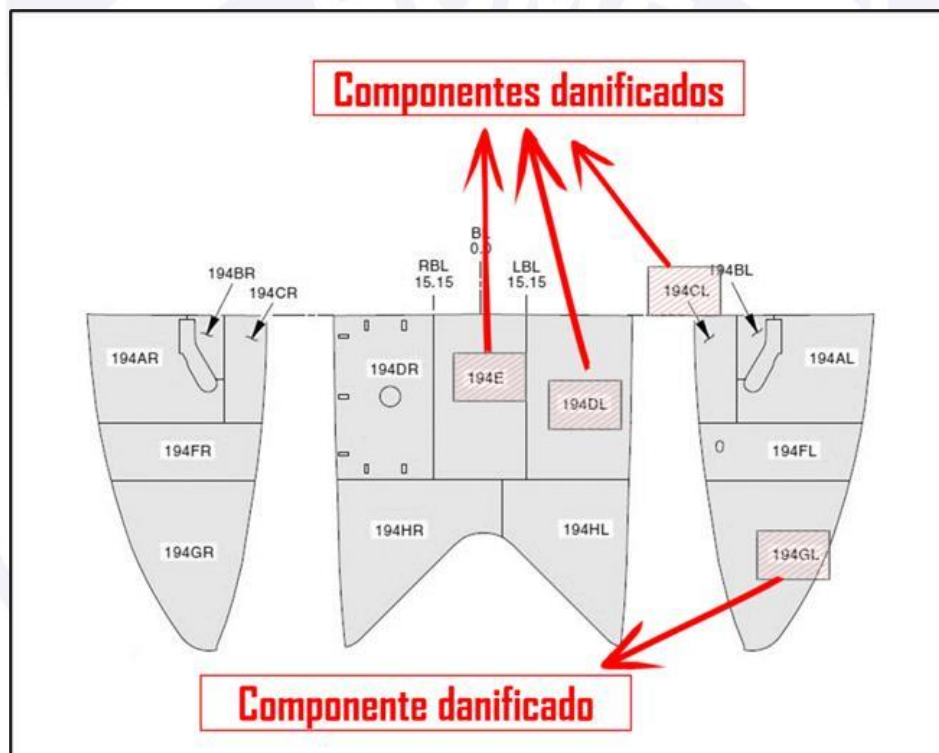
Figure 4 - Fairings damaged by the collision with the vehicle (zone 194).
Source: adapted from the AMM.

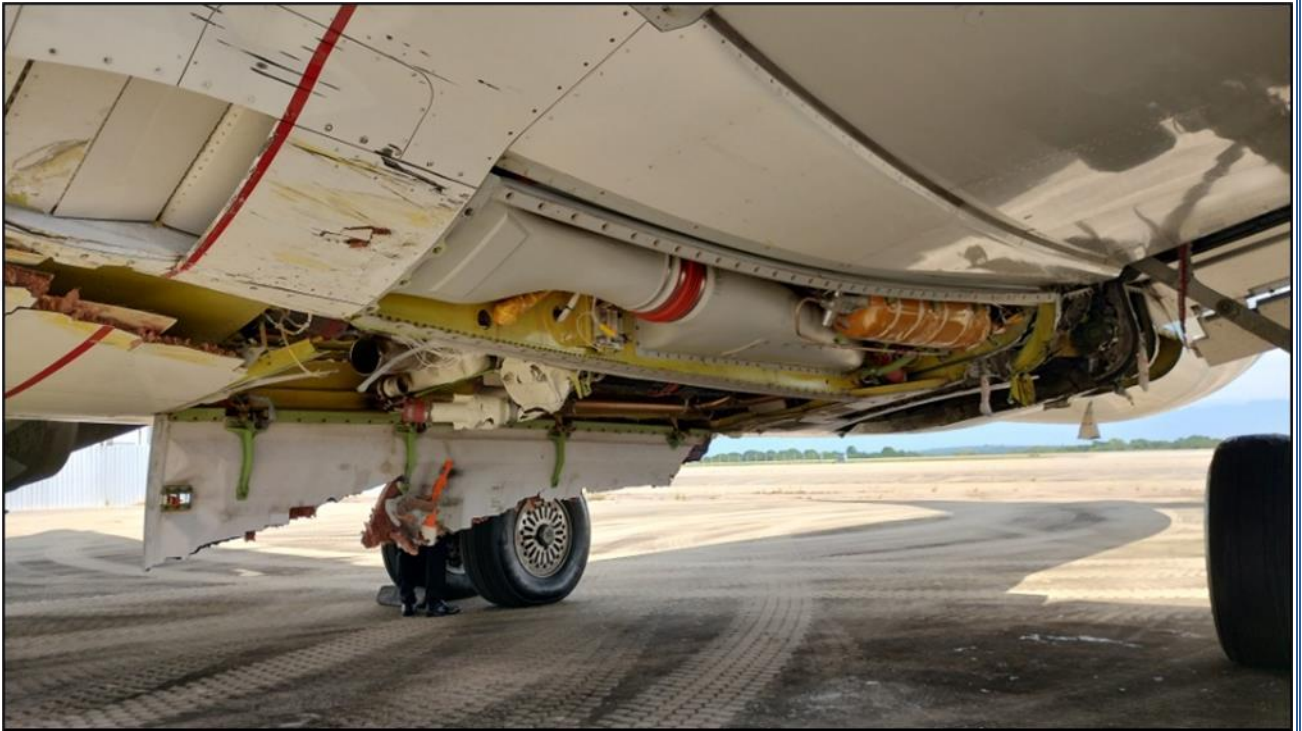
The aircraft fuselage sustained damage, including a deformation measuring 12 inches in length, 4.5 inches in width, and 0.135 inches in depth at STA (Station) 540, as well as a hole approximately 8 inches in diameter in the region between STA 727E and STA 727G.

Figure 5 - Damage to the aircraft's lower fuselage fairings.

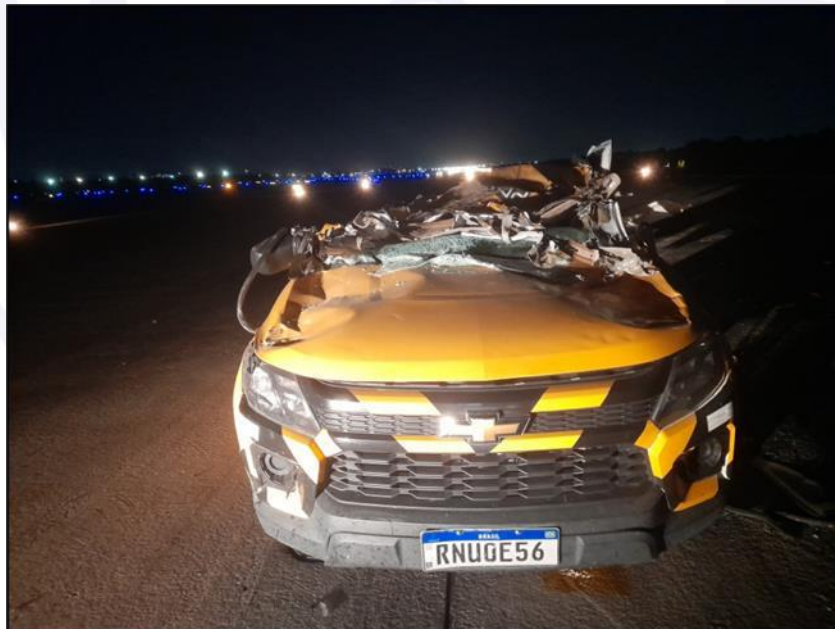
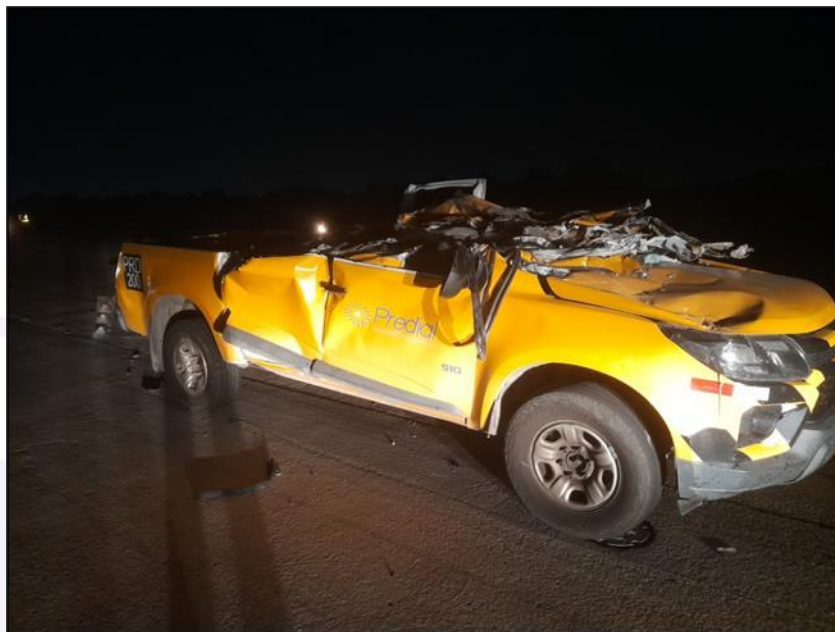
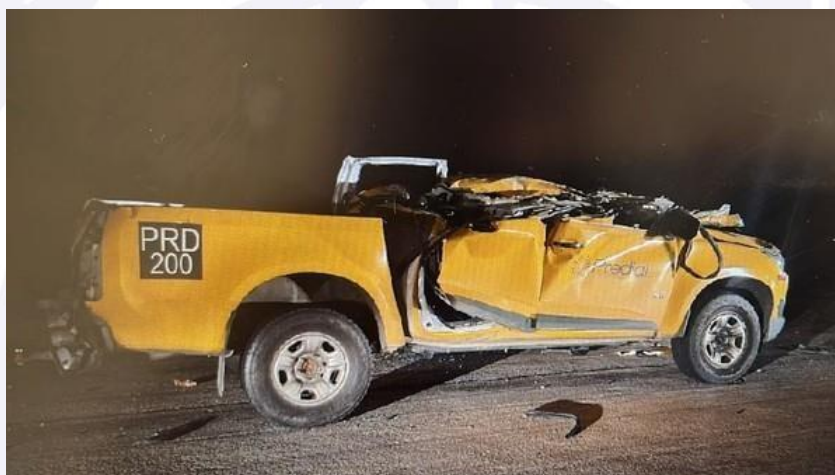
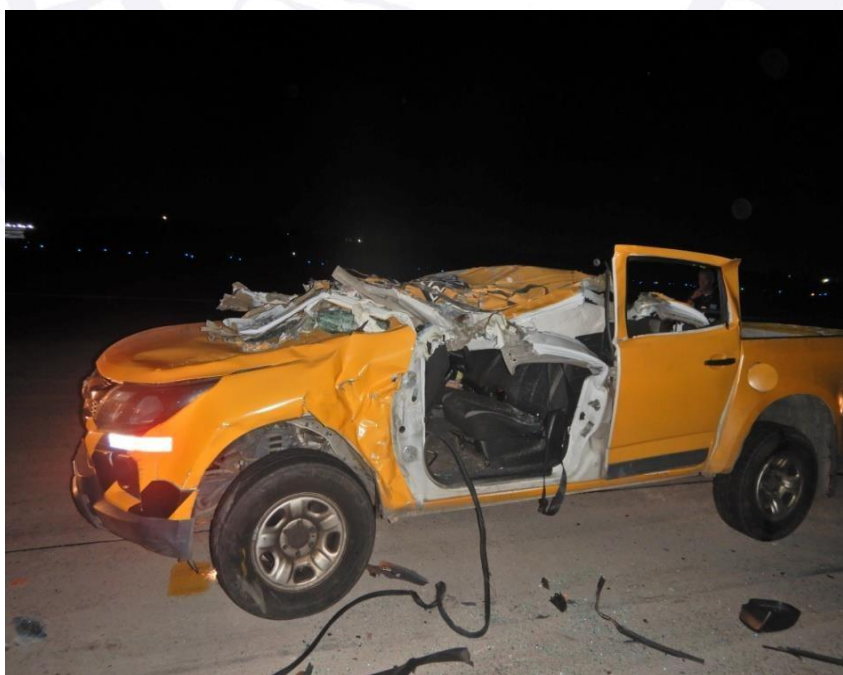
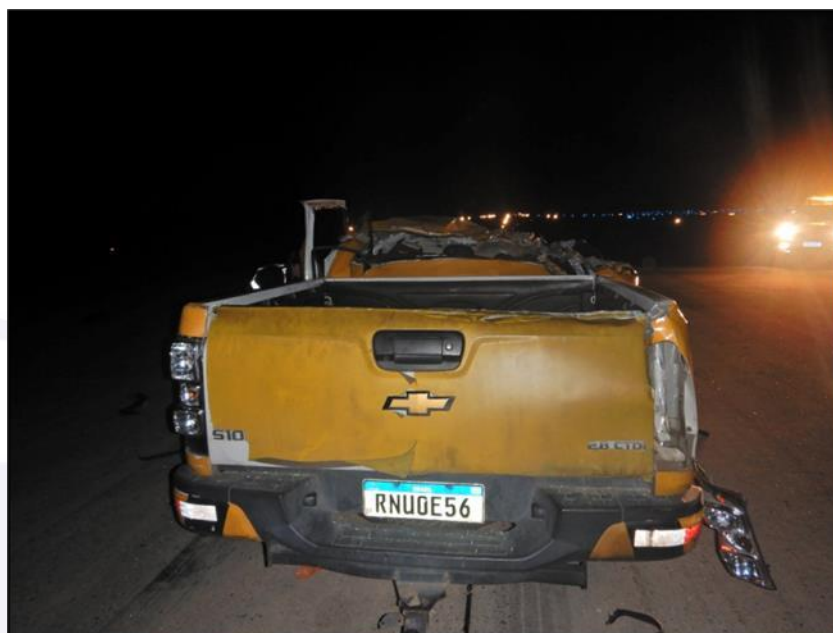
The runway-lighting maintenance vehicle sustained substantial damage (Figures 6 to 10).

Figure 6 - Frontal view of the vehicle after the collision.

Figure 7 - Right-side view of the vehicle after the collision.

Figure 8 - Right-side view of the vehicle after the collision.

Figure 9 - Left-side view of the vehicle after the collision.

Figure 10 - Rear view of the vehicle after the collision.

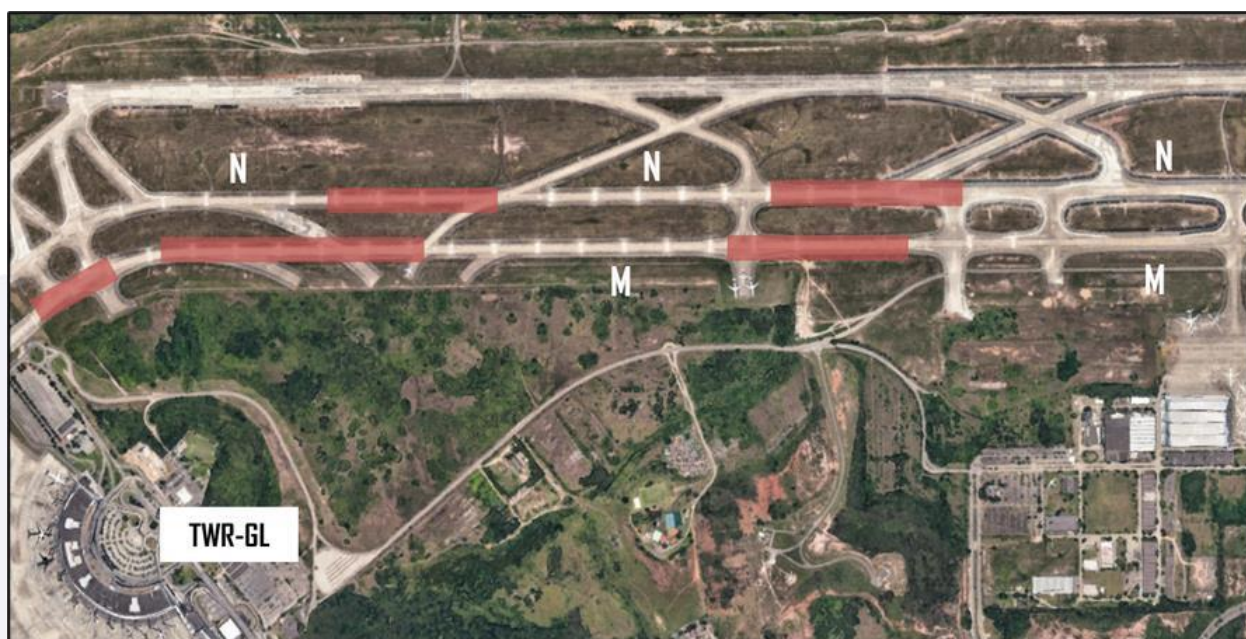
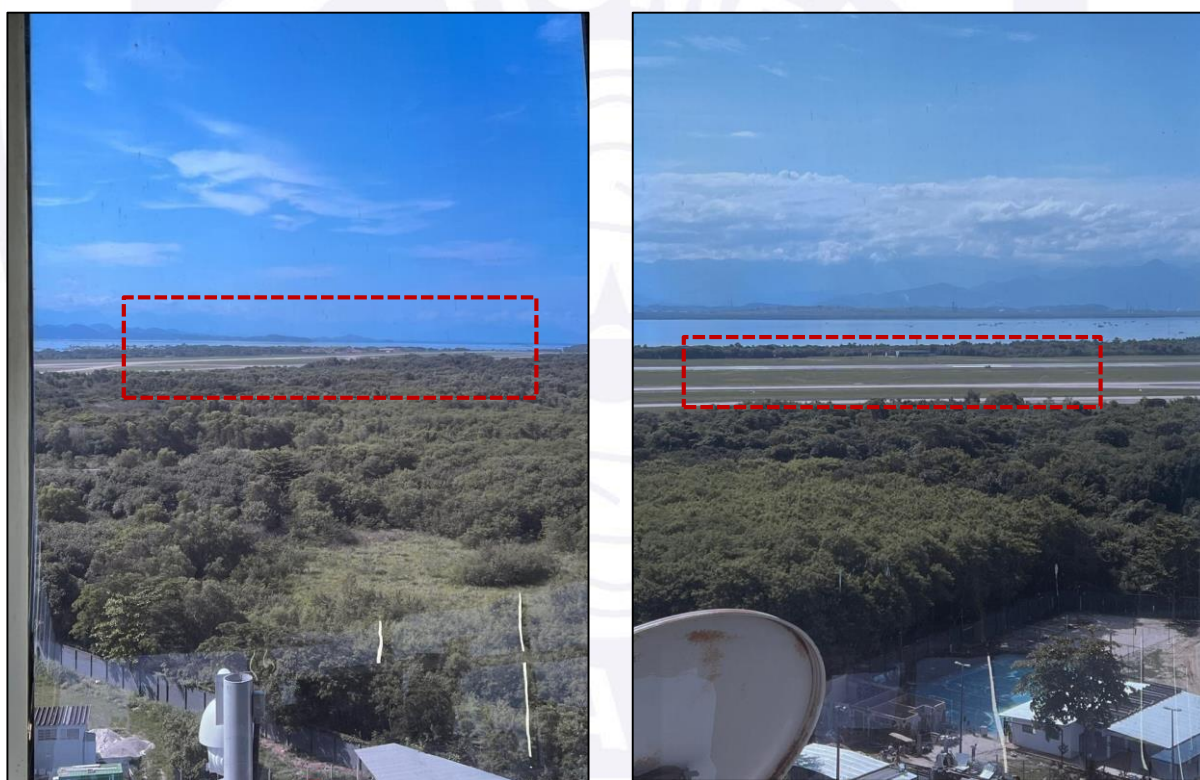
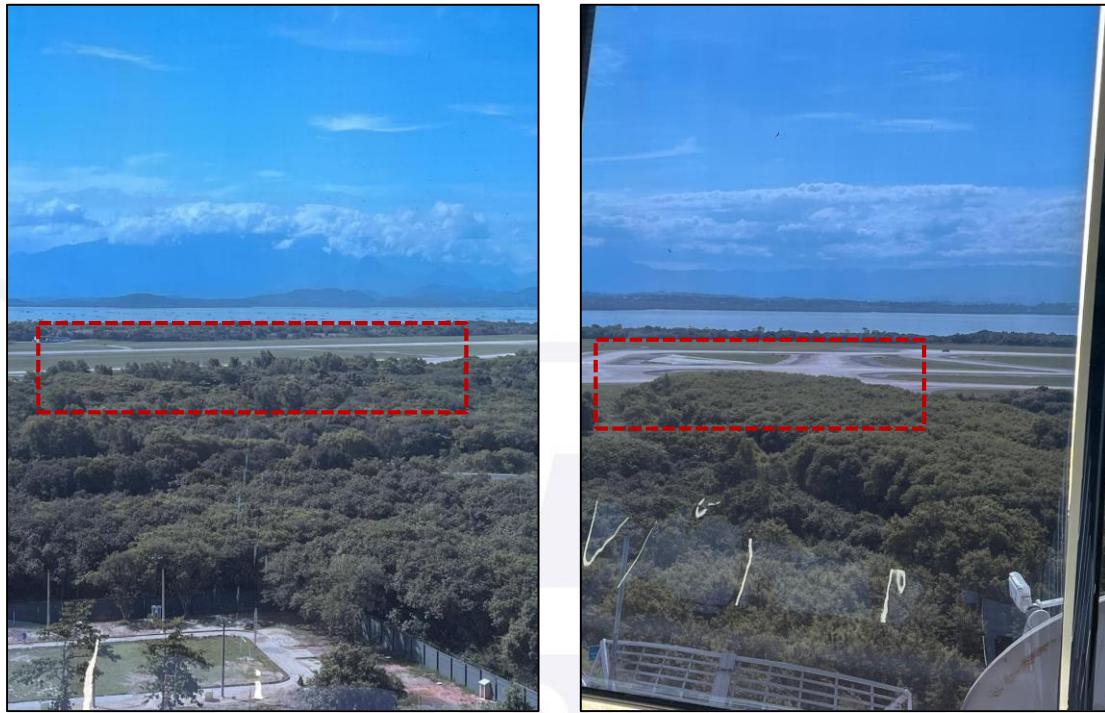
As can be observed on the left side of Figure 17, this vegetation was already affecting visibility in a limited section of runway 10/28.

Figure 16 – Satellite image showing an overview of SBGL. In red, the blind spot sectors on taxiways M and N from the line of sight of the ATCO occupying the TWR Control operational position. Source: adapted from Google Earth.

Figure 17 - Blind spot sectors on taxiways M and N from the line of sight of the ATCO occupying the TWR Control operational position.

Figure 18 - Blind spot sectors on taxiways M and N from the line of sight of the ATCO occupying the TWR Control operational position.

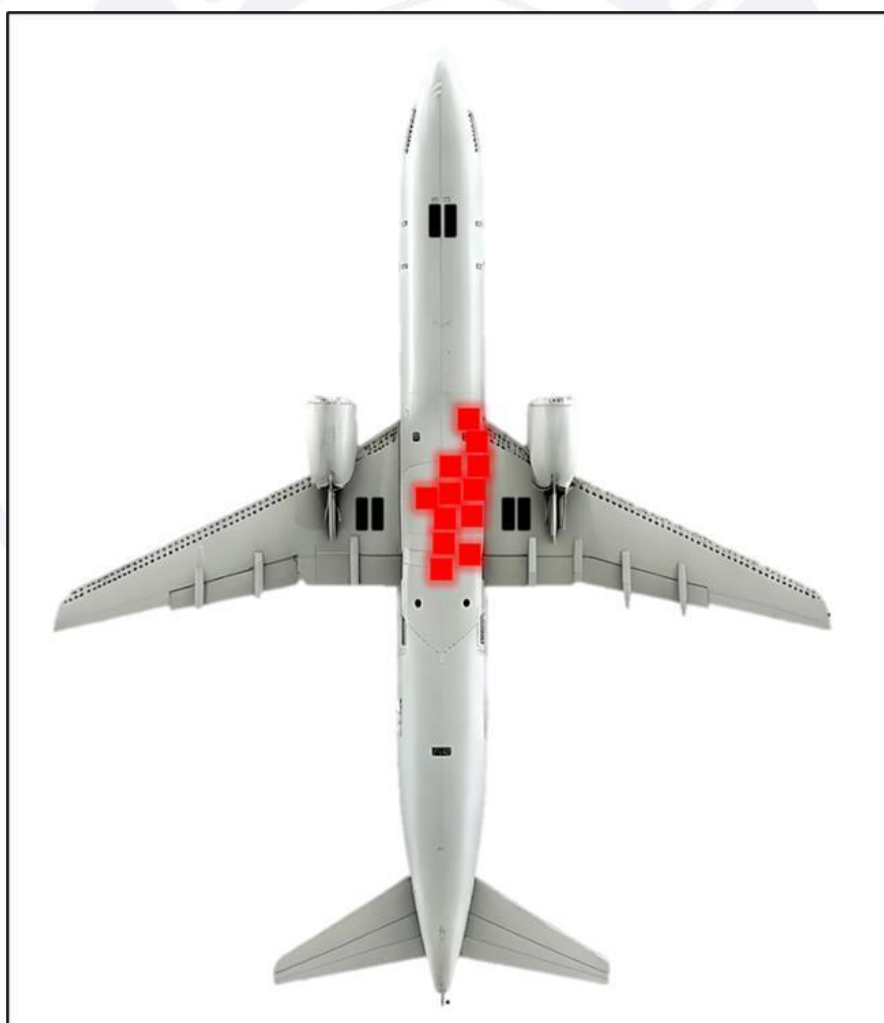
The mapping of damage to the aircraft fairings indicated that the initial impact with the vehicle occurred at the junction of the left wing and the fuselage, subsequently extending along the underside of the fuselage and resulting in damage to zones 191 to 194.

Figure 22 - Mapping of damage to the lower fuselage fairings (zones 191 to 194).

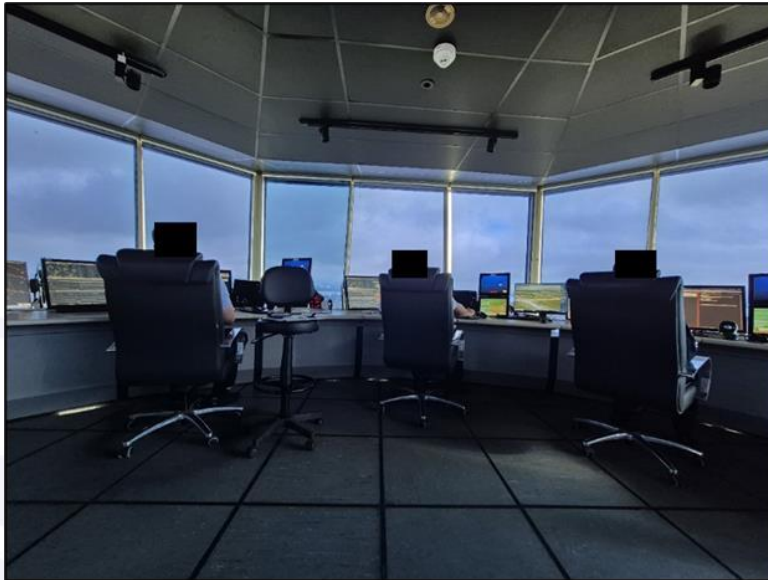
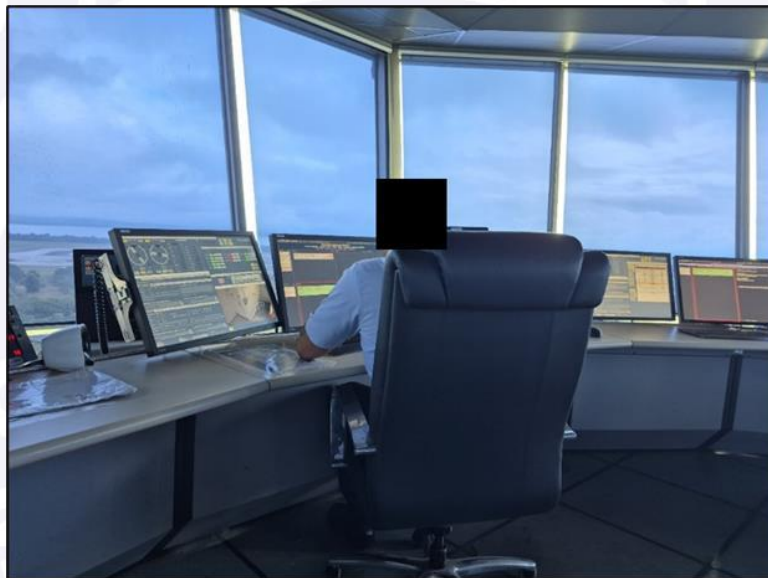
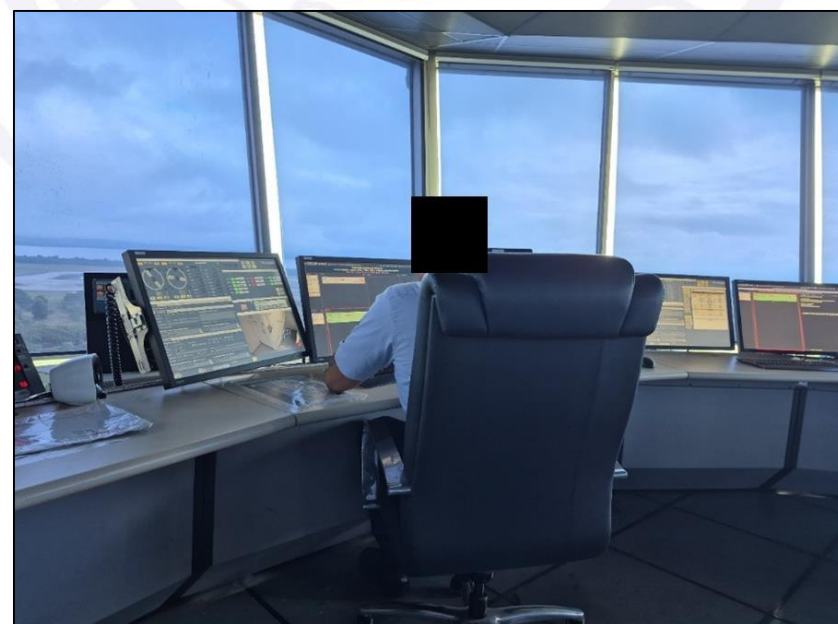
Figure 25 - Chairs used in the TWR-GL control room at the time of the occurrence.

Figure 26 - Chairs used in the TWR-GL control room at the time of the occurrence.

Figure 27 - Chairs used in the TWR-GL control room at the time of the occurrence.

The conditions observed at TWR-GL revealed an inadequate workspace layout, in noncompliance with current regulatory requirements and the operational demands of continuous visual surveillance – particularly those set forth in MCA 63-15 - *Human Factors Manual for Operational Safety Management in SISCEAB* – thereby compromising the effectiveness of direct supervision of the movement areas by the ATCOs.
