FINAL REPORT
A-120/CENIPA/2023

OCCURRENCE:	ACCIDENT
AIRCRAFT:	PS-GVR
MODEL:	AT-502B
DATE:	12AGO2023

This Final Report pertains to the accident involving an AT-502B aircraft, registered as PS-GVR, which occurred on August 12, 2023. The occurrence was classified as “[LALT] Low Altitude Operation.”

During an agricultural pesticide application flight, the aircraft collided with a power transmission line cable. The pilot then executed a forced landing in a plantation area.

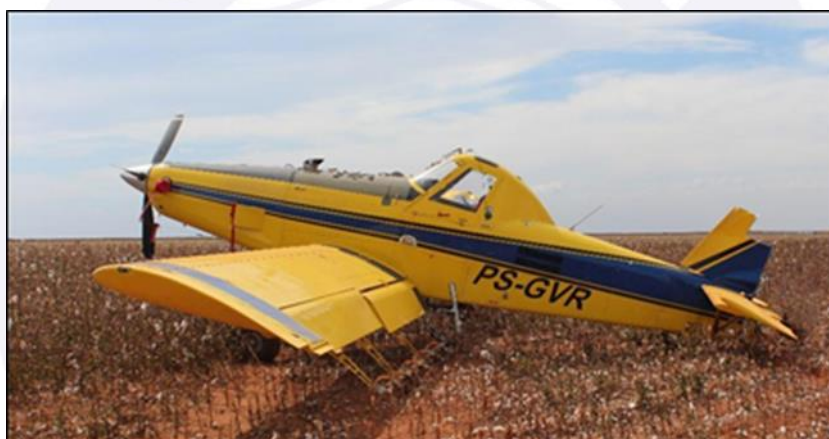
The aircraft sustained substantial damage, whereas the pilot remained uninjured.

Figure 1 – Left-side view of the aircraft after coming to a complete stop.

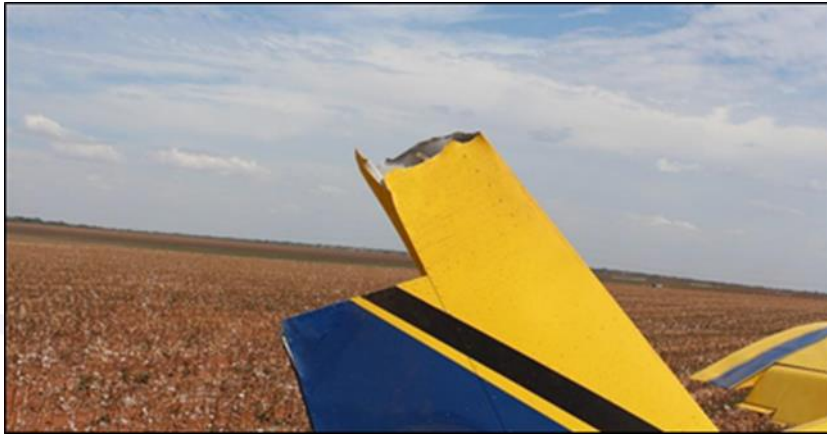
The aircraft sustained substantial damage. Upon impact with the transmission cable, it lost part of the rudder and vertical stabilizer (Figure 2).

Figure 2 – View of the vertical stabilizer.

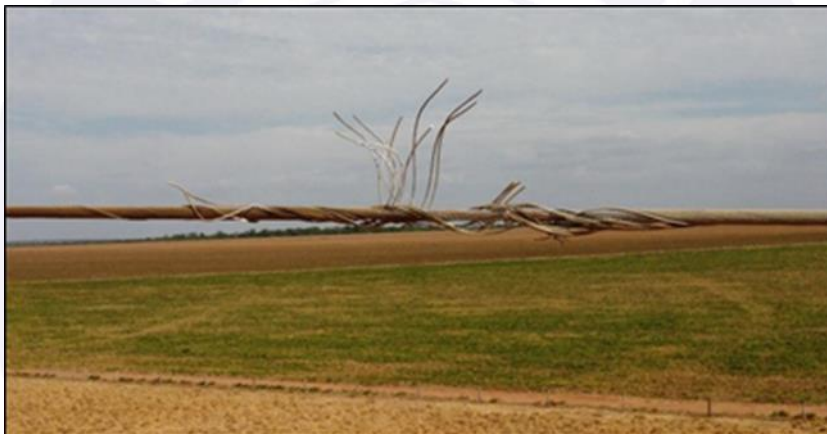
The collision damaged a power transmission cable belonging to *Aliança de Energia Elétrica S.A.*, the public electricity transmission concessionaire, resulting in the emergency shutdown of Circuit Two of the 230 kV *Brasnorte/Nova Mutum* Transmission Line.

Figure 3 – View of the transmission cable after the collision.

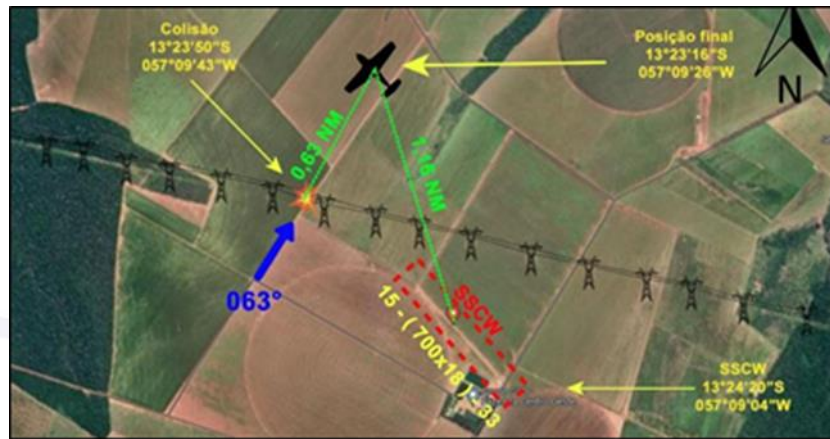
The aircraft was flying on a 063° heading when it collided with a power transmission line cable in the rural area of *Nova Maringá*, State of *Mato Grosso* (Figure 4).

Figure 4 – Sketch of the impact site and wreckage location.

Upon impact with the transmission cable, part of the vertical stabilizer and rudder were torn off. The rudder and the severed section of the vertical tail assembly were found a few meters from the main wreckage concentration site.

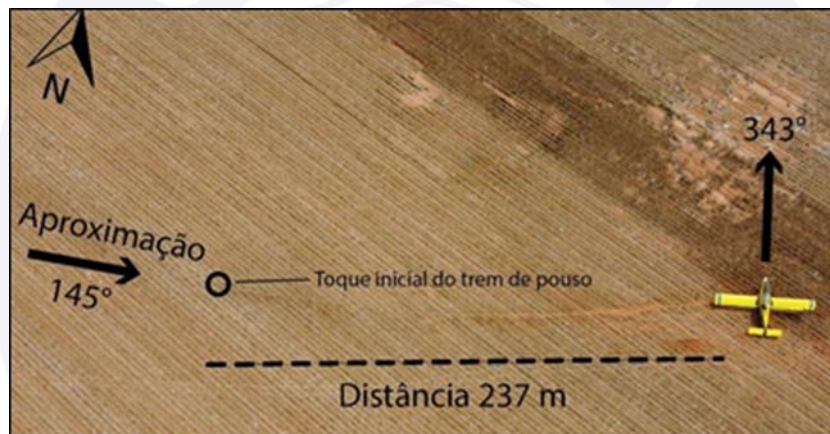
The aircraft approached the landing site on a 145° heading. Upon initial ground contact, it traveled 237 meters, veered left, and came to a stop on a 343° heading (Figure 5).

Figure 5 – Aircraft trajectory during landing.

During ground roll, the right wingtip, flap, right aileron, and right elevator made contact with the terrain, resulting in damage to these surfaces. The tailwheel also fractured and separated.

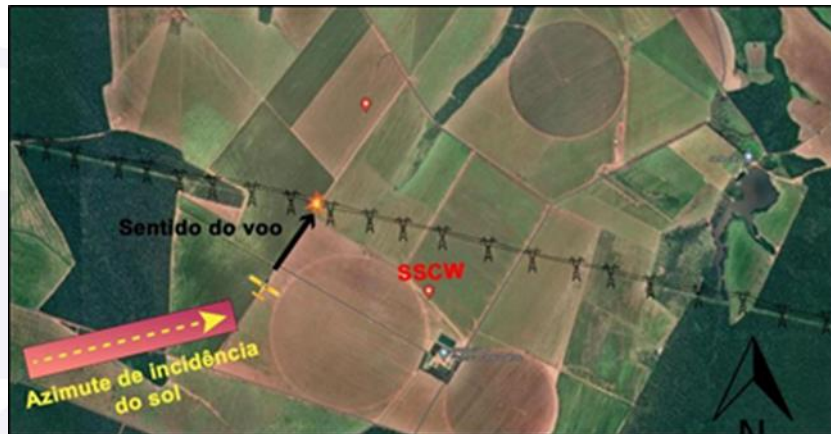
Thus, considering that the aircraft was flying on a 063° heading when it collided with the transmission cable, the sun was behind the pilot, meaning it did not directly impair forward visibility. However, given the time of operation, light conditions were reduced (Figure 6).

Figure 6 – Diagram showing the approximate sun azimuth at the time of the accident.
Source: Adapted from Google Maps.

Furthermore, given the time of the collision, it is possible that the reduced visibility of the obstacle due to low ambient light played a significant role in the accident.

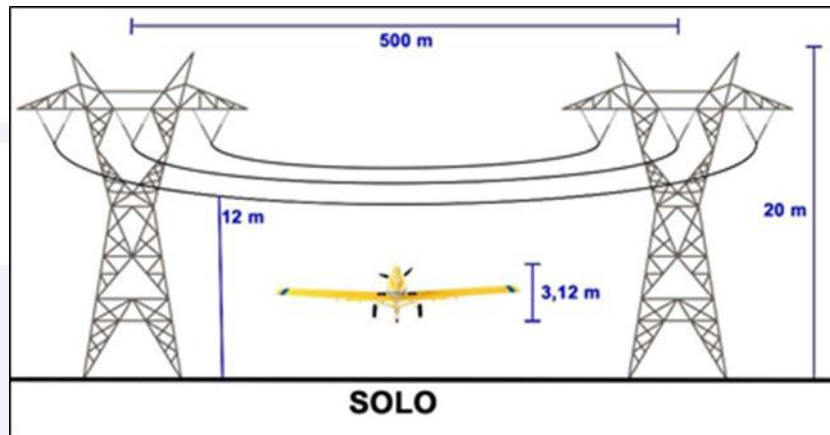
Fazenda Centro Oeste was intersected by a power transmission line with high-voltage towers approximately 25 meters high. These towers supported cables spanning 500 meters, with the lowest cable approximately 12 meters above the ground (Figure 7).

Figure 7 – Diagram of the transmission towers and cable layout.

Upon analyzing the application area and the positioning of the primary obstacle affecting the operation (the transmission line), it was determined that the chosen spray run direction placed the aircraft on a flight path that inevitably intersected the power lines, leading to the collision.

A safer alternative would have been to conduct the spray passes parallel to the transmission line, thereby avoiding the need to cross it and eliminating the necessity of performing a steep turn ("balloon") near the obstacle.

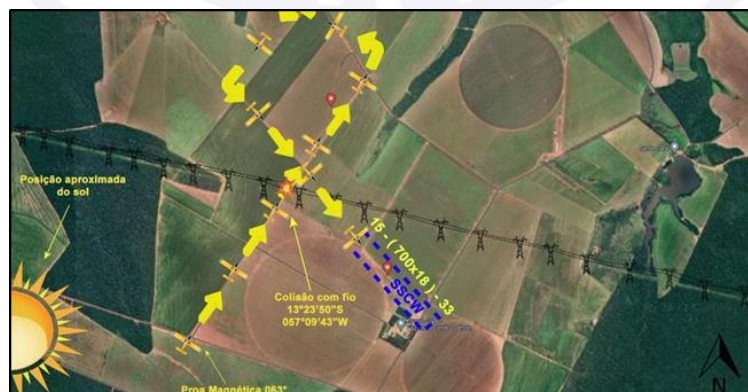
By making left turns, he aligned the aircraft for an approach to runway 15 (Figure 8).

Figure 8 – Diagram showing the trajectory from the impact point with the transmission line to the approach at SSCW. Source: Adapted from Google Maps.
