FINAL REPORT
A-041/CENIPA/2023

OCCURRENCE:	ACCIDENT
AIRCRAFT:	PS-JCB
MODEL:	AT-402B
DATE:	03MAR2023

This is the Final Report of the 03 March 2023 accident involving the AT-402B aircraft of registration marks PS-JCB. The occurrence was classified as “[UIMC] Unintentional IMC and [LOC-I] Loss of Control in Flight”.

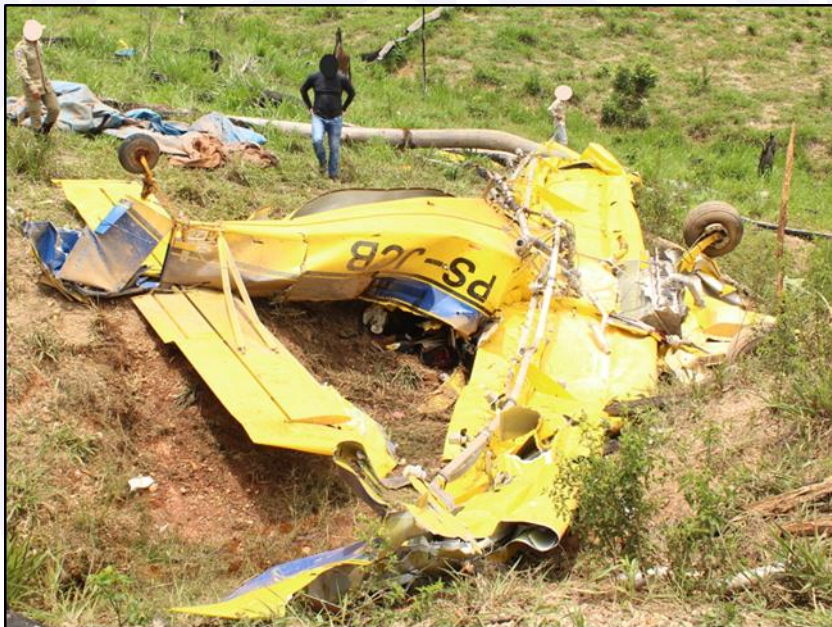
Figure 1 - View of the PS-JCB at the accident site.

The aircraft was destroyed in the crash.

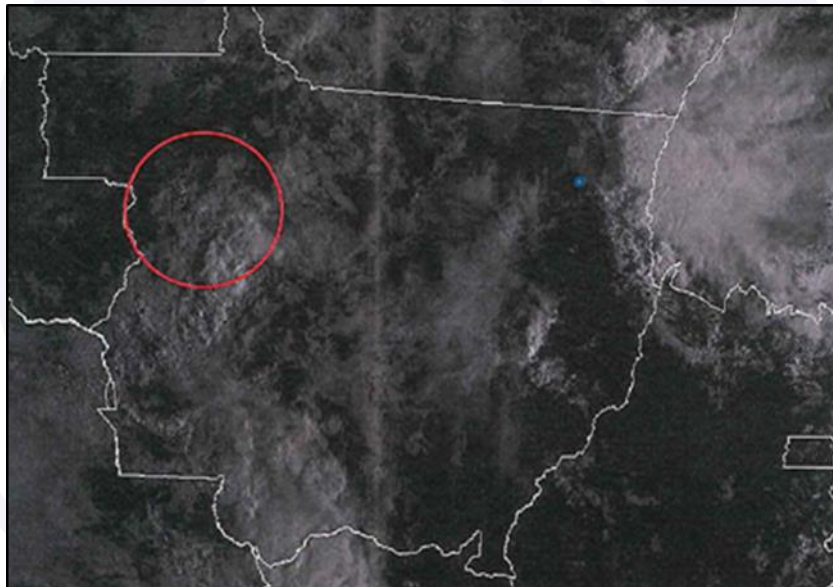
That being said, the GOES-16 satellite image of 03 March 2023 at 1110Z on the Command of Aeronautics' Meteorology Network (REDEMET), made it possible to infer, for the region of the accident (as highlighted in Figure 2), the occurrence of restricted visibility due to presence of fog and low clouds (*stratus - stratocumulus* type) with base between 400 and 600 ft. There was also the possibility of occasional heavy rain showers due to the presence of a TCU (Towering Cumulus) cloud cover.

Figure 2 - Image generated by the GOES-16 satellite. Source: REDEMET.

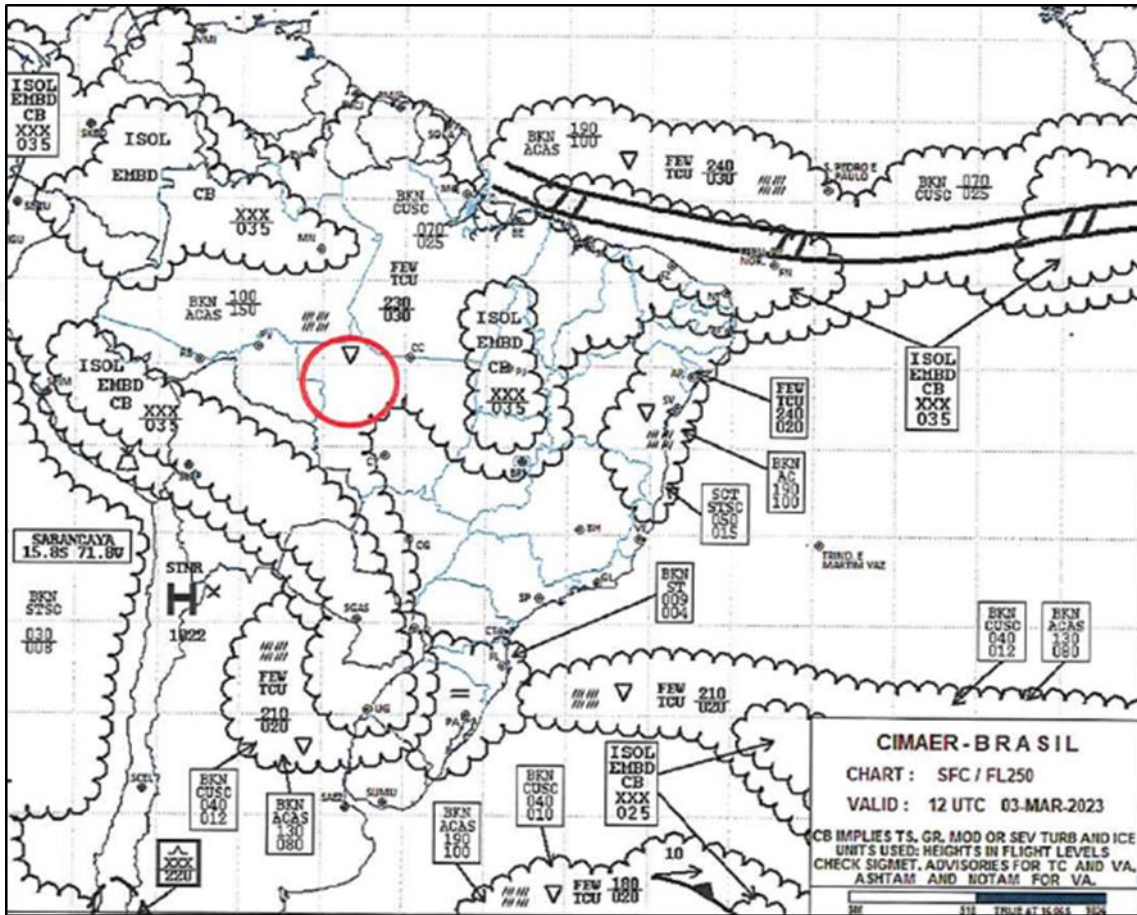
Elaborated by the Command of Aeronautics' Integrated Meteorology Center, and available on the REDEMET website, the SIGWX (Significant Weather Chart), covering from the ground to FL250, valid between 09:00 and 15:00 UTC of 03 March 2023, forecast the following meteorological conditions for the region being analyzed: clouds BKN at 2,500 ft.; BKN at 10,000 ft.; FEW TCU clouds with base at 3,000 ft. and top at 23,000 ft.; extensive areas of precipitation and rain showers (Figure 3).

Figure 3 – 12:00 UTC 03 MARCH 2023 SIGWX chart. Source: REDEMET.

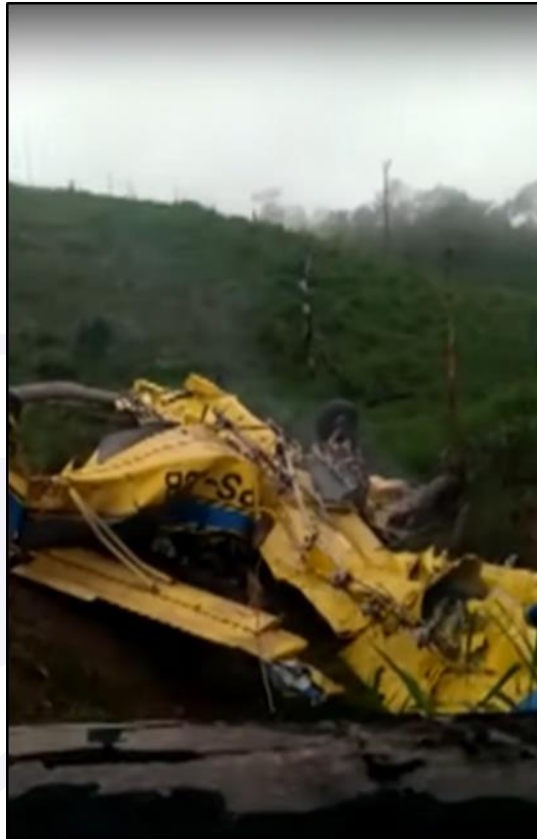
The image of the PS-JCB wreckage in Figure 5 was extracted from a video made by local residents approximately 5 minutes after the aircraft crashed into the ground.

Figure 5 - Image of the PS-JCB extracted from a video made by local residents.

In view of this scenario, one concluded that the enroute meteorological conditions were below the minimums required for VFR operations.

Observers on the ground reported having heard the noise of the aircraft's engine in the middle of the clouds. In addition, a video made by local residents approximately 5 minutes after the aircraft crashed into the ground, confirmed that the weather conditions were below the minima for VFR operations in Class G airspace in which the PS-JCB aircraft was operating. In such airspace, the pilot had to keep the aircraft away from clouds, in visual contact with the ground, and with a horizontal visibility of at least 5 km.

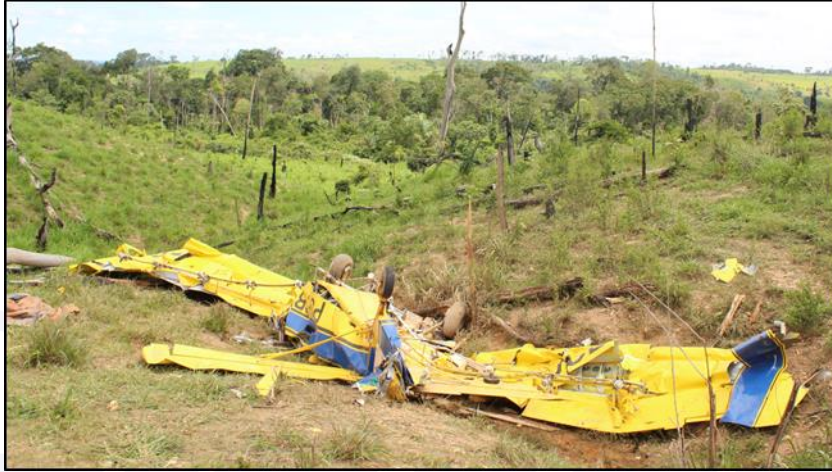
According to the physical evidence at the point of impact, the aircraft collided directly with the ground in an upside-down position, with a high impact angle and speed, and with no indication of a previous impact. The location of the crash site was in the rural area of *Juína*, State of *Mato Grosso*, a region of difficult access.

The wreckage remained concentrated in a depression of the terrain, with the longitudinal axis aligned with the magnetic heading 230°, and with the fuselage on the ground in an upside-down position (Figure 7).

Figure 7 – Position of the wreckage of the PS-JCB.

The front section of the PS-JCB aircraft ended up buried, making it impossible to observe the propeller blades. The power, propeller, and fuel levers, as well as the cockpit instruments, could not be checked due to the extent of the cockpit's destruction.

The front part of the fuselage sustained substantial damage, and the powerplant penetrated the ground. The rear part showed deformation caused by deceleration and impact with the terrain.

There was wrinkling of the leading edges of the wings and considerable denting in the upper part of the cockpit. The flaps were in the retracted position.

From the observed distribution of the PS-JCB aircraft wreckage, it was found that the aircraft collided directly with the ground in an upside down position at a high angle and speed, without any indication of previous impact. Based on this dynamic, one inferred that the aircraft entered a flight path similar to a *Graveyard Spiral*.
