COMANDO DA AERONÁUTICA
CENTRO DE INVESTIGAÇÃO E PREVENÇÃO DE
ACIDENTES AERONÁUTICOS

FINAL REPORT
A-011/CENIPA/2022

OCCURRENCE:	ACCIDENT
AIRCRAFT:	PS-RAF
MODEL:	AT-602
DATE:	20JAN2022

This Final Report refers to the 20 January 2022 accident with the AT-602 aircraft, registration marks PS-RAF. The accident was typified as “[LOC-I] Loss of control in flight”.

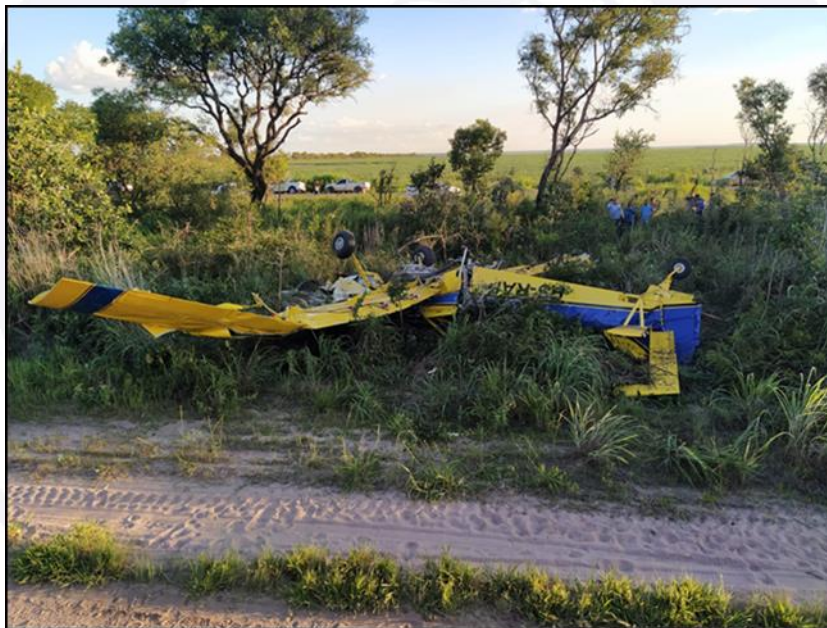
Figure 1 - View of the PS-RAF at the accident site.

The aircraft sustained substantial damage to its entire structure.

There was flexion of the wings, of the fuselage, as well as of the horizontal and vertical stabilizers.

The powerplant sustained serious damage resulting from the impact of the aircraft with the ground.

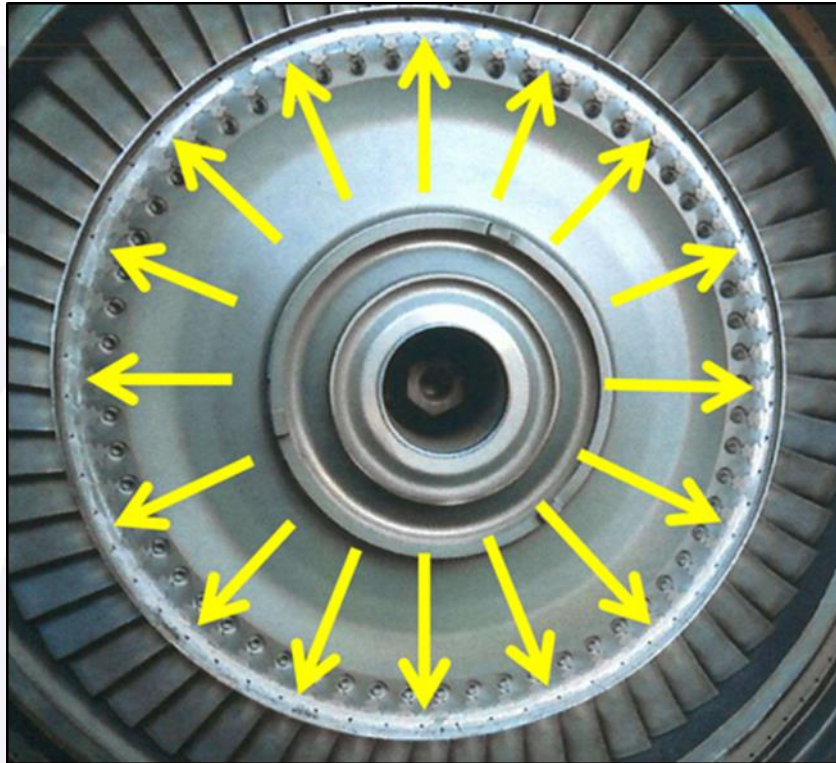
The analysis of the engine revealed rubbing marks on the compressor turbine, on the power turbines, as well as on the anterior and posterior sides of the turbine interstage baffle. (Figure 2).

Figure 2 - Rubbing marks on the roots of the compressor turbine blades.

Thus, the analyses of the SN PCE-PN0466, PT6A-65AG Pratt & Whitney engine, which equipped the PS-RAF aircraft, revealed that it had an operating condition, judging from the observed internal signatures. They also showed that the engine was developing power at the moment of the impact with the ground.

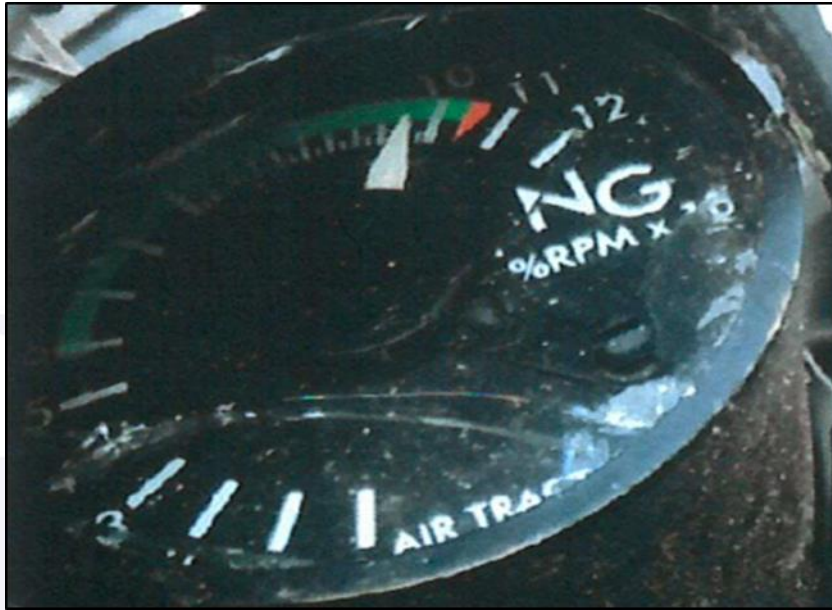
The Figure 3 shows a view of the engine Ng indicator. It was examined, and one found that the pointer was stuck in the position of almost 100%, something indicative of the operating condition of the component at the moment of the collision with the ground.

Figure 3 - Engine Ng indicator.

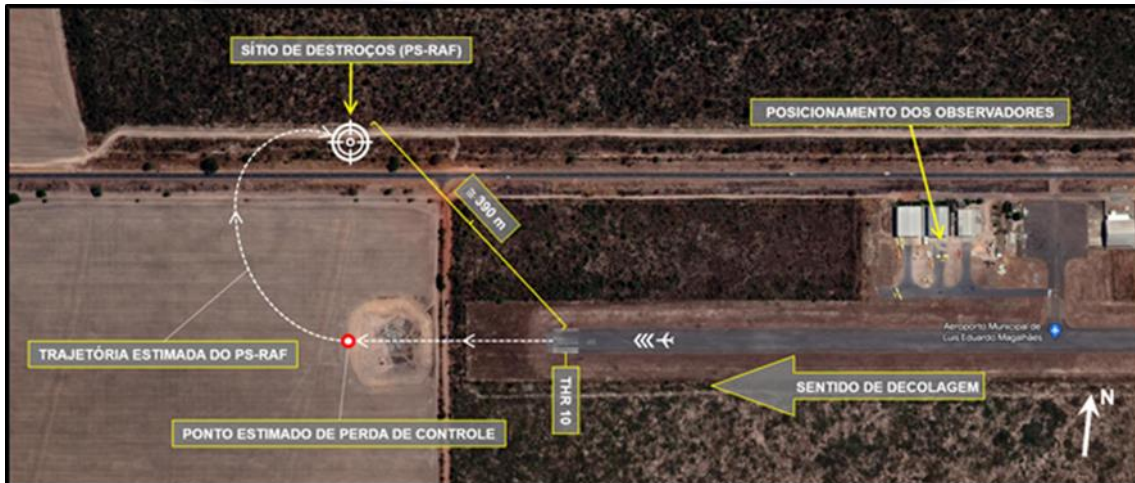
According to reports made by witnesses on the ground, the aircraft (still maintaining the takeoff axis) crossed the departure end of the runway and started climbing with a high pitch-up angle, wings level, until reaching an estimated height between 300 and 500 ft. Then, it performed a rotation of the wings to the right until reaching an upside down attitude. In that condition, according to reports, the plane began to lose height, and ended up colliding with the ground (Figure 4).

Figure 4 - Representation of the estimated dynamics of the accident, based on reports made by witnesses on the ground.

A low takeoff was performed in the direction of the departure end of the runway. Upon crossing the runway's longitudinal limit, the aircraft began a climb at a high pitch-up angle, wings level, until reaching an estimated height between 300 and 500 ft. Then, an abrupt maneuver was performed until the aircraft reached an upside-down flight attitude. In that condition, control of the aircraft was lost, and the airplane lost height until colliding with the ground.
