COMANDO DA AERONÁUTICA
CENTRO DE INVESTIGAÇÃO E PREVENÇÃO DE
ACIDENTES AERONÁUTICOS

FINAL REPORT
IG-053/CENIPA/2022

OCCURRENCE:	SERIOUS INCIDENT
AIRCRAFT:	PS-RJJ
MODEL:	PA-46-600TP
DATE:	19ABR2022

This is the Final Report of the 19 April 2022 serious incident with the PA-46-600TP airplane, registration marks PS-RJJ. The occurrence was typified as “[SCF-PP] Power Plant failure or malfunction – Engine failure in flight.”

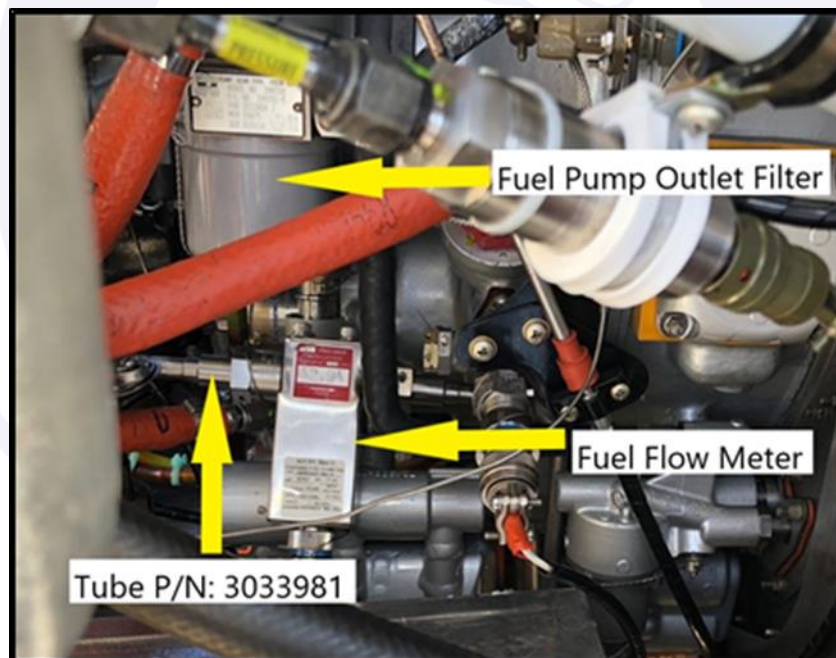
The Fuel Pump Outlet Filter location was close to the PN 3033981 fuel line, which connected the FCU to the Flow Meter (Figure 2).

Figure 2 - Image of the engine compartment showing the layout of the Fuel Pump Outlet Filter and the PN 3033981 fuel line.

Given the proximity of the fractured fuel line to the fuel outlet filter, one considered that the deformation observed in the ferrule at the end of the tube closest to the FCU may have been caused during a maintenance procedure on the mentioned filter.

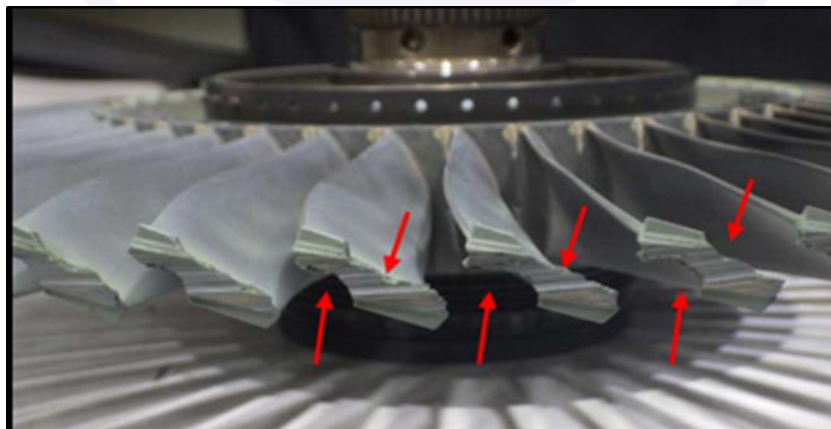
The engine was found with the power section seized. It was observed that there was rubbing between the tips of the second stage turbine blades and the sealing ring, signs that were consistent with a condition of interference between these parts of the engine.

Figure 6 - Power turbine blades with rubbing marks.

During the examination of the engine internal components, one found that there was rubbing between the tips of the second-stage power turbine blades and the sealing ring, which is consistent with a condition of interference between these parts of the engine.

Specifically, regarding the rubbing of the power turbine blades and their subsequent seizure when the engine shutdown occurred in flight, its hot section did not cool down as it should, as it would normally happen during a regular shutdown. Consequently, the accumulated heat kept the turbine assembly in an expanded state for a longer period compared to the adjacent parts closer to the engine's outer casing, which contracted, resulting in contact between these parts, as well as in the observed damage.

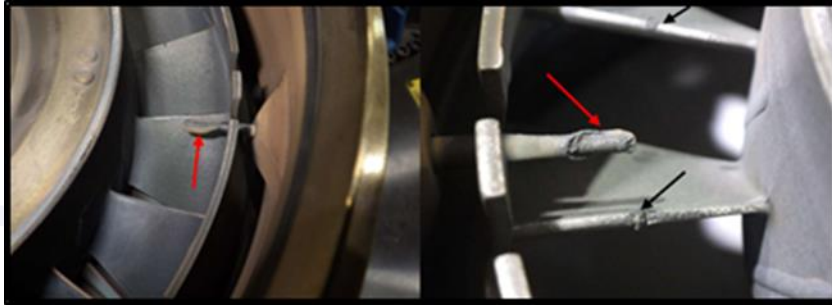
The ITT sensors, as well as the power turbine itself, showed damage, deformations, and discoloration consistent with exposure to excessive heat.

Figure 7 - Inter turbine temperature sensors showing deformations compatible with exposure to high temperatures.

In addition, there was evidence of overheating, particularly indicated by the persistent deformations of the ITT sensors and the discoloration observed inside the turbines.

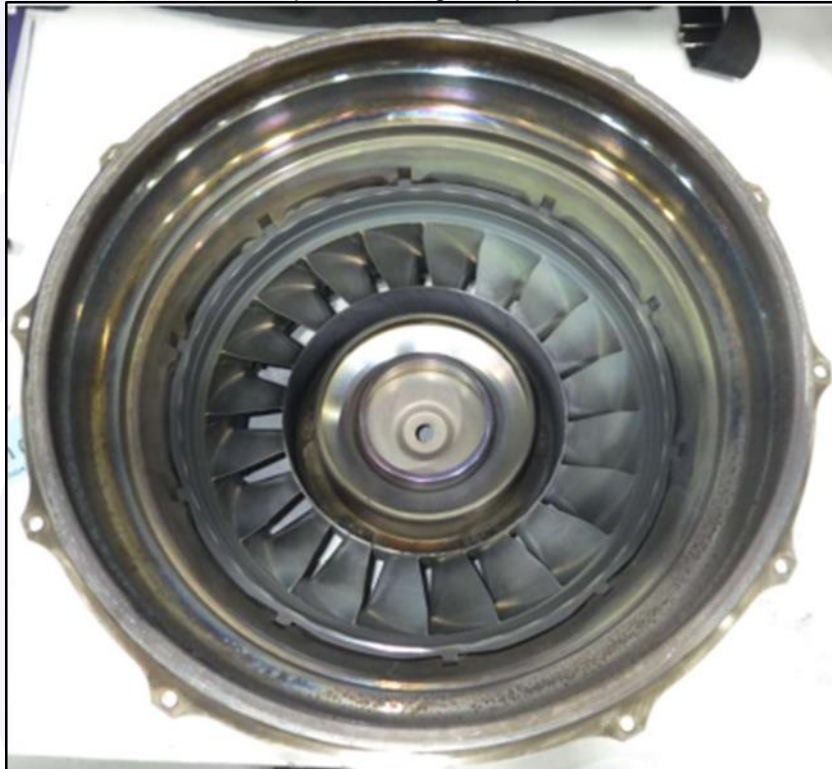
Figure 8 – turbine with discoloration compatible with exposure to high temperatures.

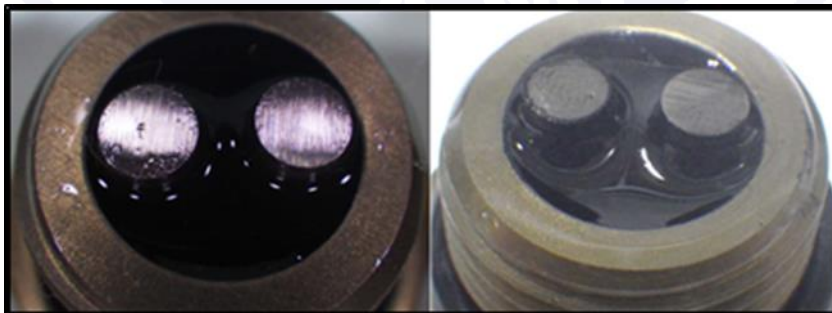
There were no metallic particles on the chip detectors' magnets of the reduction gearbox, nor in the engine's main oil filter.

Figure 9 - Chip detectors of the reduction gear box (on the left) and of the accessory gearbox (on the right).

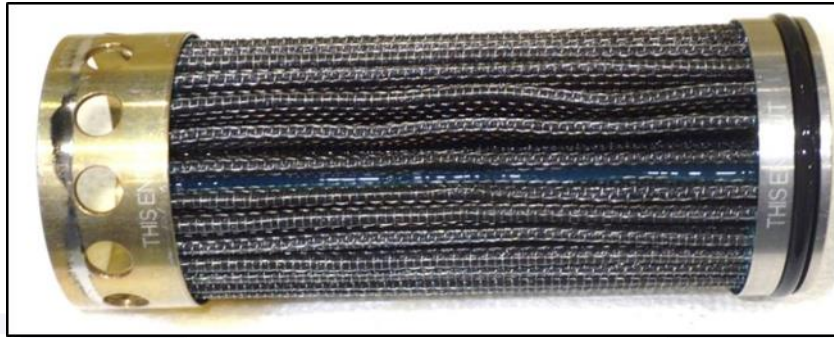
Figure 10 – Engine oil filter.

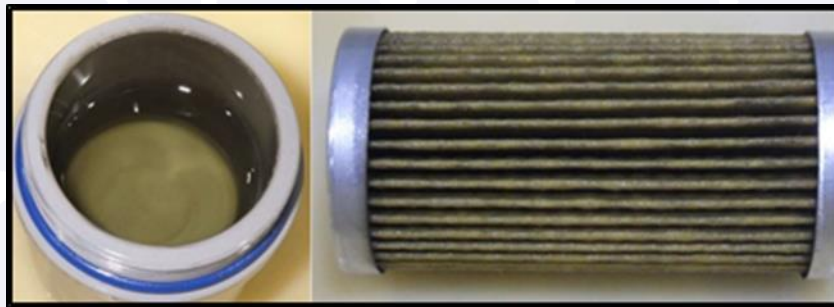
The fuel filter showed no signs of contamination of the QAv.

Figure 11 – Fuel filter.

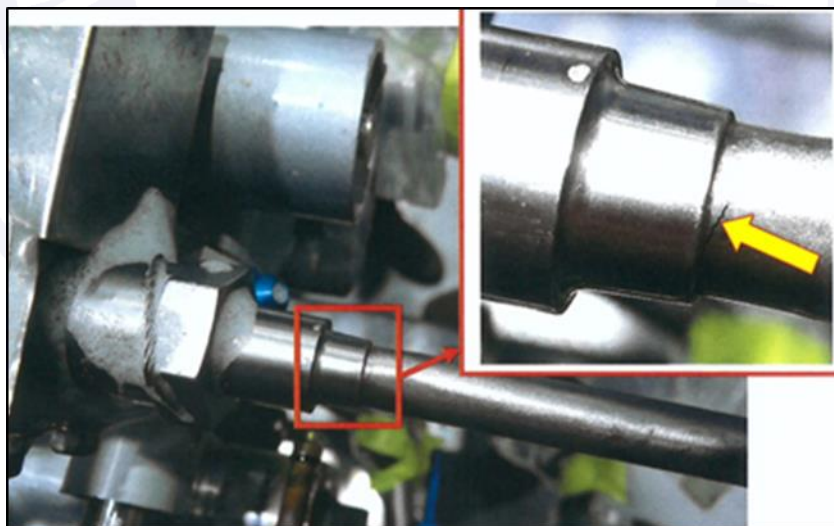
However, during the inspection of the PN 3033981 fuel line, a leak was found at the point where it connected to the fuel flow meter, an area where a crack was discovered.

Figure 12 – A crack in the fuel line.

Thus, it was concluded that the condition found (fracture in the fuel line) caused the leakage of aviation kerosene (QAv) and compromised the engine's operation during the flight.

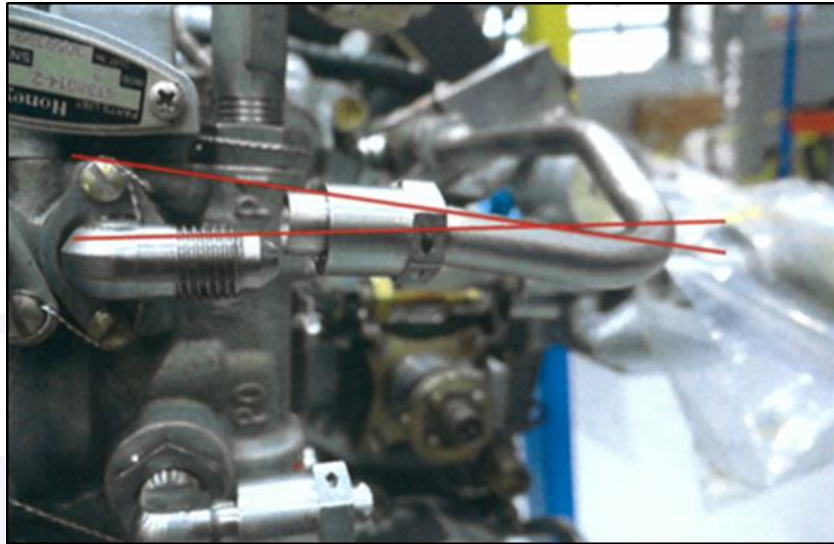
This component was disassembled to be sent for laboratory examination. During the disassembly, a misalignment between the fuel line and its connection to the FCU was observed, on the opposite end of the area where the fracture was found.

Figure 13 – Misalignment between the fuel line and its connection to the FCU.

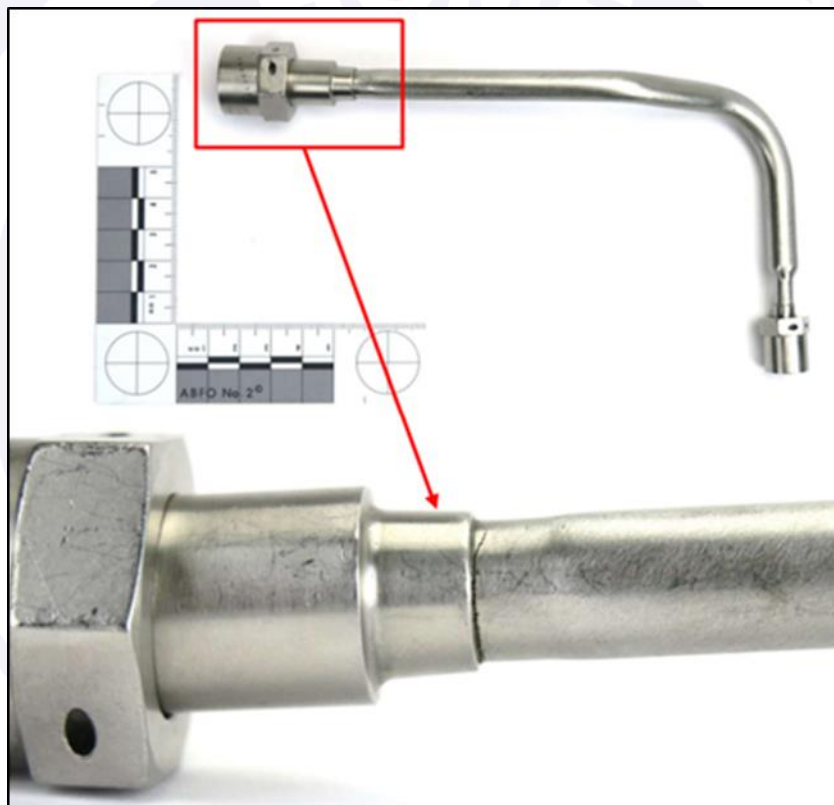
Laboratory examinations of the PN 3033981 fuel line showed that the fracture found at the connection to the fuel flow meter propagated approximately 150° around the circumference of the tube.

Figure 14 – Detail of the fracture found in the fuel line.

The fracture occurred in only one of the semicircumferences of the fuel line, a condition consistent with a situation of stress on the tube in a specific direction.

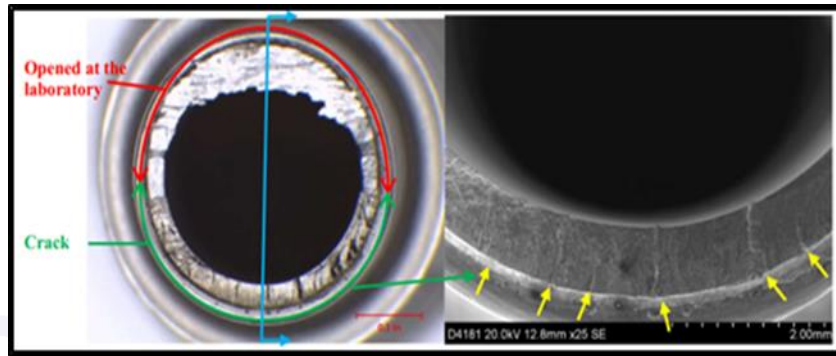
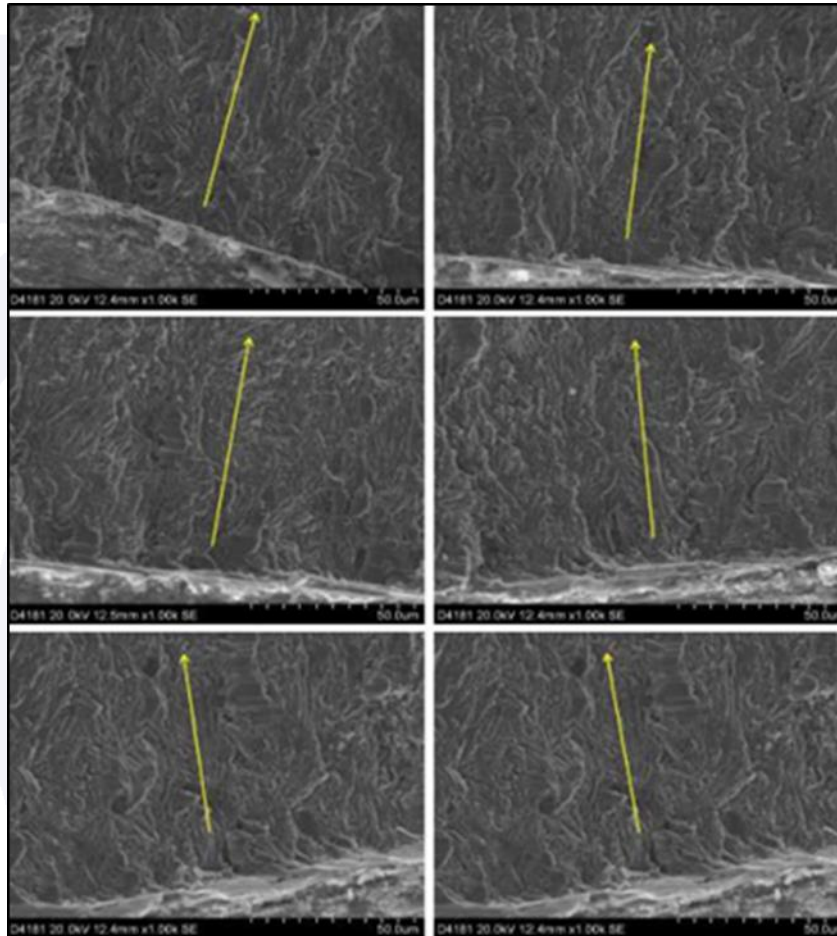
The yellow arrows in Figures 15 and 16 show multiple ratchet marks, indicating different points of origin for the fracture, a condition consistent with a failure that started in a region of stress concentration.

Figure 15 – Image of the laboratory examinations of the fracture.

Figure 16 – Image of the fracture examinations under the microscope.

The fracture propagated through the cross-section of the fuel line. The image produced during the microscopic examinations indicated relatively low cyclic stresses, consistent with a High Cycle Fatigue (HCF) process.

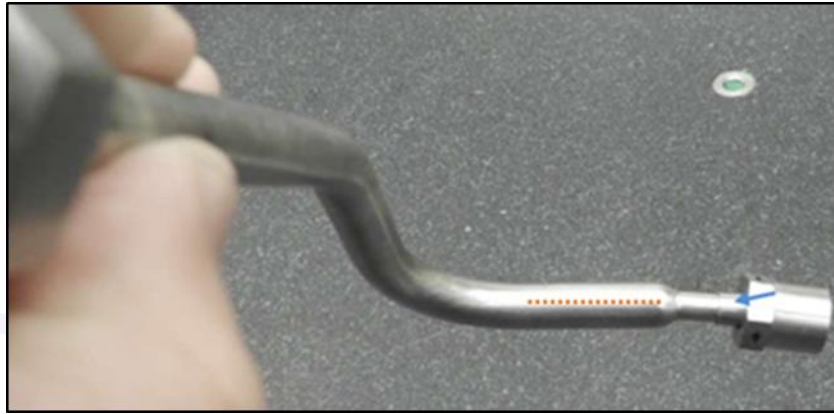
Measurements taken on the fuel line showed the component dimensions were in accordance with the manufacturer's specifications, except for a deformation found in the metal ferrule at the end closest to the FCU (the opposite end from where the fracture was found).

Figure 17 – Deformation at the end of the fuel line closest to the connection with the FCU.

The deformation was consistent with a stress-generating condition in the fuel line that could trigger a high cycle fatigue (HCF) process.

The deformation observed in the metal ferrule, which could lead to stress concentration and result in a high cycle fatigue (HCF) process, may have been caused by an intentional or unintentional displacement of the PN 3033981 tube during the execution of the aircraft maintenance service.

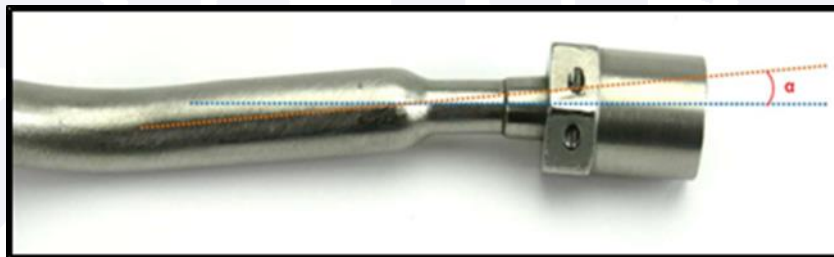
The angle of the deformation encountered (α in Figure 18) was estimated to be 5.62° .

Figure 18 – Angle of deformation (α).

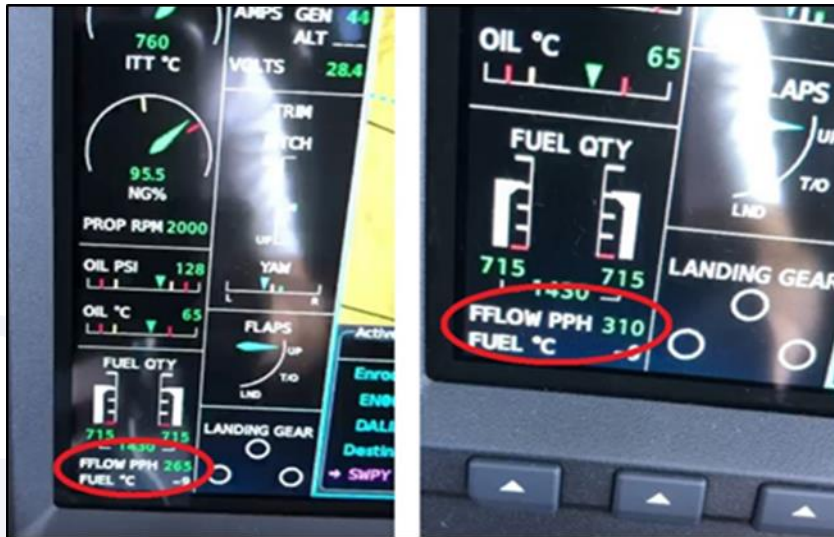
The aircraft performed uneventfully during takeoff, climb and levelling off. The PIC later reported having noticed variations in the engine fuel flow while cruising at FL280, at which point he took a picture of the numbers displayed on the aircraft's panel.

Figure 19 – Images obtained by the pilot after the aircraft levelled off, showing fuel-flow indications at two distinct moments highlighted in red ovals.

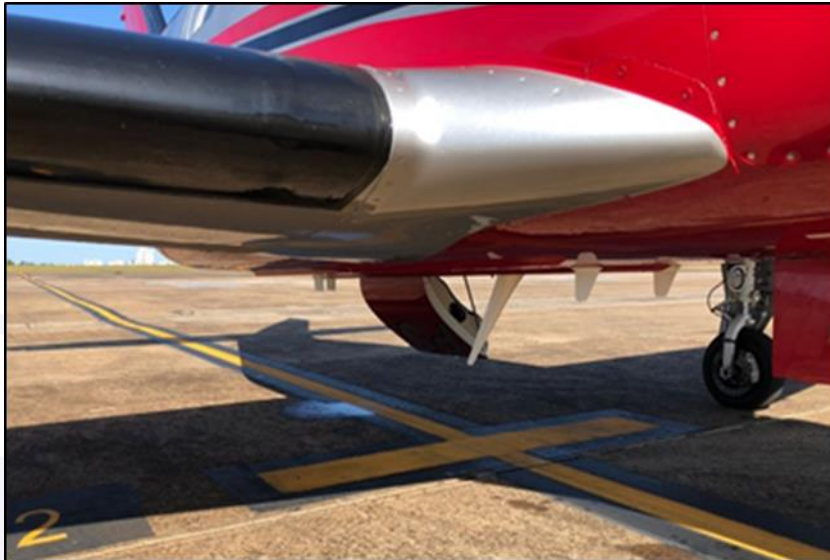
After the aircraft landed, accumulation of fuel could be observed inside the engine cowling, as well as on the floor of the parking area, as shown in the figure below (Figure 20).

Figure 20 – The aircraft after landing in SBLO.
