**FINAL REPORT**  
**A - 027/CENIPA/2019**

| <b>OCCURRENCE:</b> | <b>ACCIDENT</b> |
| <b>AIRCRAFT:</b> | <b>PT-AIG</b> |
| <b>MODEL:</b> | <b>GC-1A</b> |

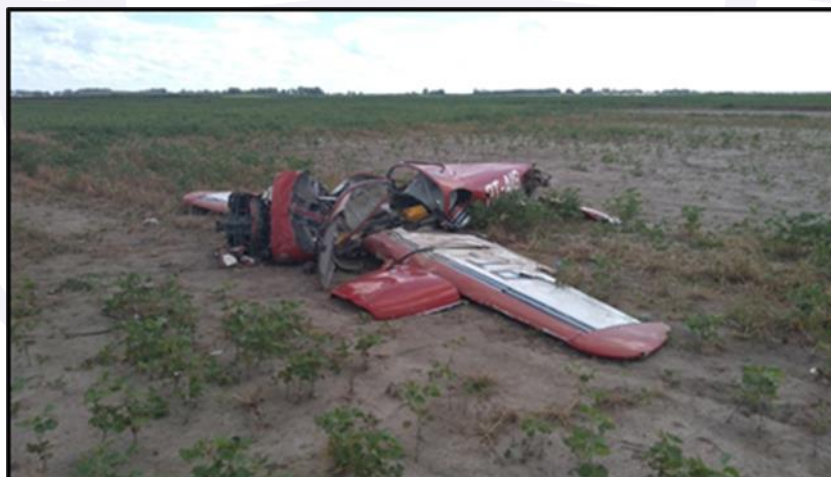
The aircraft had substantial damage to its entire structure.

Figure 1 - Situation of the PT-AIG aircraft after the accident.

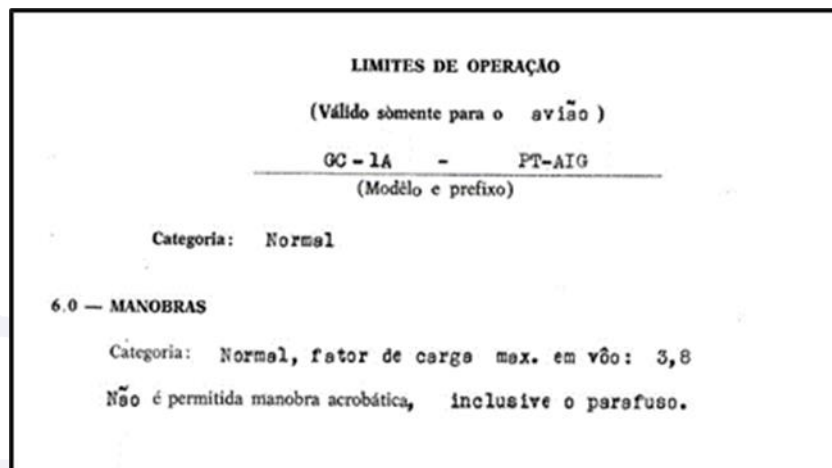
According to this Annex, the aircraft was certified in the normal category and could not perform aerobatic maneuvers, including spin (Figure 2).

Figure 2 - Extract from the PT-AIG Operating Limits Sheet.

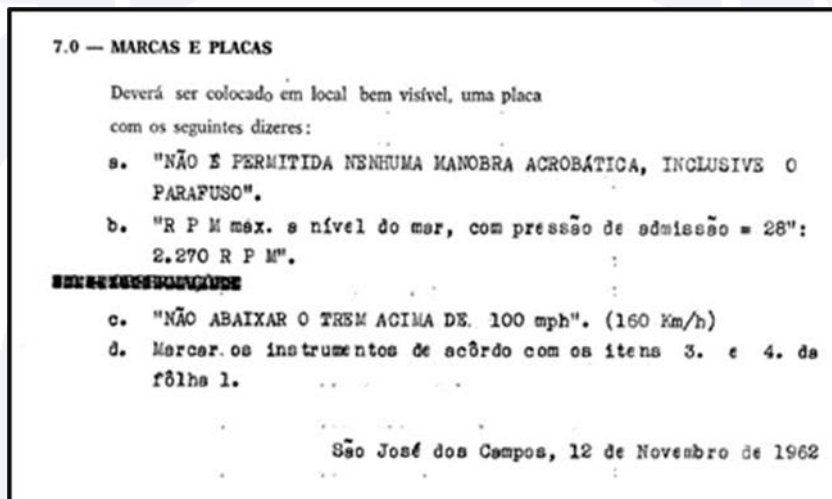
The same document required that a plate be affixed, in a visible place, containing this prohibition (Figure 3).

Figure 3 - Marks and plates required for the operation of the PT-AIG aircraft.

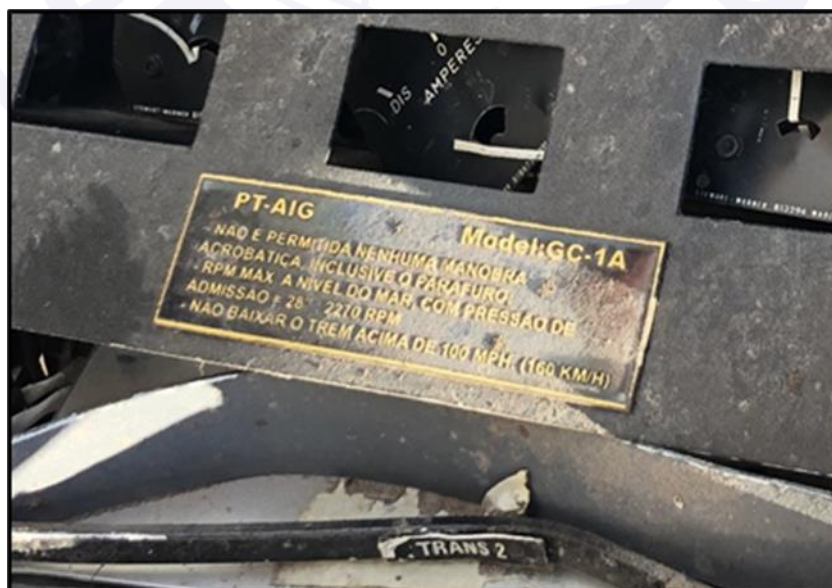
During the beginning of the field investigation, it was verified that the aforementioned plate was properly applied to the aircraft panel (Figure 4).

Figure 4 - Plate affixed to the aircraft panel.

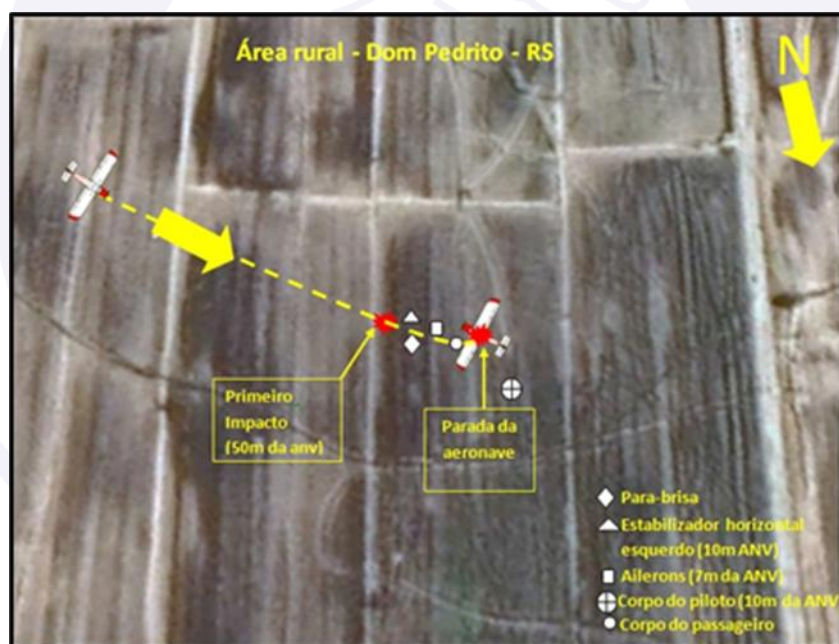
The first impact occurred 50 meters from the place of total stop. The distribution of the wreckage was of the concentrated type. After this first collision with the ground, the aircraft tipped over and stopped in the opposite direction of the flight path (Figure 5).

Figure 5 - Sketch of the final trajectory and position of the aircraft wreckage.

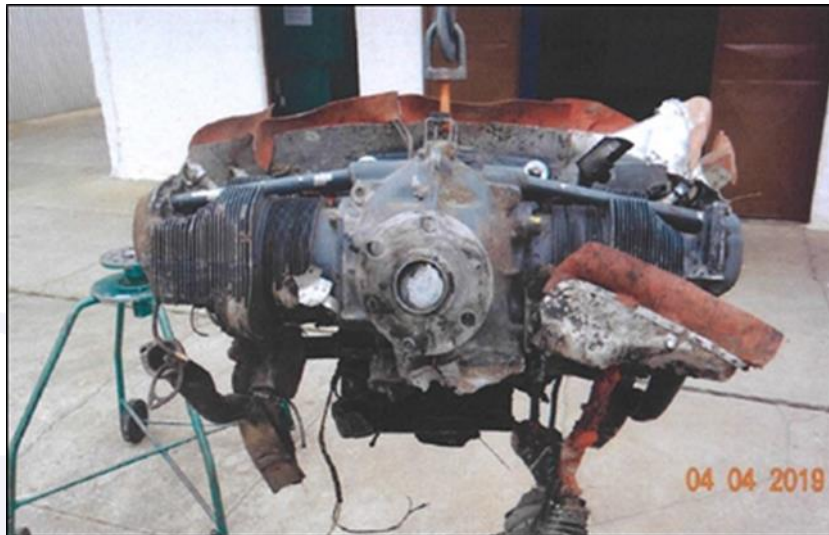
The propeller had severe damage from the impact of the aircraft against the ground (Figure 6).

Figure 6 - Front view of the engine.

The crankcase and the carburetor broke during the collision and parts of them came off, which made it impossible to carry out functional tests on the carburetor.

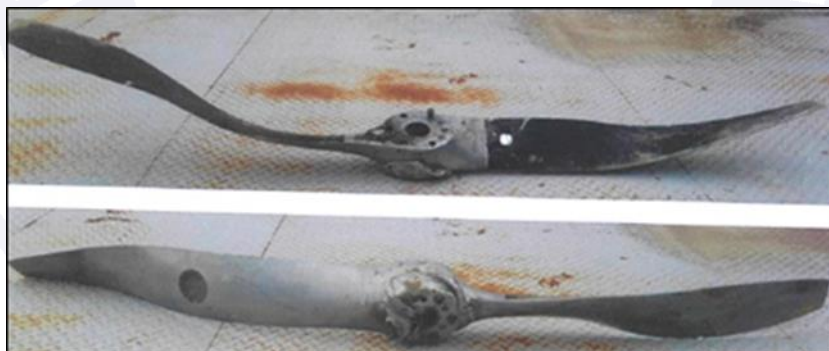
One of the propeller blades had a forward bend at its end, indicating normal engine operation with power development (Figure 7).

Figure 7 - Views of the propeller.

From the examinations carried out on the engine that equipped the aircraft, it was concluded that the severe damages presented were due to the impact that had occurred and that the analyzed components indicated that the propeller was operational and developed power normally.

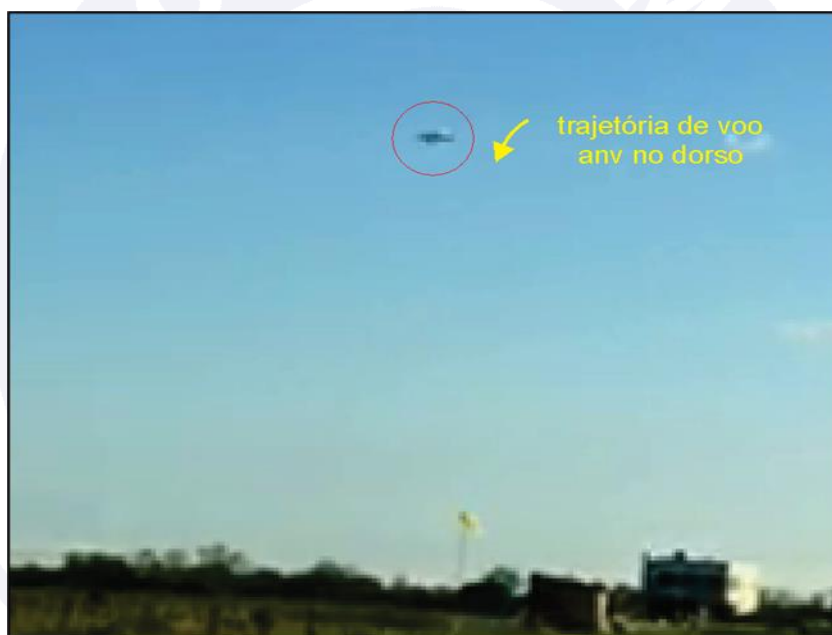
A video recorded by observers showed the aircraft at low altitude, on its back, in a downward trajectory, followed by a strong "pull" (Figure 8).

Figure 8 - Aircraft in abnormal attitude before the impact.
